Article

Neutron Radiography Study of Laboratory Ageing and Treatment Applications with Stone Consolidants

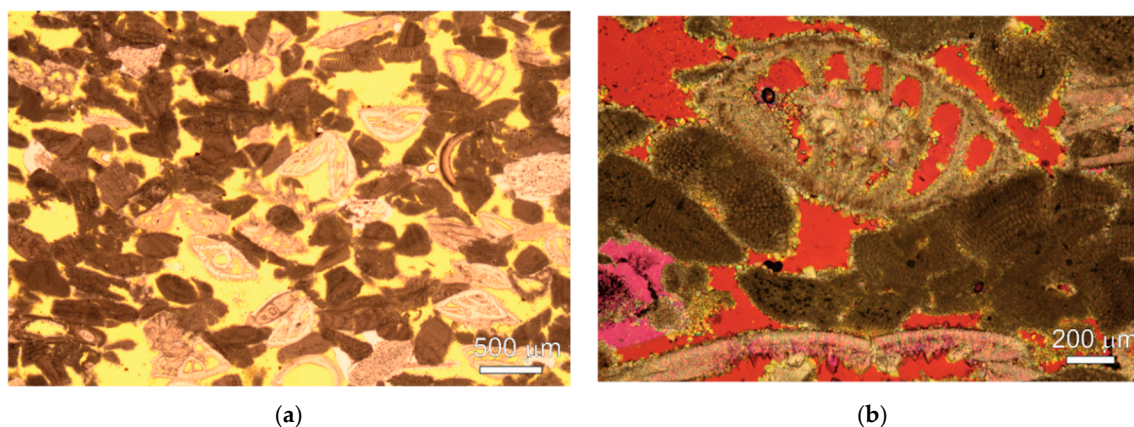
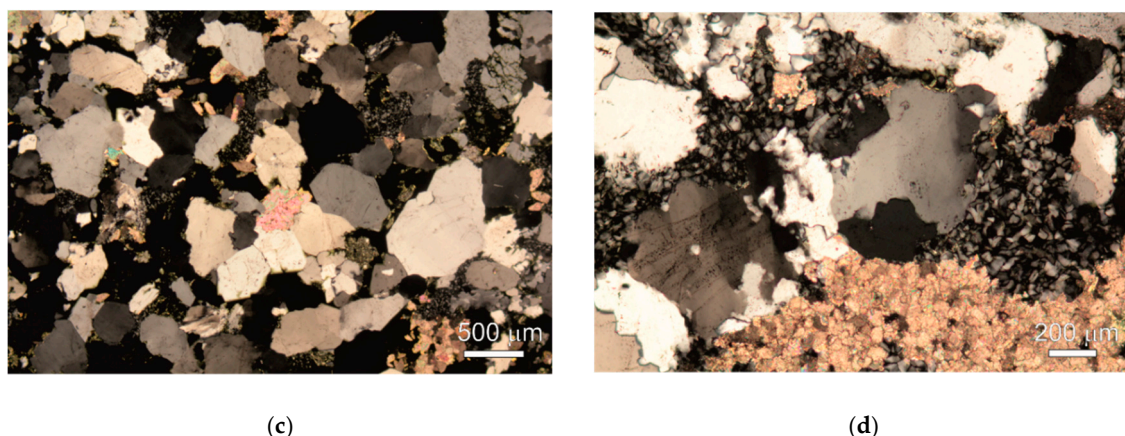
Figure 1. Micrographs of the stone fabric taken with a polarized light microscope: (a) Fabric of St. Margarethen Limestone with nearly equally distributed debris of coralline red algae and rotaliide foraminifers; (b) detail of the so-called dogtooth cement displayed as yellow binder between the microfossils; (c) fabric of Schlaitdorf Sandstone mainly consisting of quartz beneath feldspar and carbonate (pinkish colour), with planar to lobate grain boundaries, and (d) detail of the grain boundaries, the kaolinite matrix and sparitic carbonate.

Miocene (Langhian) calcareous arenite, known as St. Margarethen Limestone, can be classified as a porous grainstone or biosparite [41]. This limestone has been extracted from Roman times through to today in the quarry of St. Margarethen in Burgenland, Austria. It mainly consists of debris from coralline red algae, beneath foraminifers, and debris of echinoids and bryozoans, as well as traces of quartz and muscovite from the metamorphic geological hinterland. The cementation can be classified as early diagenetic fine-grained dogtooth calcite. The grainsize distribution can be described as nearly equigranular and moderate to well sorted. The mean grainsizes range from 0.5 to 1 mm, and the total porosity is between 25 to 30 vol.%. Additionally, larger fossils such as rhodolithes, oyster shells and skeletons of sea urchins up to several centimetres in size can be observed.

The Triassic (Keuper) lithotype, known as Schlaitdorf Sandstone, can be classified as a porous medium-grained siliciclastic arenite, which has been quarried since Roman times through to today in the province of Baden-Württemberg in Germany. This sandstone mainly consists of quartz (~72%), feldspar (~2%) beneath dolomite spar and calcite (~8%) and lithic fragments (~12%), as well as a clayey matrix which mainly consists of kaolinite (~6%) and traces of illite. The grainsize distribution can be described as well sorted, with an average grainsize of about 0.5 mm. The mean pore radius is about 3 µm, with a total effective porosity of approximately 20 vol. % [42].

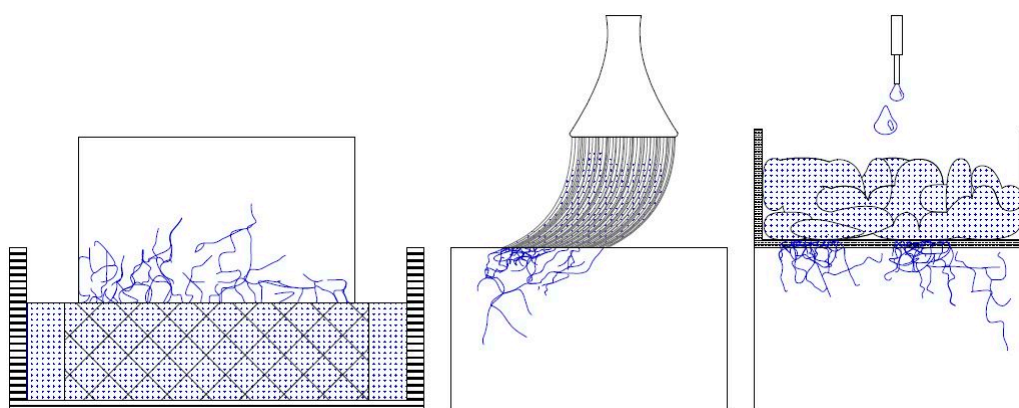
Figure 2. Schematic representation of application techniques used to consolidate stone specimens. Capillary absorption for one hour (**left**), brushing with 10 strokes (**middle**), and poultice, where a cellulose pulp packed in Japanese paper was placed on the stone surface for 1 h (**right**).

In total, 60 specimens with dimensions of 2 cm × 2 cm × 5 cm were washed with deionized water, dried at 50 °C until they reached a constant mass and kept under laboratory conditions for 24 h before the treatment application. The dry mass of the stone specimens was recorded before the treatment procedure. For each studied condition (sound, aged and consolidated), three specimens were used for both lithotypes (see Table 1). The consolidants were applied by capillary absorption, brushing and poultice (see Figure 2).

Treatment by capillary absorption was performed by placing the samples in contact with the consolidants for one hour. The specimens were placed on a wide meshed plastic grid, allowing the absorption of the products to take place from one side by capillary forces. The consolidant was refilled to assure a constant contact with the treated surface, making sure that no immersion of the specimen occurred through the lateral sides of the specimens. For such purposes, a wider box filled with consolidants was suitable. In the case of capillary absorption treatment with the product NC-12C, pre-wetting with ethanol was conducted. The aim of such pre-treatments was inspired by on-site work. Apparently, a pre-treatment using the corresponding solvent of the product allows a deeper penetration of the consolidants into the stone and avoids glossiness through particle efflorescence at the surface. Moreover, a so-called over-consolidation in the case of the capillary absorption specimens treated with the product NC-25C was mimicked by repeating the procedure three days in a row. In the case of over-consolidation, the sample was left under laboratory conditions between the application cycles (T: 20 °C ± 3 °C and RH: 55% ± 3%), where a chemical reaction might already have started.

Treatment application by brushing was done following the recommendations reported in the literature [44], by a continuous application of 10 strokes onto the stone surface. Concerning consolidation with NC-12C, one set of specimens was pre-wetted with ethanol, while a second set was consolidated without pre-wetting. The aim of such a procedure was to compare the possible influences of the pre-treatment on the behaviour of water absorption by capillarity. Pre-wetting with ethanol was completed by brushing the surface 10 times in a row.

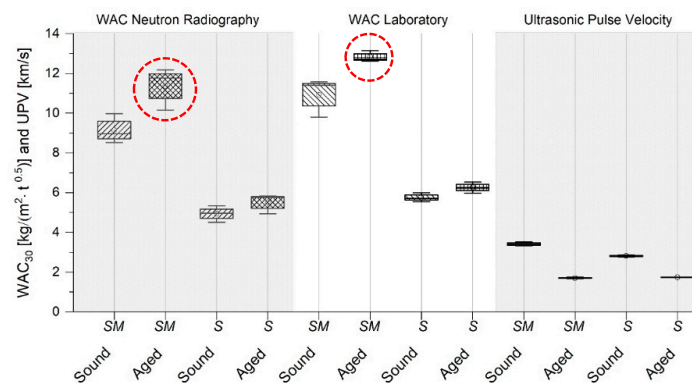
Figure 3. The effect of thermal ageing on St. Margarethen Limestone (SM) and Schlaitdorf Sandstone (S) determined by the water absorption coefficient after 30 min, as well as the ultrasonic pulse velocity before (**sound**) and after artificial ageing (**aged**). WAC was calculated from image analysis obtained from neutron radiographs and gravimetric laboratory analysis. The corresponding values can be extracted from Supplementary Materials, Table S1.

The impact of heat treatment on artificially aged stone substrates prior to consolidation was successfully evaluated by neutron radiography, the water absorption coefficient and the ultrasonic pulse velocity (see Figures 3 and 4).

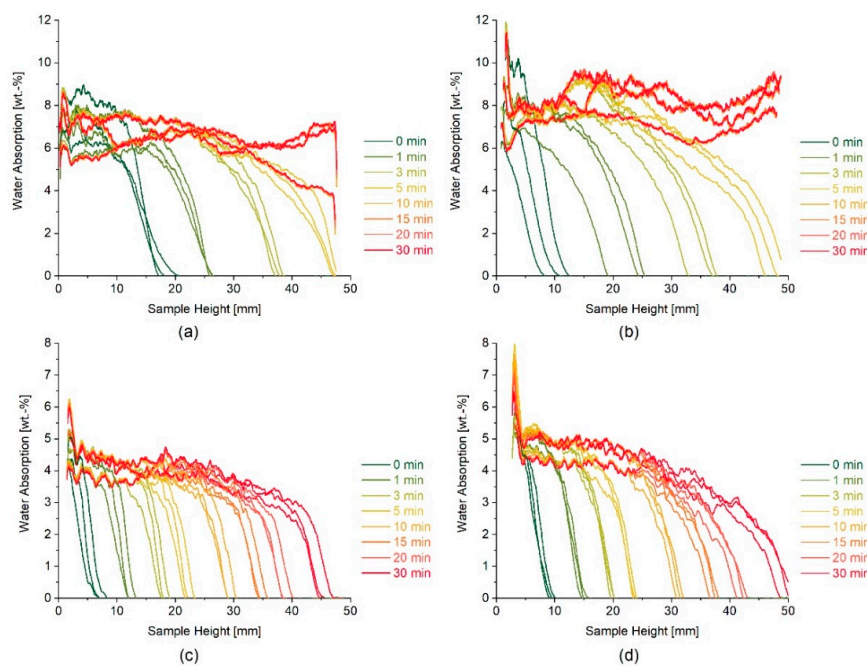
Figure 4. Neutron studies of sound (a) and artificially aged (b) water absorption kinetics (reported as wt. % and as a function of the sample height at intervals of 1, 3, 5, 10, 15, 20, 25 and 30 min) for three stone specimens of St. Margarethen Limestone, as well as sound (c) and artificially aged (d) water absorption curves of three stone specimens of Schlaitdorf Sandstone.

Neutron radiography was able to detect changes in the speed and amount of water absorption in the case of both lithotypes due to the inducement of micro cracks. The speed of capillary suction was slightly higher for aged compared to sound stone specimens (Figure 4a–d). In the case of St. Margarethen Limestone, after ageing there was a wider spread in kinetics of absorbed water, indicating that the induced micro cracks resulted in a more inhomogeneous substrate. On the contrary,

in the case of Schlaitdorf Sandstone, the recorded speed was more uniform after artificial ageing because of the induced cracks (compare Figure 4c,d).

Schlaitdorf Sandstone consolidated with NC-12C exhibits similar properties to the carbonate variety St Margarethen Limestone. A comparable amount of product is deposited despite the three different application techniques. The latter is a characteristic attributed to the structure of Schlaitdorf Sandstone, and differs entirely from St. Margarethen Limestone where the amount of adsorbed consolidant depends upon the application technique used (compare the values in Figure 5). The nano-silica consolidation slows down the capillary water absorption, with comparable trends among application techniques (compare the sound set of specimens in Figure 4c with the Figure 9

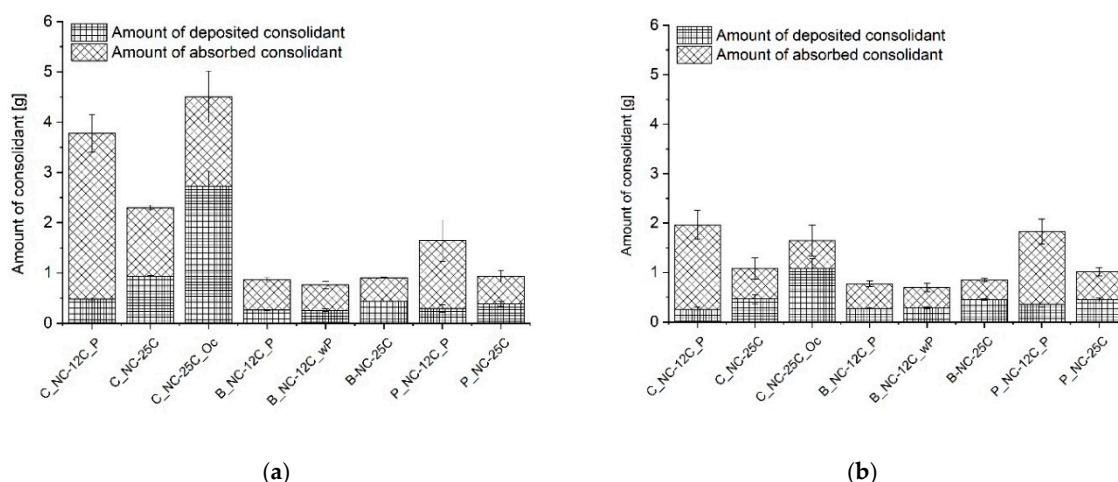
Figure 5. Comparison of the amount absorbed versus amount deposited inside (a) St. Margarethen Limestone and (b) Schlaitdorf Sandstone. For the calculation of the absorbed amount of consolidant, the weight of the stone in the initial dry state was subtracted from the weight after consolidation. To calculate the deposited amount of consolidant, the cured stone was weighed and subtracted by the weight of the initial dry state. The cured state corresponds to the mass recorded at the last day of outdoor curing, three weeks after the treatment application.

The apparent hydrophobicity present due to an incomplete reaction could also be confirmed by the amount of consolidant absorbed and deposited, which was recorded gravimetrically (Figure 5). The mass percentage of the silica gel that formed after curing could be calculated, but only when

complete hydrolysis and condensation took place, which in the present study was not the case. Incomplete reactions lead to higher values, as can particularly be seen in the case of samples labelled as over-consolidated (C_NC-25C_Oc). It can be supposed that the over-consolidation of specimens retarded the polymerisation. However, at the present moment it is not clear if the delay of the polymerisation was caused solely by the amount of consolidant applied, or possible pore-clogging caused by repetitive treatments—where gelation has already started but a second application cycle was performed onto the already gelled surfaces. In any case, the results indicate that an important factor for reaction kinetics is the amount of product applied. To further enhance our understanding of this, it would be desirable to study the reaction kinetics of consolidated stone exposed to different environmental conditions in terms of temperature and relative humidity, and with respect to varying amounts of consolidants applied on different substrates.

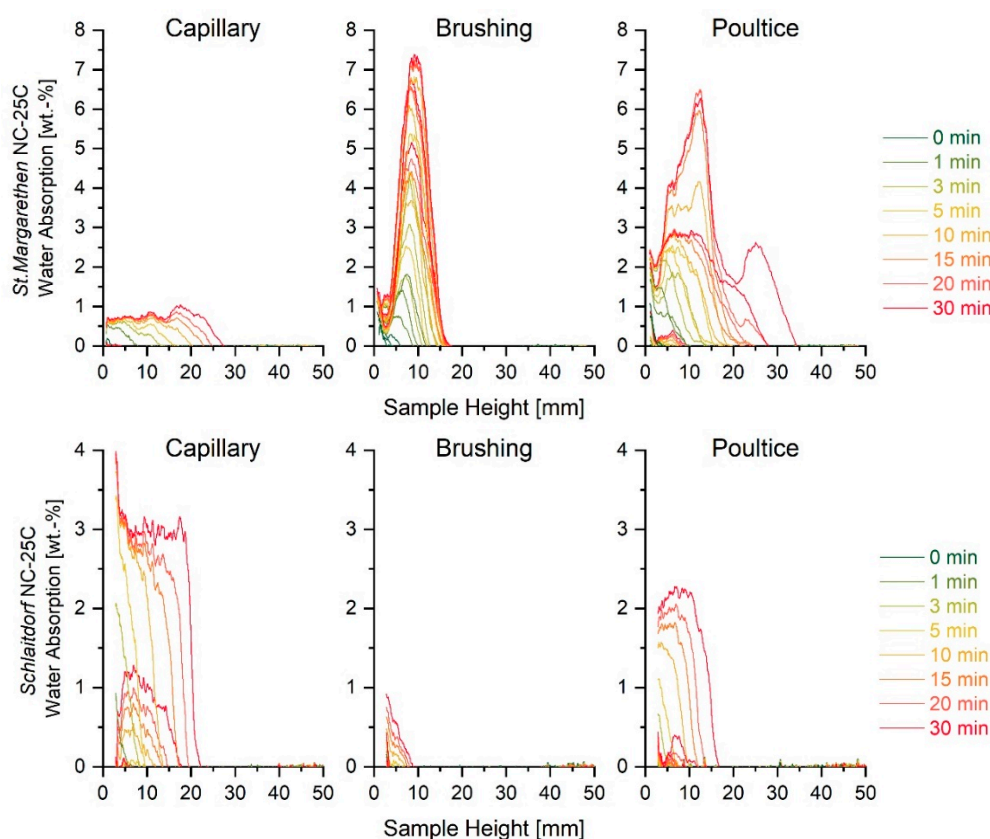
Figure 6. The top graph displays water absorption kinetics reported in weight percentage for three St. Margarethen Limestone specimens treated with NC-25C, while the bottom graph displays the same for Schlaitdorf Sandstone.

In the case of St. Margarethen Limestone, the acquired experimental data show that for the consolidant NC-25C, the reaction kinetics are influenced by the amount of product applied, and therefore it is application treatment dependent. Neutron radiographs clearly demonstrate that six weeks after the treatment application, the system was still largely hydrophobic. Derived from residual ethoxy groups, the system remained water repellent for an unknown period of time, depending on numerous factors. This apparent hydrophobicity disappears with continued hydrolysis–condensation reactions, and can even be overcome by a post-treatment with water, as demonstrated by Franzoni et al. [51]. When in contact with liquid water, the surfaces become less water repellent as hydrolysis proceeds. However, a long-lasting partial hydrophobicity might still be present after years, as shown in previous work [52]. It was determined that this effect of temporary hydrophobicity was most pronounced in the set of samples treated by capillary absorption, where the highest amount of product was deposited inside the stone's fabric (see Figure 5a). Stone specimens treated with brushing and poultice accommodated a smaller amount of product due to the given application settings, thus allowing, on average, a faster polymerisation reaction. It is important to note that it is hardly possible to make assumptions about competing processes of hydrolysis and condensation in the period after initial treatment with neutron radiography, as it cannot provide direct evidence of polymerisation (consumption and production of water), but indicates indirectly the chemical process through which the water is absorbed. A couple of phenomena, not able to be distinguished with the present methodologies, might now be relevant in understanding the polymerisation process in a stone fabric in respect to water absorption: i) capillary flow in mixed patterns of hydrophobic–hydrophilic surfaces, where the latter might correspond to unconsolidated surfaces or already polymerised residues, ii) influence of the compositional and micro structural features of the stone fabric, including effects like surface area to volume ratio of the deposited consolidant [30], surface polarities, effects like vapour pressure, steric hindrance and inductive effects, and iii) dynamic changes occurring due to direct contact with liquid water during the tests. Even without further clarification of the above-mentioned phenomena, neutron radiographs acquired for sound and consequently consolidated stone allowed evaluation of what kind of impact a treatment application might have with respect to capillary water absorption (see Figure 6).

The water absorption curves obtained from neutron radiography, as shown in Figure 6, are an average of the entire sample width-depth as a function of the height. The same kind of averaging is present within gravimetrically recorded samples. Imaging proves to be a great added value, because, by qualitative, visual analysis of the radiographs, a more profound discussion of the measured values is possible. Locally, increased amounts of water could be found (compare Figure 6, showing the kinetics of three St. Margarethen specimens treated with brushing, and Figure 7b, showing one radiograph where this kinetic was extracted from). Neutron radiography proved to be a valuable tool to examine anomalous water distributions with a strong gradient of water quantities in the stone, which relates to a gradient in polymerisation.

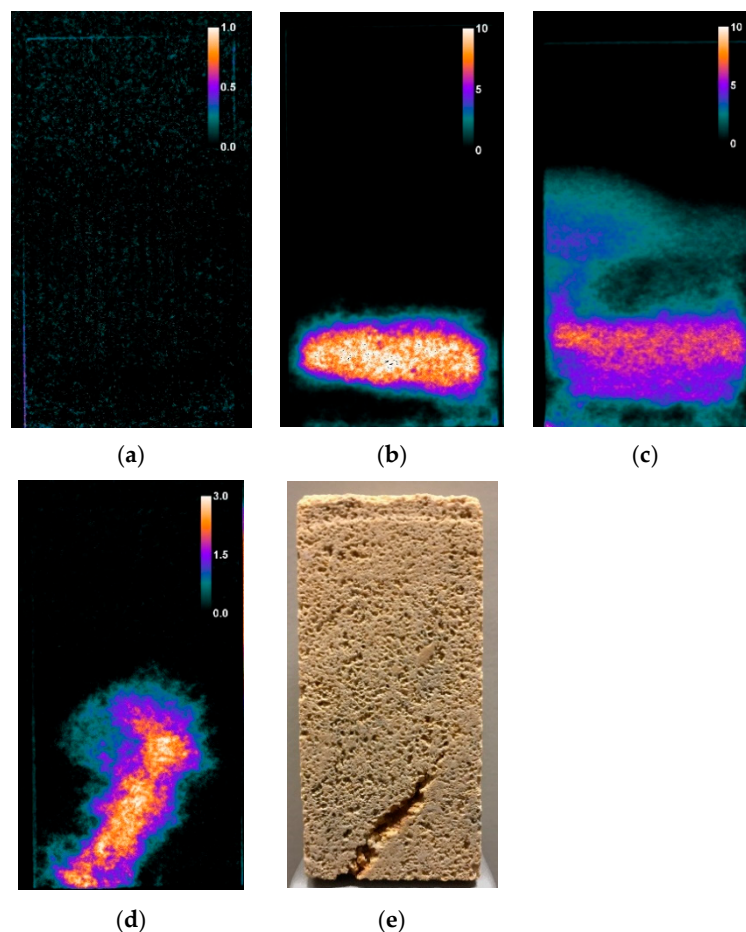
Figure 7. St. Margarethen Limestone radiographs recorded after 30 min of water absorption by capillarity and displaying the water amount in wt. % for specimens treated with NC-25C by (a) capillary absorption, (b) brushing and (c) poultice. A radiograph (d) displays the water absorption by capillarity in the presence of a vugular porosity and (e) the so-called vugs, which are large cavities in a natural stone, usually exhibiting mineral precipitants on the pore walls.

It was demonstrated that the specimens consolidated with NC-25C and applied by poultice and brushing result, due to the apparent hydrophobicity, in so-called ‘water trapping’ (see effects of this phenomenon in Figure 7b,c). This water trapping occurred in the inner core of the stone specimens,

while the lateral surfaces were still mostly hydrophobic with the exception of small passages where capillary forces sucked the water inside the material. This inner core of the stone specimens that was filled with water possibly indicates a polymerisation that was initiated inside the stone or parts of the structure that were not consolidated in the first place. Particularly, Figure 7b suggests that the very bottom of the stone was hydrophobic, and above the water trapping zone the specimen was also hydrophobic, even though it was a highly porous lithotype. The latter radiograph therefore indicates that water was trapped in between the very bottom and first third of the specimen. This represents an unusual phenomenon where hydrophobic and hydrophilic patterns intersect. Trapping of liquid water inside an incompletely polymerised consolidant could jeopardise the silica gel structures, promote the solubility of salts, increase bio-growth or cause spalling of the surface due to differential stresses, all phenomena that potentially lead to harmful effects. Furthermore, neutron imaging was able to show that in the presence of fabric inhomogeneities like the so-called vugs (large pores with calcite crystallization on the pore walls), water uptake was promoted along those structural paths, since these interfaces were most probably not completely covered by the consolidant during the treatment (Figure 7d,e).

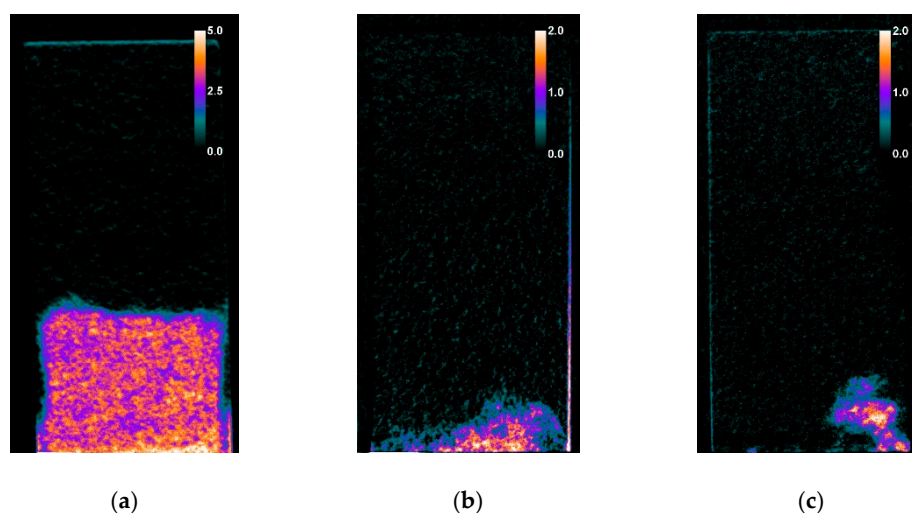
Figure 8. Radiographs of Schlaitdorf Sandstone recorded at 30 min of water absorption by capillarity for specimens treated with NC-25C by (a) capillary absorption, (b) brushing and (c) poultice. The calibration bar displays the water amount in wt. %.

specimens treated by capillary absorption, which was observed in one out of three studied specimens (Figure 8a). Brushing and poultice caused a more pronounced clogging of the pores, so that water penetrated through small, unconsolidated or already polymerised passages in minor amounts.

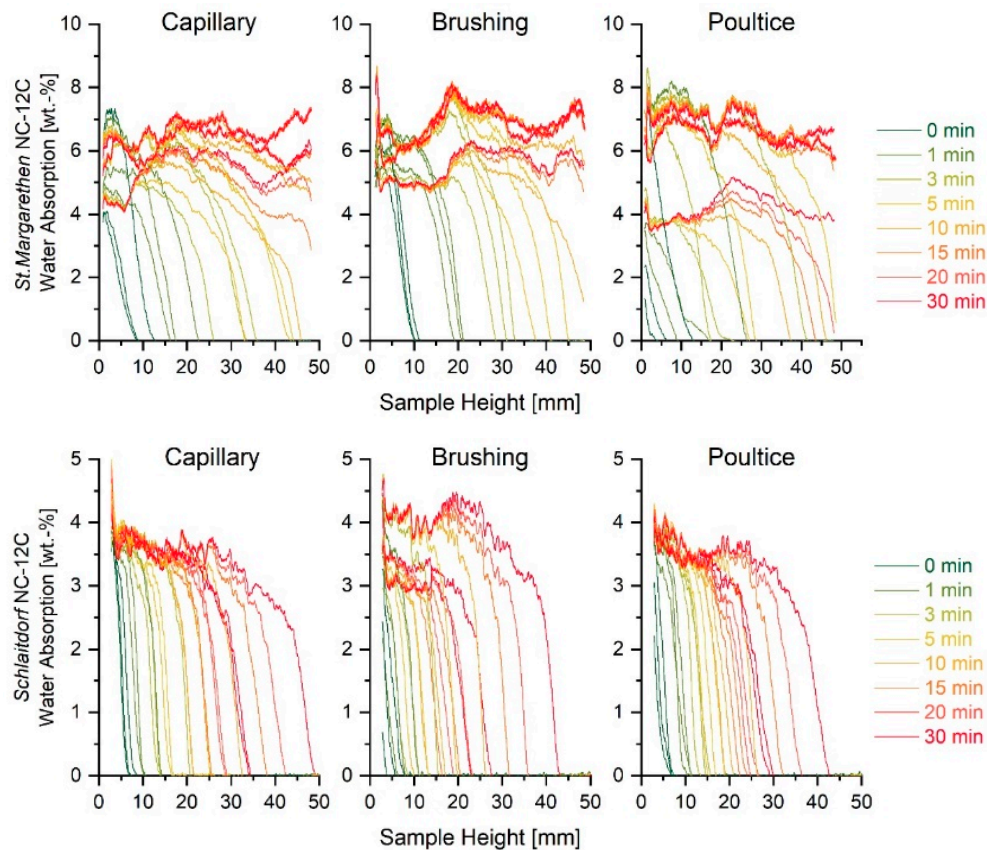
Figure 9. The top graph displays water absorption kinetics reported in weight percentage for St. Margarethen Limestone treated with NC-12C, while the bottom graph displays the kinetics of water absorption by capillarity for Schlaitdorf Sandstone, also treated with NC-12C.

bottom graphs). However, based on water absorption profiles extracted from neutron imaging, it can be noticed that the water behaviour was more homogenous in specimens treated by capillary absorption. Brushing and poultice is less favoured, as the widespread nature of the results indicates a more inhomogeneous behaviour of water kinetics caused by the treatment application.

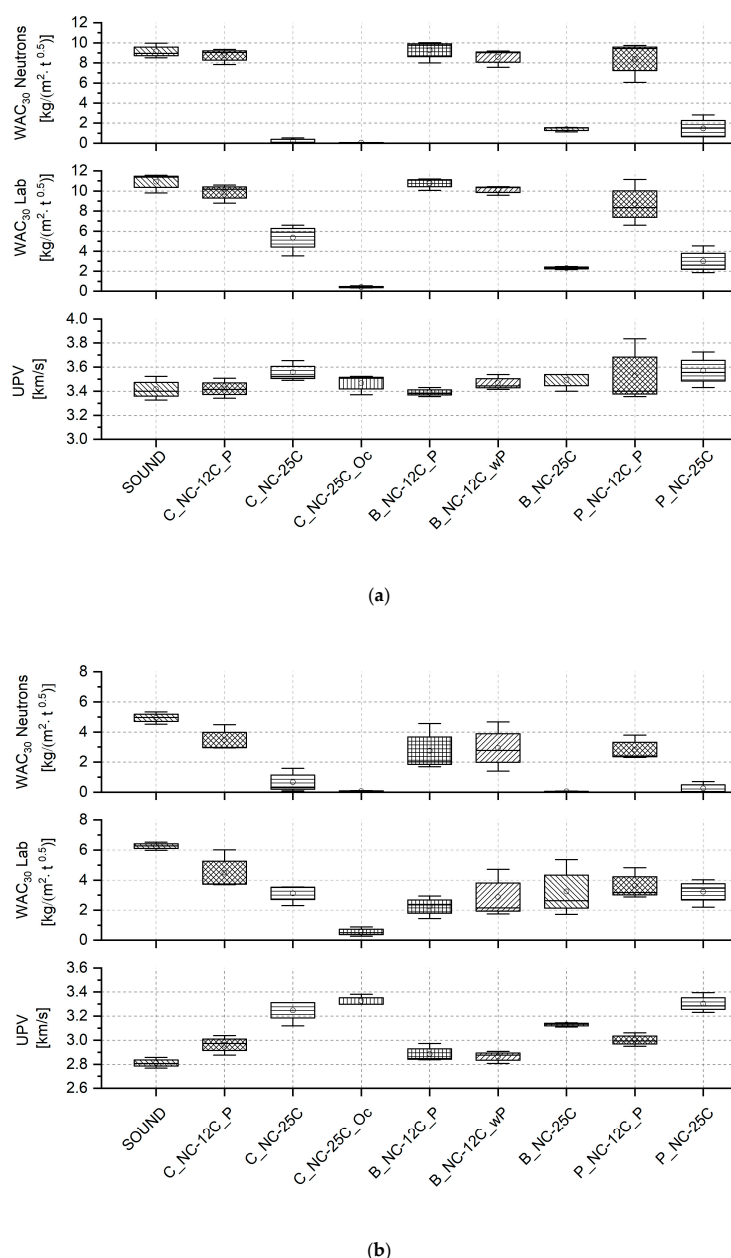
Figure 10. Comparative graph displaying water absorption coefficients reported as $[\text{kg}/(\text{m}^2 \cdot \text{t}^{0.5})]$ after 30 min for (a) St. Margarethen Limestone and (b) Schlaitdorf Sandstone, calculated from (top) neutron radiography and (middle) gravimetrically determined laboratory studies, and compared to values of (bottom) ultrasonic pulse velocity reported in $[\text{km}/\text{s}]$. Corresponding numerical values of the graphical representation can be extracted from Supplementary Materials, Table S2. Moreover, all water absorption curves extracted from neutron radiographs can be seen in Supplementary Materials, Figure S3 (St. Margarethen Limestone) and Figure S4 (Schlaitdorf Sandstone).

To cross validate the water absorption by capillarity, monitored by neutron radiography, the WAC calculated from the laboratory mass increase, as well as UPV, were determined on the same specimens. The comparative values displayed in Figure 10a,b show that there is a clear trend between all tests employed to study alterations caused by the treatment application. When the WAC increased, UPV decreased accordingly. As already mentioned above, the slight difference between absolute values reported for the WAC gained from neutron radiography and laboratory-based gravimetric results can be explained through averaging when image analysis is used. The impact of the advanced polymerisation is visible in the WAC values, based on gravimetrically determined laboratory studies. Those values evolved over time, thus suggesting a more advanced chemical reaction, when compared to the WAC obtained through neutron radiography. The latter effect is evident when comparing calculations from neutrons and laboratory studies of NC-12C with NC-25C values. This comes as no surprise, as these tests were performed eight weeks after consolidation and the specimens had already been in contact with water through previous water absorption tests when the neutron radiographs were acquired.

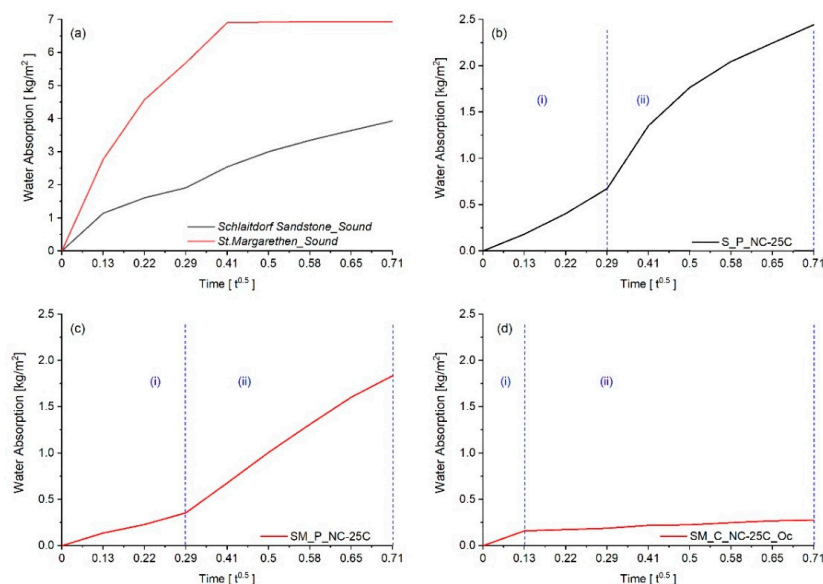
Figure 11. Examples of water absorption curves after 30 min (here reported as the square root of time in hours), extracted from gravimetric monitoring. Graph (a) represents absorption curves from sound stone specimens, (b) Schlaitdorf Sandstone, (c) St. Margarethen Limestone where the consolidant NC-25C was applied by poultice and (d) a specimen of St. Margarethen Limestone representing the over-consolidation attained by a repetitive capillary absorption of NC-25C.

The water absorption curves are more complicated to interpret when the stone specimens are consolidated, especially when reactive treatments are present. Figure 11b,c displays two curves, depicted as part (i) and (ii) in the graphs, which correspond to changes in slope and thus in water absorption kinetics. For both cases, it can be observed that the water absorption increased steadily, and after five minutes a speed increase of the capillary suction took place. The accelerated water absorption rate, represented as part (ii) where the slope increases, represents a phenomenon where a greater pore volume contributes to the suction and increases the slope. Figure 11d represents a water absorption curve of a hydrophobic specimen, where water is initially absorbed on the surface (measurement at 1 min) and diffuses gradually with time. In the latter case, the magnitude of absorbed water per surface area displays the water repellence or hindrance of the stone specimen. The evolution of water absorption kinetics as the polymerisation proceeds should be investigated more in depth by means of neutron radiography and additional laboratory water-based methods.
