Cite this article as: Trana C, Muller O, Tozzi P, Qanadli SD. Free-floating aortic thrombus originating from the right coronary artery. Eur J Cardiothorac Surg 2015;47:1110-1.

Free-floating aortic thrombus originating from the right coronary artery

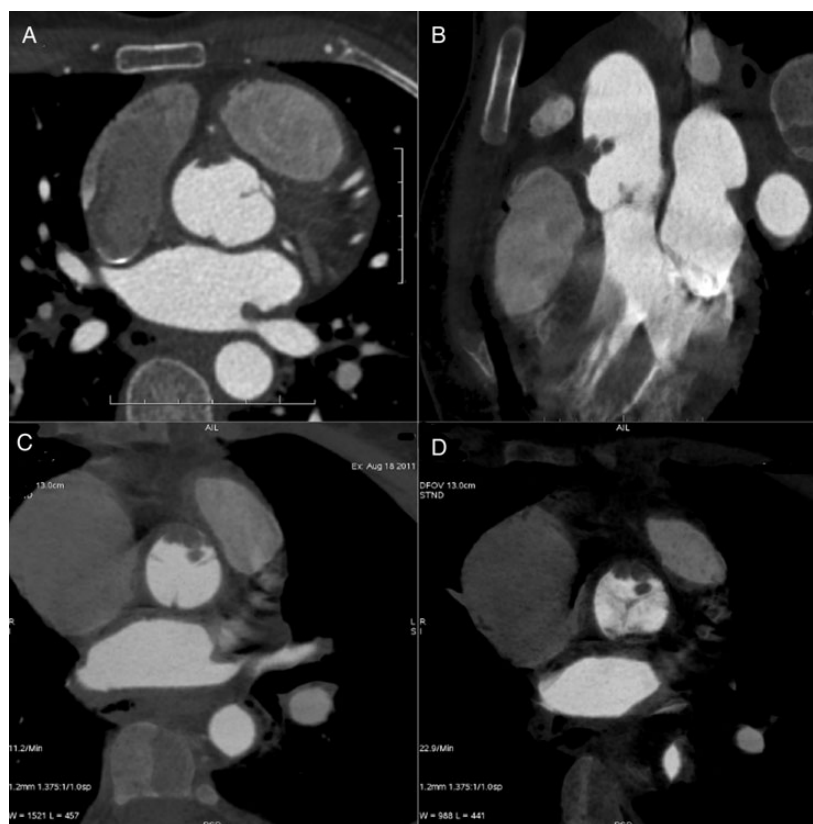
Figure 1: Cardiac computed tomography angiography. (A) Axial-transverse image that shows a low-attenuation material in the right coronary cusp of the sinus of Valsalva. No image suggestive of aortic or coronary dissection was identified. (B) 2D reconstruction in the coronal plane that clearly shows the intracoronary component of a pseudo mass. (C) Thin slab 'maximum-intensity-projection' reconstruction in the axial-transverse plane. (D) Thin slab 'minimum-intensity-projection' reconstruction showing the extension of the pseudo mass and its relationship to the aortic valve. Similar findings were found on echocardiography that showed no additional anomalies, particularly no intracardiac thrombus and no patent foramen ovale.

A 48-year old woman presented with atypical chest pain suggestive of aortic dissection. Computed tomography (Fig. 1) was performed

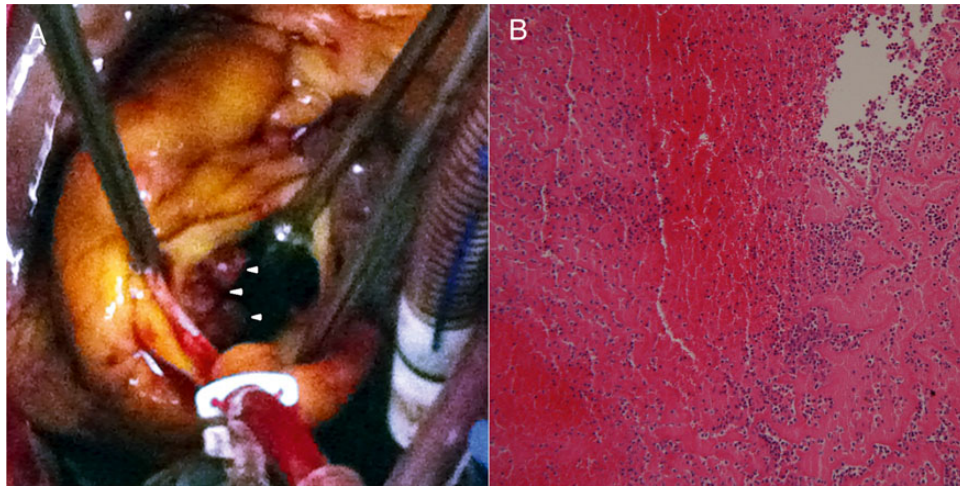
Figure 2: (A) After aortotomy, friable material protruding from the right coronary artery into the right coronary cusp of the sinus of Valsalva (arrowheads) was removed with no adherence. (B) The pathology of the removed mass was suggestive of a partially organized thrombus.

and showed a mass protruding from the right coronary artery, the pathology of which was identified as an organized thrombus (Fig. 2).
