## LIABILITY AND DAMAGE CLAIM ISSUES IN INDUCED EARTHQUAKES: CASE OF GRONINGEN

Ihsan Engin BAL<sup>1</sup>, Eleni SMYROU<sup>2</sup> & Elles BULDER<sup>3</sup>

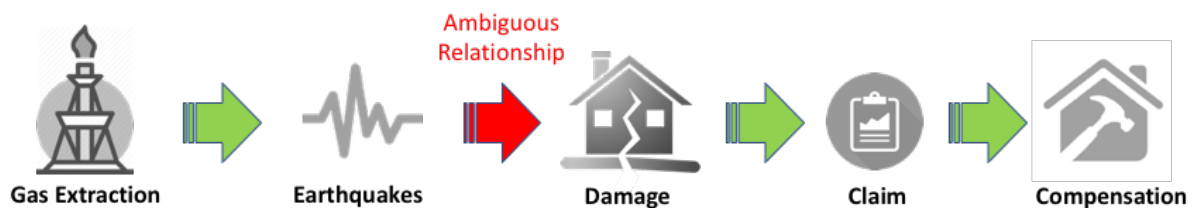
Figure 1. The earthquake cycle in Groningen.

The “gas extraction-earthquake-damage-claim-compensation” cycle in Groningen given in Figure 1 has issues from a technical point of view. This is a legal liability case, but the proof is expected from technical people. The required proof however does not fit to the earthquake engineering perspective. The very reason for this is the ambiguous relationship between small recursive earthquakes and visible structural cracks. A clear relationship is further hindered by the particular soil and structural properties in the Groningen region.

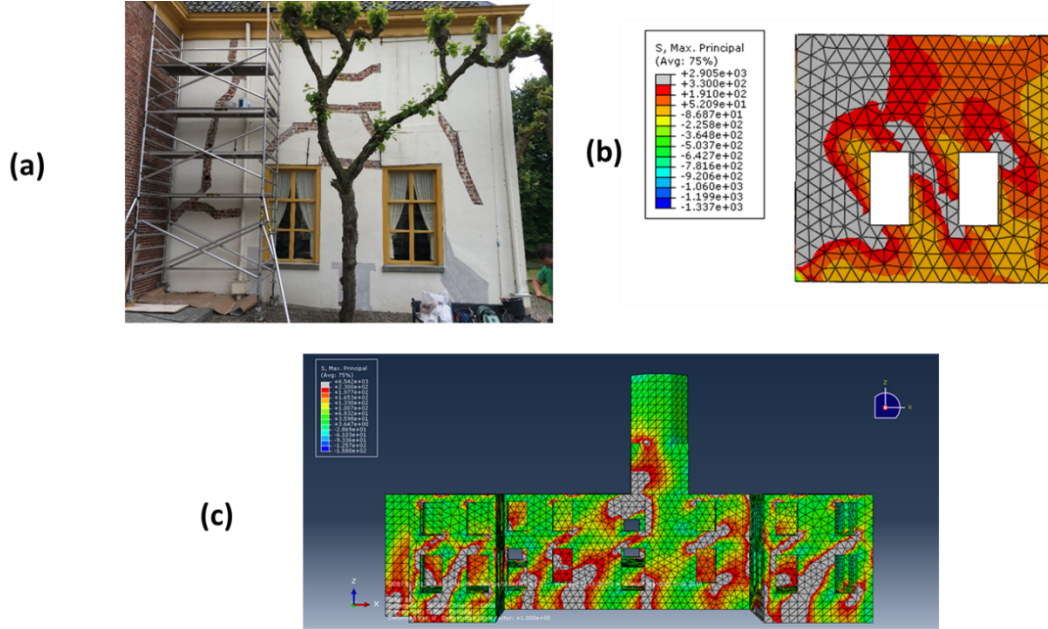
Figure 2. Fraeylemaborg in Slochteren, (a) The real crack pattern observed in North-West wing of the structure, (b) the response of the same wall for the seismic scenario simulated in the computer with maximum principal stresses in kPa (c) the response of the entire structure for the same seismic scenario (the grey contours show the regions at which cracks would be expected).

One good example to show the difficulty of this task is the work by Dais *et al.*, 2018. The study focuses on Fraeylemaborg, a noble house in the earthquake region from the 13<sup>th</sup> century. The monument experienced serious damages in recent earthquakes and was repaired twice in 2015. Detailed structural computer simulations did not explain why these damages had occurred as the estimated accelerations were too low to create structural damage. After scrutinized work and with the help of an extensive real-time monitoring system on the building, a damage scenario was built. Comparison of this scenario with real damages is shown in Figure 2. According to that, the mostly-damaged North-West wing of the structure must have lost support in order to trigger the cracks observed on that part of the structure. This loss of support can only occur if the masonry retaining structure, together with the foundations, moved forcing the load bearing walls to follow in a mostly lateral direction. There are signs around the structure supporting this scenario. In this case, the observed cracks may seem soil-related to a technical person who does not know the earthquake history of Fraeylemaborg. However, the soil movement is most probably related to the earthquakes. This is collateral damage that is extremely difficult to prove, and yet the presented scenario remains just a scenario even after the detailed work.
