Post-Flood Cleanup Alternatives along Stream Corridors in Central Pennsylvania Helping Resolve River and Land Use Conflicts in an Economically and Ecologically Sustainable Manner

Post-Flood Cleanup Alternatives Along Stream Corridors in Central Pennsylvania

A Scientific and River Engineering Perspective

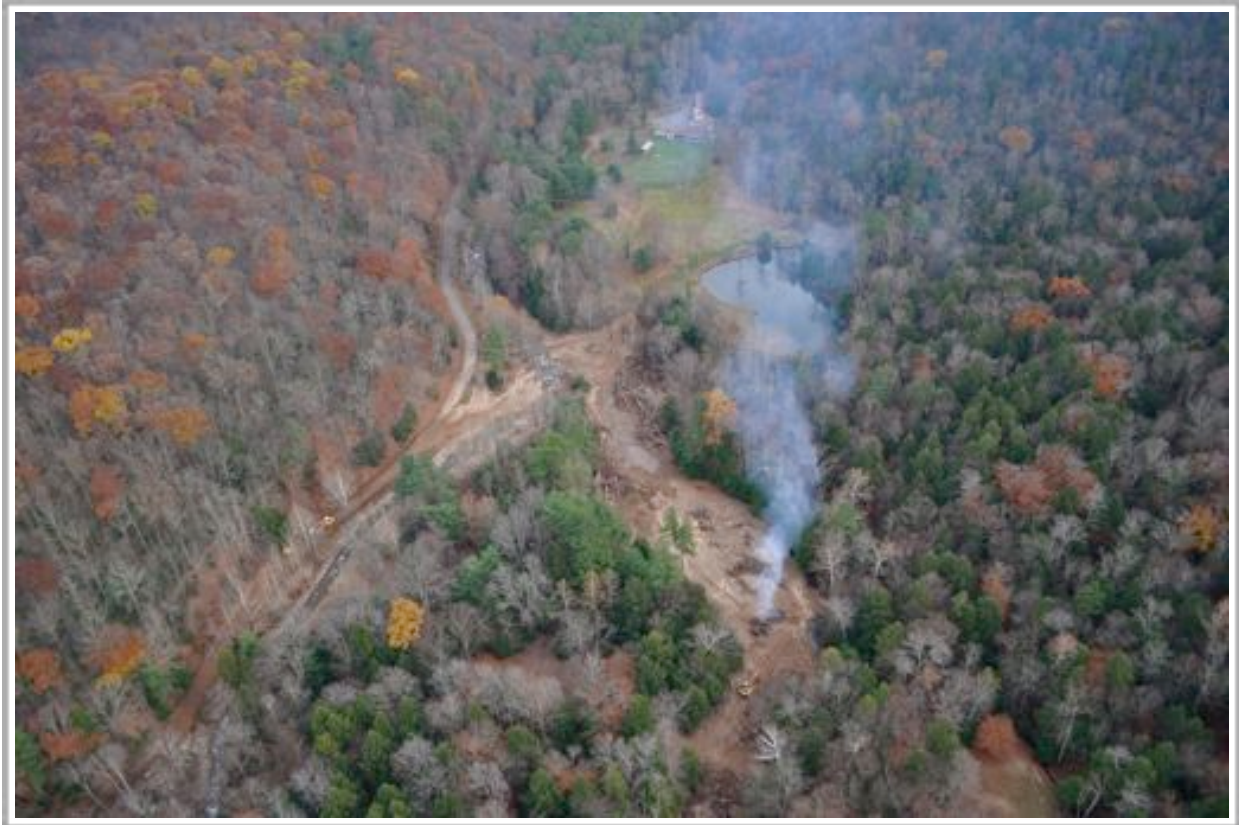
“Stream cleaning” efforts underway shortly after the devastating floods of Tropical Storm Lee in September 9-11, 2011. Big Bear Creek, a tributary to the Loyalsock Creek in the West Branch of the Susquehanna River in north-central Pennsylvania.

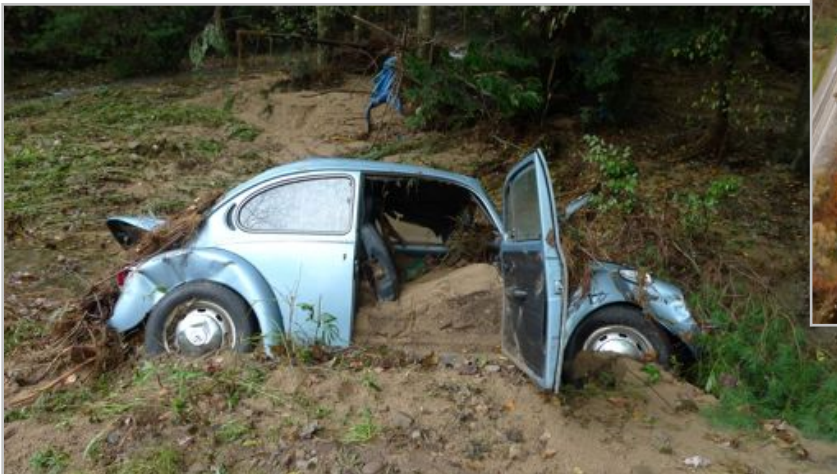
Tropical Storm Lee delivered over 18 inches of rain to steep, narrow watersheds in north-central Pennsylvania, devastating homes, roads, and bridges in the Muncy, Loyalsock, Fishing Creek and Lycoming creek watersheds.

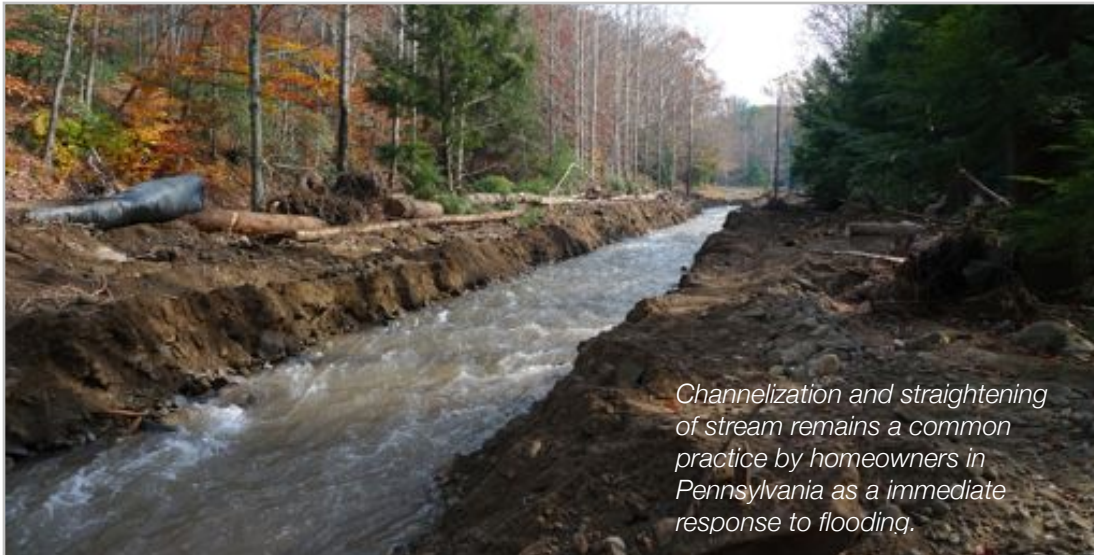
- Channelization practices that were started over 100 years ago to accommodate early settlement, roads, railroads, logging, farms, mills, and other “human investments” have been periodically maintained through gravel removal, realignment, channel armoring, and post flood remediation projects (Hayes and Field, 2009).

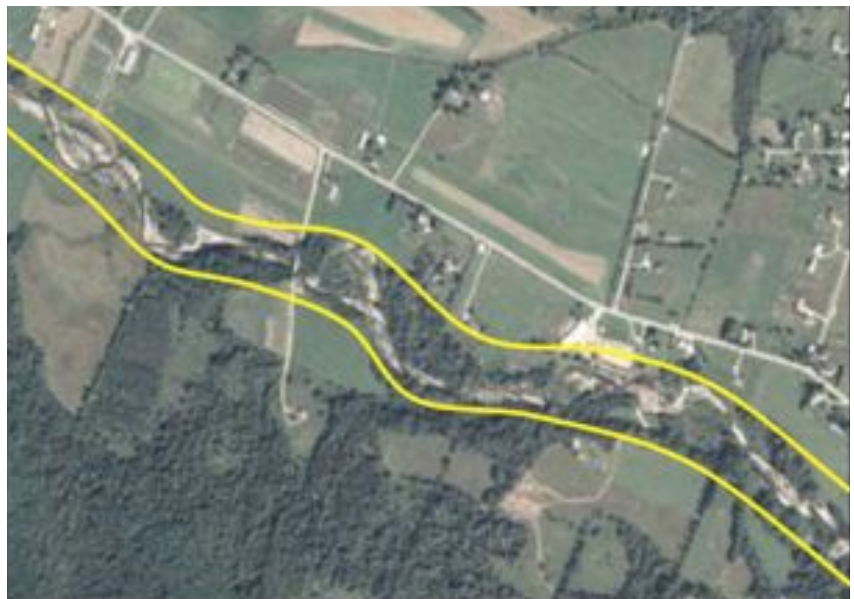
Defining and protecting the meander belt or stream width corridor that will accommodate equilibrium conditions may be the most important objective in any stream restoration and flood recovery project.

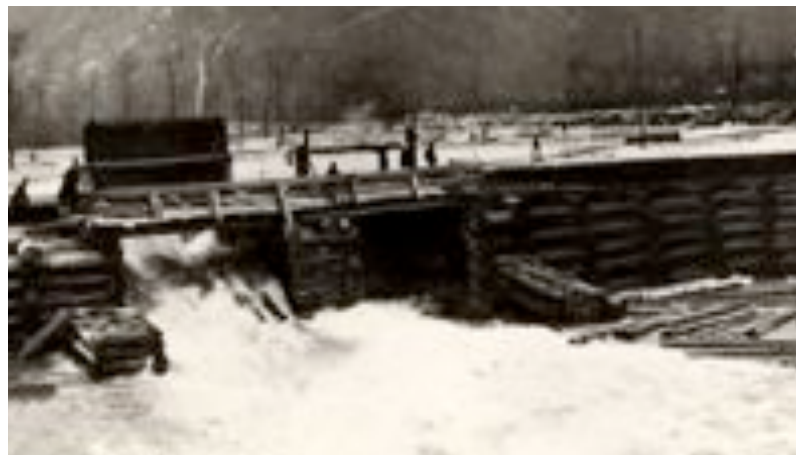
During the peak of the logging boom in the 1880s, watersheds such as this one - Pine Creek in the West Branch of the Susquehanna River - were completely denuded; their hillslopes were stripped bare of protective forests. Stream channels were straightened, snags removed, and temporary “splash dams” constructed to float the logs downstream to the saw mills and log booms of the Susquehanna. As a result, millions of tons of sediment were washed into the rivers, destabilizing the streams for decades. Geomorphic and hydrologic studies are showing that over the past 100 years, these logging legacy sediments are being flushed downstream with each major flood.

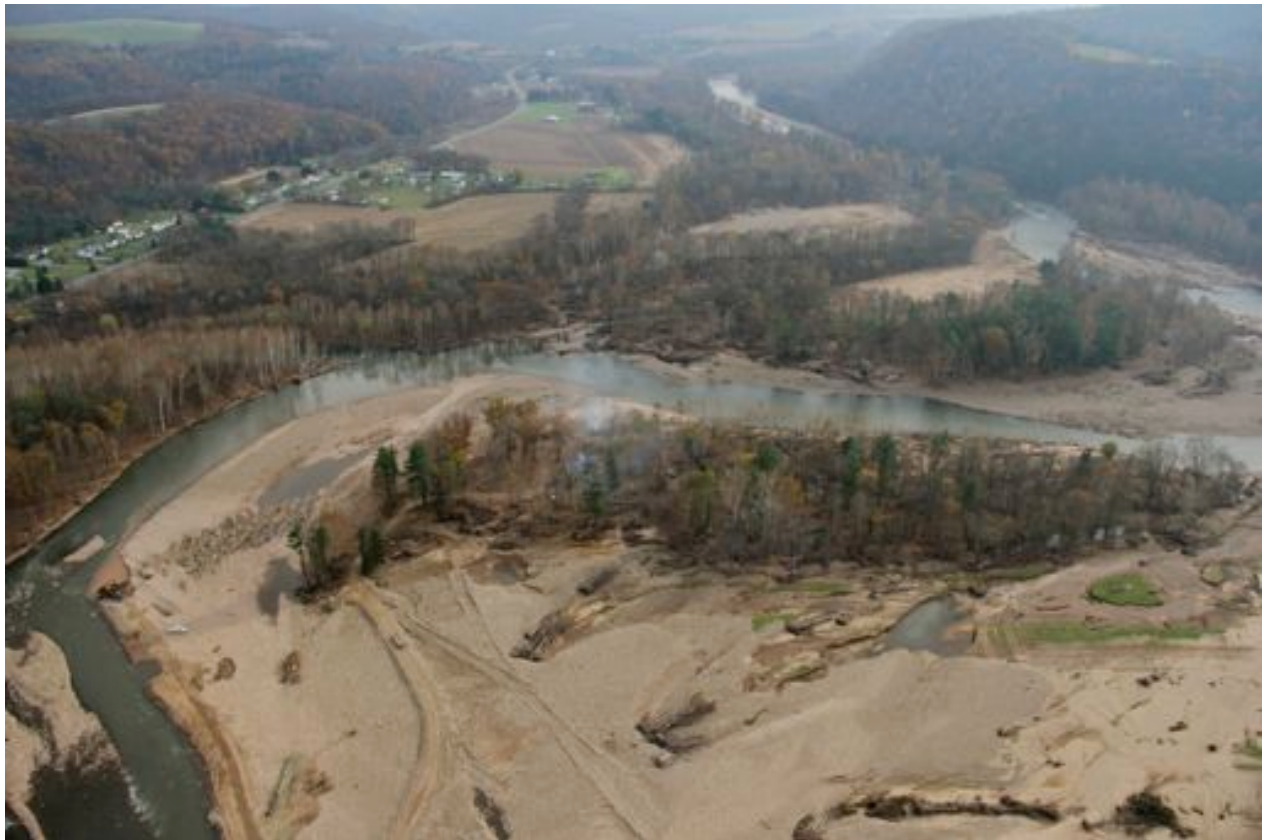
Aerial view of staggering amount sediment deposition in the channel and adjacent floodplain areas in the lower reaches of Loyalsock Creek during the record floods of Tropical Storm Lee on September 9-11, 2011. The river is adjusting its channel and floodplain corridor as it tries to accommodate enormous quantities of sand and gravel delivered to the headwater regions of the watershed during the logging era. The meandering low-flow channel is visible (note excavators and pickup trucks for scale), with gravel bars and braided high-flow channels visible across the forested floodplain corridor. Loyalsock Creek and most other streams in the north-central Pennsylvania remain in a protracted phase of adjustment from the complete deforestation of these watersheds 100 years ago. Enormous quantities of sediment were delivered to the river and pulses of gravel continue to work their way downstream during floods such as this one. Attempts to dredge, channelize, or realign streams in this condition are unsustainable and usually only increase flooding and channel erosion further downstream.

Try to minimize development in the entire river corridor is the most inexpensive and sustainable alternative in situations such as this. Efforts to rebuild homes or farm within the floodplain corridor stand a high likelihood of being damage by floods in the future as well - Loyalsock Creek needs this space to move the gravel through its system as seeks a new equilibrium state in the future.

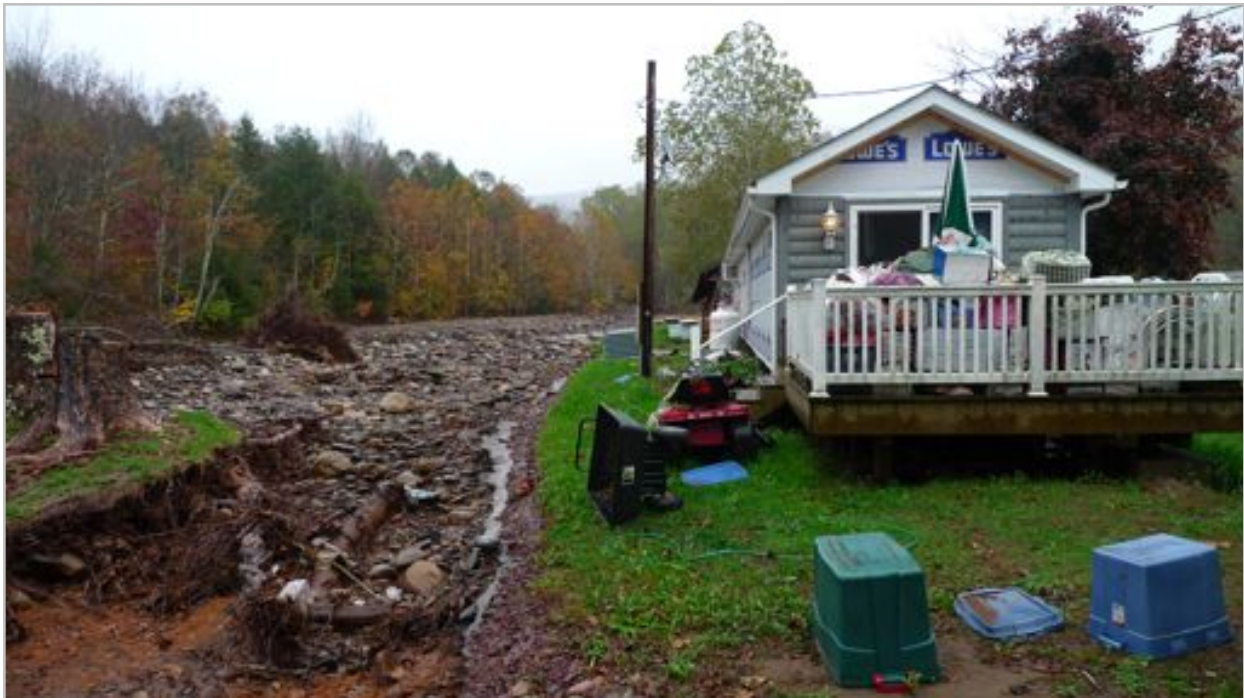
This property, located in the headwaters of the Muncy Creek watershed, has experienced increased erosion over the past forty years, since Hurricane Agnes in June 1972. Upstream, the channel was been straightened and bermed for log drives eighty years ago. Well-intended efforts and expenditures by the home owner to dredge the channel on the upstream end of the property have not been effective. In fact, the channel is returning to its braided, multithreaded condition it was in before European settlement and logging in the watershed took place. Efforts to constrain the channel to one static location will be unsustainable over the long term.

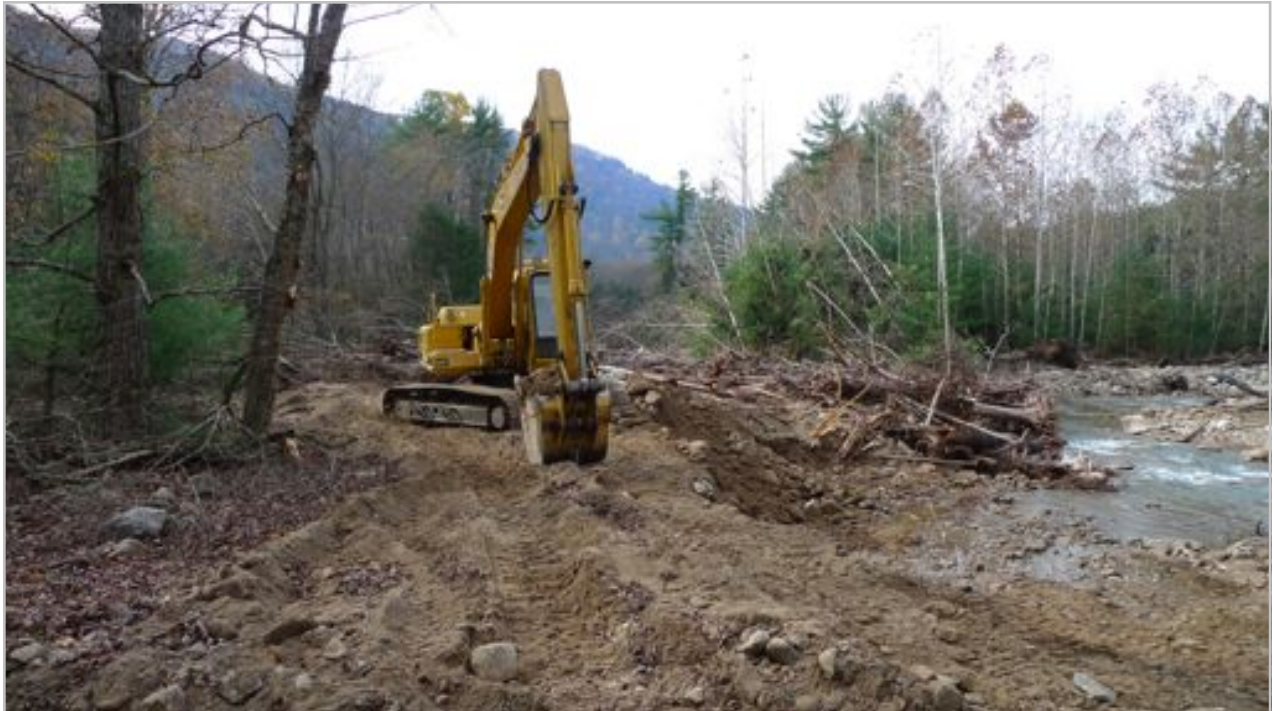
Stream ecosystems in Pennsylvania rely upon a complex cascade of water, nutrients, and woody debris for their health and survival. Flooding is a natural part of maintaining the stream, providing energy for the channel to rework its bed and bank and create new habitat for aquatic life. Trees washed into the channel provide fresh wood and organic material, complexity and refuge for trout, salamanders, and all life in the river.

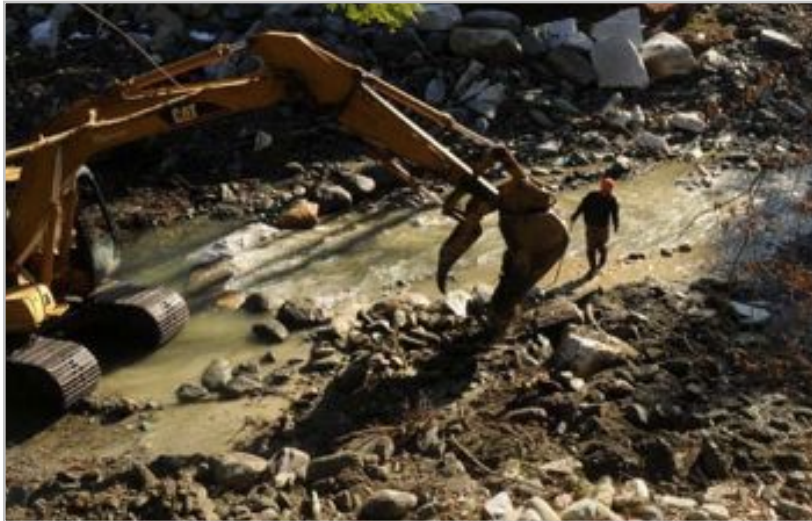
For the straightened river, it is only a matter of time before a flood drops a very large load of sediment at some point along its course. The wedge of sediment that builds in the channel during the recession of the flood may cause the river to avulse, or leave the channel, and head cut back through the landscape from the point where it returns to the channel further downstream. These events can erode river banks tens of feet and sometimes create whole new channels through adjacent lands, often someone's farm field.

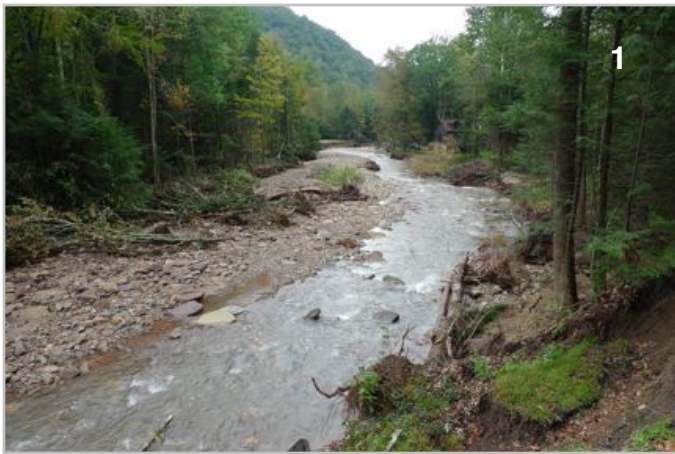
1. Immediately after the Tropical Storm Lee flood of record, September 9-11, 2011.

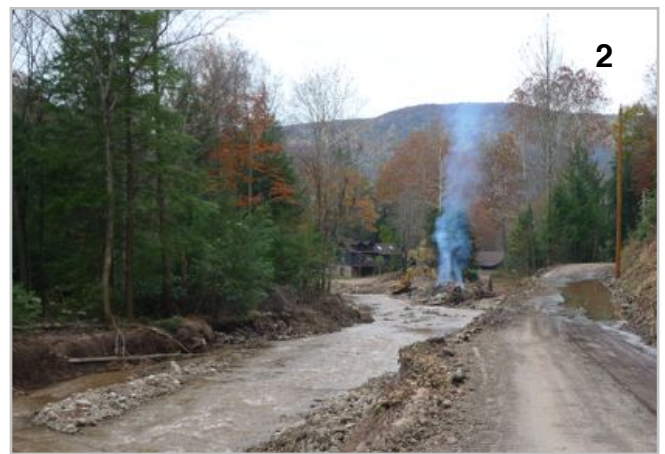
2. Snagging and burning of woody debris, gravel, realignment of channel, and installation of rock veins. (mid to late September, 2011)

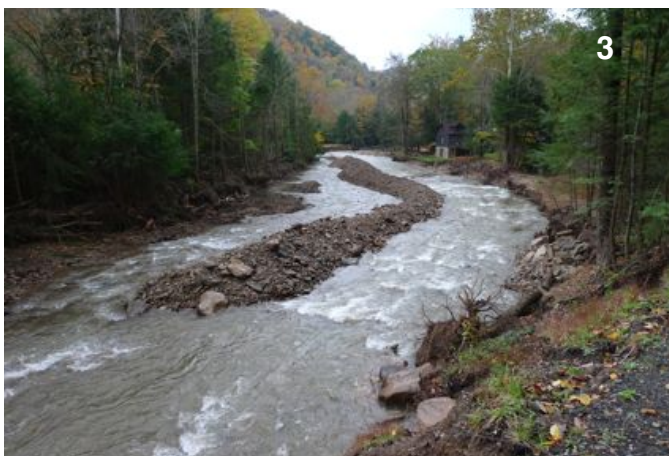
3. Removal of gravel point bar, realignment of main flow channel, regrading of channel slope and width. (late September 2011).

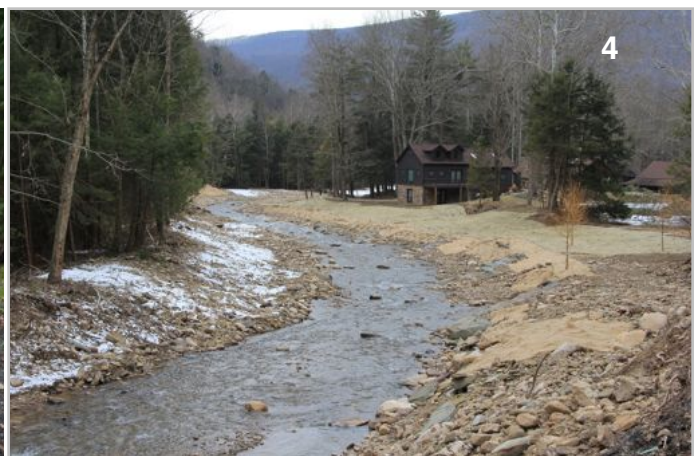
4. Reworking of channel banks, installation of rock veins on meander bend, regrading and armoring of channel banks. (October, 2011)
