Behaviour of strengthened timber beams using near surface mounted Basalt Fibre Reinforced Polymer (BFRP) rebars

Gand, AK, Yeboah, D, Khorami, M, Olubanwo, AO and Lumor, R (2018) Behaviour of strengthened timber beams using near surface mounted Basalt Fibre Reinforced Polymer (BFRP) rebars. Engineering Solid Mechanics. 6 (4). pp. 341-352. ISSN 2291-8744

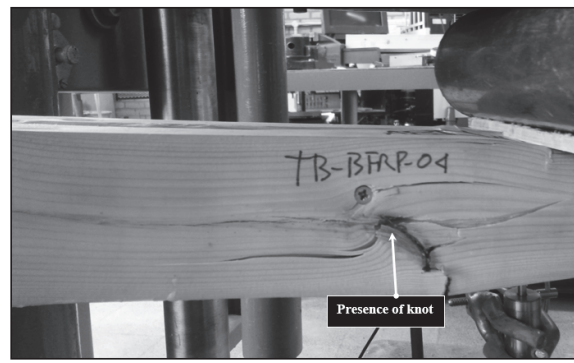
Fig. 8. Observed tensile failure of specimen TB-BFRP-04

Beam TB-BFRP-01 suffered horizontal shear failure of the timber. Minor ruptures were observed at the tension zone and the rebar-adhesive was still intact. This mode of failure occurred due to splits and shakes located at the centre of the cross section shown in Fig. 7. TB-BFRP-01 was, therefore, unable to obtain ultimate load capacity and was consequently the weakest of all the beams tested. Cross-grained tensile failure of the timber occurred in beam TB-BFRP-02. Additionally, severe indentations were detected in the compression zone as the beam reached ultimate load capacity. Similar to TB-BFRP-02, beam TB-BFRP-03 suffered tension and compression failure of the timber. The beam was severely splintered at mid-span which resulted in the adhesive shattering whilst the beam failed. Observation of the adhesive interface showed that the epoxy was still marginally saturated resulting in the debonding of the rebar. Beam TB-BFRP-04 failed in simple tension of the timber. Prior to testing TB-BFRP-04, a large knot was prominent at mid-span. Horizontal shearing and de-bonding of the rebar-adhesive interface occurred shortly after the cracks formed in the tensile zone (see Fig. 8). For beam TB-BFRP-05, the timber suffered severe fractures at mid-span failing in compression and tension. The rebar in specimen TB-BFRP-05 debonded because of the timber splitting (see Fig. 9). Similar to TB-BFRP-05, beam TB-BFRP-06 failed due to splintering at the compression and tension zones. Subsequently, shearing in the timber transpired following the ultimate load capacity. TB-BFRP-07 failed as tensile cross-grained cracks had formed on the timber. Indentations were also detected in the compression zone of TB-BFRP-07. The base of the specimen TB-BFRP-03 suffered moderate splitting at mid-span resulting in the epoxy resin cracking, with the Rockbar remaining unaffected (see Fig. 10).
