# Pollution Profiling and Particle Size Distribution within Permeable Paving Units - With and Without a Geotextile

Jennifer Mullaney\*, Päivi Rikalainen, Chris Jefferies.

*University of Abertay Dundee, Urban Water Technology Centre, Level 5 Kydd Building, Bell Street, Dundee DD1 1HG, Scotland*

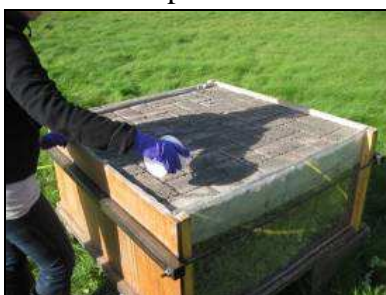
Figure 3. Sediment application

The retention of sediment was tested by adding known volumes of sediment before a rainfall event (Figure 3). A total of 20 years of sediment was applied to Rigs C and D, 220g (per m<sup>2</sup>) being chosen to represent the equivalent of one year of sediment, the study by Brown et al (2009) also simulated the application of a total of 20 years runoff and sediment application. The sediment was sprinkled onto the paving surface and watered in using 15 litres of water

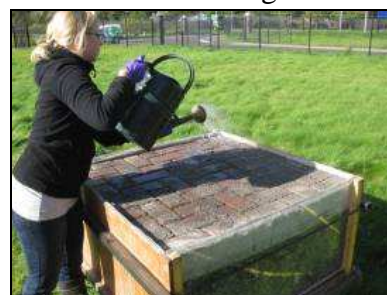
Figure 4. Watering in

prior to rainfall simulation (Figure 4). Sediment was applied in batches of 3, 3, 4, 5 and 5 years with the equivalent of one year of rainfall applied after each sediment application. Flow volume and time was recorded throughout the application of the simulated rainfall.

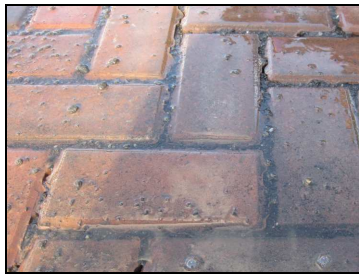
The sediment applied to the test rigs caused increased pooling and overflowing of water as the total sediment mass applied increased (Figures 6 & 7). This was a result of lower infiltration rates into the paving structure caused by the sediment blocking the gaps within the surface of the paving. After the equivalent of 10 years of sediment had been applied, both rigs showed significantly more pooling during watering in. Figure 8 is an illustration of the simulated rainfall passing through the paving unit.

**Figure 6.** Pooling Rig D after 3yrs

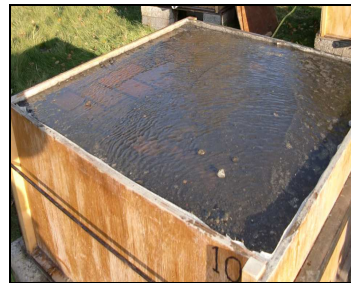
**Figure 7.** Overflowing after 20yrs
