Integrity and life estimation of turbine runner cover in a hydro power plant

ABSTRACT. This paper presents integrity and life estimation of turbine runner cover in a vertical pipe turbines, Kaplan 200 MW nominal output power, produced in Russia, and built in six hydro-generation units of hydroelectric power plant „Đerdap 1” in Serbia. Fatigue and corrosion-fatigue interaction have been taken into account using experimentally obtained material properties, as well as analytical and numerical calculations of stress state, to estimate appropriate safety factors. Fatigue crack growth rate, da/dN , was also calculated, indicated that internal defects of circular or elliptical shape, found out by ultrasonic testing, do not affect reliable operation of runner cover.

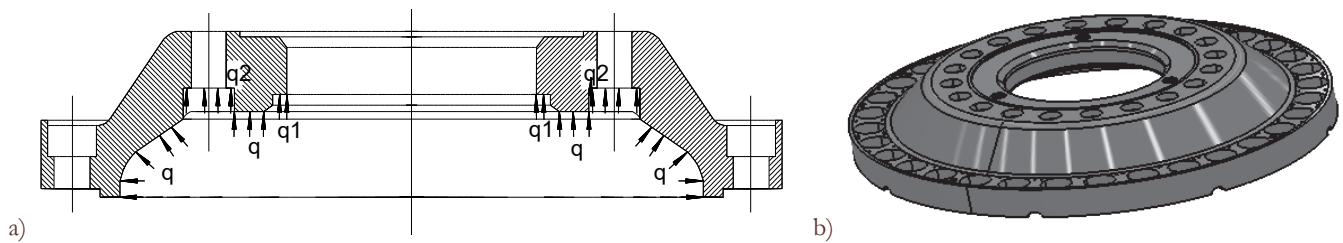
Turbine runner cover at the hydro power plant "Djerdap 1" is presented in Fig. 1.

Figure 1: Vertical Kaplan turbine, with nominal output power of 200 MW.

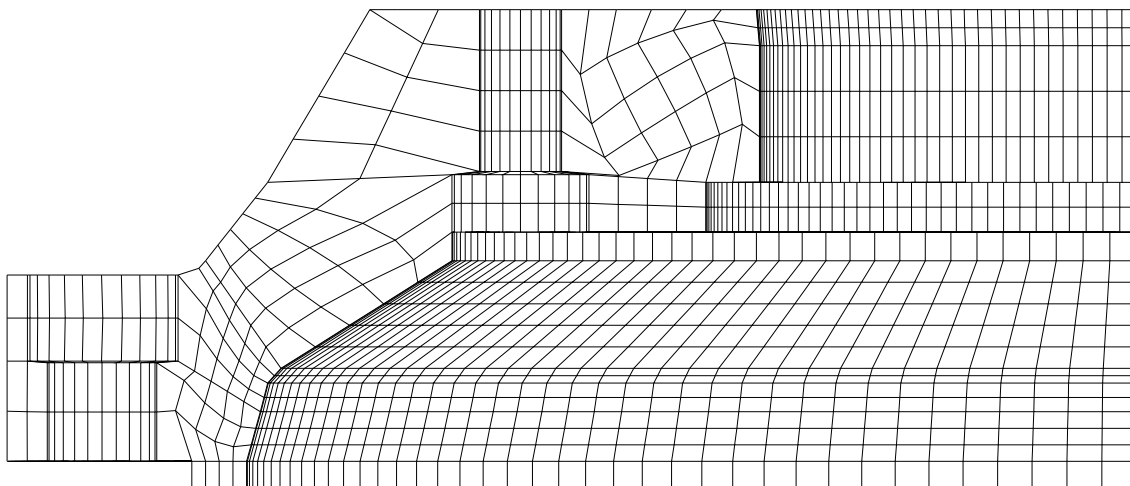
Loading is defined for normal operation conditions, comprising combined action of pressure, axial force and torsion moment, as explained in [1]. Finite element mesh for axisymmetric model is shown in Fig. 2. The results, indicating max. stress 81.1 MPa , is shown in Fig. 3.

Figure 2: Finite element mesh for axisymmetric model.

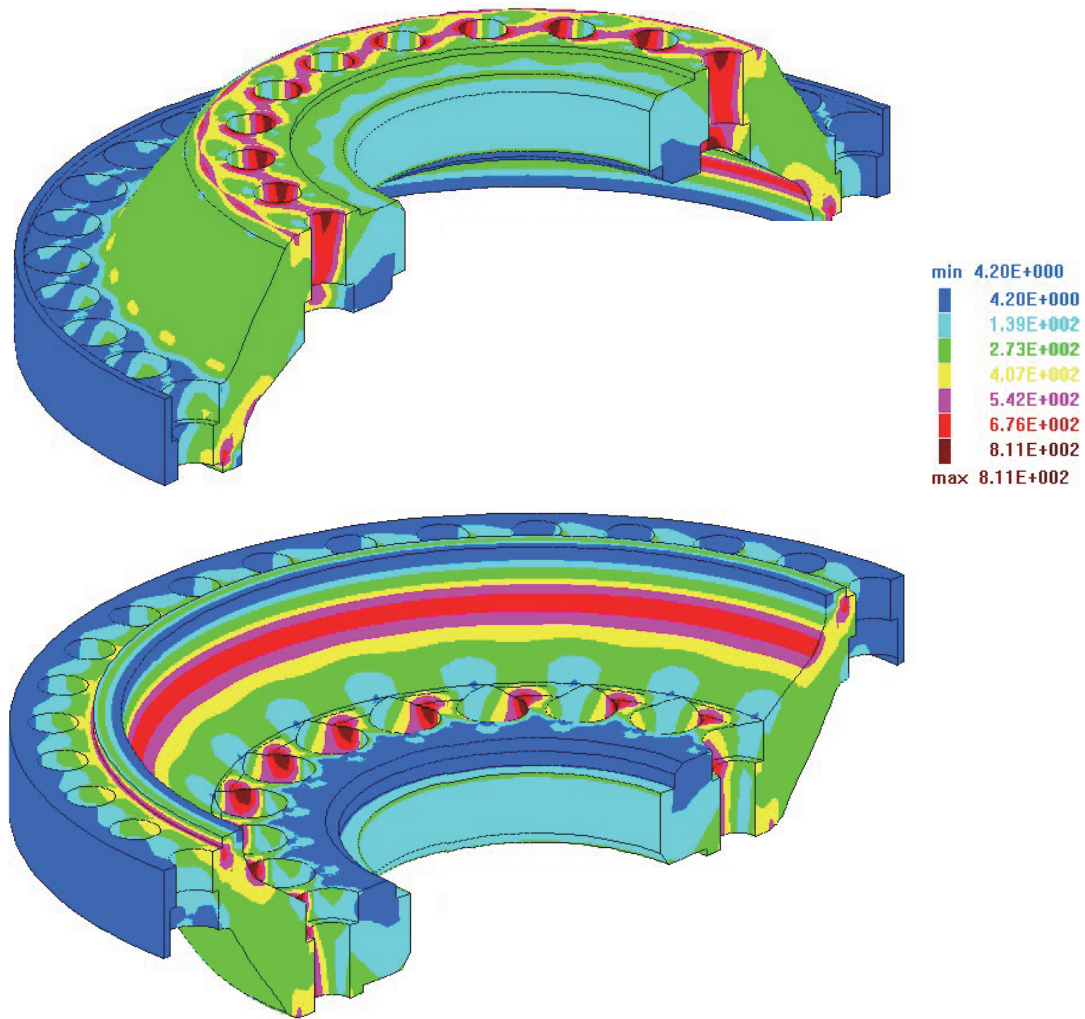
Figure 3: Equivalent stresses for combined loading (pressure, axial force, torsion).

For the turbine under consideration the maximum stress at shut down and start up is $\sigma_{\max} = 81.1 \text{ MPa}$, thus the amplitude stress $\sigma_a = 40.55 \text{ MPa}$.
