Events of Corrosion Phenomena on Carbon Steel Pipes in Environment of Sea Water and Ammonia Solutions due to the Presence of Sweet Gas

Abstract. Based on the results of the study that the test sample material using carbon steel pipe plate API 5L-X65 is in chamber. With the research using the three point loading method is the environment of CO_2 gas and saturated H_2S gas in a solution of 7900 ml of sea water and 100 ml ammonia, the corrosion phenomenon occurs. And the corrosion event that occurs, is stress corrosion cracking transgranular and intergranular based the results of microstructure test results and based the results of polarized microscopy test. The corrosion rate that occurs will increase with the deflection given to the larger test samples for the same exposure time, the corrosion rate that occurs will increase with the deflection given to the test sample getting larger for the same exposure time and inside crack will get deeper with the deflection given to the test sample getting larger for the same exposure time.

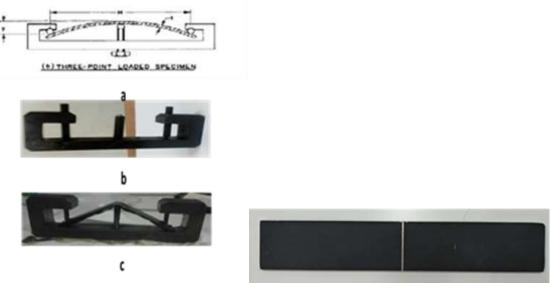
To make a house a corrosion test sample is required a sheet of steel in the form of a plate or flat extruded section with a rectangular cross section. In addition it can also be used cast iron or iron in the form of a beam as shown in Figure 1. The material to be tested is thinly sliced and then bent at both ends to obtain a voltage, and the magnitude of the voltage can be adjusted by providing a deflection through a screw-driven thread as shown in FIG. 1b. And this research uses 5L-X65 API carbon steel plate with length 12.5 cm, width 2 cm and thickness 2 mm stored in holder specimen three dot loading as shown (1.a) inserted into chamber room of corrosion test as much as 3 sample test corrosion with deflection variation as shown in figure (1.c) and image (1.d) is a 5L-X65 API test plate^[3].

d. Samples of 5L-X6 API test specimens. Figure 1. Holder shape and mounting of test specimen.

Flat-shaped specimens have dimensions of width, length, and thickness of specimens usually determined by the product of the material used. The specimen holder in both ends of the specimen is bent / pressed with the screw (fitted with the ball), the support is in the middle of the plane. The dimensions of the specimens used can be modified according to

H = distance between external buffer (mm) and small deflection (y / H less than 0.1) as shown in Figure 3. Flat chip specimens with 25-51 mm (1-2 inches), 127-254 mm length (5 - 10 inches) and the thickness of the specimen is usually determined the product of the material used as shown in figure 1.
