Volume 86 | Issue 3

## Magnetometer Surveys: Attempts and Issues in Locating a 1948 Private Water Well on the Shore of Lac Sault Dore, Price County, Wisconsin

Two different magnetometer surveys in northern Wisconsin during the summers of 1997 and 2010, using two different Geometrics magnetometers, a proton precession G-816 unit and a cesium vapor G-858 unit, in an attempt to locate a surface-target position of, and depth to, an abandoned 1948 private water well, successfully targeted the suspect surface position and the depth to the well head spike. Both surveys detected 400-gamma anomalies and estimated the depth to the spike at 2 meters. A land owner, private family photograph taken in 1951, was used to compare the anomaly's position to the actual surface position of the well. Two, one meter deep pits were hand dug in 2004, in an attempt to excavate, remove and replace the well spike; however, the attempt was not successful due to large trees, roots, and available equipment. For aesthetic reasons, the land owners were reluctant to cut the trees down at that time in order to continue excavation. After the 2010, magnetometer survey, a second excavation attempt was not made, and n

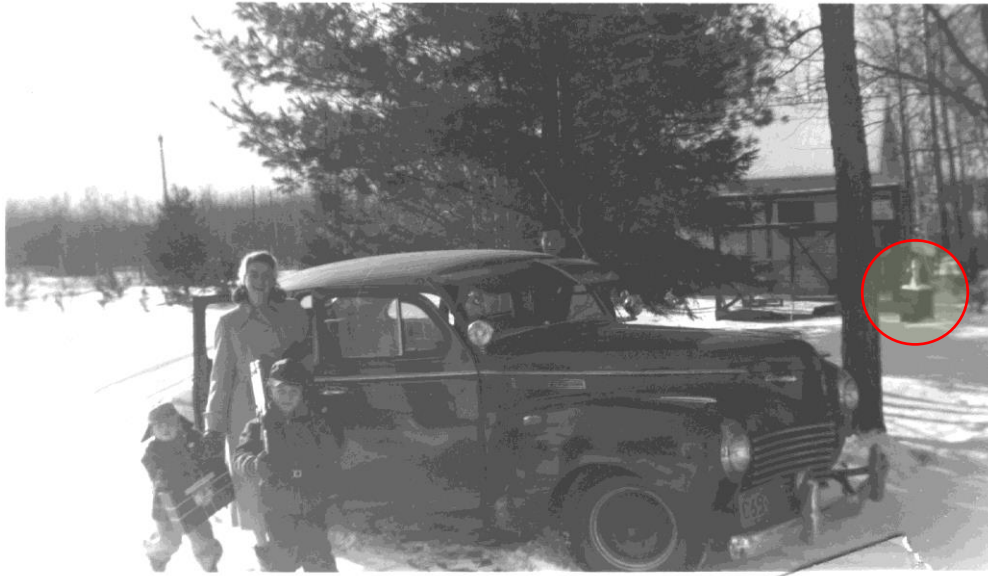
**Figure 1.** Surface hand pump visible right center (circle). Author (right foreground) in 1951. Author's brother and mother also pictured. Photo by Mrs. Marie Forber, author's grandmother.

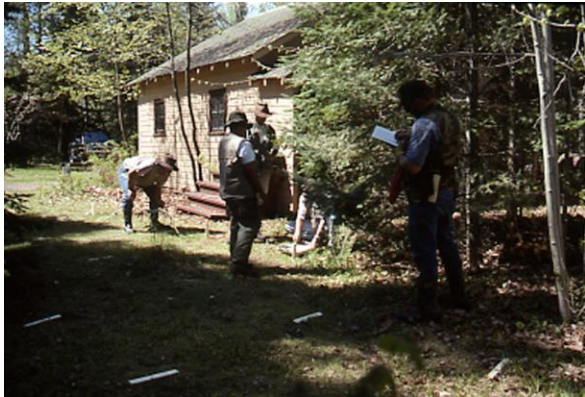
**Figure 3.** Fort Hays State University's 1997 Geology field camp students setting up grid east of garage. Photo by K.R. Neuhauser.

Techniques employed to locate the well head followed those outlined by Breiner (1973), Frischknecht, *et al.* (1983), Jachens, *et al.* (1985), Martinek (1988), Rivers (1995), and Jordan and Hare (2002). In the 1997, survey a 10 x 10 meter grid with wooden stakes placed every 1.5 meters with one grid axis oriented N20W and a second grid axis was at N70E (fig. 3). A Geometrics G-816 proton precession magnetometer was used for the 1997, survey (fig. 4A) and in 2004 to spot check the 1997, suspect site (figs. 4B). Individual data points were recorded with the G-816, and the data were typed into a spreadsheet, imported to and contoured using Surfer 4.0 (Golden Software).

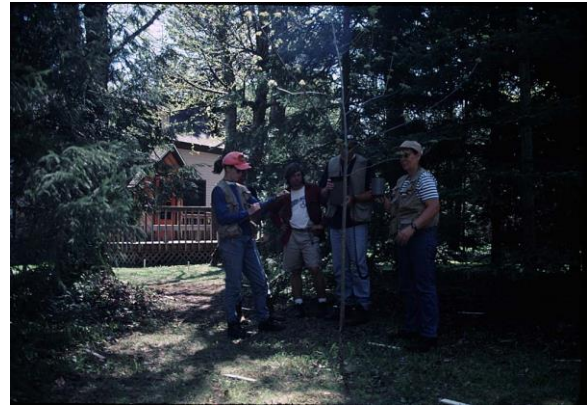
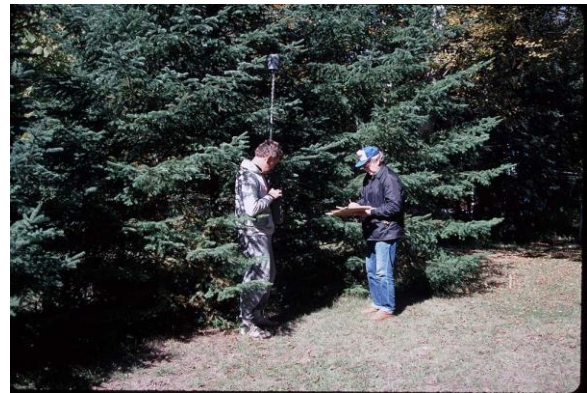
**Figure 4.** A) Students using G-816 in 1997, survey on left (photo by K.J. Neuhauser).

B) Author with G-816 unit and Mr. John Neuhauser (father of co-author K.J. Neuhauser) taking field notes during spot check in 2004 on right. Photo by K.R. Neuhauser.

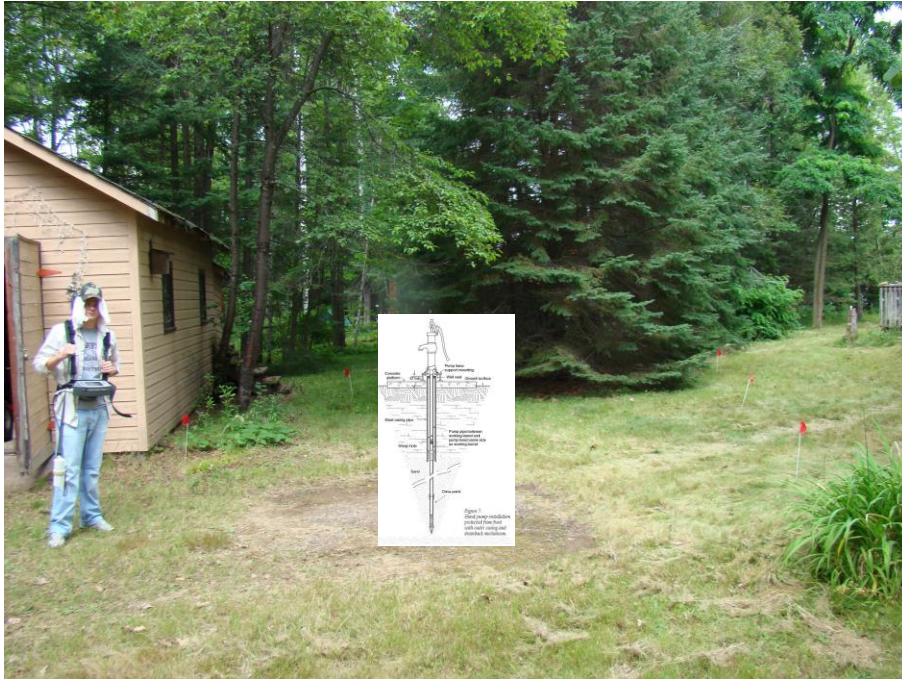
**Figure 5.** 2010 study site. Co-author Kris Neuhauser ready with G-858 cesium magnetometer unit. Plastic flags at 5-meter grid intervals. Inset diagram of a hand pump system with drill spike (WSH, 2012). Photo by K. J. Neuhauser.

The 2010, survey used a 5 x 15 meter grid (fig. 5) with EW-NS oriented plastic flags at 5 meter intervals. A Geometrics G-858 optically pumped cesium magnetometer was used for the 2010 survey. The G-858 unit recorded the data continuously on the recording console as the operator walked along the grid, and the data

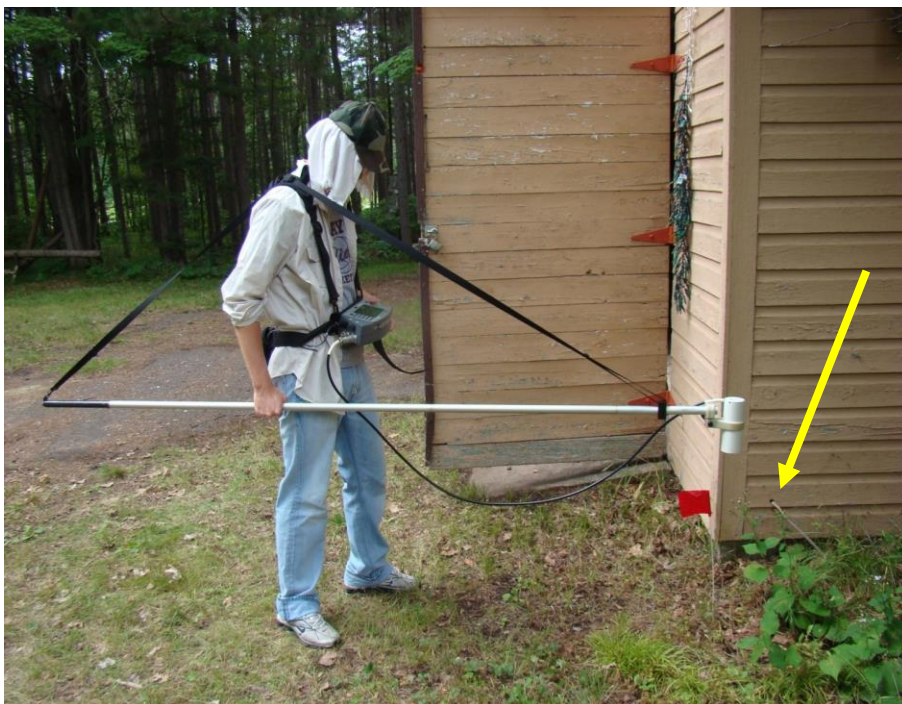
**Figure 6.** Checking to verify electricity turned off. Arrow points to electric line to garage. Photo by K. J. Neuhauser.

In both surveys, we verified that the electricity was turned off and that metal tools in the garage, as well as vehicles and one boat were moved far enough away as to not interfere with the magnetic readings (fig. 6). However, we were unable to move the iron clothes line which was connected to a buried cement base.

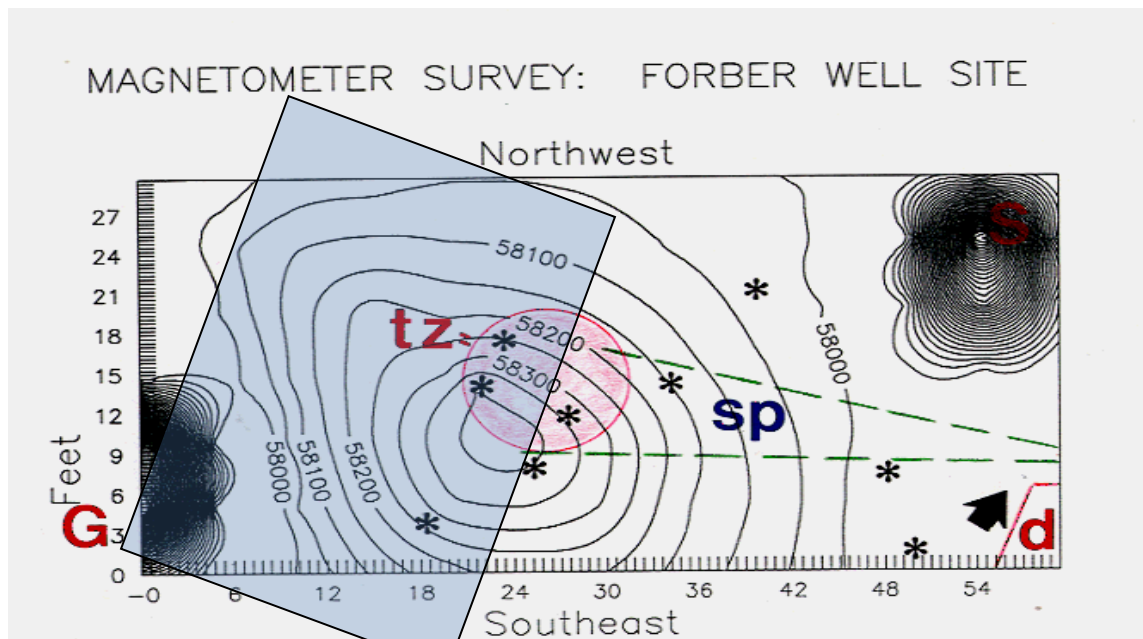
**Figure 7.** Figure illustrates the isogam anomaly map of the 1997 survey. Blue rectangle = 2010 survey zone G = garage tz = target zone (red circle) d = deck sp = suspect buried water line to house. S = steel clothes line post \* = fir trees

Analyses indicate a near circular, 400-gamma anomaly (fig. 7) from the 1997, survey; and a sub-circular, elongate 400-gamma anomaly (fig. 8) from the 2010, survey. The target zone for both anomalies is amid a grove of large balsam and blue spruce trees which made excavation difficult. The well pipe head causing the anomaly is calculated to be buried ~2.0 meters below ground level (fig. 9). In 2004, two, one-meter deep pits were hand dug using spades, chisels, and axes in an attempt to excavate, remove and replace the well spike; however, the attempt was not successful due to the trees, their roots, and

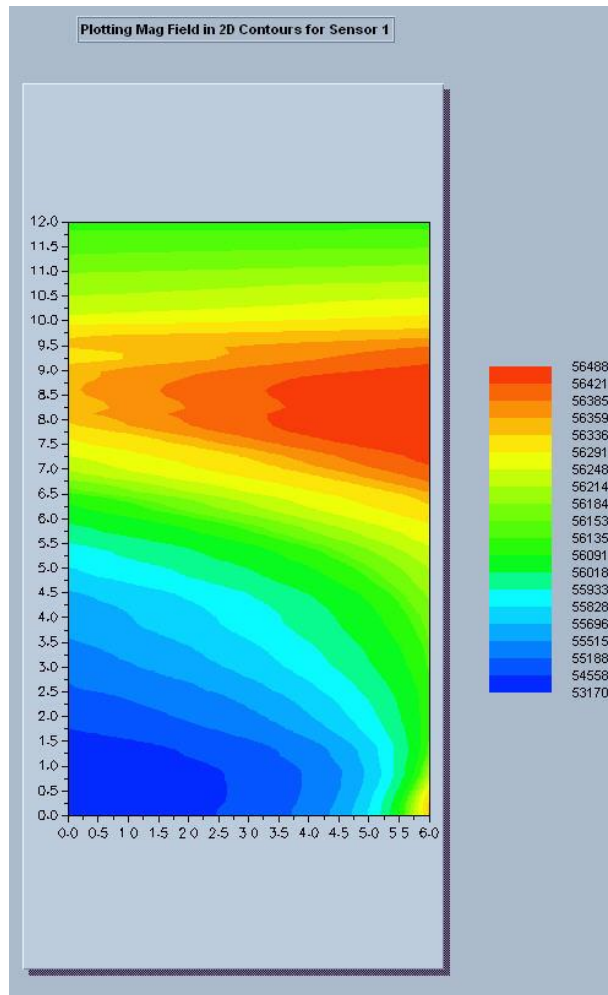
**Figure 8.** Isogram anomaly map of 2010 survey. North is to top of map. Red zone targets suspect well head surface position. Created with MagMapper 2000 (Geometrics).

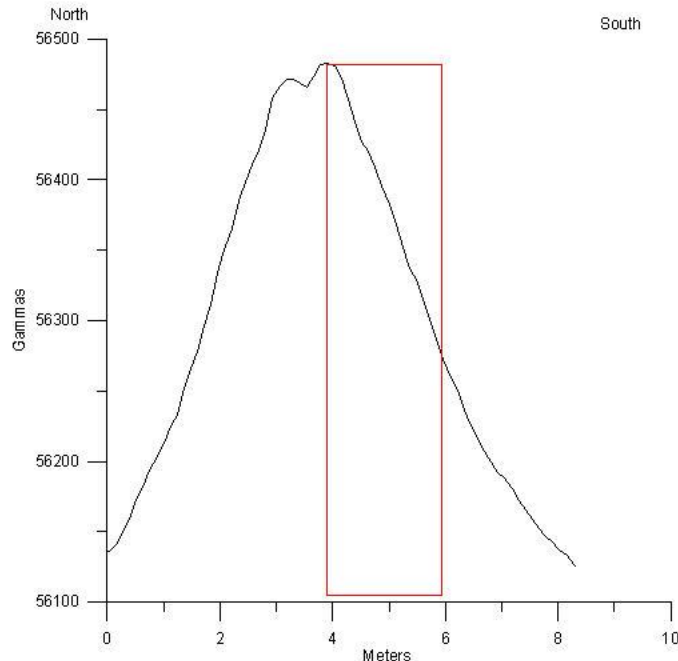
Figure 9 Depth estimate of ~2 meters using Peter's half-slope rule (1949).

The depth estimate was calculated using *Grapher* 6.0 (Golden Software) and the half-width rule (Peters, 1949). 2010 grid GPS points were recorded using a Garmin GPS-12 unit. No GPS coordinates
