### The microstructure of drill steel

THESIS

FOR THE DEGREE OF B.S. IN MINE ENGINEERING.

THE MICROSTRUCTURE OF DRILL STEEL

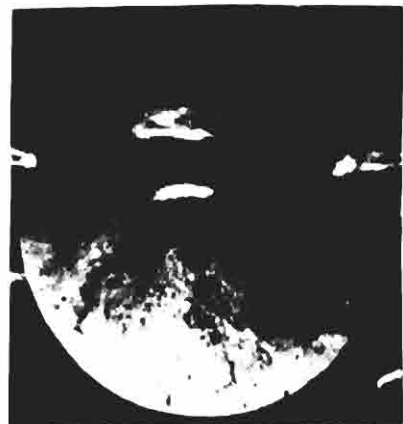
#11 HARDENED

HARDENED: Bright cherry and drawn to a light straw. Nine hundred diameters. The field is nearly all very fine martensite with about one-tenth white cementite. Shows a very crystalline structure.
