International Conference on Case Histories in  
Geotechnical Engineering

(2013) - Seventh International Conference on  
Case Histories in Geotechnical Engineering

## Impacts of Drain Water on Soils and Crops and It Causes: A Case Study of Kamber Taluka, Pakistan

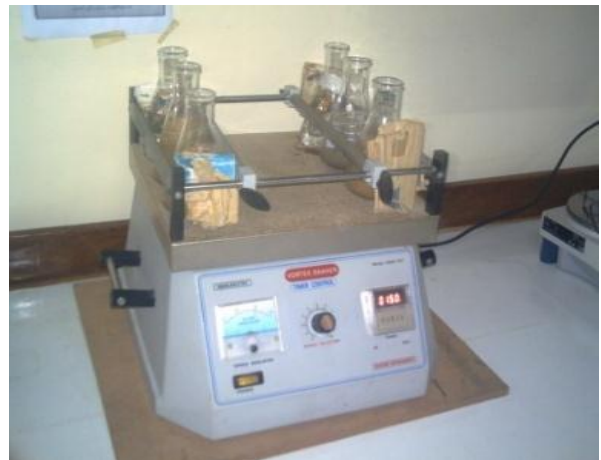
Figure 4 Laboratory process of Soils filtration

For the laboratory analysis purpose Soils and Water samples were collected from the 40 different locations of the Taluka, (34 samples of soils and 6 samples of water). Soils samples were collected from 34 different locations of the study area (soils samples were ranged from 0-15, cm depth and packed in plastic bags, then those samples were air dried. Thirty grams of filtered soil mixed in 150 ML of distal water in conical flasks. All samples were kept on the Mechanical Shaker in Conical Flasks for 30 minutes only. After the shaking process, all the elements dissolved in water. We used filter paper for pure filtration of soil analysis, and then we check the pH, E.C and TDS of the soil. pH measured by pH meter (Hanna instruments HI 8014), Electrical Conductivity (E.C) calculated by E.C tester (Hanna instruments HI 98304) and Total Dissolved Salts (TDS) were calculated by the TDS tester (Hanna instruments HI 98301) at Soil and Water testing
