Deep Caisson Sinking in Soft Soils, Grand Forks, North Dakota

DEEP CAISSON SINKING IN SOFT SOILS, GRAND FORKS, NORTH DAKOTA

ABSTRACT

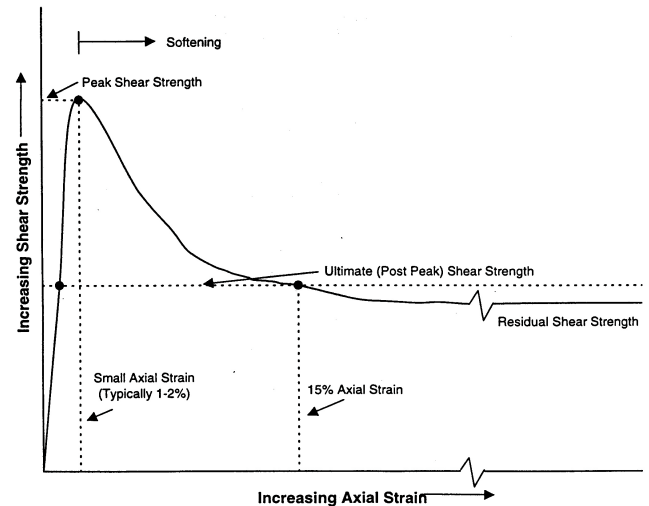
Fig. 2. Typical Softening Behavior (Shannon & Wilson, 2000)

The soils in this region, especially the Brenna Formations, reach peak shear strength in laboratory tests at low axial strains (often 1 to 2 percent). With further axial strain, a significant reduction in shear strength then occurs.

To account for strain softening behavior, ultimate shear strengths were used for design instead of peak shear strengths. These ultimate shear strengths were determined from triaxial compression tests by recording the deviator stress at an axial

strain of 15 percent. For a majority of the soils, this strain occurred after peak strength had been reached and hence the ultimate strengths were referred to as “post-peak shear strengths.” The post-peak shear strengths were horizontally projected from the descending limb of the stress-strain curve to the ascending limb (Fig. 2). This mechanism provided a means to assure that the soil would not reach peak shear strengths and undergo potentially significant strength loss.

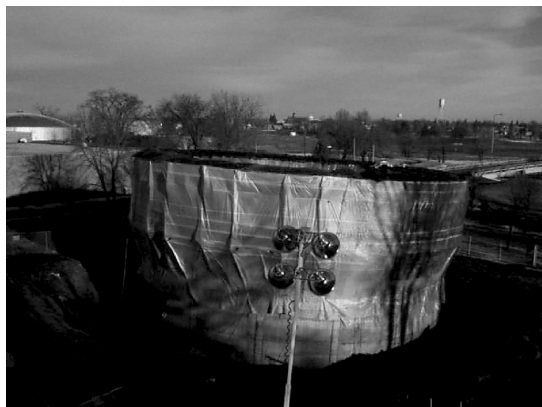
Fig. 5. Photo showing early tilt of caisson

- The second 17-foot wall section was then formed and poured. During pour, the caisson again began to sink under its own weight. As the pour progressed, the caisson was observed to tilt (Fig. 5). Upon investigating the issue, an isolated area of frost under the cutting shoe was observed. The frost apparently was caused by insufficient insulation that allowed the January cold to penetrate the soils near the caisson wall. To correct the tilt, the contractor first excavated and removed the piece of frost from beneath the cutting shoe, and began excavating within the caisson by removing soils from near the frost location. The

decrease in soil mass resulted in lower friction forces at the interior wall of the caisson, thus prompting the “high” side of the caisson to sink faster than the “low” side. This process was continued and monitored until the tilt was corrected.

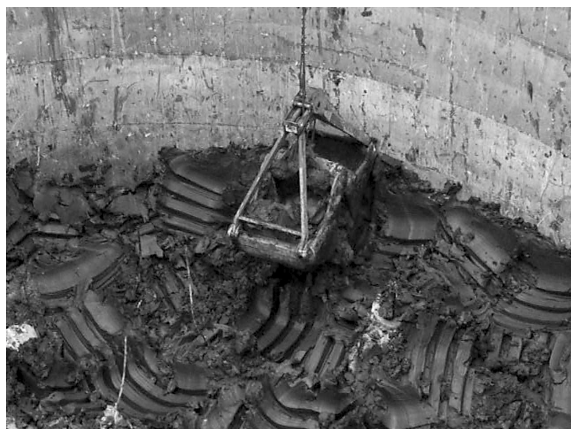
Fig. 6. Photo showing excavation inside caisson.

- Soil excavation and removal from inside the caisson continued using a small backhoe near the walls and a crane with a 3-yard clam bucket. This process continued until the top of each caisson section was sunk to within 2 feet above existing grade (Fig. 6).
