F. E. Volkov
Institute "BashNIIstroy", Ufa, Russia

USE OF STRENGTHENING CEMENTATION WHEN CIVIL STRUCTURES ON KARSTED TERRITORIES CONSTRUCTION

The paper describes the experience of construction on a karsted site with the karst protection. A subject of construction is a 14-storey, 2-section building. Each section is 20 x 40 m in plan, 36 m height with a basemnt of 2.5 m height. The walls of the building are brick, the foundation is a reinforced concrete raft.

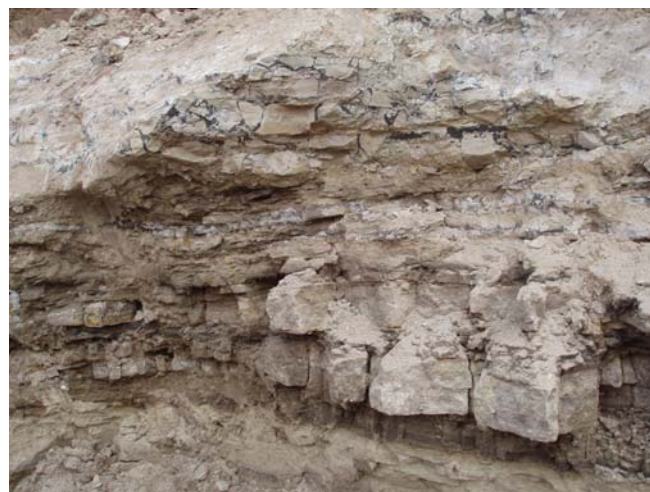
Fig. 1. Layer-flaggy structure of rocks with clear tracing of cement treatment

Drilling works and laboratory test of samples and monoliths showed the soil mass after cementation to become strong and dense. All the caverns met and discompactions were filled with cement. The strength of samples with caverns and fractured void filled with cement was within 2 – 8 MPa and was comparable with the strength of the mother rock (figures 1,2).

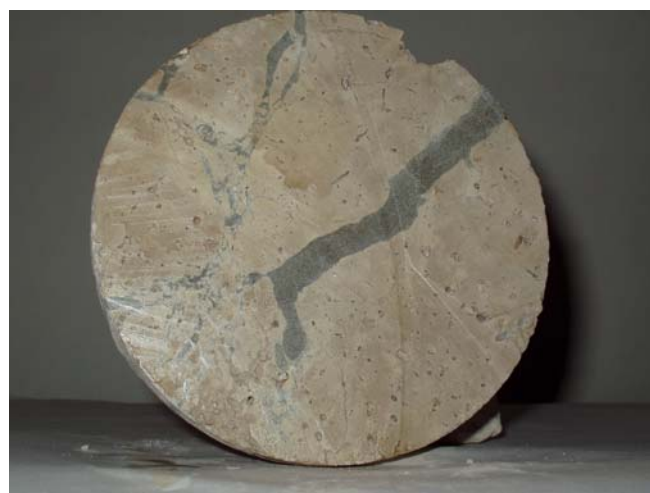
Fig. 2. Horizontal shear of the cement treated specimen
