(2004) - Fifth International Conference on Case
Histories in Geotechnical Engineering

Analysis of the Behavior of the Piled Foundations of a Group of Earthquake Damaged Buildings

ANALYSIS OF THE BEHAVIOR OF THE PILED FOUNDATIONS OF A GROUP OF EARTHQUAKE DAMAGED BUILDINGS

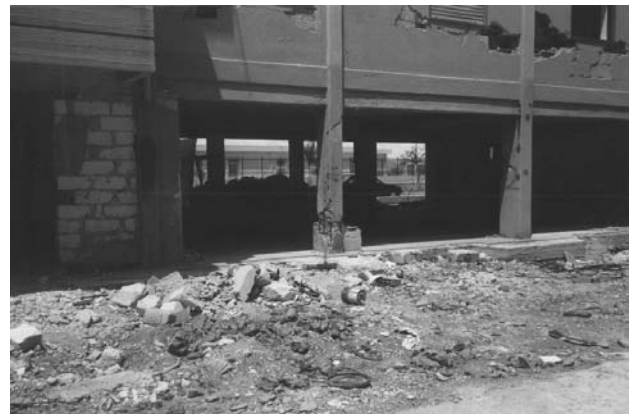
A group of reinforced concrete buildings with 228 flats, located in the Saline of Augusta site, were heavily damaged (Figure 2) by this earthquake of moderate magnitude ($M = 5.4$). To evaluate the possibility to repair these buildings, an investigation on soil, building foundations and structures was carried out.

Fig. 2. Damages occurred on buildings.

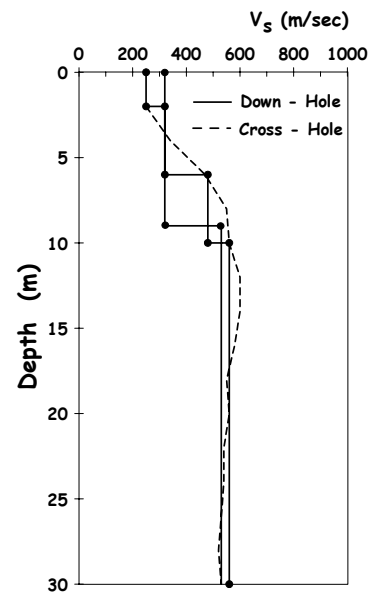
Particularly up to -10 meters from the ground surface, an average value of the shear waves velocity $V_s = 320$ m/s can be assumed.

An average value of the shear waves velocity approximately equal to $V_s = 530$ m/s can be estimated up to -30 meters from the ground surface.

Fig. 8. Shear waves velocities versus depth.

In addition to the abovementioned in situ tests, dilatometer tests (*DMT*) and seismic tests (*Down-Hole* and *Cross-Hole*) were also carried out. In Figure 7 the variation versus depth of the material index I_d , coefficient of earth pressure at rest k_0 , dilatometer modulus E_d , undrained shear strength c_u obtained by means of the dilatometer tests are reported respectively. Finally Figure 8 shows the variation with depth of the shear waves velocity determined by the cross-hole and down-hole tests. In this case, comparing the values measured, a good agreement between the values of the shear waves velocity V_s determined by means of the two different seismic tests can be observed.

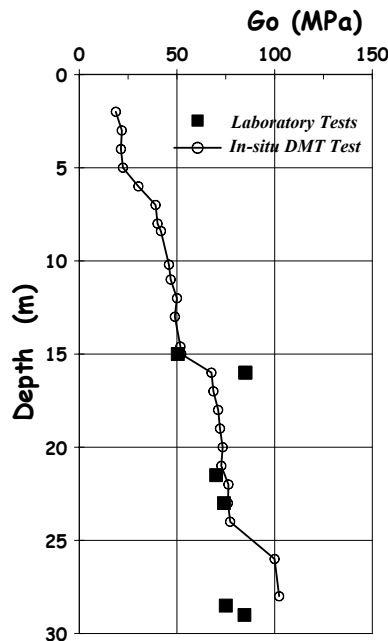
By laboratory tests, the G_o values were determined at shear strain levels of less than 0.001 %. It is possible to observe that quite a good agreement exists between the laboratory and in-situ test results. The G_o values for the upper silty-clay steadily increase from 20 to 80 MPa with depth.

In the transition zone, where stiff sand layers are present, G_o increases up to 110 MPa. In the lower blue-grey clay G_o values range in the range 80 up to 120 MPa.

A very good agreement was observed (Figure 9) between the value of G_o determined by the laboratory tests and those derived by the following empirical correlation proposed by Hryciw (1990):

Fig. 9. G_o values versus depth.

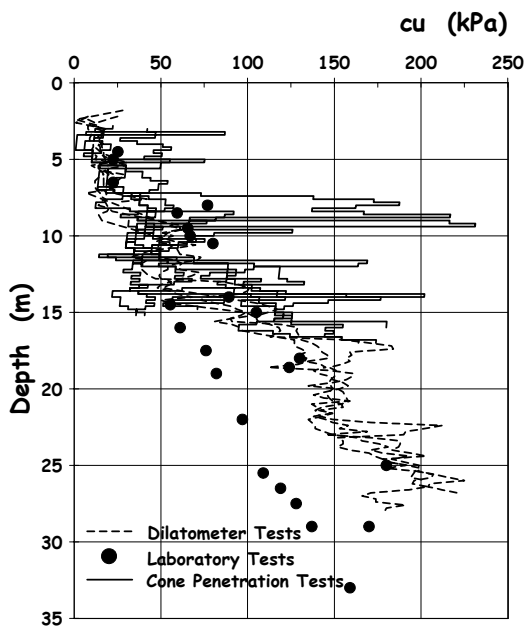
Fig. 10. Assessment of the undrained shear strength values.

and laboratory tests has been carried out (Figure 10).

To express the variation of the undrained shear strength versus depth, the following relationship was derived: c_u (kPa) = 7.5 z , where z is the depth from the ground surface.

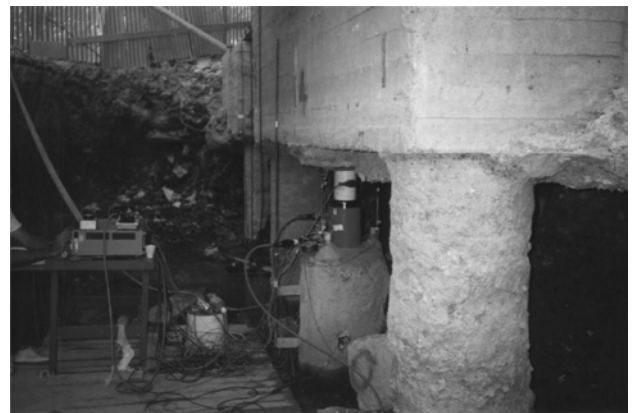
To evaluate the integrity of the piled foundations after the earthquake, the piles were inspected and also an experimental load tests program was carried out. Three piles placed beneath the existing foundations were chosen and their head was disconnected from the foundation (Figure 11) to execute vertical and horizontal load tests. At the end of the load tests, the connection between piles and foundation was restored.

Fig. 11. View of the load test on a pile of the piled foundation.

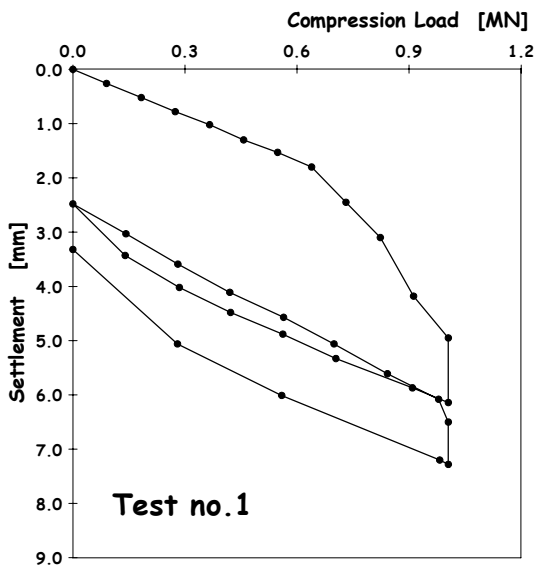
The experimental results show that the measured settlements were less 7.2 mm for the maximum load applied and less than 2.0 mm for the design load.

The residual settlement was ranging between 1.0 and 0.34 mm and the trend of the load-settlement curves derived by the load tests, named *Test no.1* (Figure 12), *Test no.2* (Figure 13) and *Test no.3* (Figure 14), shows a marked non-linear behavior of the soil-pile interaction. In particular, load-settlement curves seem to follow a hyperbolic law, then the loading curve may be analyzed by transforming the data and plotting to yield a straight-line relationship in a plane (*settlement, settlement/load*), the slope of which allows to estimate the ultimate failure load, as suggested by Chin (1970). The ultimate pile capacity is assumed generally equal to 90 % of the value so determined.

Fig. 12. Test no.1: Measured load-settlement curve.

Fig. 13. Test no.2: Measured load-settlement curve.

Fig. 14. Test no.3: Measured load-settlement curve.

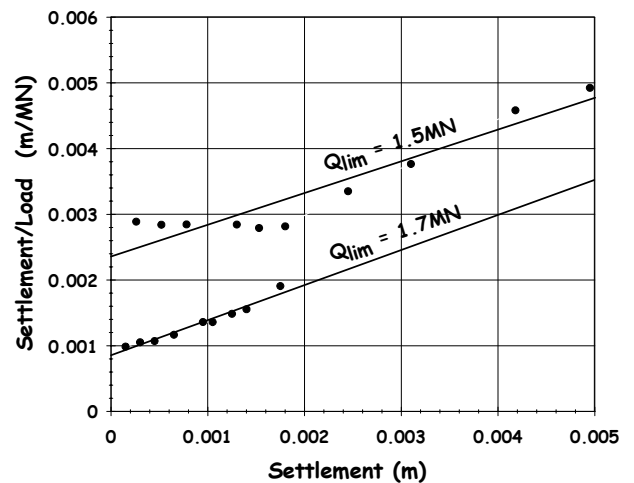
According to this procedure the ultimate failure load derived by the load tests is ranging between around 1.5 MN and 1.7 MN (Figure 15), in a very good agreement with the value of 1.53 MN computed in undrained conditions by the well-known Vesic's pile capacity relationships.

Fig. 15. Evaluation of the ultimate vertical failure load.

The safety factor of the soil-pile system derived by the back-analysis of the load tests is greater than 3, thus the effectiveness of the piled foundation was considered able to support axial loads, instead of the damages occurred on the structures due to the earthquake.

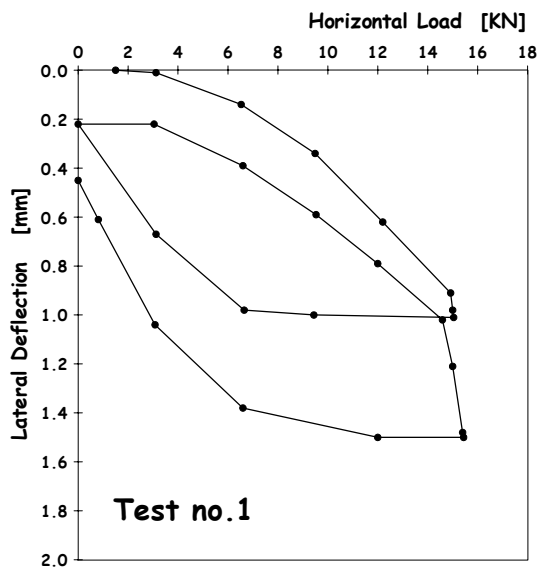
To evaluate the piles performance due to lateral forces, after conducting the axial tests, lateral loading tests were also performed on two piles. Figures 16 and 17 report the experimental load-deflection curve derived by the load *Test no.1* and 2 respectively.

Predicted lateral responses based on dilatometer-evaluated model parameters agreed well with measured field behavior from the two lateral pile load tests. It is found that, also in the case of lateral loading, the hyperbolic representation of load-deflection curves provides an objective means to determine the ultimate lateral load capacity (Castelli *et al.*, 1995), which is comparable with the computed values based on Brom’s theory. The experimental results show that the measured lateral deflection for the maximum load applied was ranging between 1.5 and 4.0 mm, while the residual lateral deflection was ranging between 0.45 and 1.3 mm. The ultimate failure lateral load derived by the hyperbolic representation of the load-deflection curve is equal to around 1.9 kN.

Fig. 16. Test no.1: Measured load-lateral deflection curve.

Fig. 17. Test no.2: Measured load-lateral deflection curve.

The ultimate failure lateral load was not able to support horizontal seismic forces for the scenario earthquake, thus a few number of piles were added to the existing piled foundations.
