## Liquefaction During the October 12, 1992, Egyptian Dahshure Earthquake

# Liquefaction During the October 12, 1992 Egyptian Dahshure Earthquake

**SYNOPSIS:** On October 12, 1992 a moderate earthquake  $M_B = 5.9$  ( $M_S = 5.2$ ) occurred about 18 km southwest of the center of Cairo and resulted in significant damage to numerous poorly constructed structures. Soil liquefaction associated with the occurrence of large sand-boils was observed close to the epicenter. As a consequence, a main road suffered a maximum settlement of about 1.75 m. In this study, the earthquake characteristics, soil profiles and resulting liquefaction are discussed. The observed liquefaction mechanisms provide valuable information on the seismic response of Nile deposited alluvial soils. Such soils constitute much of the inhabited area of Egypt.

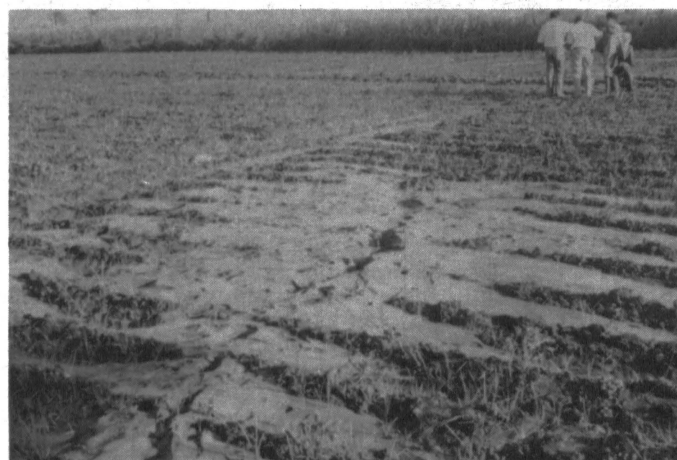
Fig. 6. Ground fissure and sediment eruption.

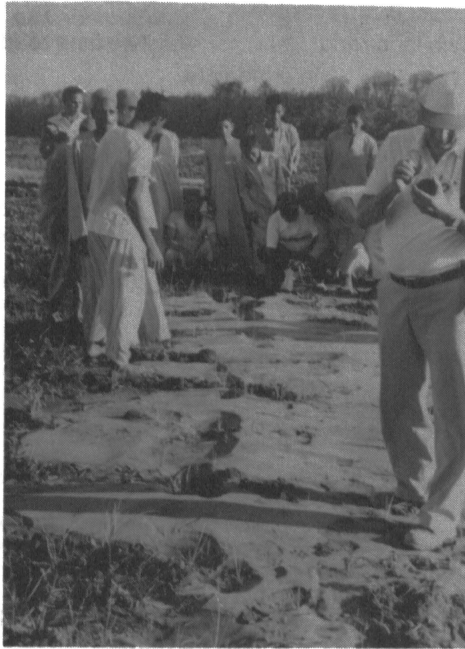
Fig. 7. Close-up of sediment eruption shown in Fig. 6.

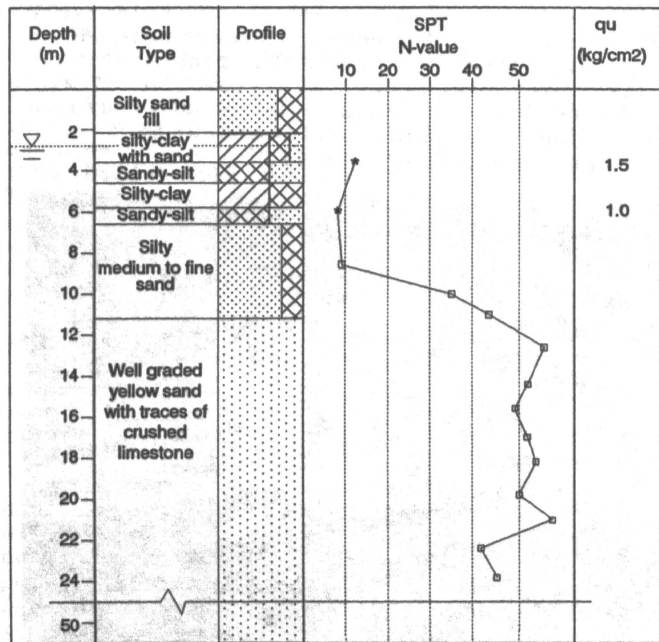
A soil profile from a boring near the road, taken after the earthquake is shown in Fig. 8. This profile denotes that liquefaction could have occurred anywhere within the zone bounded by elevations -3.0 m to -9.0 m. In this zone, significant stratification is evident, and low SPT silts and sands appear to be prone to liquefaction. Indeed, the soil ejected to ground surface during liquefaction was thought to be mostly constituted of fine silty sand. A more thorough program of site investigation and laboratory dynamic testing is needed in order to clarify the involved liquefaction mechanisms at this site.

(\* denotes that value was inferred from the corresponding qu)

Fig. 8. Soil profile near the road settlement area.

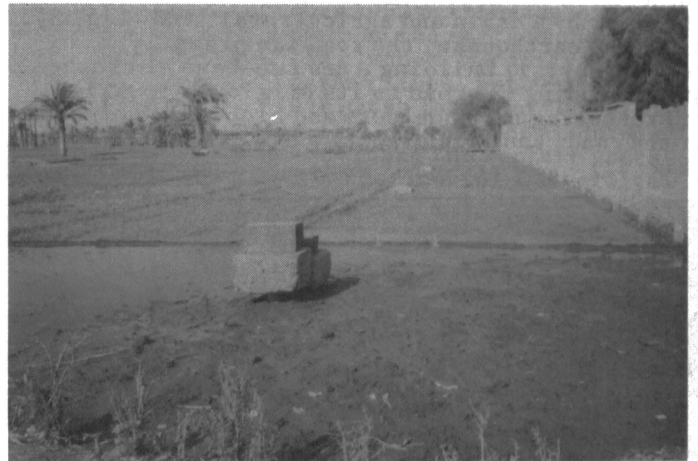
Fig. 10a. An abandoned steel pipe covered with a concrete block moved upwards relative to the surrounding soil.

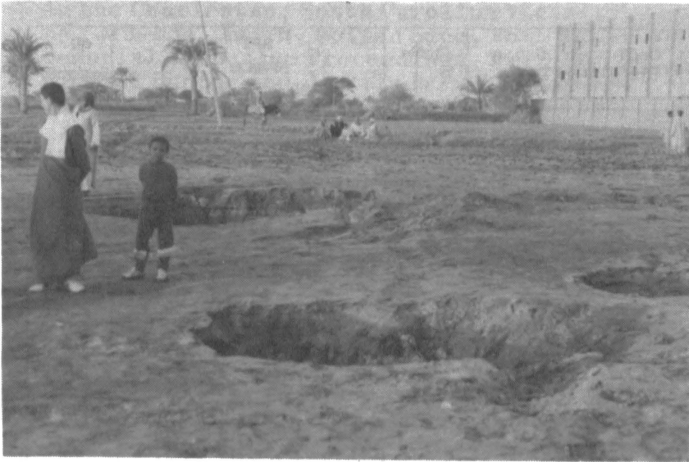
Fig. 11. Craters No. 2, 3, and 4 of Fig. 9.

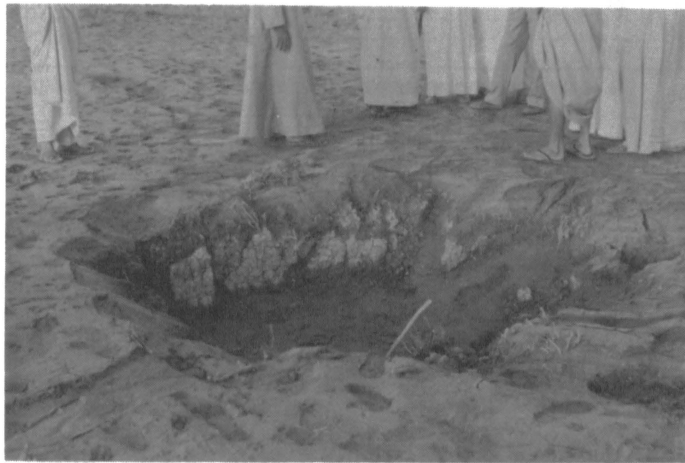
Fig. 12. Crater No. 5 of Fig. 9.

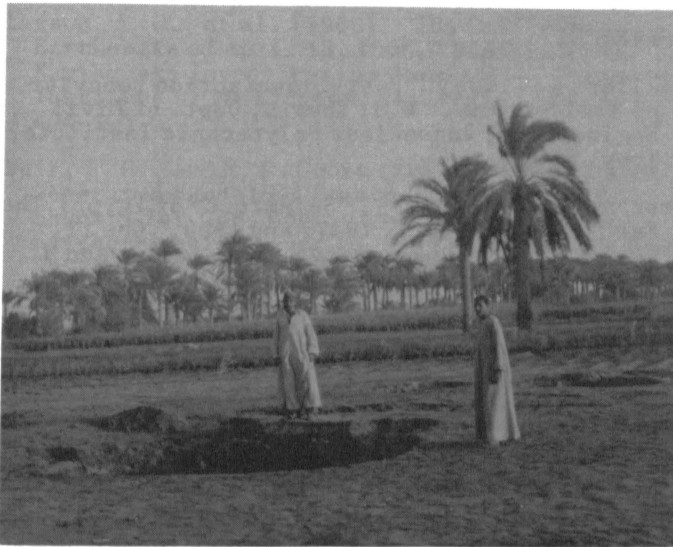
Fig. 13. Craters No. 6, 7, 8, 9, and 10 of Fig. 9.

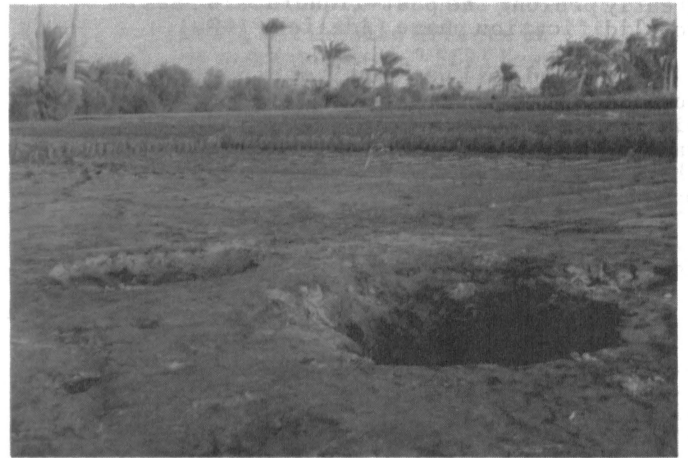
Fig. 15. Close-up of Craters No. 8 and 9 of Fig. 9.

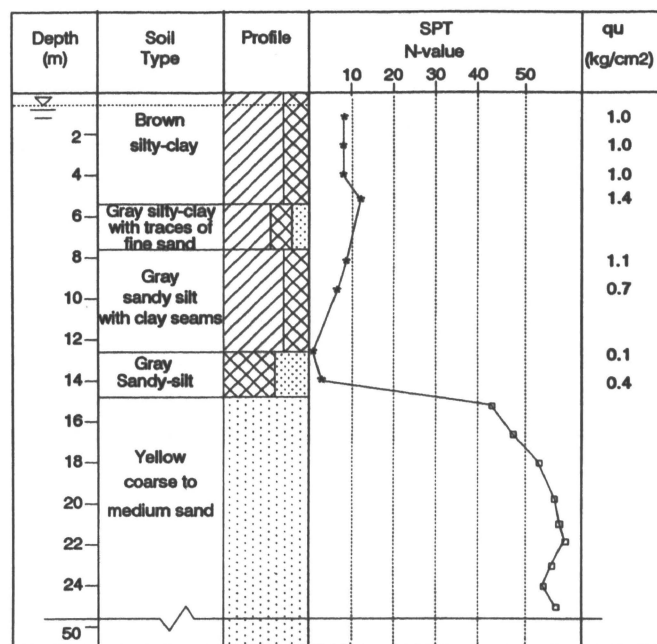
Figure 17 depicts the soil profile obtained from a boring at Bedsa. Underlying a low permeability silty-clay stratum, low SPT blow counts are seen to prevail in the upper 7.0 m of liquefiable sandy and silty soil materials (elev. -8 m to -15 m). The gray color of these materials is similar to that of the sediments ejected to ground-surface during the sand-boil process. Accurate continuous boring data, and SPT/CPT results are needed at Bedsa in order to further analyze the involved pore-pressure buildup and post-liquefaction mechanisms.

(\* denotes that value was inferred from the corresponding  $q_u$ )

Fig. 17. Soil profile near sand boils at Bedsa.
