A Case History of Liquefaction Flow Failures in Mountains Mine Waste Dumps

A Case History of Liquefaction Flow Failures In Mountainous Mine Waste Dumps

Paper No. 2.29

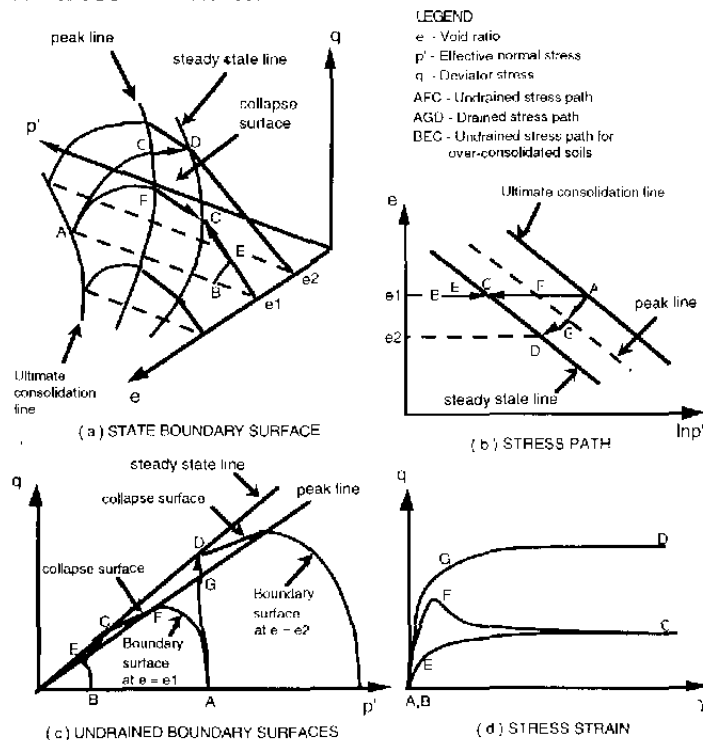
Fig. 1 State Boundary Surface For Loose Sands

conditions have been observed in laboratory tests (Sladen et al., 1985, Skopek et al., 1994). The residual strength of loose sands under undrained conditions has been defined as a steady state by Castro et al.(1975). Figure 1 shows schematically a boundary surface introduced by Gu et al (1992, 1994) for loose sands to incorporate the concept of steady state and collapse surface into the framework of critical state boundary surface theory. As shown in Figure 1(c), each undrained boundary surface is respective to a constant void ratio e and depends on the soil structure directly rather than on the normal stress. A strain softening liquefaction model has been developed and implemented into a finite element program based on the undrained boundary surfaces (Gu et al., 1993, 1994).

The critical state boundary surface theory was developed by Roscoe et al.(1958). In this theory, a critical state line has been defined in p' - q - e three dimensional space. The critical state line relates the soil strength and yielding behavior to the soil structure directly. This is a necessary feature for a soil experiencing complicated stress paths or histories, such as over-consolidation, loading in variable drainage conditions and loading under both dynamic and static conditions. It is more importance for highly mobile soils, such as the loose sands under undrained conditions in which the soil strength and yielding behavior may change rapidly depending on the current soil structures.

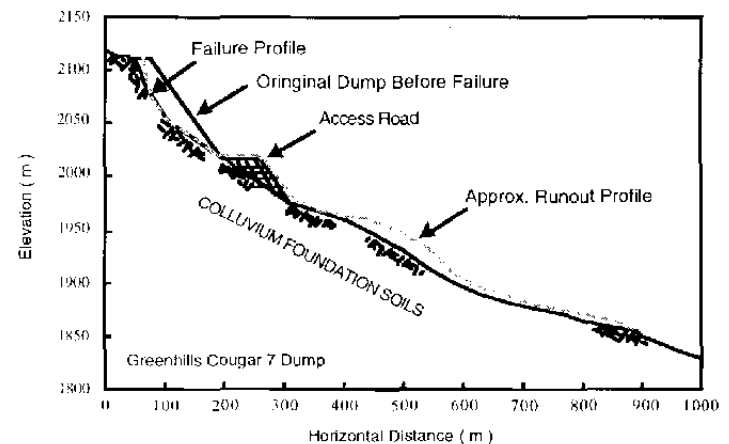
Fig. 2 Flow Failure of Greenhills Cougar 7 Dump

The Cougar 7 dump at the Greenhill's Mine located near Elkford, British Columbia was constructed in the winter of 1991 between February and May. The dump was inactive and remained stable for 13 months until a large flowslide occurred in the morning about 07:00 am of May 11, 1992. Approximately 200,000 cubic meters of failure debris slid off the 100m high waste dump, traveled across an access roadway, and flowed down slope for a total runout distance of 700m. The cross sections and runout profile for the slide are shown in Figure 2. The site conditions prior to and immediately following the failure event were investigated by Golder Associates(1992) and the BC Ministry of Energy, Mines and Petroleum Resources(1993). Cracks were noticed on the dump face in the previous night. Seepage zones were also noticed. By a judgment of the short time in which a service truck couldn't escape from the hazard area, the failure occurred very rapidly and the debris attained considerable velocity.

The site investigation (Dawson et al., 1992) revealed that the dump was developed in the headwater area of Cataract Creek. Water was observed flowing through the runout debris below the original dump toe during the investigation. The runout zone of the Cougar 7 dump consisted predominately of sandy gravel materials. The dozer cut revealed a wet sandy gravel layer at the foundation contact. Layers of fines were observed near the dump crest and in the failure debris. It is clear that the dump was riding on a fine saturated layer before the failure.

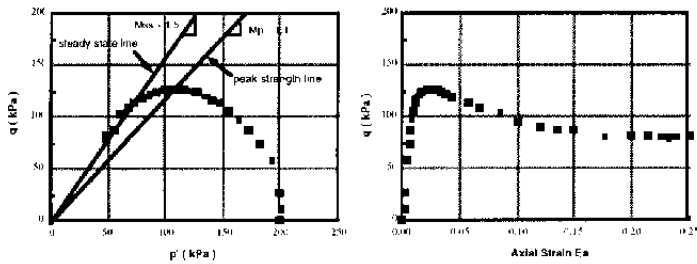
Fig. 3 Strain Softening of Sandy Gravel In An Undrained Triaxial Test

Undrained triaxial tests were conducted on lab prepared sandy gravel samples in 10.2cm diameter cells. The samples were prepared by removing oversized particles(-20mm) from the field sampled materials. Results for a typical strain softening undrained test are shown in Figure 3. The peak strength is reached at an axial strain of about 2%. The steady state strength of about 80 kPa is achieved at the axial strain of about 20%. The results from all test samples indicate that the steady state points mostly lie close to a straight line defined by a slope of 1.5 on the p'-q plane which is equivalent to an effective friction angle of 38°. The peak strength relationship shows a straight line with a slope of about 1.1 which is equivalent to an effective friction angle of 20°. At average stresses of 50 to 300 kPa brittle behavior is well defined, the stress paths in this range show a collapse surface with a slope of about 0.5 on the p'-q plane.

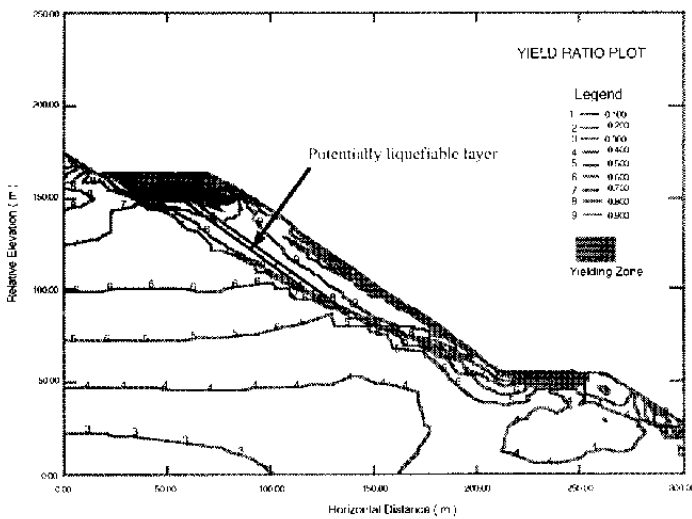
Fig. 4 Initial Yielding Ratio In Greenhills Cougar 7 Dump

Figure 4 shows the initial yield ratio in the Greenhills Cougar 7 dump. The results indicated a stable slope with a yielding zone near the crest. The displacements are small and appear to be controlled. But the initial stresses for a potentially liquefiable layer in the dump are found sitting in a critical state that is very close to the peak line. Any small increase in pore water pressure could bring these materials to collapse.

The initial stresses in the dump slope were calculated by incremental steps to simulate the construction of the dump in layers parallel to the face. The hyperbolic model (Duncan and Chang, 1970) was used to model the soil behavior during the construction.

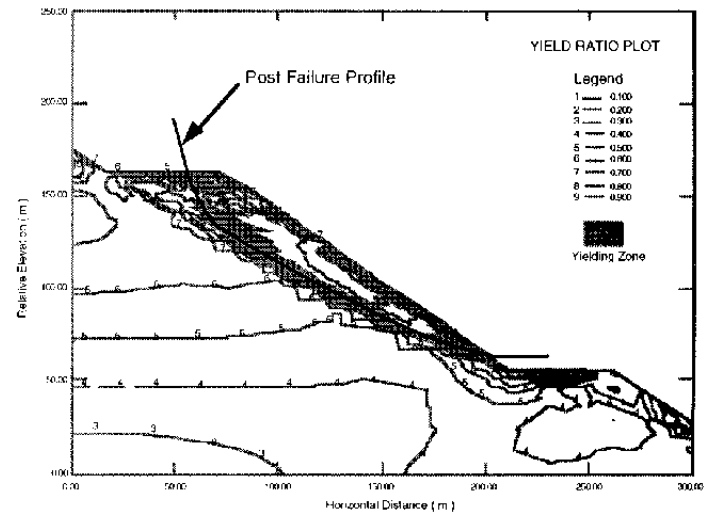
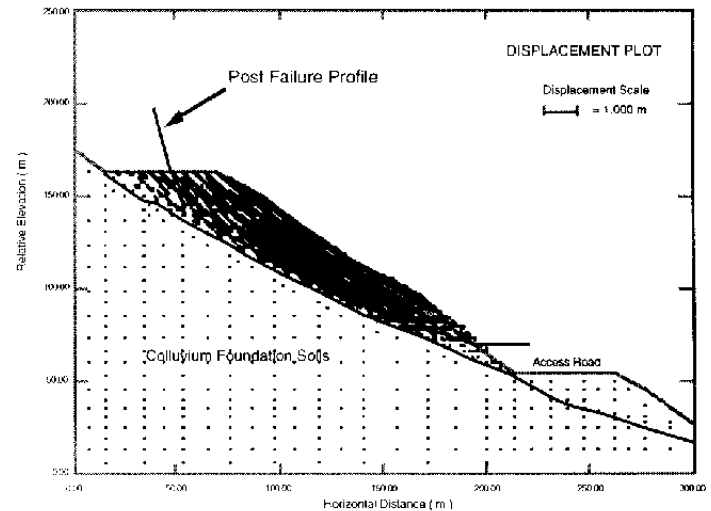
Fig.5 Yielding and Collapse In Greenhills Cougar 7 Dump

The potentially liquefiable layer in Greenhills Cougar 7 dump was assumed to be located about 15m behind the dump face based on the site investigation. As pore pressures are built up in the liquefiable layer as a result of rising water table in this layer, collapse occurs. Figure 5 shows the failure pattern of the dumping slope initiated by stress re-distribution in the slope. The yield zone in the dump that has expanded from the crest to toe and the pattern of displacements well indicate the post failure profile.

This paper presents part of the results obtained in a study on flowslides in Rocky Mountain coal mine waste dumps under static and drained conditions. The framework of the study is founded on the concepts of steady state and progressive failure soil mechanics. Numerical modeling on the Greenhills Cougar 7 flowslide demonstrated a manner in which overall collapse or progressive failure occurs. A local failure of brittle materials may occur initially by increase of pore water pressure that bring these materials to an unstable state. A local failure of the material need not always result in flow sliding in a slope. If the unbalanced stress generated by local material failure can be re-balanced by surrounding non collapsing materials, only limited deformation may develop. Otherwise, local material failure may initiate large scale shear stress redistribution and result in sudden flowslides in the slope.
