## A US-India Example in Case History Use in Levee Safety – A Multi-Cultural Perception of What It Is, and How Should It Be Applied

## **A US - INDIA EXAMPLE IN CASE HISTORY USE IN LEVEE SAFETY - A MULTI-CULTURAL PERCEPTION OF WHAT IT IS, AND HOW SHOULD IT BE APPLIED**

The State of Bihar, India experienced substantial flooding in the Ganges Basin as a result of levee (embankment) non performance. As a result of the 2008 failures the Bihar Water Resources Department is examining, as a programmatic model, the US experience in establishing and conducting the United States Army Corps of Engineers (USACE) Levee Safety Program. This case model examination is intended to structure a new program for managing the Bihari embankment infrastructure. Similar to many historical flood control initiatives throughout the world, India's embankment infrastructure shows the effects of aging and multi-purpose use of the facilities. To examine what practices that could be employed to increase the reliable performance of the embankment system; the World Bank facilitated a detailed case history examination of the USACE Levee Safety Program. The case study included a trial application of elements of the

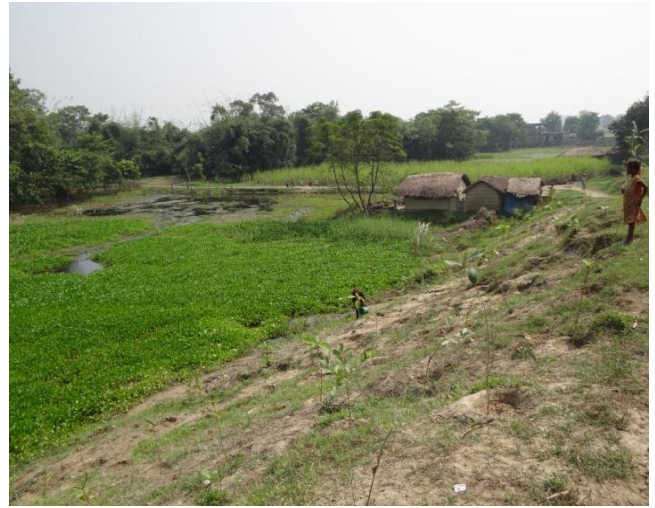
Most of the side slopes and levee top were without grass cover. The levee top was observed to have deep ruts.

In several reaches there was a thick forestation consisting of approximately 40 to 50-foot-tall trees with diameter exceeding 18 inches. In USACE, woody vegetation is not permitted due to its adverse impact on accessibility for inspections and floodfighting, and the uncertainty it introduces in structural performance. The writers were informed by the Indian officials that these trees were cultivated by the Forest Department and cannot be removed without their permission. The writer was further informed that in India it is preferable to plant trees on the land side of the levees.

**Photo 1. Lack of grass cover and intentional planting of trees on the levee side slopes**

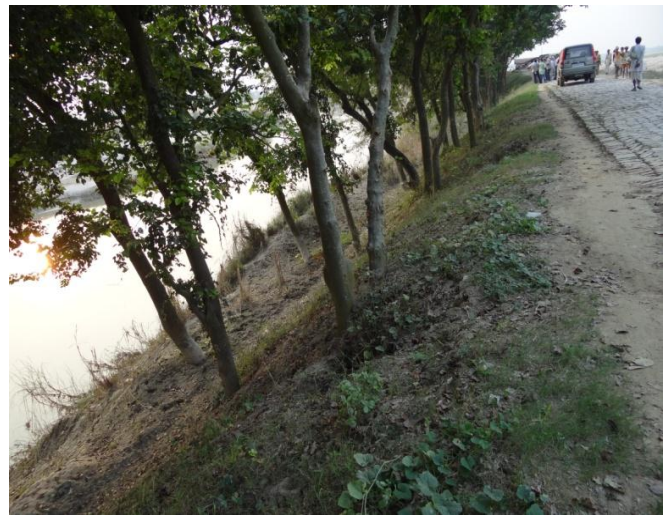
**Photo 2. Trees growing on the water side slope of the levee**

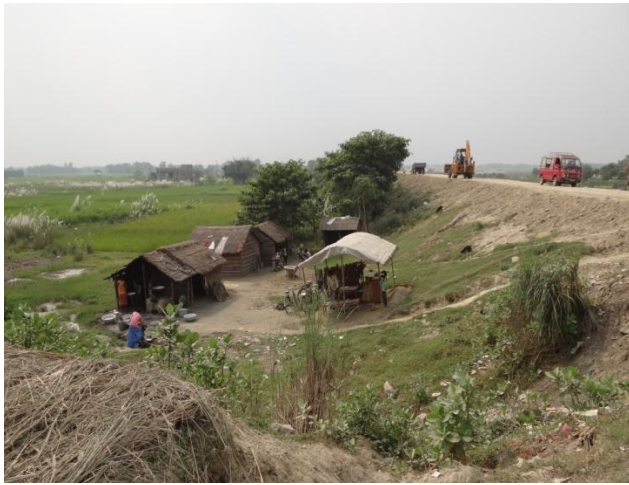
Most of the side slopes were populated with huts in which people were living.

**Photo 3. People living within the Right-of-way of levee**
