## Case History of an Uplift Problem

**SYNOPSIS** Deformation and related stability problems of dikes in the western parts of Holland were for many years ascribed to creep and excess pore water pressures only. However in the spring of 1988 during a high water period in the river Rhine the so called uplift mechanism was for the first time measured in practice. It was then recognised that in some cases the problems have been caused by the uplift phenomenon. For a few years the pore water pressures and the deformations were observed in a test site. With the results of the observations a procedure was formulated for design and reconstruction.

This paper describes a dike section near the town Bergambacht (20 km east of Rotterdam). After reconstruction 12 years ago the road on top of that dike showed severe damage due to deformations. Maintenance was necessary each year. Also the toe of the dike moved landwards.

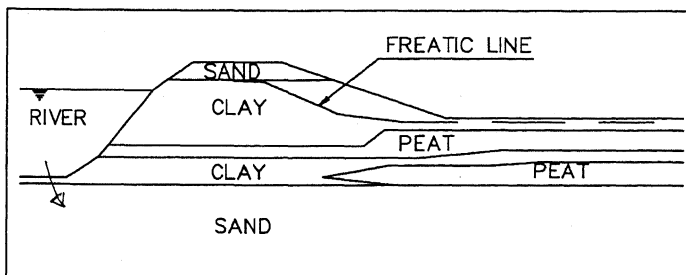
The first result of the investigation was a geotechnical profile of the concerning dike near the town Bergambacht (figure 1).

Fig. 1. Geotechnical profile of test site.

In the western parts of Holland the ground level lies usually lower than the mean river level. For that reason the land is separated from the rivers by water retaining structures called dikes or levees. These dikes exist usually of impermeable heavy clay and which are constructed on a relatively impermeable and weak subsoil of peat and clay. The pore water pressure in the sand beneath this weak layer is related to the water level of the river, in case the riverbed is in direct contact with this sand layer, as illustrated in figure 1.

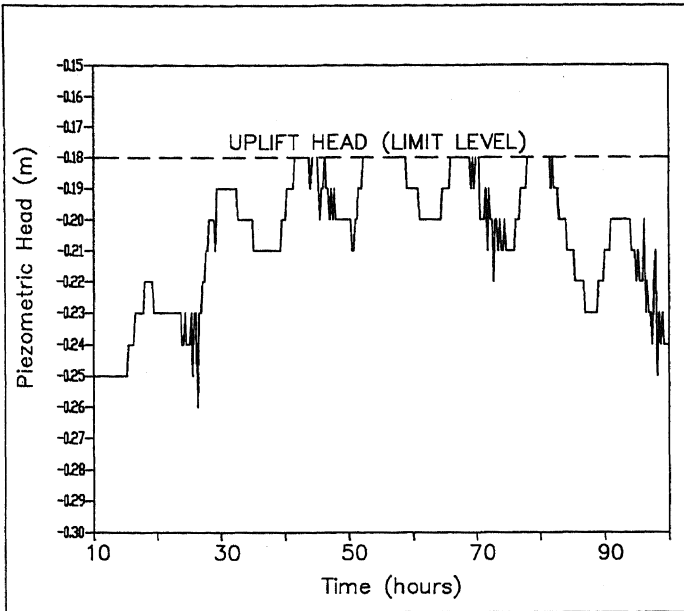
After finishing the above mentioned investigation programme the measurement of pore water pressure was continued. In the spring 1988, during an extreme high water period in the river Rhine, it was suddenly observed that pore water pressure measurements in the sand reached an ultimate value while the river level was still increasing (figure 2).

Fig. 2. Observation of the uplift mechanism.

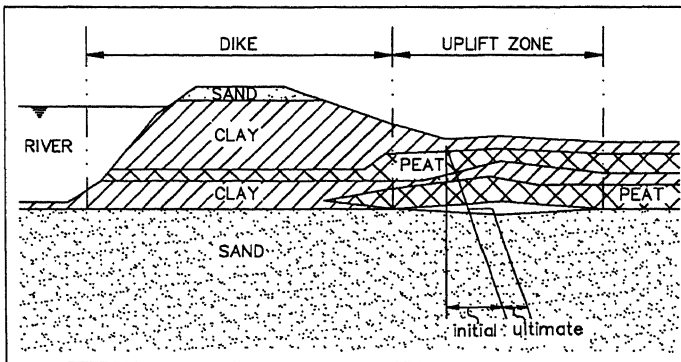
At that time it was recognised that the deformation problems were not caused by creep, but by uplift of the weak toplayer at the passive zone of the dike. The measurement of the pore water pressures had reached the same value as the weight of the weak toplayer (figure 3).

Fig. 3. The uplift mechanism with initial and ultimate pore water pressures.

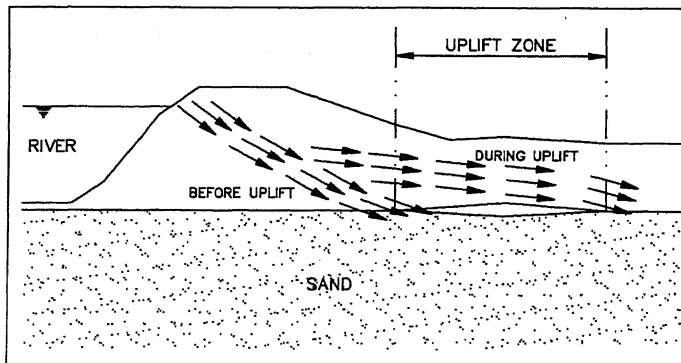
During uplift conditions there will be a zone between the weak toplayer and the sand layer underneath, where no shear strength is present. Even before the uplift condition is reached the shear strength will reduce strongly. This phenomenon is of great importance for the evaluation of the stability of water retaining structures. Uplift means a change in stress distribution. The shear stress along the sand layer is reduced and can even be zero, while the initial horizontal stress in the weak layer increases (figure 4). This causes relatively large horizontal deformations of the weak toplayer and temporary instability of the water retaining structure.

Fig. 4. Shear stresses before and during uplift conditions.

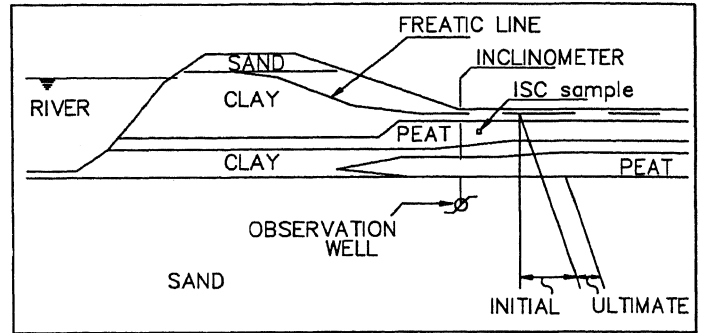
After the observation of the ultimate pressure at Bergambacht the Dutch Public Works Department in association with Delft Geotechnics decided to start a monitor programme, which includes monitoring of the horizontal deformations and pore water pressures for a long period (figure 5).

Fig. 5. Instrumentation of test site at Bergambacht.

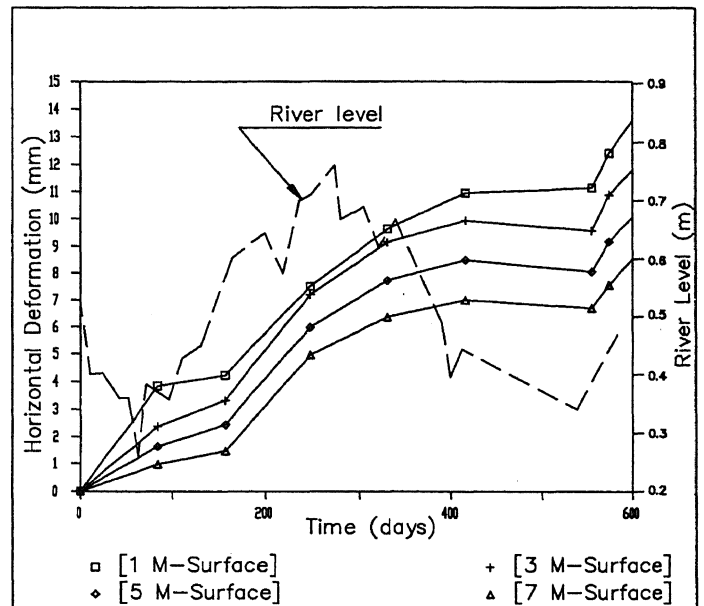
The main result of the monitor programme was the relation between the water level of the river which is related to the pore water pressure in the sand and the horizontal deformation of the toplayer of the dike (figure 6).

Fig. 6. Relation between tide of the river and horizontal deformation of the toplayer of the dike.

Clearly can be seen the increase of horizontal deformation velocity with increasing water level of the river and decreasing horizontal deformation velocity with decreasing water level of the river. When the water level in the river reduces, consequently the water pressure in the sand reduces too. At a level of 70% of the uplift pressure the velocity reduces to zero. The effective stress between weak toplayer and sand will probably increase and consequently the horizontal stress in the weak layer will reduce. This implies that the observed horizontal deformations of the weak toplayer behind the dike were caused by uplift and not by creep.

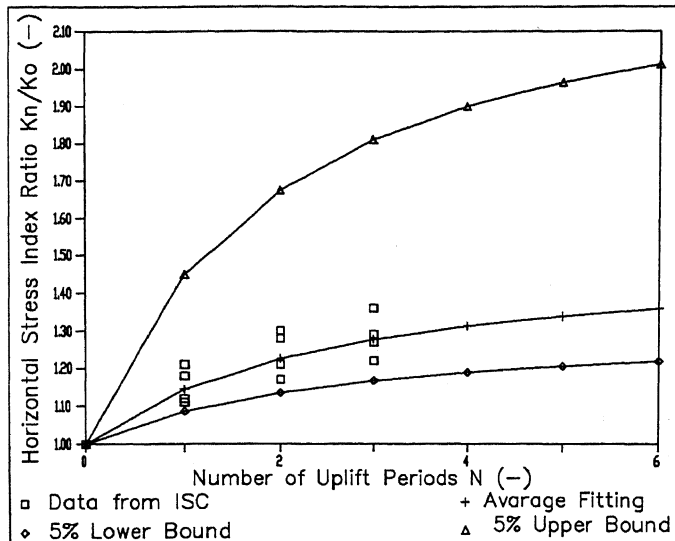
The horizontal stress index observed in the four ISC tests, after 1, 2 and 3 loading cycles shown a permanent increase of horizontal stress index ratio after each uplift period. Figure 7 shows a typical test result. From this figure the increase of the horizontal stress index can be derived. In the same figure a square hyperbolic fitting is given together with the 90% reliability interval.

This has resulted in an average formula for the horizontal stress index  $K_n$  after  $N$  uplift periods, dependant on the initial horizontal stress index  $K_0$  and the number of uplift periods  $N$ :

$$K_n = K_0 * \left( 1 + \frac{N}{1.96 * N + 4.93} \right) \quad (1)$$

Fig. 7. Typical test result and square hyperbolic curve fitting of stress index ratio and number of uplift periods.

Field observations with the Pressuremeter shown an index ratio of  $K_n/K_0$  of 1.23 between the uplift zone and the undisturbed landward zone. This means that in the field 2 uplift periods have occurred according to the average ISC formula .

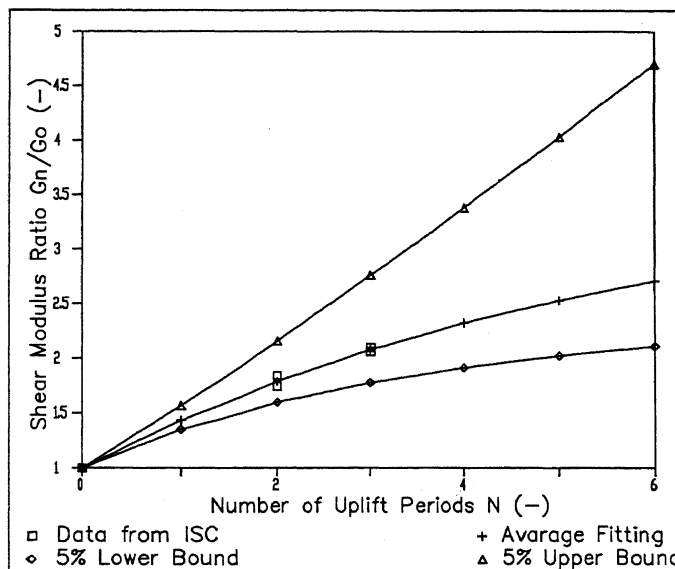
The results also shown a permanent increase of horizontal stiffness. The increase of stiffness can be expressed by the stiffness ratio  $G_n/G_0$ . The observed ratios in the four ISC tests after 1, 2 and 3 loading cycles are plotted in figure 8 together with a square hyperbolic fitting and a 90% reliability interval.

Fig. 8. Test results and square hyperbolic curve fitting of shear stiffness ratio and number of uplift periods.

This has resulted in an average formula for the horizontal stiffness  $G_n$  after  $N$  uplift periods dependant on the initial stiffness  $G_0$  and the number of uplift periods  $N$ :

$$G_n = G_0 * \left( 1 + \frac{N}{0.24 * N + 2.06} \right) \quad (3)$$

With Pressuremeter tests a stiffness ratio of  $G_n/G_o$  of 1.79 was measured. This means that in the field 2 uplift periods have occurred according to the average formula.

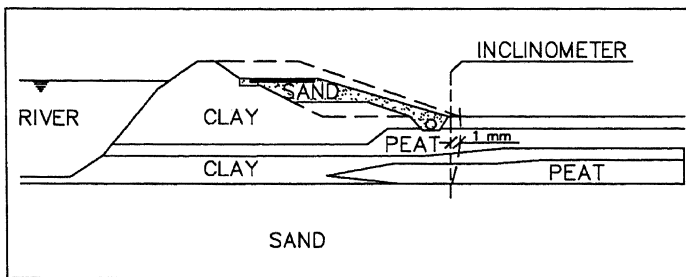
Fig. 9. Cross section of reconstruction and measured deformations.

With the results of the field observations and the laboratory testing a plan for the reconstruction of the river dike was made, taking into account the houses at the toe of the dike. A soil improvement was realised within the inner side of the dike in combination with a drainage system (figure 9). This improvement makes sure that there will be a limit stress increase and consequently a limit deformation of the weak toplayer. After the reconstruction the monitoring of horizontal deformations still continue. Until now no further deformations were observed (figure 9).
