International Conferences on Recent Advances in Geotechnical Earthquake Engineering and Soil Dynamics 2010 - Fifth International Conference on Recent Advances in Geotechnical Earthquake Engineering and Soil Dynamics

FAULT HAZARD CHARACTERIZATION FOR A TRANSPORTATION TUNNEL PROJECT IN CORONADO, CALIFORNIA

This paper presents the results of a fault hazard study performed as part of a proposed traffic tunnel project in Coronado, California. The 2.3 km alignment crosses the Coronado fault, which is considered active by the California Geological Survey. Although the location of the Coronado fault offshore of Coronado had been well established through previous studies, the fault had never been definitively located on land. A study was undertaken that utilized four principal investigation methods: a seismic reflection survey, large diameter borings, closely-spaced cone penetrometer tests (CPT) and a fault trench. This study was the first to positively locate the Coronado fault on land and to show that approximately 29 cm of vertical displacement has occurred in the Holocene. The field investigation provided evidence that strike slip displacement has also occurred. For design purposes, t

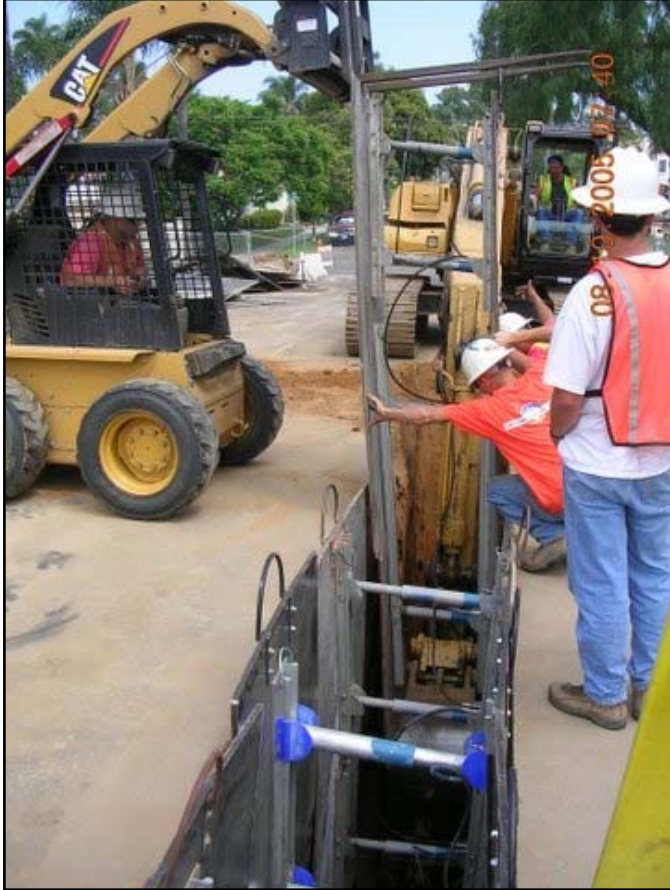
Fig. 6. Sequential shoring operations in fast-raveling sands.

Clean fine sands with little to no cementation, along with shallow groundwater, were expected at the site. With these conditions it was questionable whether adequate stability could be achieved in an exploratory fault trench. It was also questionable whether adequate stratification would be present for fault identification. Therefore, three large diameter borings were performed to test the feasibility of trenching and fault mapping at the site. Three 60 cm borings were penetrated to depths of up to 6.1 m below ground surface. The top of boring elevations ranged from 3.4 to 8.5 m above mean sea level (MSL) with a minimum bottom elevation of 1.2 m MSL. Groundwater was encountered in one of the borings at an elevation of 1.8 m MSL. The materials consist mostly of massive unconsolidated sands with isolated layers of finely laminated micaceous sand and abundant late Pleistocene illuviated clay concentrated in B horizon laminations (B-lams). The micaceous sand layers and B-lams appeared to provide adequate horizontal markers to make dip-slip faulting observable in a trench. The stand-up time of the boring sidewalls was limited and caving occurred at several locations, indicating that shoring would be required in an exploratory trench.

Based on the CPT data, an exploratory trench excavation was made. The trench was 24 m in length and bracketed the CPT-interpreted fault zone by approximately 6 m on either side. The trench was excavated to a depth of 4 to 4.3 m. Due to the presence of clean, weakly cemented sand that was prone to fast raveling, hydraulic aluminum shoring with integrated finform panels (1.2 by 3.7 m) was required to protect the trench from collapse. The trench had to be excavated in short section sequences (1.2 m) with the shoring placed progressively as the trenching proceeded (Figure 6). The southern trench wall was first “cleaned” by scraping the lowermost exposed 60 cm of the sidewall, as well as the open spaces between adjacent shoring panels. A gauged string line was installed across the bottom of the trench in several level steps to provide both vertical and horizontal control during logging. After the trench walls were cleaned and the points of reference were established, the exposed sidewall surfaces were

logged. During the logging, several prominent fault features located within the western side of the trench were identified for more detailed study. Shoring panels were removed one at a time so that detailed logging could be performed in the fault feature area. After the panels were removed, a gauged string grid system was installed in the sidewalls of the exposure and photographs were taken. After each area was logged, the shore panel was replaced and then the next panel was removed for logging. Shoring panels were only removed for detailed logging where fault features were observed extending upward from the base of the trench to behind the panels.

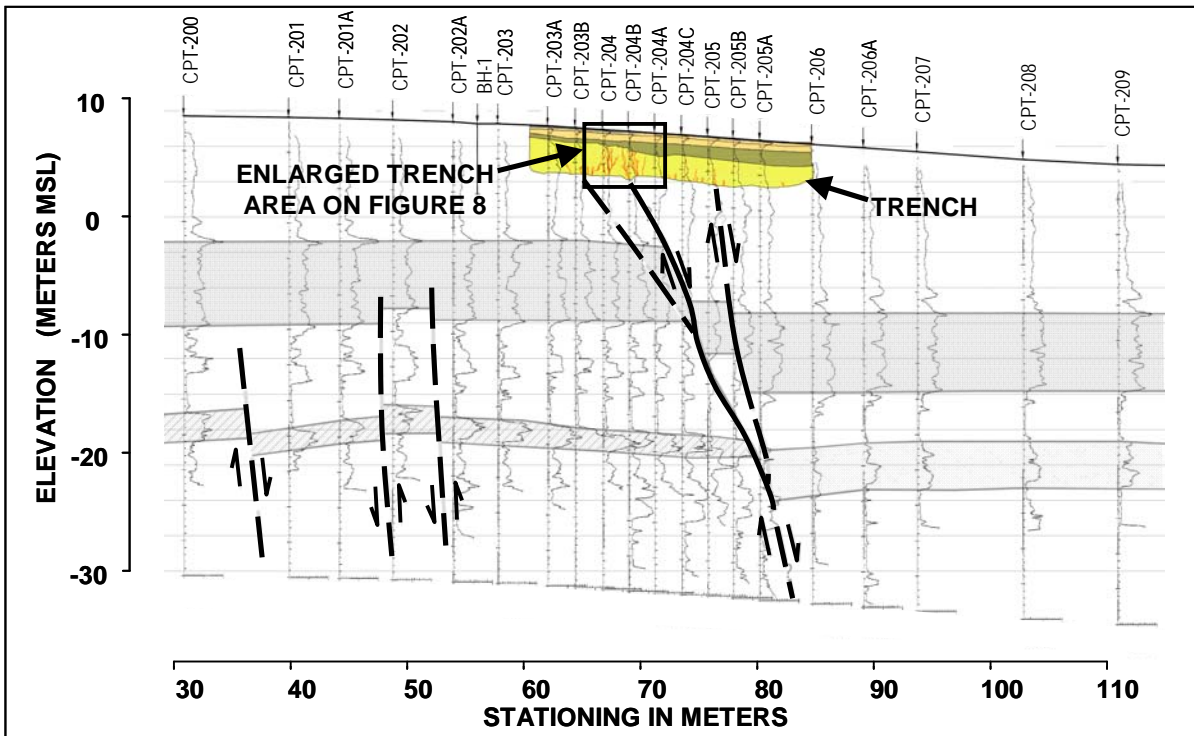
Fig. 7 – Profile showing CPT tip resistance, interpreted faulting and trench location.

In the next phase, 36 CPT soundings were performed along a 220 m alignment within 5th Street, between A Avenue on the west and Pamona Street on the east. The CPTs extended to depths ranging between 18 and 37 m below ground surface (bgs). The surface profile elevations ranged from approximately 9.1 m MSL near A Avenue to 5.5 m MSL near Pamona. Initially 26 CPT soundings spaced approximately 9.1 m apart were completed. The penetration resistance and soil identification data were then plotted and reviewed as the field investigation progressed to identify areas of potential faulting. In areas where the initial CPT data suggested faulting was present, secondary and tertiary CPT soundings were performed to provide increased resolution. CPT spacing as close as 2.3 m was performed. The data showed a clearly

defined zone of faulting extending upward to where it approached the ground surface. The faulted zone coincided with the location of the topographic lineament. Several distinct geologic horizons were offset within this zone (discussed in more detail later). Outside this zone, the horizons were found to be uniform and nearly horizontal. Figure 7 shows a profile of CPT tip resistance.

The CPT data revealed several prominent and continuous depositional units east and west of the scarp, which when traced into the expected area of faulting, could be used to measure vertical displacement across the fault (Figure 7). Several fault features were identified, with the most significant located toward the west, upper side of the topographic lineament. These faults consist of two or more strands that appear to be part of a branching upward flower structure. The structure widens from a width of 2.1 m at a depth of 23 m bgs (-15.2 m MSL) to a width of approximately 13.7 m near the ground surface. The faulting in the CPT data could be followed to within 6 m of the ground surface. The sense of bedding displacement is down to the east with a maximum vertical separation of up to 6.1 m in the lowest part of the CPT section. The amount of vertical offset appears to lessen upward, which would indicate some faulting to be contemporaneous with deposition. The dip of the fault is steeply inclined toward the east, suggesting a normal component of displacement. Three other faults were identified to the west of the flower structure below the crest of the fault scarp. These faults were found to offset bedded units upward to a depth of about 14.6 m bgs (-6 m MSL), indicating that they are buried and probably inactive.

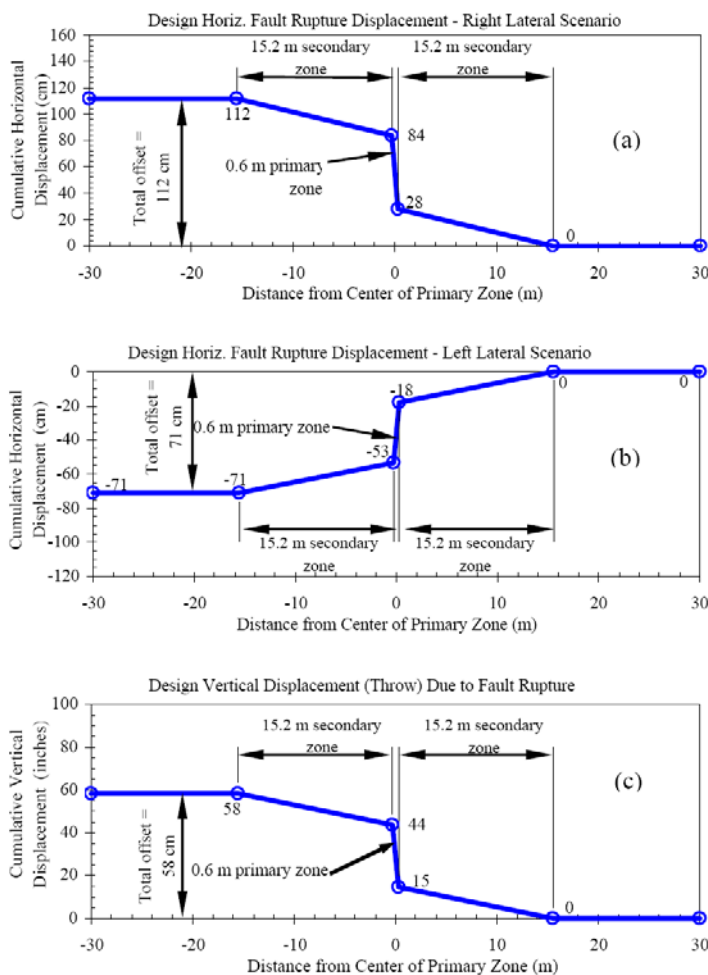
Fig. 12. Distribution of fault displacement used for design.

For design we conservatively assumed that the 29 cm of vertical throw that was determined from the fault trenching could occur in a single event. While the fault trench data suggested that faulting was concentrated in a 1.2 m wide zone, we conservatively assumed the “main zone” of faulting occurred over a 0.6-meter width.

Using the 50 percent secondary displacement rule, the secondary displacement was 28 cm for the right lateral

scenario and 18 cm for the left lateral scenario. The secondary offsets were linearly distributed over a 15.2-m width on the hanging wall side of the main zone and a 15.2-m width on the footwall side of the main zone.
