International Conferences on Recent Advances
in Geotechnical Earthquake Engineering and
Soil Dynamics

Considerations About Some Aspects of the 23rd November 1980 Earthquake

Considerations About Some Aspects of the 23rd November 1980 Earthquake.

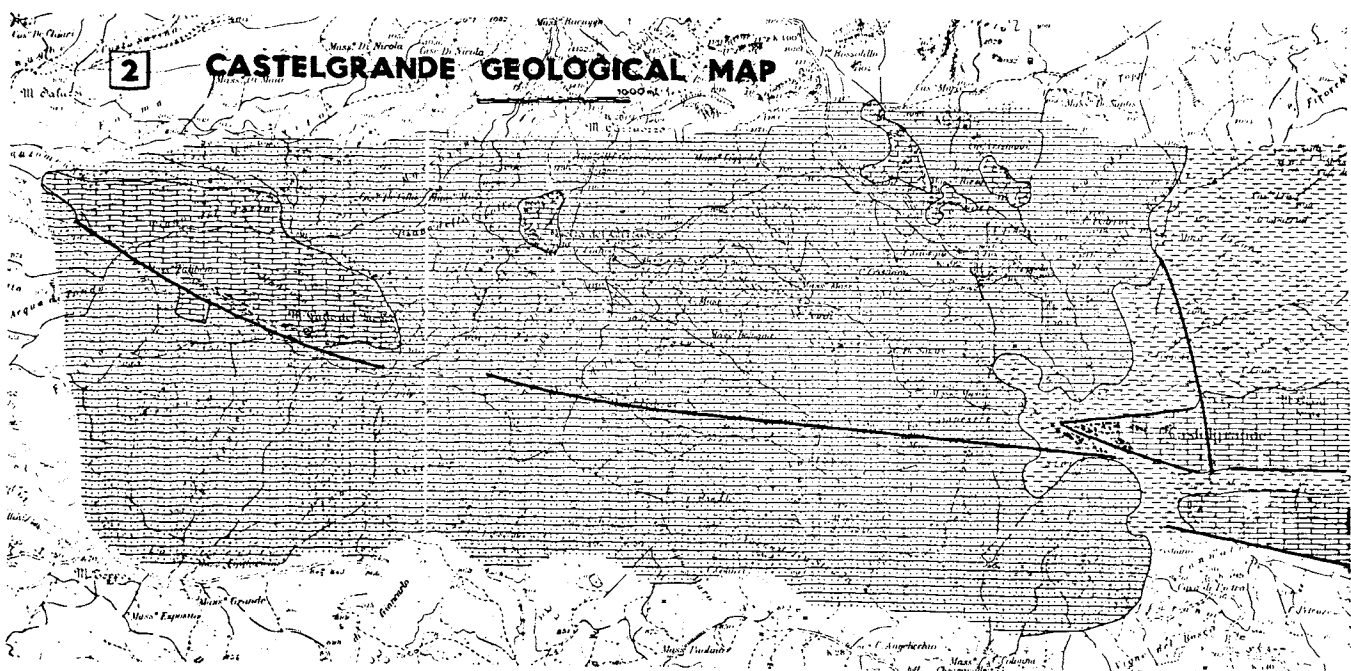
We want to put in evidence that the behaviour of the faults during earthquakes is a still unsolved matter. In fact the faults indicated in the pictures have had, during the earthquake of the 23rd of November a completely different behaviour: the first ones (fig. 2) have had sudden movements which produced tremendous damages; the second one (fig. 3), on the other hand, did not have any movement. Paradoxically the area on the second fault is the damagedless side in the little town which has had, anyway, many damages.

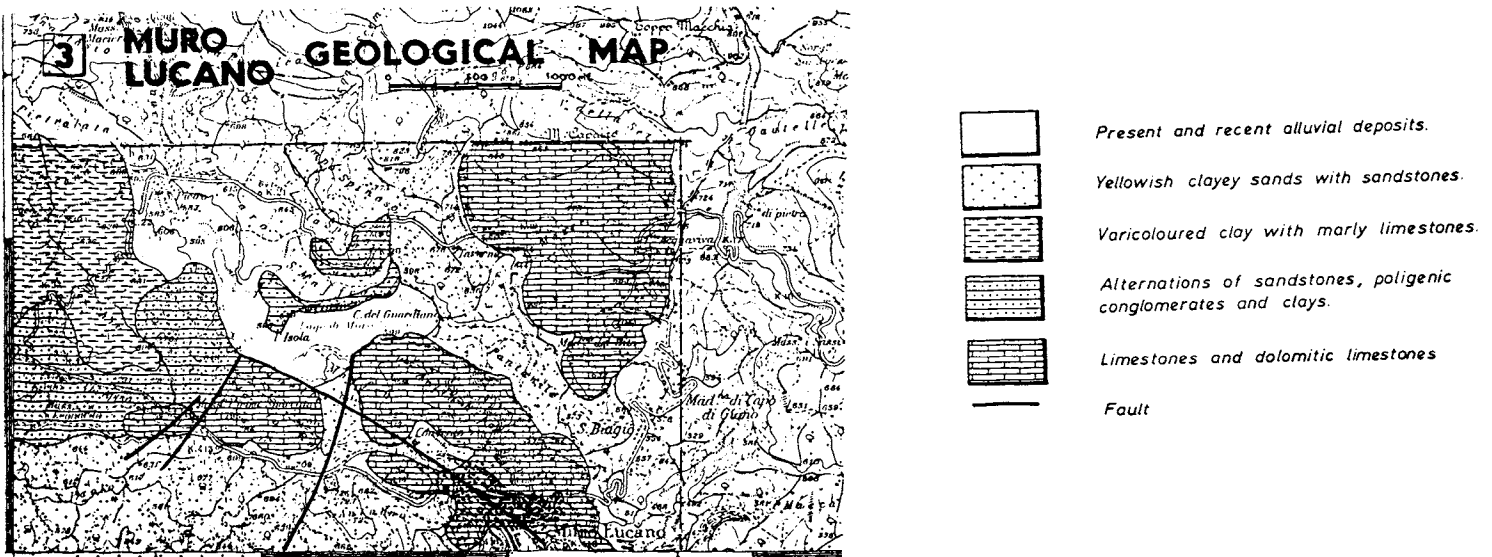
Figure 3.

We have to precise that this study has been done on the examination of aerial photographs.
