## Cyclic Torsional Shear Tests to Obtain Dynamic Soil Properties for Seismic Design of Road Embankments

## CYCLIC TORSIONAL SHEAR TESTS TO OBTAIN DYNAMIC SOIL PROPERTIES FOR SEISMIC DESIGN OF ROAD EMBANKMENTS

### ABSTRACT

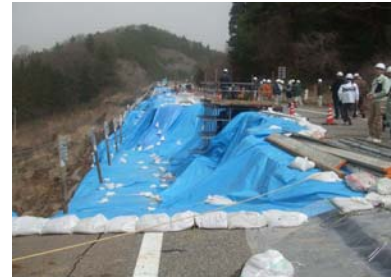
Photo. 1. Slide of the embankment of Noto-yuryo road at site No. 9

On March 25, 2007, the Noto-hanto earthquake, of  $M_j=6.9$ , occurred. The highway embankments of the Noto-yuryo road were very seriously damaged and huge slides occurred at 11 sites (Yasuda and Tanaka, 2010). Photos 1 and 2 show the slides at sites No. 9 and No. 32, respectively.

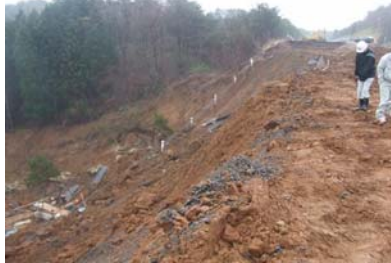
Photo. 2. Slide of the embankment of Noto-yuryo road at site No. 32

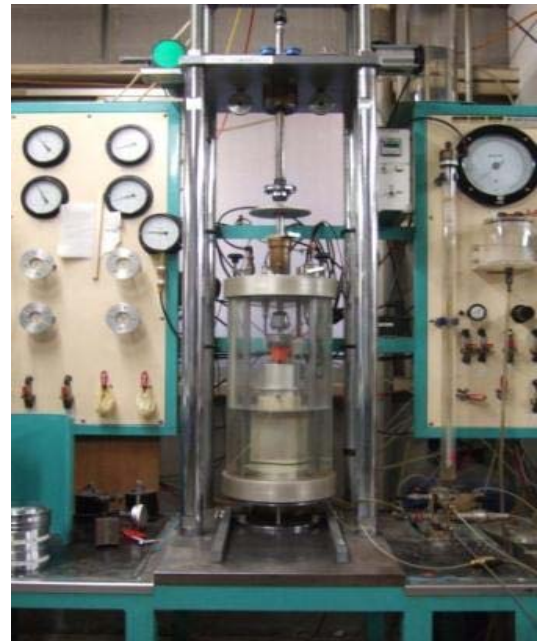
Photo. 3. Hollow-cylindrical torsional test apparatus

Cyclic torsional shear test apparatus with cyclic and static loading devices, shown in Photo. 3, was used for the tests. Tested soils were the five samples taken at the damaged embankments mentioned above. In addition, the embankment soil at Atsugi of Tomei Expressway was tested also. These soils were compacted by tamping method in a mold to become hollow cylindrical specimens with 10 cm in outer diameter, 6 cm in inner diameter and 10 cm in height. Moisture content and degree of compaction of the soils were adjusted as optimum moisture content and 90 %, respectively.

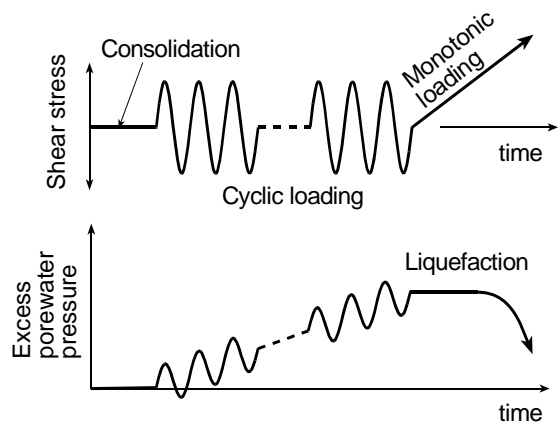
Fig. 4. Procedure of cyclic and monotonic loadings

20 cycles of cyclic loading with 0.1 cycle/sec was applied to the specimens as shown in Fig. 4 under undrained condition. After the cyclic loading, a monotonic loading was applied under undrained condition with a speed of 10 % of shear strain/minute. Time histories of shear stress, shear strain and pore water pressure during the monotonic loading were measured. About 4 to 8 specimens were used in one sample. And, different amplitude of cyclic loading was applied to each specimen to control safety factor against liquefaction (failure),

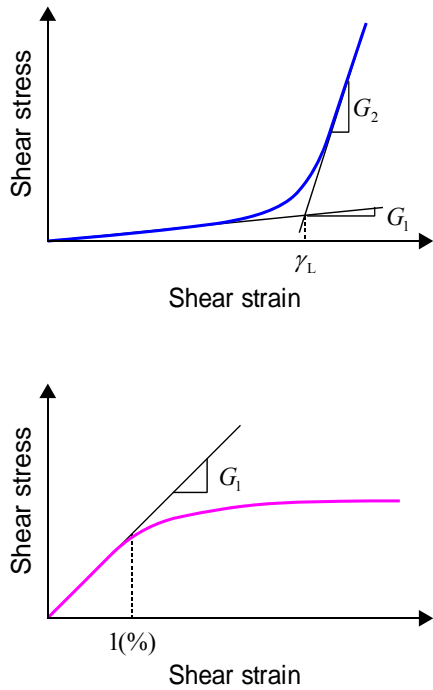
Fig. 5. Definition of  $G_{0i}$ ,  $G_1$  and  $\gamma_L$

In the liquefied specimen, shear strain increased with very low shear stress up to very large strain as schematically shown in Fig. 5 (a). Then, after a resistance transformation point (turning point), the shear stress increased comparatively rapidly with shear strain, following the decrease of pore water pressure. Stress-strain curves before and after the reference transformation point,  $\gamma_L$  can be presented approximately by a bilinear model with  $G_1$ ,  $G_2$  and  $\gamma_L$  :

On the contrary, stress-strain curves of the clayey soils are different from those of liquefied sandy soils, as shown in Fig. 5 (b). Then the authors classified the shape of the stress-strain curves into two types as shown in Fig. 5 (a) and (b) (Yasuda et al., 2006). In clayey soils, it seems that large shear strain does not induce due to earthquake because some amount of resistance remains after cyclic loading. Therefore the authors defined shear modulus of softened soil,  $G_1$  as the secant modulus at 1 % of shear strain as shown in Fig. 5 (b).

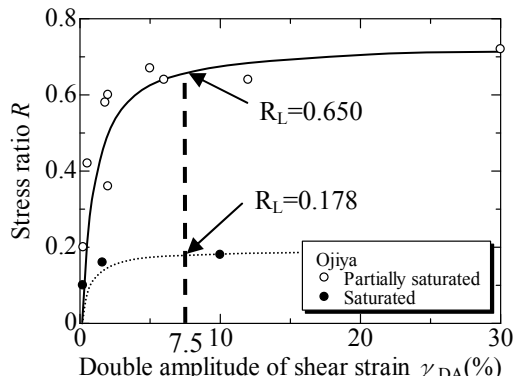
Fig. 10. Relationships between  $R$  and  $\gamma_{DA}$

Fig. 10 shows relationships between double amplitude of shear strain and stress ratio for saturated and partially saturated specimens of Ojiya soil. The stress ratio to cause 7.5% of shear strain by 20 cycles,  $R_L$  ( $\gamma_{DA}=7.5\%$ ,  $N_L=20$ ) was estimated based on these relationships. Fig. 11 shows relationships between  $R_L$  ( $\gamma_{DA}=7.5\%$ ,  $N_L=20$ ) thus determined and Plasticity Index  $I_p$ . As shown in the figure,  $R_L$  ( $\gamma_{DA}=7.5\%$ ,  $N_L=20$ ) increased with  $I_p$ . And, the  $R_L$  for partially saturated specimens are larger than the  $R_L$  for fully saturated specimens. Fig. 12 shows relationships between excess pore water pressure ratio,  $\Delta u/\sigma'_c$  at 20 cycles and safety factor against liquefaction,  $F_L$ . Excess pore pressure ratio decreased with  $F_L$ . Then the excess pore water pressure ratio at  $F_L=1$ ,  $\Delta u/\sigma'_c$  ( $F_L=1$ ) were plotted on Fig. 13 with  $I_p$ .  $\Delta u/\sigma'_c$  decreased with the increase of  $I_p$  for fully saturated specimens. This means that some resistance remains if  $I_p$  is large even though large shear strain induces. For partially saturated specimens,  $\Delta u/\sigma'_c$  was less than 1 and decreased with  $I_p$ .

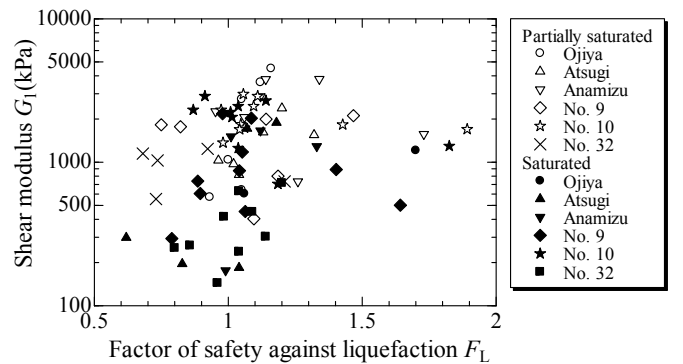
Fig. 14. Relationship between  $G_1$  and  $F_L$

Fig. 14 shows relationships between shear modulus,  $G_1$  and safety factor against liquefaction,  $F_L$ . Yasuda et al. (2006)

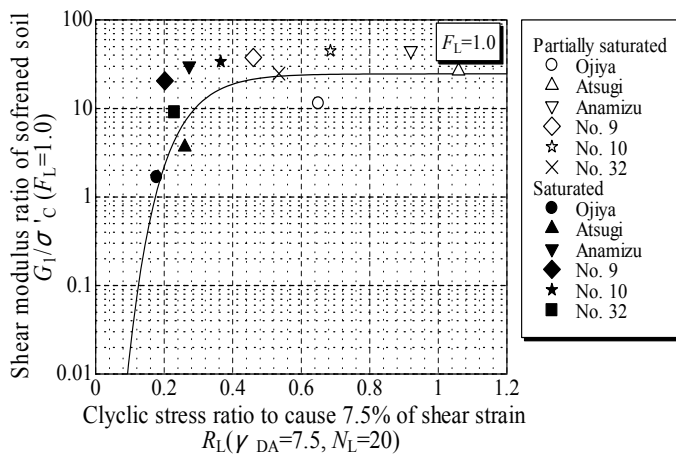
Fig. 15. Relationships between  $G_1/\sigma'_c$  and  $R_L$   
( $\gamma_{DA}=7.5\%$ ,  $N_L=20$ )

conducted many torsional shear tests and proposed the relationship between  $F_L$ ,  $R_L$  and  $G_1/\sigma'_c$  as shown as the curve in Fig. 15. Test data for  $F_L=1$  in this study were plotted in the figure. Though the data are scattered, tested data for both fully saturated and partially saturated soils were plotted on near the proposed curve.
