Static evaluation of the out-of-plane behavior of URM infill walls utilizing modern blast retrofit systems

A THESIS

MASTER OF SCIENCE IN CIVIL ENGINEERING

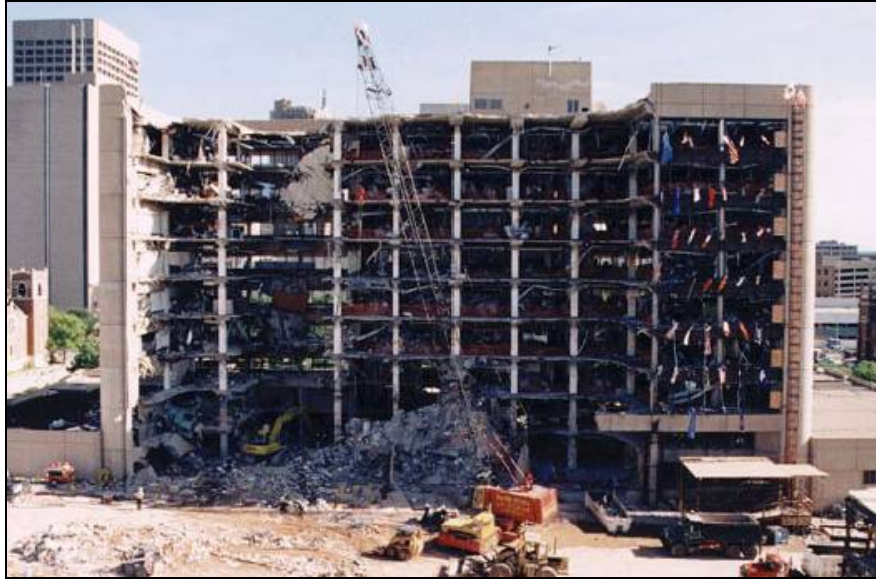
Figure 1.1. Damage to Alfred P. Murrah Building (FEMA, 2003)

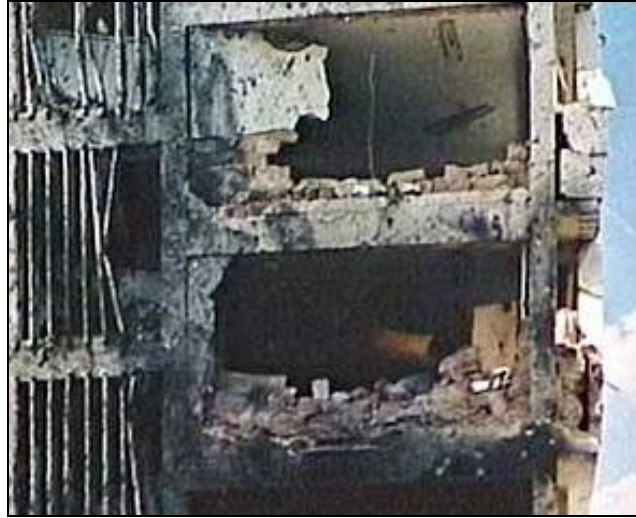
Figure 1.2. Failure of Exterior URM Infill Walls

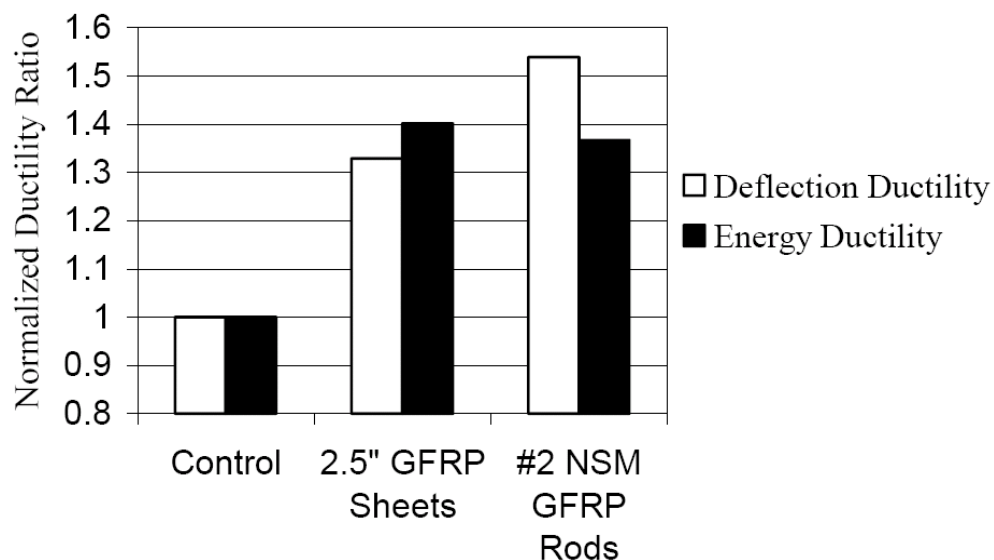
Another study carried out at UMR implemented the use of two different FRP retrofit techniques resulting in significant increases in the flexural capacity of partially framed URM infill walls. The walls in this study were tested in the laboratory under static loading using an airbag system. A second phase of study tested strengthened walls in the field under actual blast loads (Carney and Myers, 2003). The walls in this study were restrained between two rigid boundary elements at the upper and lower boundaries of the wall, had a slenderness ratio of 12, and were constructed using CMUs. Due to the low slenderness ratio and the restraint at the member-ends imposed by the surrounding frame, one-way arching action was observed in all of the strengthened and unstrengthened URM walls. The use of both NSM GFRP rods and surface laminate GFRP strips was investigated, and both were found to significantly increase the out-of-plane load carrying capacity as well as the ductility of URM infills. The ductility results from testing have been presented in Figure 2.6.

Figure 2.6. Normalized Ductility Results (Carney and Myers, 2003)

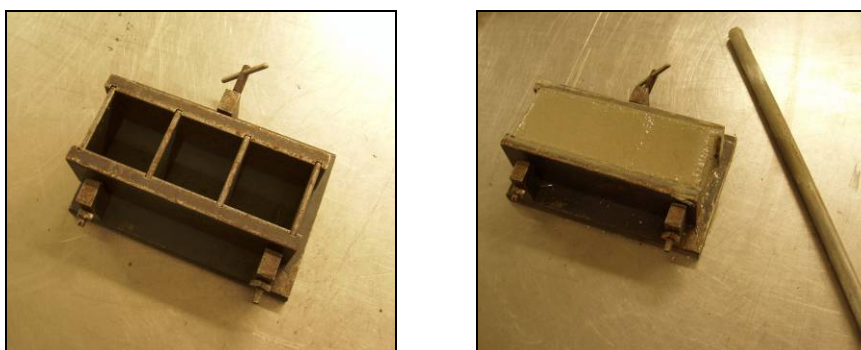
The mortar used for construction of the URM walls was a readily available premixed product classified as Type-S defined by ASTM C270. The compressive strength of the mortar was verified by testing 2in. (50mm) mortar cubes in accordance with ASTM C109. A set of 3 mortar cubes were cast, moist-cured, and tested at 28 days for verification of the mortar type. Additional sets of mortar cubes were prepared and match cured for each URM wall constructed. The match cured mortar cubes were tested at the same time as the wall specimens. The casting and testing of the mortar cubes is illustrated in Figures 3.5 and 3.6, respectively. The results from the cube testing have been summarized in Table 3.6.

Figure 3.5. Mortar Cube Casting

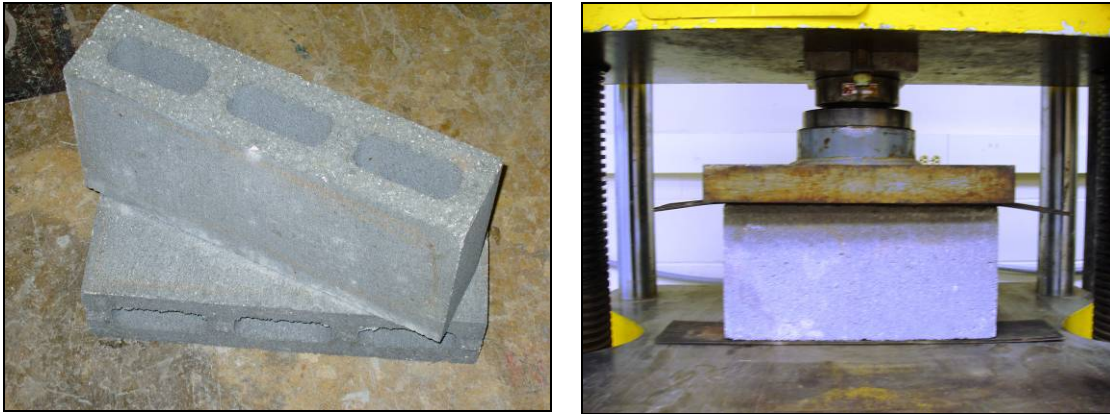
was determined by testing full-length uncapped units in accordance with ASTM C140-05a. The gross compressive strength of the CMU units was found to be 1,700psi (11.7MPa), and the net compressive strength was determined to be 2,100psi (14.5MPa). The testing of the individual concrete blocks is illustrated in Figure 3.8.

Figure 3.8. Testing of Individual Concrete Masonry Units

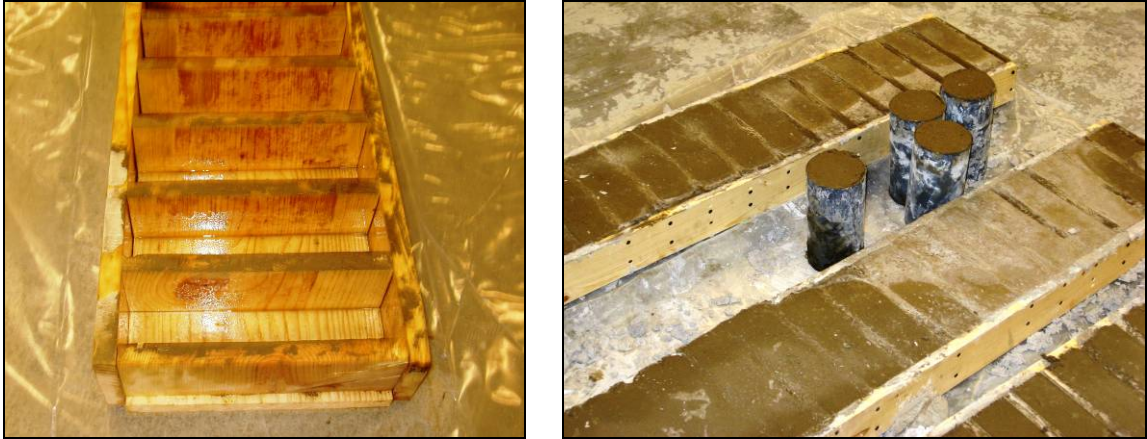
The WF-FA material was mixed in 2ft³ (0.057m³) batches using a rotating drum mixer with a volumetric capacity of 4ft³ (0.113m³). As shown in Figure 3.10, after adequately mixing, the material was placed into wooden forms, which were subdivided into a series of brick sized units. The material was placed in two layers, and voids were removed by way of rodding the material with a standard tamping rod.

Figure 3.10. WF-FA Material Placement

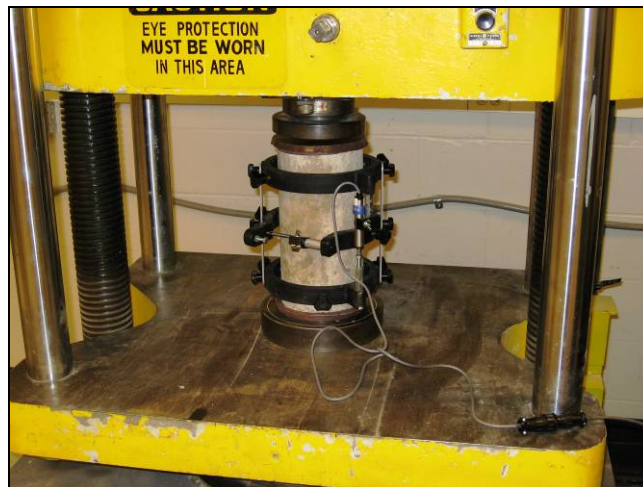
compressive strength from each of the batches of material was based solely on cylinder testing and was found to be 450psi (3.1MPa). The stiffness of the material was determined in accordance with the ASTM C469 test method. The 6 x 12in. (152 x 305mm) cylinders were loaded at a rate of 500lb/sec (2.22kN/sec), and longitudinal strain data were acquired using a compressometer. The testing resulted in relatively low stiffness values with an average modulus of elasticity value of 300ksi (2070MPa). The compressive strength testing of the WF-FA material is presented in Figure 3.11.

Figure 3.11. WF-FA Compression Testing

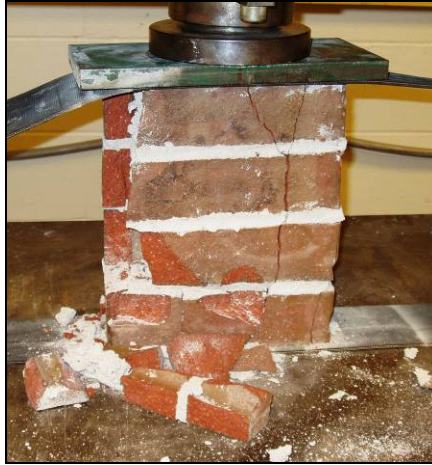
Figure 3.12. Compression Testing of Clay Prism

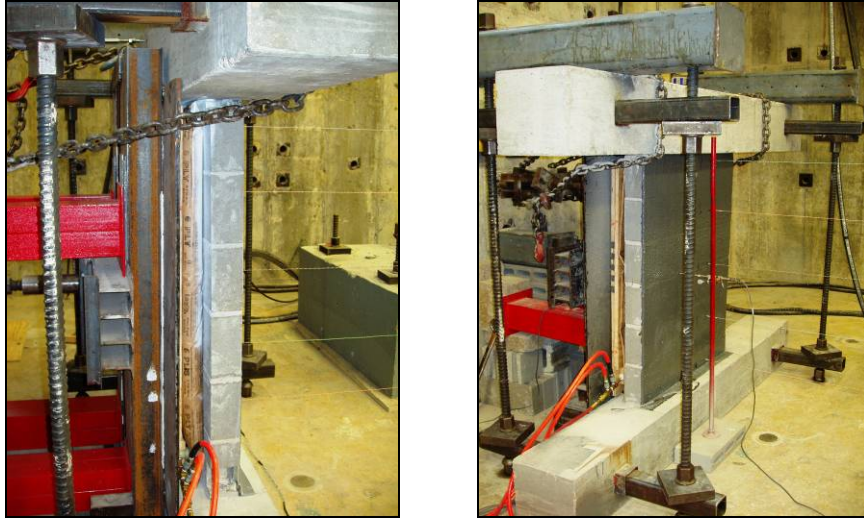
assembly, and it resulted in a relatively large coverage area of the URM wall when the airbag was inflated. In most cases, sheets of plywood were used to decrease the space between the reaction plate and the URM walls. The full test setup for the Phase 1 walls is illustrated in Figure 5.10 and Figure 5.11.

Figure 5.11. Phase 1 Test Setup

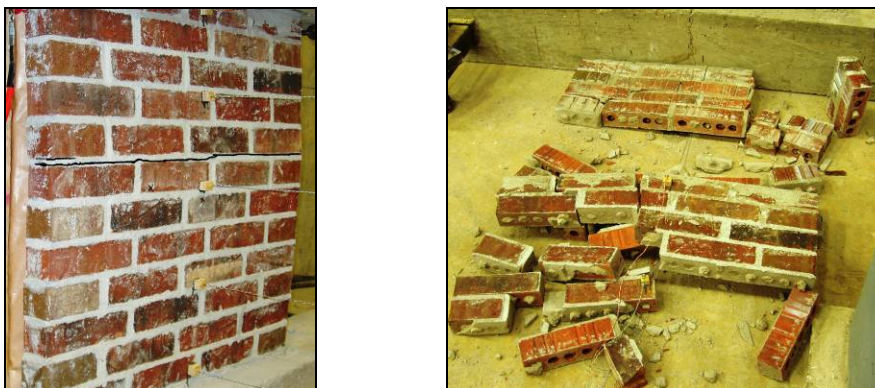
5.2.1. Wall P1-1. Wall P1-1 was the clay control specimen. At an applied pressure of 0.8psi (5.5kPa), the first crack was visible on the pressure applied face of the wall in the bed-joint at the lower boundary element location. At a pressure value of 1.9psi (13.1kPa), a major horizontal crack began developing one course above the mid-height location on the exposed face of the wall, and visible rigid body deformation was observed (see Figure 5.13). As the formation of the arch progressed, the mid-height crack grew along the full length of the bed-joint and continued to open. Wall P1-1 reached a peak airbag pressure value of 4.6psi (31.7kPa) at a deflection of 0.62in. (15.7mm) before the behavior of the wall became unstable and the pressure resistance began to drop, as shown in Figure 5.14. Ultimately, the pressure resistance decreased to a value of 3.6psi (24.8kPa), and the wall collapsed. The clay control wall achieved a maximum deflection value of 1.10in. (28.0mm). The debris scatter and poor resistance to fragmentation of the base masonry material can be seen in Figure 5.13b. In examining the masonry units of Wall P1-1, it was found that only minor crushing had occurred in the mortar of the bed-joints at the mid-height and boundary location. The wall ultimately failed due to instability.

(a) Horizontal Crack

(b) Wall Collapse

Figure 5.13. Wall P1-1 Failure

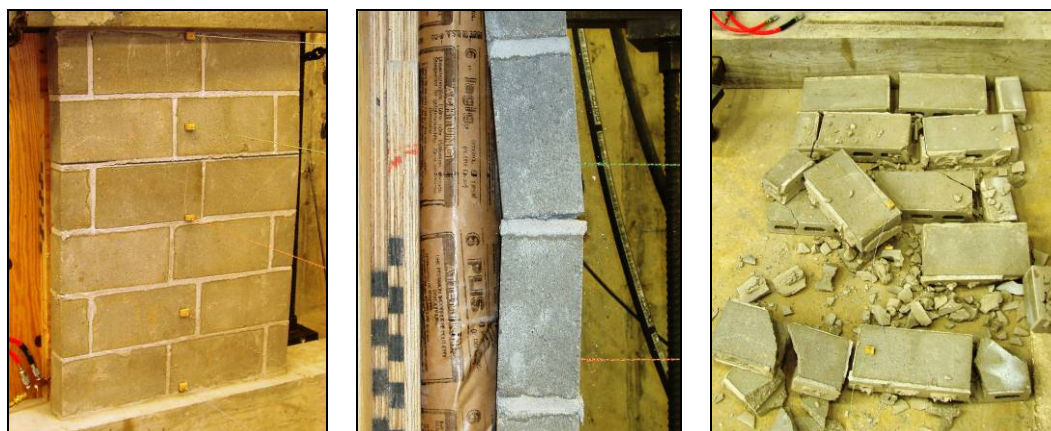
joint one course above the mid-height location, as illustrated in Figure 5.17. Once the crack developed over the full-width of the bed-joint, the upper and lower segments of the wall began to rotate as rigid elements, and the cracks at the boundary locations and mid-height continued to grow in width. Wall P1-3 reached a peak pressure value of 5.9psi (40.7kPa) at a deflection of 0.75in. (19.1mm). Once reaching the peak pressure value, the mortar from the top bed-joint began to crush, and the load resistance began to decrease as shown in Figure 5.18. The wall collapsed at an applied pressure value of 4.0psi (27.6kPa) and a mid-height deflection value of 1.08in. (27.4mm). As illustrated in Figure 5.17c, the wall had little resistance to fragmentation.

(a) Horizontal Cracking (b) Rigid-Body Behavior (c) Debris Scatter

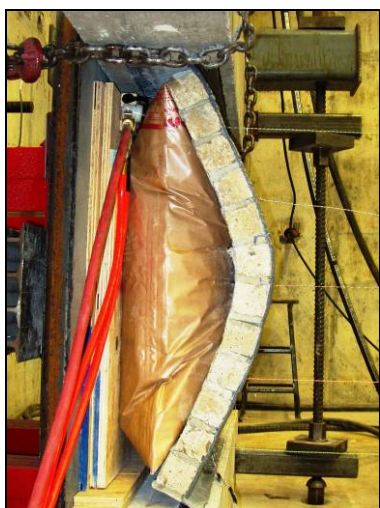
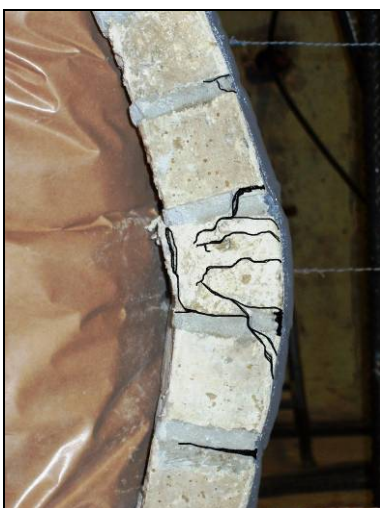
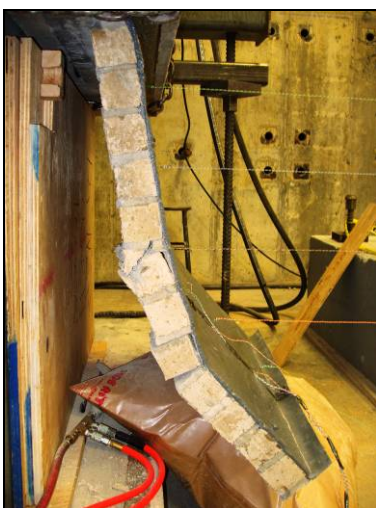
as well as the bed-joints (see Figure 5.25). The load resistance remained relatively constant until failure occurred in the polyurea at the location of the lower boundary element. The failure of the wall has been presented in Figure 5.25c, and the load resistance behavior is illustrated in Figure 5.26. The maximum measured mid-height deflection achieved by the wall was 6.90in. (175.3mm).

(a) Deformed Shape

(b) Flexural Cracks in WF-FA

(c) Failure

Figure 5.25. Wall P1-7 Failure

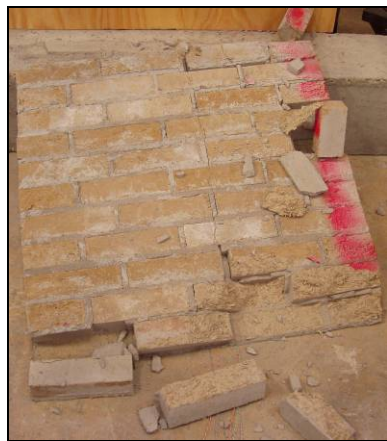
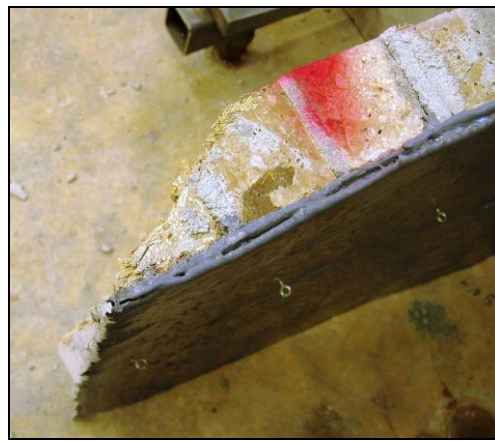
further inspection, it was also found that the units at the boundary locations had sustained damage due to a combination of shearing forces and membrane forces (see Figure 5.27b).

(a) Wall Collapse

(b) Damage Sustained to WF-FA Units

Figure 5.27. Wall P1-8 Failure

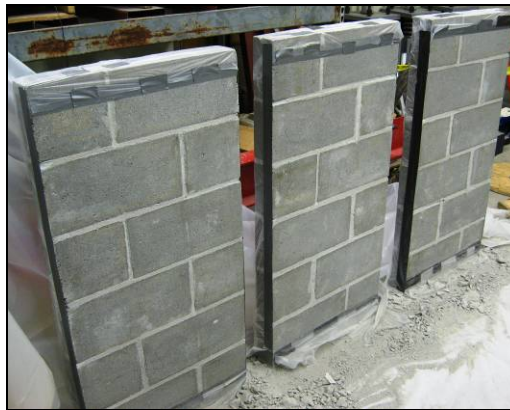
Prior to the application of the strengthening materials, the mortar joints of the walls were ground smooth to the face of the masonry units using a mason's stone, and all dust and debris were removed from the surface of the walls. In the case of the URM walls utilizing the unanchored retrofit, the wall edges and support locations of the walls were taped off, so only the free-span of the URM wall was exposed during the spray-on application of the elastomeric polyurea material. For the anchored retrofit, only the edges of the URM walls were taped off. The taped off Phase 2 walls are shown in Figure 6.2.

Figure 6.2. Phase 2 URM Walls Prior to Strengthening

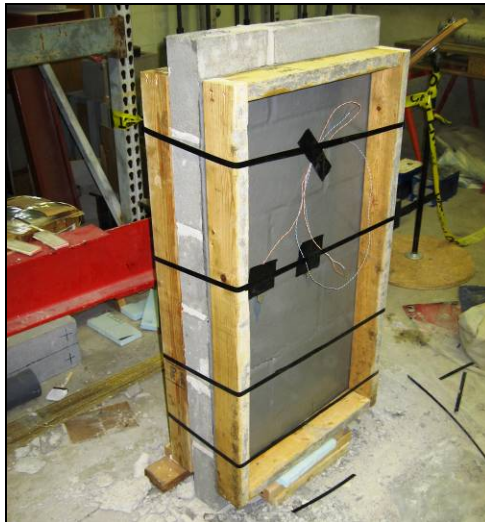
6.1.3. Test Setup and Testing Procedure. The wall tests for Phase 2 of the research program were performed in the UMR's Engineering Research Laboratory (ERL). The walls in this phase of the study were loaded horizontally under four-point bending using a 400k (1780kN) capacity Baldwin Universal Testing Machine. The walls were constructed outside of the testing area and were later moved into place with the use of a standard pallet jack. To prevent any damage or cracking from occurring while moving the URM test specimens, the walls were braced using a metal banded wooden frame assembly. Once transported to the test-bed of the testing machine used to load the specimens, the wooden bracing system was removed from the URM walls. The wooden framing that was used to brace the URM walls is shown in Figure 6.6.

Figure 6.6. Braced URM Wall

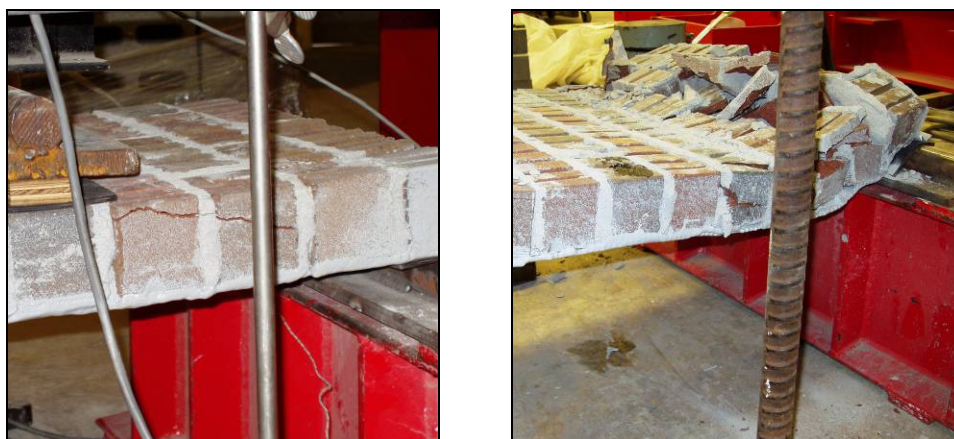
(24.9kN) and midspan deflection of 1.63in. (41.4mm). The separation and splitting of the masonry is illustrated in Figure 6.10b. The load-deflection response for Wall P2-1 has been provided in Figure 6.11.

(a) Flexural-Shear Cracking

Figure 6.10. Wall P2-1 Failure

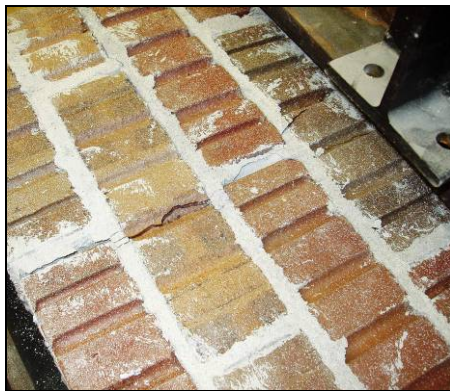
6.2.2. Wall P2-2. This wall was the second of two strengthened URM walls constructed from clay brick units. Wall P2-2 was strengthened with two layers of grid material using the GFRP-polyurea retrofit system with polyurea applied to the entire face of the wall to simulate the presence of an anchored retrofit system. The wall behaved similarly to Wall P2-1 in that cracking occurred almost immediately at an applied load value of 0.7k (3.1kN). As testing progressed, flexural cracking was observed in the bed-joints throughout the constant moment region of the wall. At an applied load of 10.9k (48.5kN), the formation of flexural-shear cracks originating from the point of load application were observed. At 12.8k (56.9kN), a major longitudinal crack forming through the shear-span on the compression face of the wall originating from the applied load was observed (see Figure 6.12). The wall reached a peak load resistance value of 15.3k (68.1kN) at a midspan deflection of 0.75in. (19.1mm). The wall failed almost immediately after reaching the peak load resistance (see Figure 6.13) by way of masonry splitting due to the development of flexural-shear cracks as shown in Figure 6.12b.

(a) Longitudinal Cracking

Figure 6.12. Wall P2-2 Failure

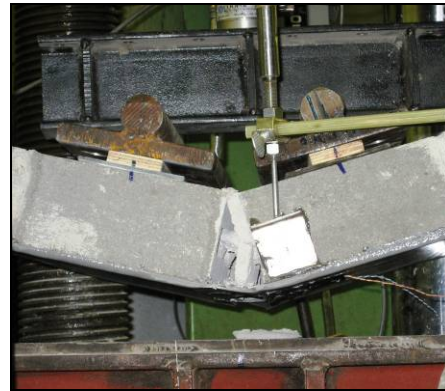
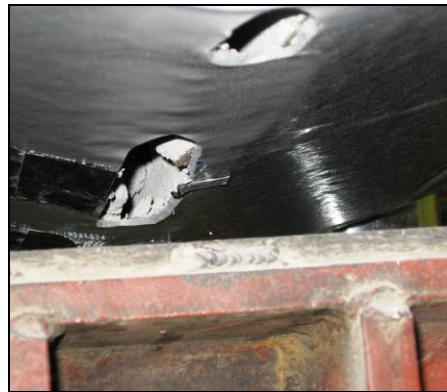
the wall began to separate into two segments and displayed rigid body deformation behavior. As the polyurea material continued to rupture, the load resistance of Wall P2-3 slowly decreased, as shown in Figure 6.15. Ultimately, the wall failed due to full rupture of the polyurea material, which occurred at a midspan deflection value of 7.01in. (178.1mm). Upon failure, the wall collapsed and separated into two half-wall segments (see Figure 6.14d).

(a) Midspan Cracking

(b) Growth of Crack Width

(c) Rupture of Polyurea

(d) Wall Collapse

Figure 6.14. Wall P2-3 Failure

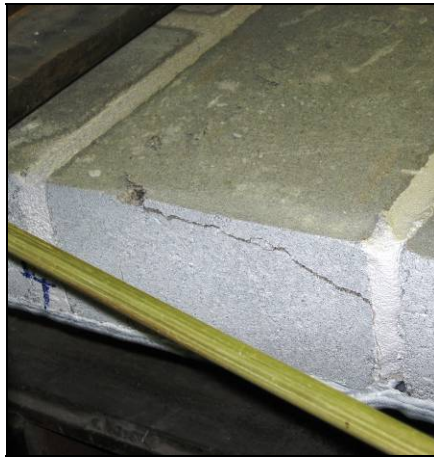
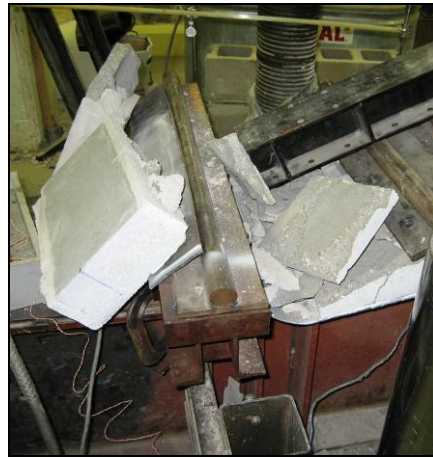
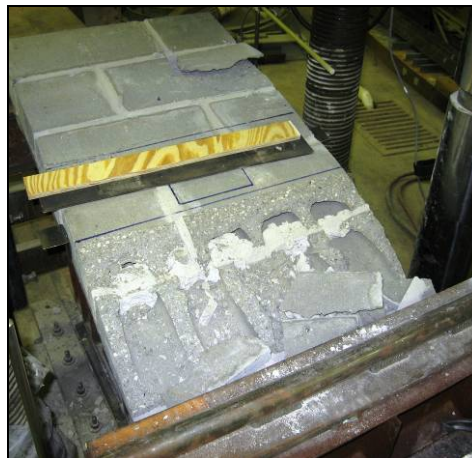
(a) Flexural-Shear Cracking

(b) Debonding of Masonry

(c) Fracturing of Masonry

Figure 6.16. Wall P2-4 Failure

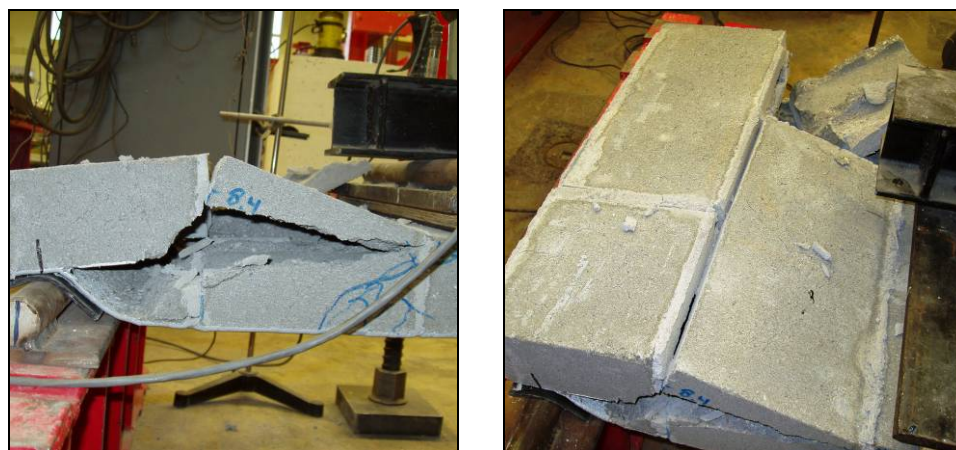
(a) Separation from Polyurea

Figure 6.18. Wall P2-5 Failure
