Coastal Landslide Hazards

Southwest Harbor Quadrangle, Maine

Open-File No. 05-35
2005
 This map supersedes Open-File Map 03-25.

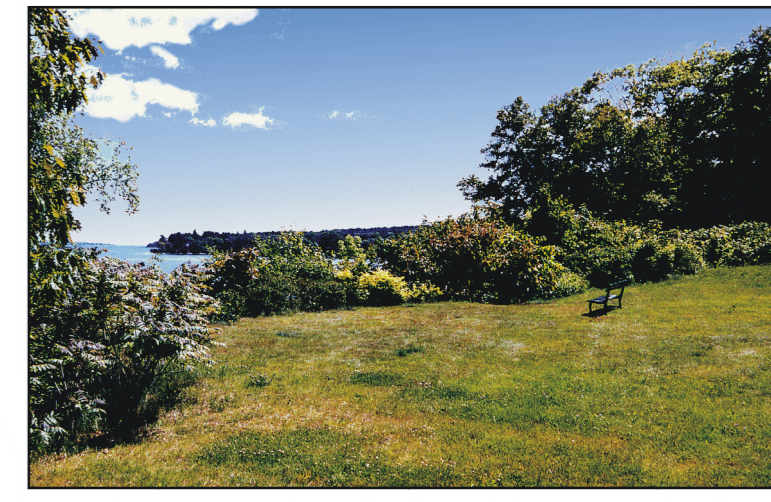
Figure 3. The shape of the top edge of a bluff can be an indicator of landslide risk. Clay bluffs often fail at points of weakness. Such a "slump" can expand into a larger landslide that cuts into the bluff and forms a curve around the original point of failure. Multiple slides and slumps will form an irregular or arcuate top edge to the bluff as shown in the photo above. Bluffs made of coarse materials or sand have a more even upper edge caused by a more constant rate of erosion along the bluff face.

Careful observation of the land surface, vegetation, and shape of a coastal bluff reveals evidence of instability. Starting at the top of a bluff, an irregular or arcuate edge can indicate past landslides or areas of increased coastal erosion (Figure 3). When a weak point on a bluff fails, the slide moves inward into the slope face forming a curve around the original point of failure. Tension cracks may form near a weak zone where the soil surface is moving downslope (Figure 4). These cracks appear as splits in the ground where the soil and vegetation have moved apart. Cracks may be visible along the top edge of the bluff or on the bluff face itself. On the slope of a bluff, a hummocky land surface or terraces indicate past slumping or landslides (Figure 5). Unvegetated slump scars or slopes are obvious evidence of rapid soil movement. A bowl-shaped slope often shows the location of a former landslide, with the center of the bowl as the area of greatest failure. Distorted vegetation provides evidence of soil creep or former landslides. Tree trunks curved near their base are evidence of downslope movement (Figure 6). Trees tilted at different angles are evidence of former slides or undercutting by erosion. At the base of a bluff, toppled trees and bare roots are evidence of erosion that steepens the bluff (Figure 7). Undercutting and steepening of the bluff may destabilize the slope and lead to increased erosion and possibly a landslide. Lobes or terraces of sediment in the intertidal zone are often remnants of old landslides. Because the evidence of earth movement listed above cannot predict a landslide, it is used to recognize unstable shorelines. This landform evidence is related to factors listed below that influence landslide risk.

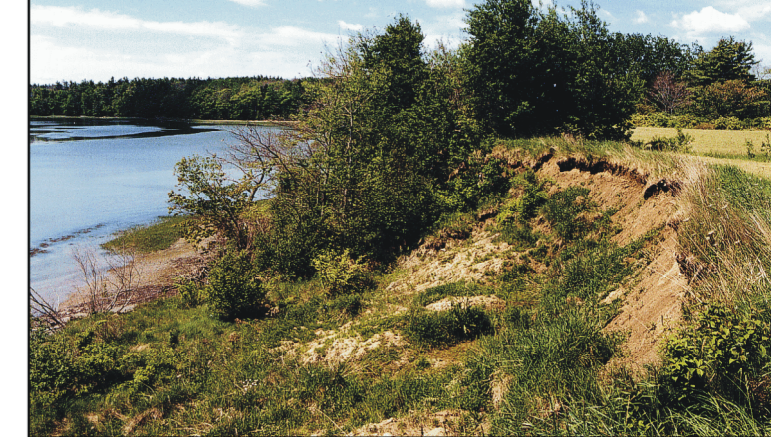
Figure 5. Terraces on a hummocky land surface on the slope of a bluff can indicate a former landslide. Terraces can be the surface of downropped blocks which moved during a slide. Vegetation on the surface of these blocks may be tilted in various directions. The irregular land surface may also occur in a bowl-shaped depression below an arcuate top edge of the bluff, additional evidence of a former landslide.

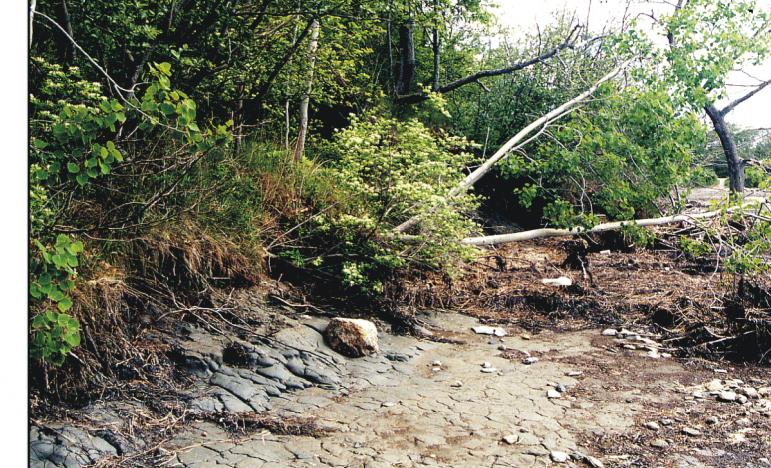
Figure 6. Wave erosion at the base of a bluff removes slope sediment and steepens the bluff. Erosion has undercut the trees in the photo above and caused them to tilt toward the ocean. This steepening reduces the stability of the bluff, and a landslide may result. Ongoing sea-level rise along the Maine coast will cause wave erosion at the base of coastal bluffs and continue to make some coastal bluffs at risk of experiencing a landslide.
