International Journal of Environmental Research and Public Health

Article Analysis of a Historical Accident in a Spanish Coal Mine

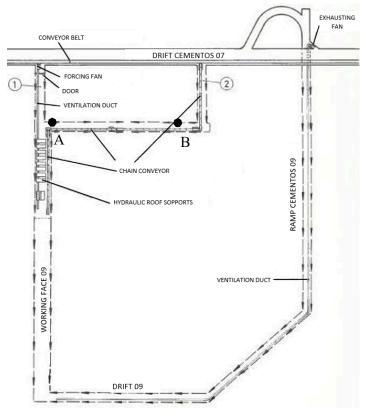
Figure 1. Workshop where the accident occurred. Point 1 and 2 are entry and exist of the working face, respectively, while point A and B are the measuring points.

Originally, it was thought that the source of such amount of methane was some fractures in the coal seam. Subsequently, a set of measures was done to determine its behavior. Table 1 gathers the measures done in the most adverse points of the roof after the accident, Point A and Point B from Figure 1, switching off the ventilation system.

The accident occurred due to a very strong explosion. The first shift entered to the mine at 8:00 am and the accident was at 9:00 am. 28 miners died in the *Working Face 09*, Figure 1, where number 1 is the entry of the workshop and number 2 is the exit. This workshop had a length of 224 meters with a seam between 1.5–1.8 meters and a slope of around 11°. Figure 2 shows the characteristics details of the workshop.

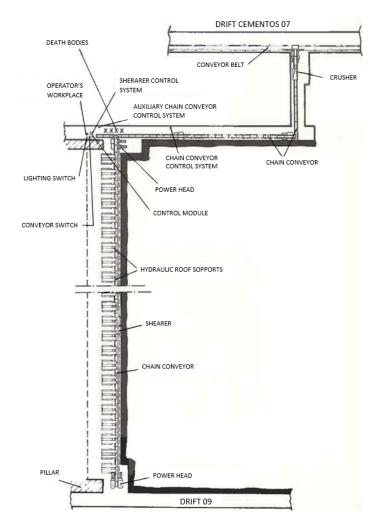
Figure 2. Detailed scheme of the workshop.

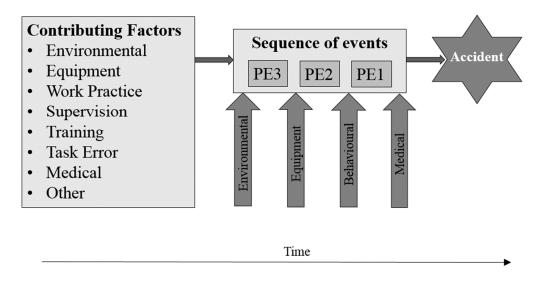
Figure 3. Elements that compose the Feyer and Williamson method. PE1, PE2, and PE3 are Precursor Events.

On the other hand, the Feyer and Williamson method (Figure 3) allow determining up to three events that preceded the accident, called precedent events, and are crucial for the accident occurrence. These are called Precursor Events (abbreviated to PE1, PE2, and PE3). Each of these events could be classified in one of four possible ways:

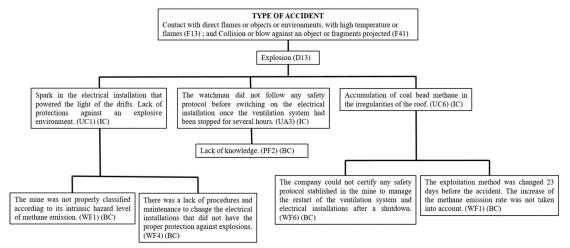
Figure 4. Causal tree using the Spanish Instituto Nacional de Seguridad y Salud en el Trabajo (INSST) method.

Figure 4 summarizes the accident by means of a causal tree using the INSST method. The specific conditions of the accident are also detailed below.

- F13: Type of accident by contact with direct flames or objects/environments with high temperature or in flames.
- F41: Type of accident by collision or blow against an object or fragments projected.
- D13: Deviation or anomalous event due to an explosion.
- UA3: Unsafe act due to carry out anything without proper insurance.
- UC1: Unsafe condition due to the usage of one or more inadequate protections and guards.
- UC6: Unsafe condition due to there is a danger of explosion or fire.
- PF2: Personal factor due to a lack of knowledge.
- WF1: Work factor due to an insufficient leadership and supervision.
- WF4: Work factor due to an inadequate maintenance.
- WF6: Poor labor rules.

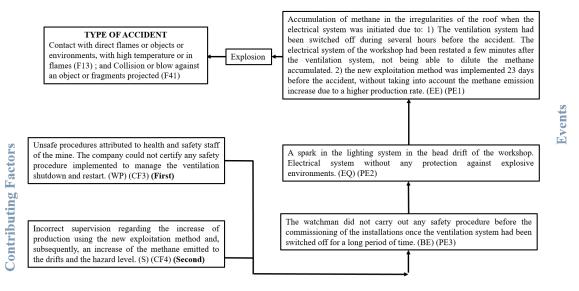
Figure 5. Causal tree using the Feyer and Williamson method.

Three events have been identified in this accident analysis: PE1, PE2, and PE3, see Figure 5. PE1 happened before the accident, environmental event (EE), and it took place because of the coal bead methane in some irregularities in the roof of the drift. All the evidences point out that this accumulation of explosive gas was caused by:

Two contributing factors have been identified (Figure 5) as crucial in the occurrence of the accident.
