iMedPub Journals
<http://www.imedpub.com>Journal of Organic & Inorganic Chemistry
ISSN 2472-1123

Rock-Water Interaction and Chemical Quality Analysis of Groundwater in Hard Rock Terrain of Chamrajanagara District, Karnataka, India Using Geoinformatics

**Basavarajappa HT,
Manjunatha MC and
Pushpavathi KN**Department of Studies in Earth Science,
Centre for Advanced Studies in Precambrian
Geology, University of Mysore, Mysore,
India

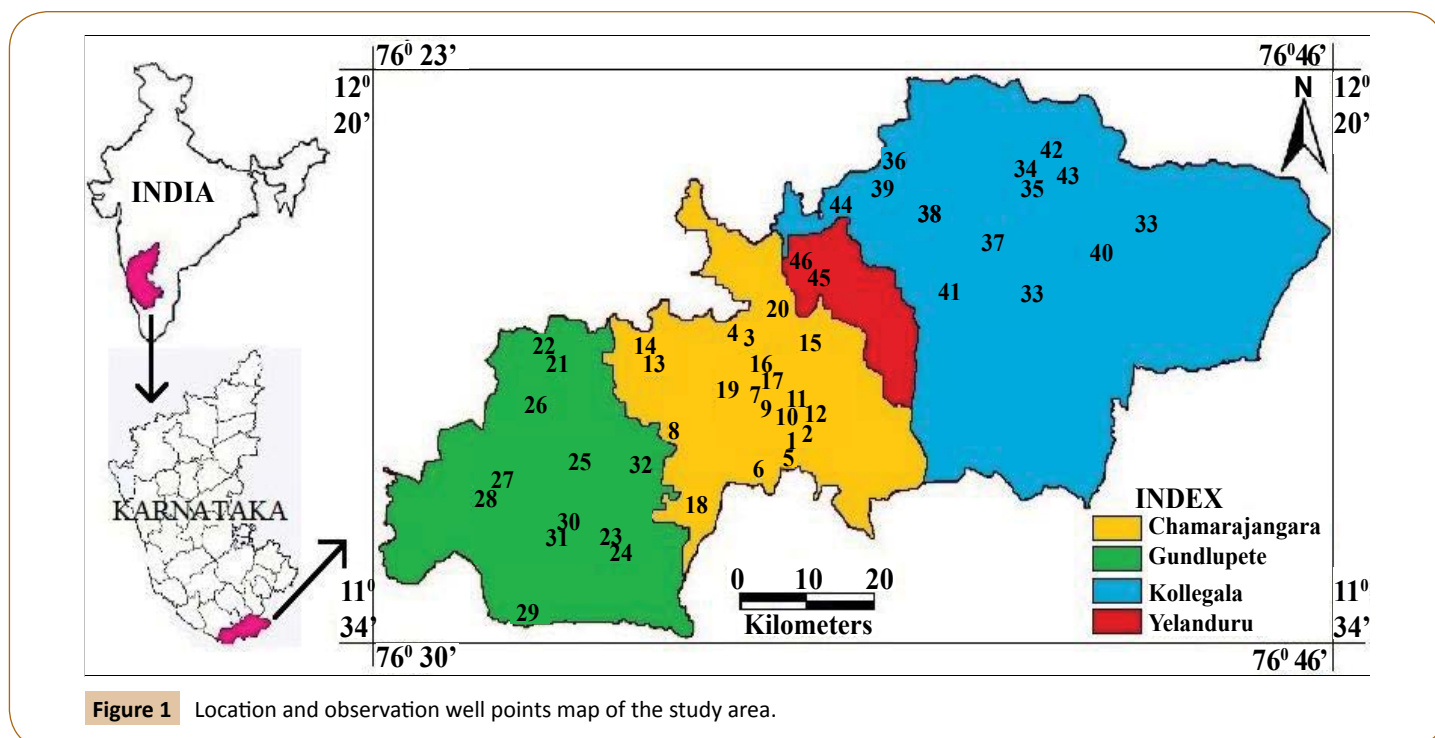
About 46 groundwater samples are collected (32-borewells and 14-dug wells) during pre-monsoon period (April-May 2005) to assess its parameters such as Fluoride (F⁻), Nitrate (NO₃⁻), Carbonate (CO₃²⁻), Chloride (Cl⁻), Calcium (Ca²⁺), Magnesium (Mg²⁺), Sodium (Na⁺), Sulphate (SO₄²⁻), Iron (Fe), Potassium (K⁺), Potential of Hydrogen (pH) and Electrical Conductivity (EC). Survey of India (Sol) Toposheet no's such as 57H/3, 57H/4, 57H/7, 57H/8, 57H/12, 57H/16, 57D/12, 57D/16, 57A/5, 57A/6, 57A/9, 57A/10, 57A/13, 57A/14, 57E/1, 57E/2, 57E/5, 57E/9 of 1:50,000 scale (considered as base maps) which are geo-rectified and each LU/LC patterns are digitized and updated using Satellite Image. Lithological map is digitized based on each lithological units encountered during field visits and key elements interpretation on Satellite images; Lineament overlaid on LU/LC map and Spatial distribution maps of groundwater parameters are well digitized using ArcGIS v10. IRS (Indian Remote Sensing)-1D, LISS-III (Resolution: 24 m, year: 2010-11), PAN (year: 2005-06, Resolution: 5.8 m); PAN+LISS-III (2.3 m resolution) Satellite images are acquired and digitized the linear features/ faults/ fractures by Visual Image Interpretation Techniques (VIIT) and overlaid on LU/LC map. Arc GIS v10 and Erdas Imagine v2013 are the GIS's software applied to generate different thematic layers in the present study. A handheld GPS (Garmin-12) is used during the field visits to record the exact locations of Groundwater bore/ dug well points in the study area.

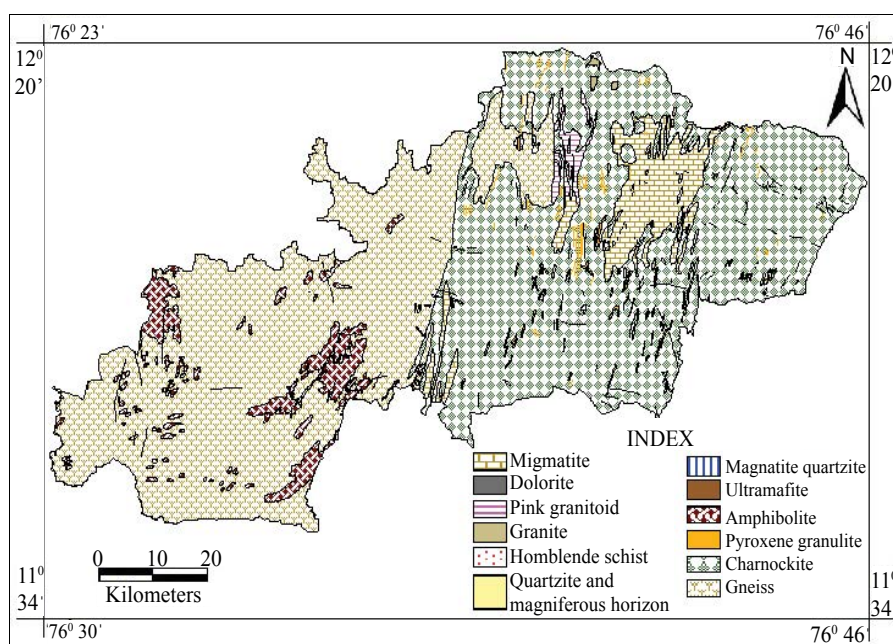
Figure 3 Lithology map of the study area.

The study area is broadly described under the dominating Archaean Granulite facies rocks generally termed as Charnockites occur extensively towards southern margins of the Dharwar Craton [19-23]. Lithological map is derived from published Geological map of 1:250,000 scale [24] and updated using IRS 1D PAN+LISS-III geocoded standard FCC (False Colour Composite) Satellite image using key interpretation elements (Figure 2). The contacts of litho units can be accurately marked and extended by using the tonal characteristics of satellite imagery with limited ground checks. The structures like dykes, faults, their trend and extensions are mapped based on synoptic viewing and discontinued with black signature. Encountered district litho units noticed as Gneisses, Charnockites, Pyroxene granulites, Ultramafic rocks, Amphibolites, Banded magnetite quartzite, Quartzites and Manganese horizons, Meta-hornblendite, Granites, Pink granitoid, Dolerites and Migmatites [17,25,26] (Figure 3). Structural investigation in the study area; mainly in Biligiri-Rangan Granulites (BRG) has shown at least three deformational events viz., D1, D2, D3 [19,26-28]. A major portion of Chamarajanagar district forms hilly and undulating terrain. The Kollegal Shear Zone (KSZ) [19,21,29] which trends N10°E to S10°W where retrograde metamorphic alteration is observed and demarcates the boundary between the gneisses and Biligiri-Rangan [29,30]. The Malai Mahadeshwara hills are defined by the NNE-SSW oriented Hogenakal and Mettur fault planes [20].

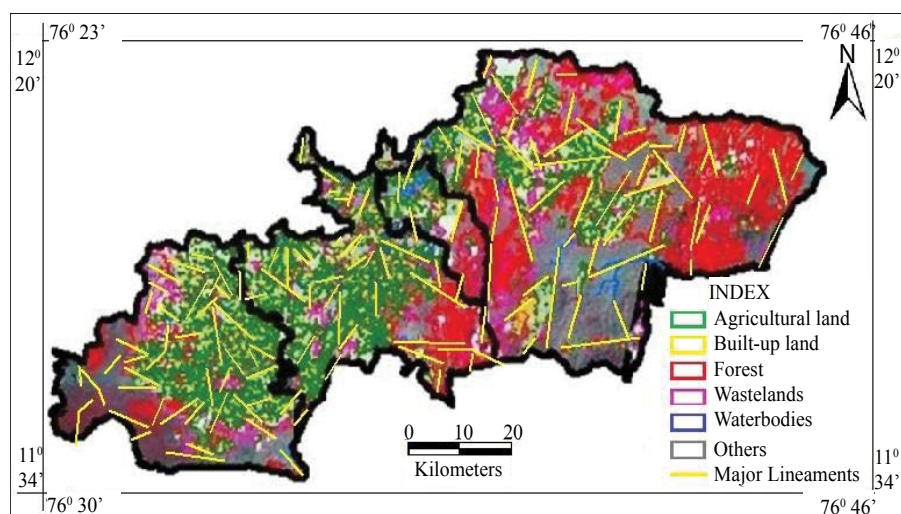
Figure 4 Lineament overlaid on LU/LC map.

Identification and analysis of underground fractures and concealed lineaments are crucial in hard rock terrains [37] ranging from ten to hundreds of Kilometers. Fractures, rock cleavages, joint systems and fault/thrust play a vital role in affecting the surface storage, groundwater recharge and movement [38] which depends on secondary porosity of lithological and structural aspects such as lithological contact, unconformities, folds, faults, bedding planes, fracture, joints, dykes, shear zones, etc. Lineaments are derived from IRS-1D, PAN+LISS III satellite images and the prominent linear structures are trend towards NE, NW and NE-SW [23] (Figure 4). Lineaments noticed on pediplain, alluvium plain, valley and valley fill areas depicts very good groundwater storage and movement. LU/LC pattern of a region reveals of both natural and socio-economic factors and their utilization by man in time and space. Deriving information on LU/LC is helpful in suitable planning and implementation to provide the increasing demands for basic human needs [23]. LU/LC map is digitized using satellite images overlaid on Sol topomap on 1:50,000 scale in conjunction with conventional Ground Truth Check (GTC) [38-41]. Permanent features such as National and State Highways, Temples, Tanks, Power lines, Hills and other features in categorization of LU/LC patterns [41] are digitized. Land use/land cover classes of the study area are noticed as agricultural land (2419.52 Km²) built-up land (57.21 Km²), forest (2688.08 Km²), wastelands (283.68 Km²), water bodies (119.56 Km²) and others (100.87 Km²) [16,23] (Figure 4). Lineament overlaid on LU/LC map highlights the seepage, fractures, joints, dykes, faults, shear zones on different land patterns providing the major sources of contaminating the groundwater quality and to take measures in future plans.

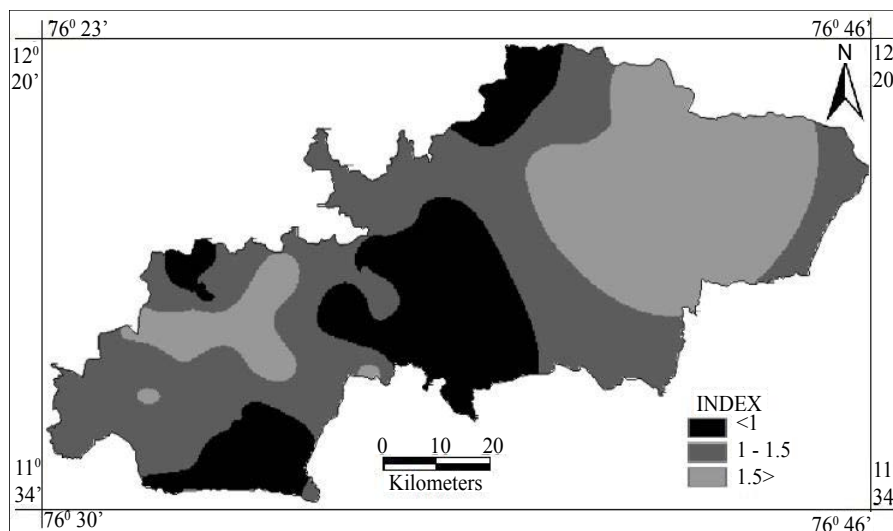
Figure 5 Spatial distribution of Fluoride.

surface and subsurface water bodies during irrigation and groundwater exploration during groundwater movement/ storage and rock layers interaction. The fluoride concentration is found to be beyond permissible limit in western parts of Chamarajanagar taluk.

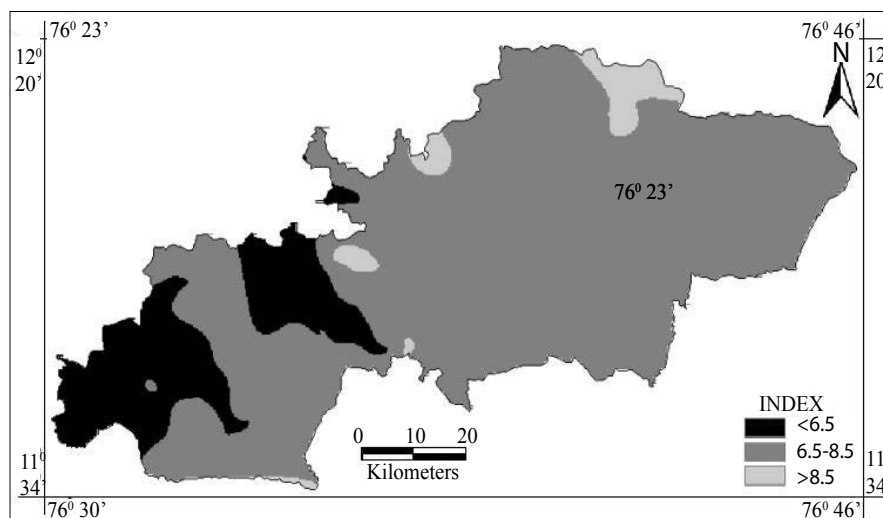
Figure 6 Spatial distribution of Iron.

Iron: Iron varies from 0.2 to 2.5 mg/L with an average of 0.8 mg/L, in which 80% of all the collected samples are above permissible limit with reference to BIS Standards only (**Figure 6** and **Table 2**). Many Banded Magnetitic Quartzites (BMQ) bearing isolated patches are encountered in northern parts of the district with higher Fe content. These range from 1 m to 10 m thickness in size. They are generally parallel to regional trend of $\text{N}5^\circ\text{W}$ - $\text{S}15^\circ\text{E}$ with vertical dip. Magnetitic quartzites are seen in the charnockite gneiss as a mixed zone along the foliation of the country rocks. These are folded with alternate layers of magnetite rich bands noticed in the villages of Devarabetta and Tumbe betta. Manganiferous horizons are also encountered as very thin bands in Charnockite Gneiss mixed zone and well exposed in Hoonganur, Gumballi, Vadayarapalya area. Oxidation-reduction reactions constitute an important influence on concentrations of both iron and manganese [1,23]. High dissolved iron concentrations can occur in groundwater, when pyrite is exposed to oxygenated water/ ferric oxide/ hydroxide minerals are in contact with reducing substances.

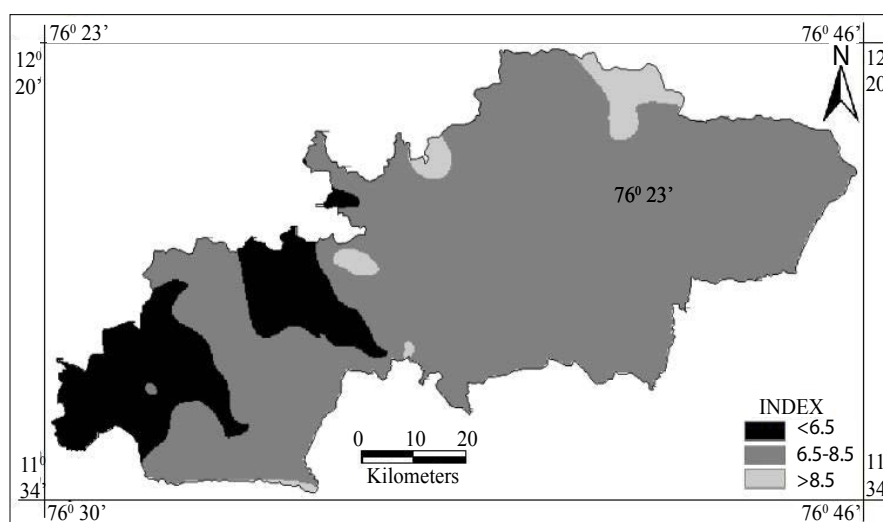
Figure 7 Spatial distribution of P^H.

Potential of hydrogen (P^{H}): P^{H} represents the numerical value indicating whether water is acidic and alkaline [46]. P^{H} ranges from 6.81 to 9.0 mg/L with an average of 7.63 mg/L, in which 84% of the collected samples are above the permissible limits of

WHO and BIS Standards (**Figure 7** and **Table 2**). The alkalinity in most natural water is primarily due to the presence of dissolved carbon species, particularly bicarbonate and carbonate. Other constituents that may contribute minor amounts of alkalinity to water include silicate, hydroxide, borates and certain organic compounds. Carbonate contributors to alkalinity include atmospheric and biologically-produced carbon dioxide, carbonate minerals and sulfate reduction. Non-carbonate contributors to alkalinity include hydroxide, silicate, borate and organic compounds [1].

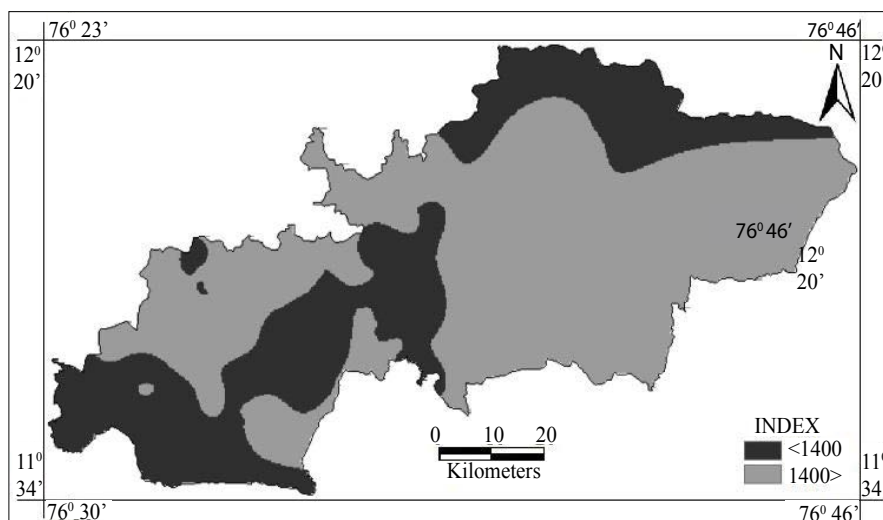
Figure 8 Spatial distribution of electrical conductivity.

Electrical conductivity (EC) or specific conductance: Electrical Conductivity is a measure of the ability of water to pass electric current, is generally affected by the presence of inorganic solids such as, Na^+ , Ca^{2+} , Mg^{2+} , SO_4^{2-} , Cl^- etc. It is affected primarily by the geology of the local area that is in contact with water [44]. The large variation in EC is mainly attributed to distinct processes such as, saline sources, mineral dissolution and influx of pollutants from anthropogenic activities. In the study area, EC ranges from 230 $\mu\text{S}/\text{cm}$ to 3192 $\mu\text{S}/\text{cm}$ with an average of 1497.31, in which 54% of all the samples are above permissible limit with reference to WHO only (**Figure 8** and **Table 2**).

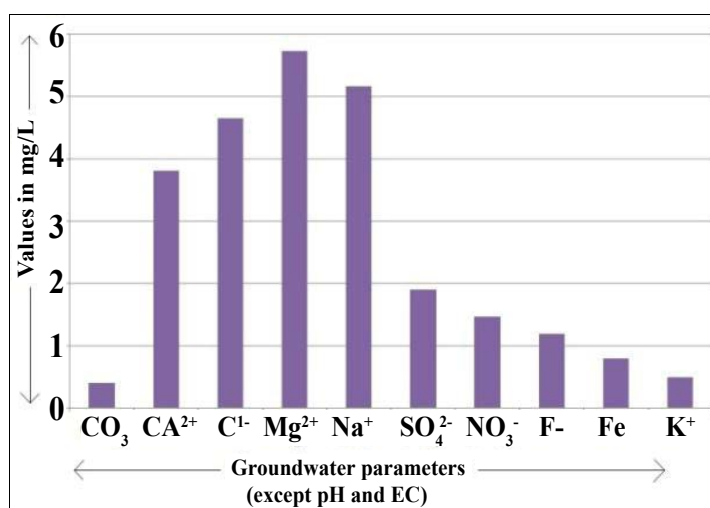
Figure 9 Column graph depicting the average observed values of groundwater parameters in the study area (Except pH and EC).

containing minerals such as the release of phosphate fertilizer from rock phosphates as byproduct (Figure 9).
