Revisiting District Six: A Case Study of Digital Heritage Reconstruction from Archival Photographs

This paper investigates the digital reconstruction of destroyed buildings from small sets of old, uncalibrated photographs. The application domain is the heritage preservation of District Six – a mixed race area in Cape Town that was leveled during the South African Apartheid regime and whose residents were forcibly removed.

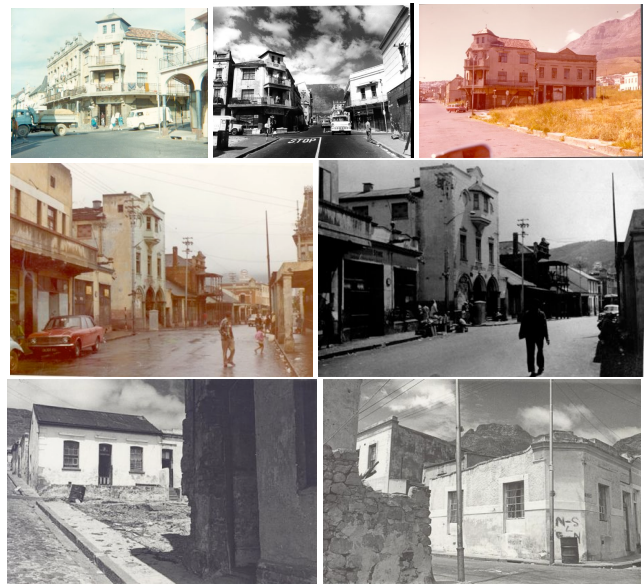
Figure 2: Some examples of the District Six photographic material. [Top] three photographs of the Hanover Building, a local landmark. One of the photographs is in greyscale, while another was taken during the demolition of District Six. [Middle] two photographs of the British Bioscope — a building we go on to reconstruct in Section 5. Again, one image is in greyscale, while the second is in colour. [Bottom] two images of different District Six buildings, for which we were unable to find additional, matching photographs

Unfortunately, the photographs in this collection (a selection of which appear in Figure 2) are all at least 30 years old, often in poor condition, and with little or no contextual information. For the purposes of photogrammetric reconstruction, this presents a number of challenges:

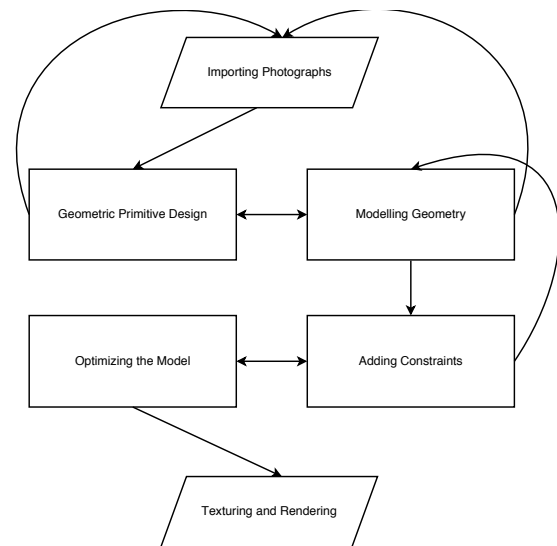
Figure 3: A user's view of the overall reconstruction framework.

From the user's perspective, the functionality of the framework can be partitioned into six actions (as illustrated by the flowchart in Figure 3):

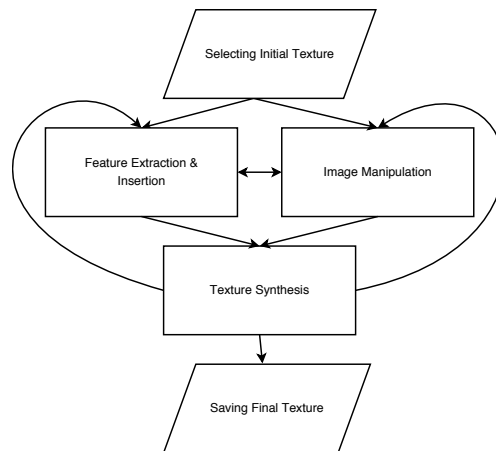
Figure 4: A user's view of texture reconstruction.

- Texturing and Rendering.** The final operation that the user performs to complete a reconstruction is the texturing of the model. This involves texture extraction, synthesis and manipulation as discussed above, and Figure 4 illustrates the typical workflow for this process.

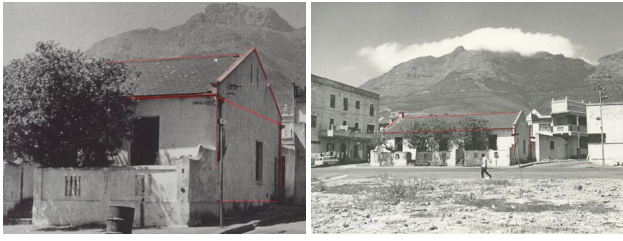
Figure 5: Photo input for a Large District Six residence. The relevant edges of these photographs have been marked out in red by the user.

The first reconstruction is of a large residence that existed prior to the demolition of the District Six region. The input for this reconstruction comprised two photographs of the residence, shown in Figure 5. The first photograph is from nearby, encompassing only part of the building, and the second from a significant distance, showing the entire building, but at a very low resolution. The field of view for both cameras was computed to be approximately 45 degrees.

The major problem with the reconstruction of this building, is the difficulty of marking edges where the building joins the ground. This is partially as a result of the sloping ground, and partially as a result of a lack of landmarks on the photograph. Aside from this, however, the model, when projected onto the image-planes, matches the marked edges and visible geometry within the images with a high degree of accuracy.

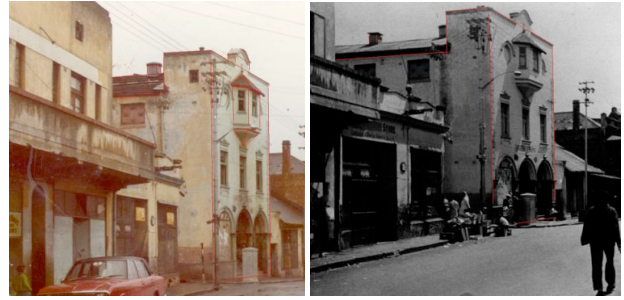
Figure 7: Photo input for the British Bioscope. Note the poor viewing angle with respect to the front wall, and the obstructions present in both photographs.

sons. First, the building has far greater geometric complexity. This can be seen in the two input photographs of the building appearing in Figure 7. The building has a bay window, two chimneys and decorative geometry atop the façade. A second complication, is that the two photographs have different chromatic schemes. Furthermore, the second image is substantially older than the first, and of very poor quality. As a result, it was only useful in reconstructing the geometry, and not for texturing purposes. Finally, both photographs are taken from a very similar vantage point, offering a poor view of the front wall. This is exacerbated by large portions of the building being obscured by external geometry, including other buildings, a lamp post, and a pillar box.

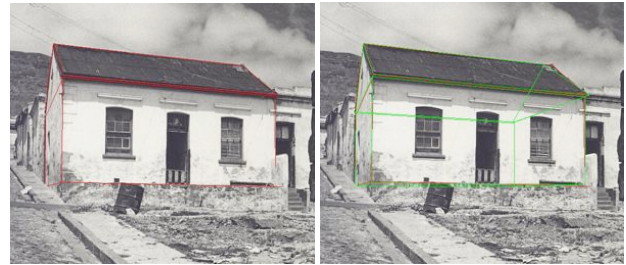
Figure 11: *Photo input for a small District Six residence. [Left] The original input photograph, after the relevant edges have been marked out. [Right] The photograph with the reconstructed model projected onto it from the perspective of the reconstructed camera. Note the large error at the top right-hand corner of the roof.*

The final case study is of a small residence. This building is architecturally simple, but reconstruction remains problematic as there is only one sample image (shown in Figure 11). Furthermore, the photograph, although providing an excellent view of the front wall, has a correspondingly limited view of the side (and hence its depth). Additional difficulties are caused by the degree of radial distortion evident in the image, and by the roof of the building, which sags along the depth axis, both of which introduce non-linearities.

The geometric reconstruction of the house is correct with two caveats. First, due to sagging and radial distortion, the top right-hand corner of roof in the reconstructed model, fails to conform closely to the user’s observations (as shown in Figure 5.3). Second, the side wall appears to be longer than expected. However, due to the poor camera angle, it is impossible to visually determine the actual wall length, and the projected model does match up accurately with that portion of the image. Although this building sits on a slope, this presented no problems since the border of the foundation is clearly visible. The building was modelled, very simply, with a cuboid for the base and a prism for the roof. Including the camera parameters, the entire model comprised only 10 free parameters.

One example of where error is introduced into the system through a combination of poor image quality and geometric approximations is the roof of the small residence. In this case, the model edges are, on average, 1.14 pixels out, with a standard deviation of 1.23 pixels. However, much of this error can be attributed to a single edge at the top right of the roof of the building, which deviates from its observation by 4.32 pixels on average. Discounting this edge, the model edges are, on average, 0.86 pixels out, with a standard deviation of 0.53 pixels.

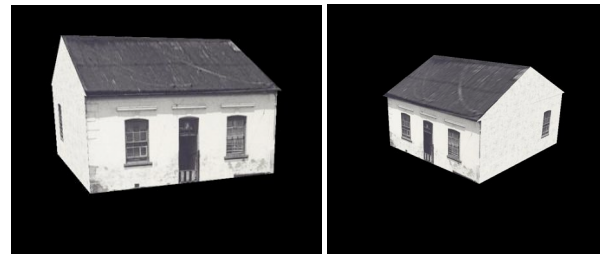
Figure 12: *The final reconstruction results for a small District Six residence.*

This example represents a worst case scenario for reconstruction. However, the results remain acceptable. An additional photograph would ensure that the depth of the building is perceived correctly, but that was not possible in this case. The final reconstruction results are shown in Figure 12.
