## Drilling Strategy for Thick Carbon Fiber Reinforced Polymer Composites (CFRP): A Preliminary Assessment

**Abstract.** Carbon fiber reinforced polymer or CFRP composites are the epitome of high-performance materials in lightweight design. However, their machinability can be problematic due to non-homogenous and anisotropic material properties. This preliminary assessment emphasizes drilling strategy by using mechanical drilling and laser machining on 25.4 mm thick CFRP, which has not been investigated so far. In mechanical drilling, three drilling strategies were applied with the same parameters in order to assess the feasibility of drilling thick CFRP. The laser machining experiments were conducted to identify the potential of fiber laser machines to cut thick CFRP due to their superior laser beam quality. The results showed that choosing the appropriate drilling strategy in mechanical drilling is essential for reducing damage when drilling thick CFRP. Significant damage occurred in all experiments. The results are useful to define the relationships between machining parameters related to mechanical/laser drilling and hole/cut quality.

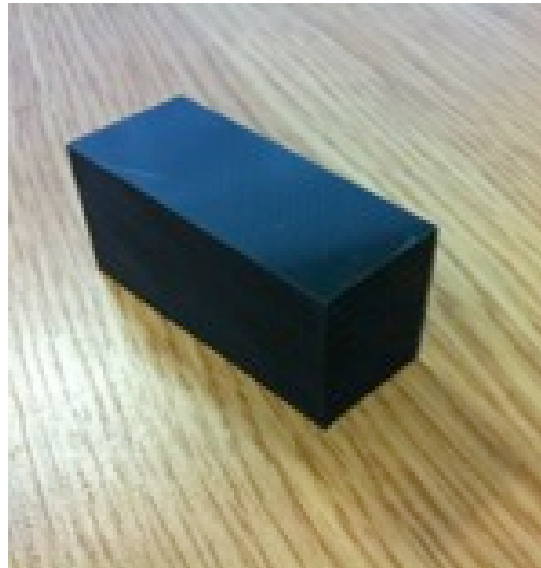
The mechanical drilling experiments were conducted on 25.4 mm thick CFRP composites (see Figure 1) in order to drill a  $\varnothing$  8mm hole (material sample size 50 (length) x 20 (width) x 25.4 (thick/height) mm) by using a 2-flute tungsten carbide drill bit (WC-uncoated  $\varnothing$  8 mm with a point angle and helix angle of  $118^\circ$  and  $35^\circ$  respectively) on a Takisawa MAC-V3 Machining Center (maximum spindle speed and power of 6,000 rpm and 5.6 kW, respectively) in

**Figure 1** CFRP specimen.

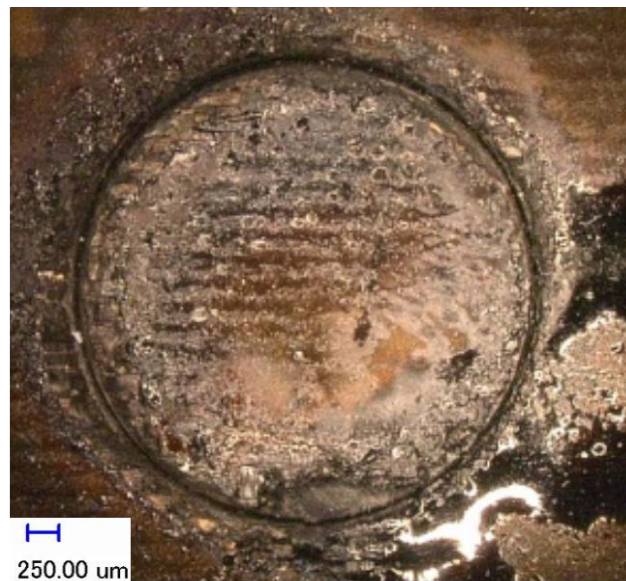
Initially, it was decided to focus only on laser power and scanning speed to determine the processing window for single-pass cutting. Figure 8 shows the attempt of laser drilling, which was unsuccessful in penetrating the workpiece, even though the experiments were conducted with variation of laser power and scanning speed. A significant amount of HAZ appeared at the outer region of the hole circumference. Then, another experiment was conducted to investigate how far the laser could penetrate the 25.4 mm thick CFRP workpiece in multiple passes at different depths, since the earlier tests were unsuccessful in cutting through the entire block in a single pass.

**Figure 8** Initial laser drilling result (power: 900 W; speed: 10 mm/sec; single pass).
