The Hindenburg disaster: Combining physics and history in the laboratory

The *Hindenburg* Disaster: Combining Physics and History in the Laboratory

Gregory A. DiLisi, John Carroll University, University Heights, OH

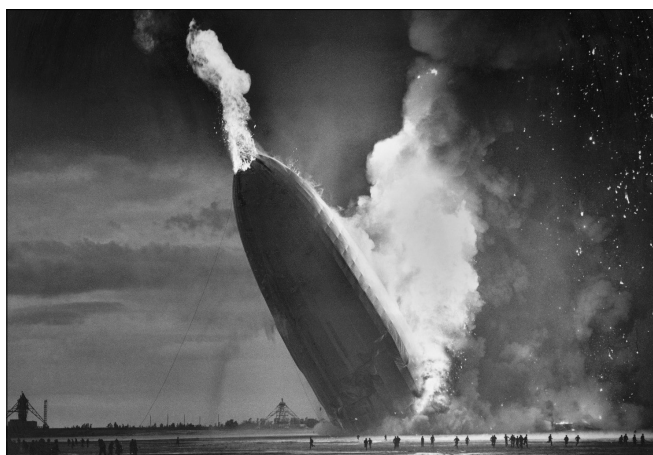
Fig. 3. The final moments of the *Hindenburg*. As the bow angled upward, a blowtorch of fire erupted out of the nose. (Public Domain)

Using eyewitness accounts to determine the origin of the fire proved confusing, but the first sign of trouble appears to have been at the top, rear of the ship, just in front of the vertical fin.³ Both R. H. Ward (stationed with the port bow landing party) and R. W. Antrim (stationed atop the mooring mast) testified that they noticed a fluttering of the ship’s outer cover at this location — suggesting hydrogen was leaking out of a rear interior bladder against the outer covering.³ Crewmen in the control stations of the lower fins testified hearing “muffled detonations” near the top of the ship. When they looked up, they saw bright red and yellow reflections of fire.³ By 7:25 p.m., a yellow flame appeared on the outside of the ship at this spot. Within seconds, the tail section was engulfed in flames. The ship managed to stay afloat for a few seconds, but eventually the tail section sank, slamming crew and passengers 15-20 ft backwards into the rear walls of the control room, cabins, dining lounge, and promenade. As the *Hindenburg* tilted upward, the fire traveled inside the ship along the central axis until a blowtorch of fire erupted from the nose (Fig. 3). Crewmen stationed in the bow were incinerated.
