## Effectiveness of Elevated Skid Trail Headwater Stream Crossings in the Cumberland Plateau

THESIS

A thesis submitted in partial fulfillment of the  
requirements for the degree of Master of Science in the  
College of Agriculture  
at the University of Kentucky.

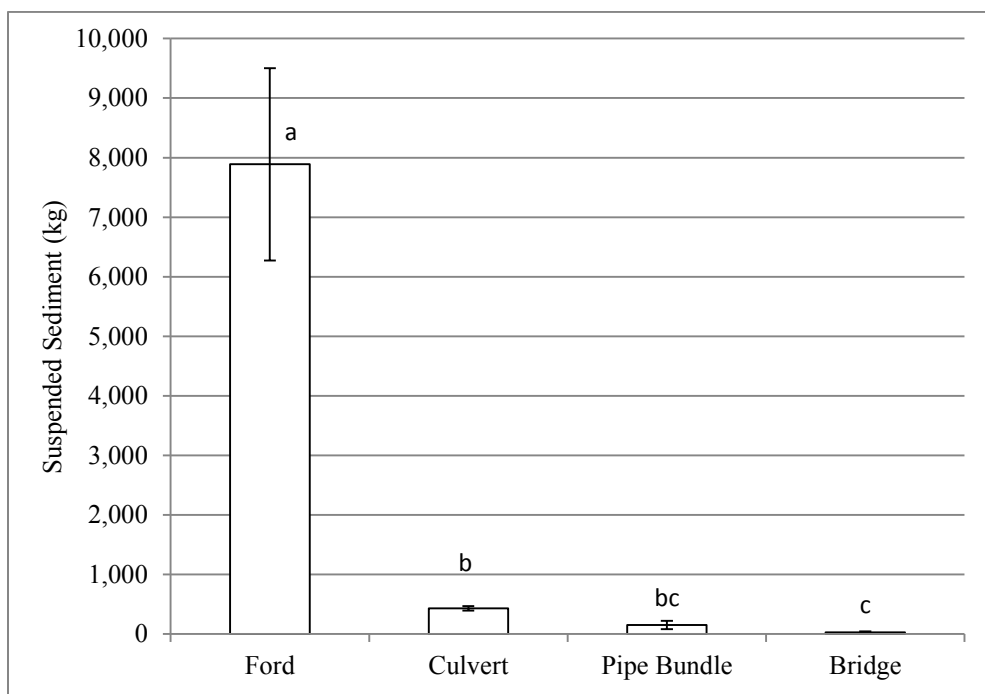
Figure 2.1. Total suspended sediment (mean and standard error) among all crossing types. Different letters indicate significant differences ( $p \leq 0.05$ ) using least squares difference

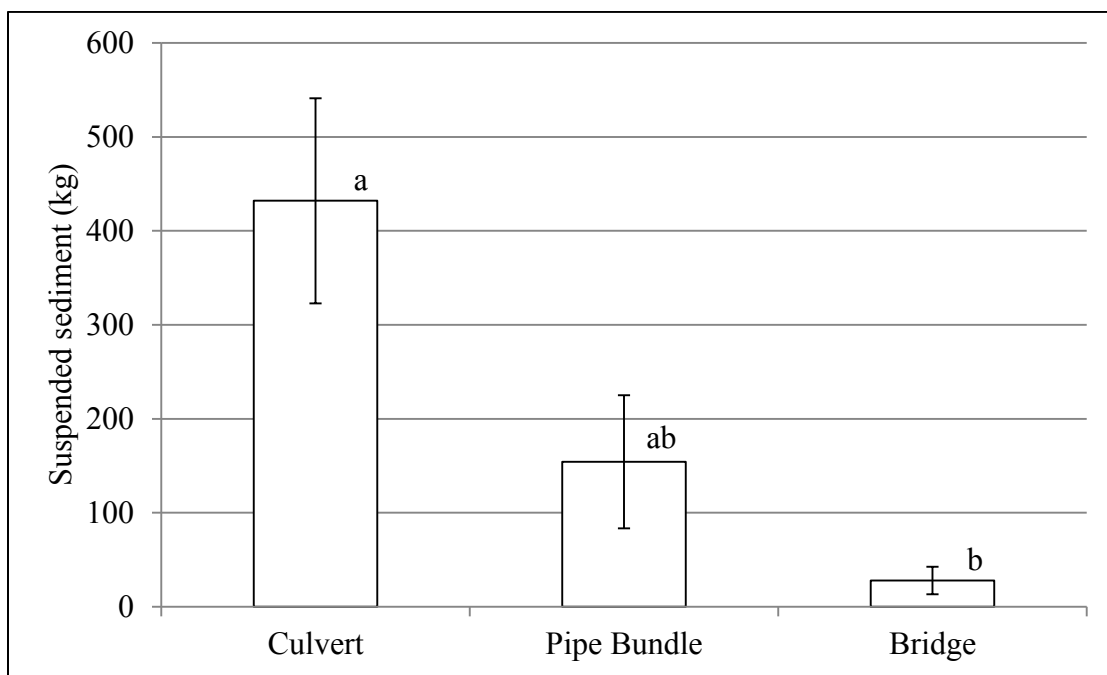
Figure 2.2. Total suspended sediment (mean and standard error) among elevated crossing structures. Different letters indicate significant differences ( $p \leq 0.05$ ) using least squares difference

Significant differences were found among elevated crossing types relative to total suspended sediment production (Fig. 2.2). Bridges yielded significantly lower amounts of suspended sediments than culverts, but pipe bundles were not significantly different from bridges or culverts. Culverts mean total suspended sediment value ( $432 \pm 38 \text{ kg}$ ) was significantly higher than the mean total suspended sediments for bridges ( $28 \pm 15 \text{ kg}$ ). The performance of bridges relative to culverts was anticipated and mirrors studies conducted on higher-order streams (Looney 1981, Thompson et al. 1995, Tornatore

1995). These results are also similar to those of Witt et al. (2011) showing the effectiveness of elevated stream crossings at mitigating sediment contribution. Witt found that bridges and culverts reduced total suspended solids concentrations 88% and 85% respectively. Pipe bundles were able to reduce total suspended solid concentrations 77%. Similar reductions were found with turbidity values. The pipe bundles mean total sediment ( $154 \text{ kg} \pm 71 \text{ kg}$ ) was not significant different from culverts or bridge. Although not statistically different from the other tested elevated crossing types the results do indicate that pipe bundles could be recommended as an improved crossing type to mitigate sediment from headwater streams.

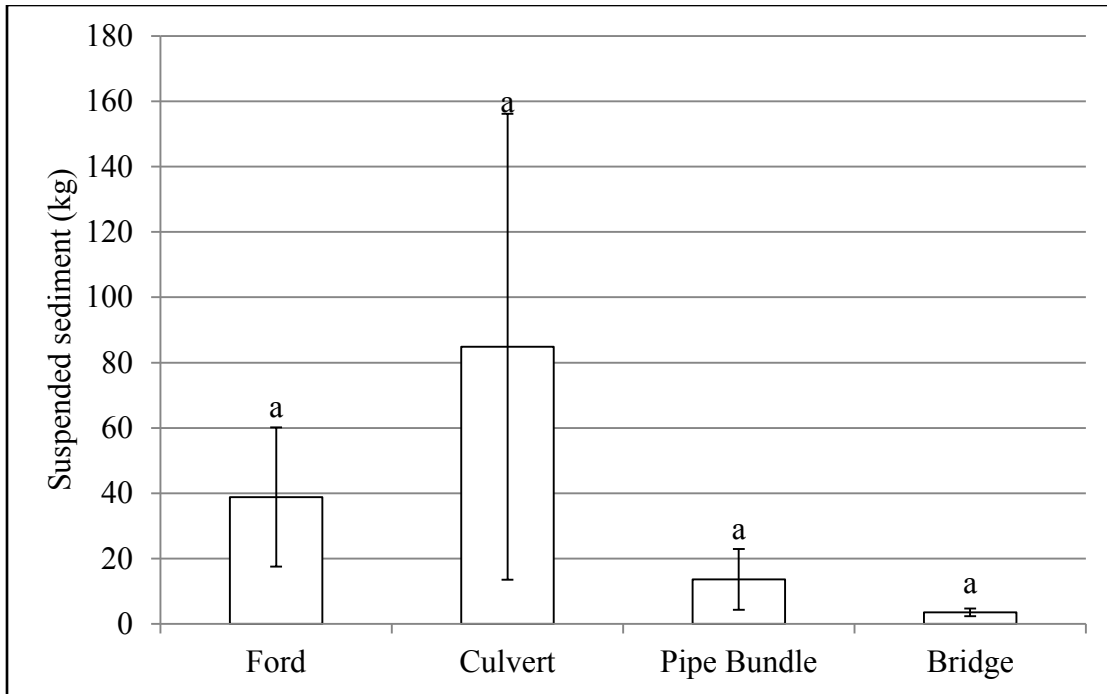
Figure 2.3. Installation produced sediment (mean and standard error) among crossing type. Different letters indicate significant differences ( $p \leq 0.05$ ) using least squares difference

While the numeric average suspended sediment mass was greater for the culvert compared to other treatments during installation there were no significant differences among all crossing types ( $p = 0.56$ ) (Fig. 2.3). The lack of difference among crossing types during installation may reflect the low flow levels that were present at that time. It was hypothesized that the backfill required for a culvert would cause significantly higher sediment levels than the other crossing types. Bridges introduce sediment only from being dragged across the channel for installation and construction of approach ramps up to the edge of the wood panel structure. The pipe bundle only has backfill across the top of the structure and large amounts of sediment do not come into contact with the stream flow itself. The low flow of headwater streams during this time may have not generated the energy required to move significant amounts of sediment that was being placed in the stream as backfill during culvert installation.

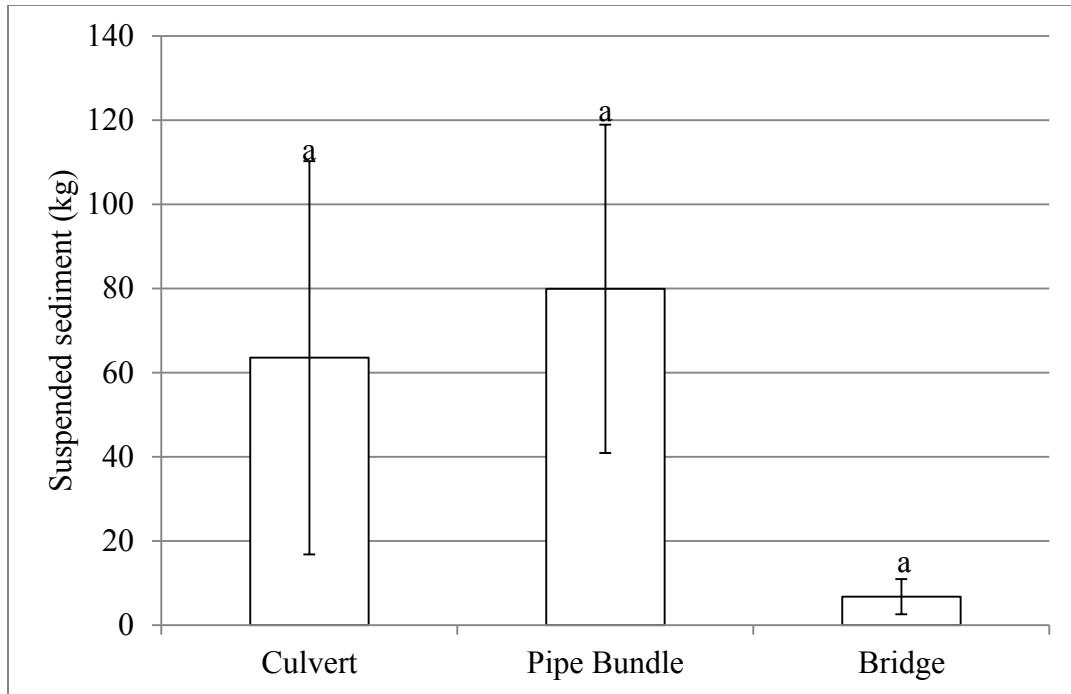
Figure 2.4. Equipment passes produced total suspended sediment (mean and standard error) among elevated structure types. Different letter indicate significant differences ( $p \leq 0.05$ ) using least squares difference

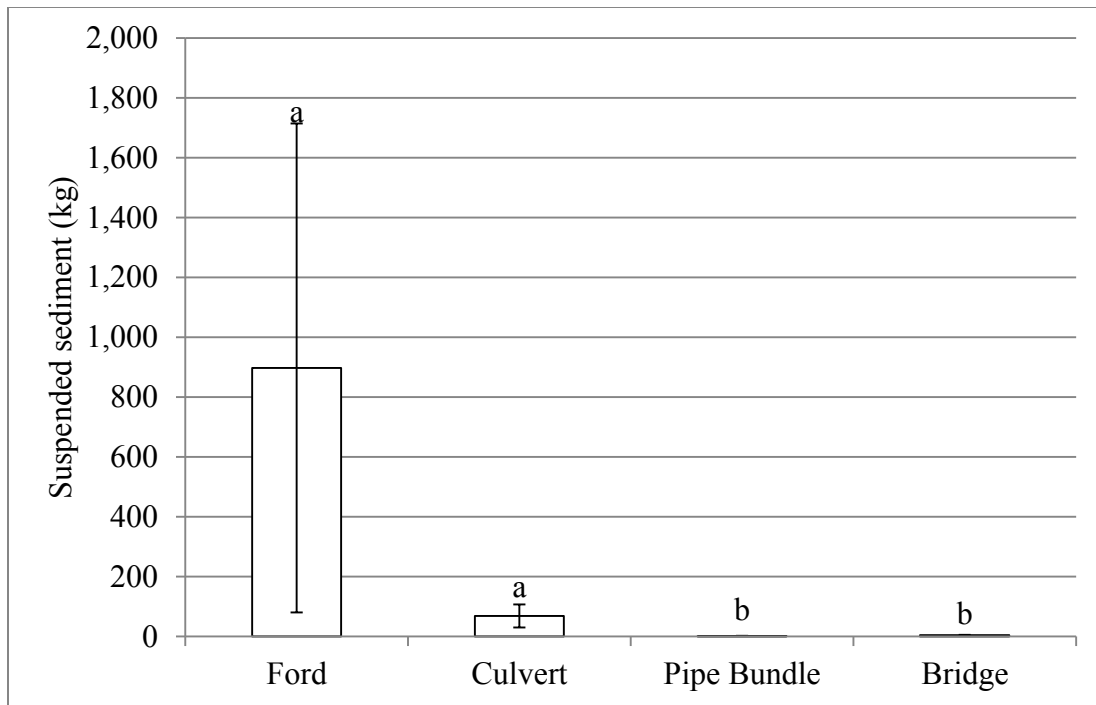
Figure 2.5. Rain event total suspended sediment (mean and standard error) produced among all crossing types. Different letters indicate significant differences ( $p \leq .05$ ) using least squares differences

During rain events, while the crossings were installed, there was a significant difference ( $p < 0.05$ ) among crossing types (Fig. 2.5). Fords and culverts were not significantly different ( $p < 0.05$ ) but were significantly higher than bridges and pipe bundles during rain events while the structures were still in place (Figs. 2.5 and 2.6). There were no differences between pipe bundles and bridges. It is probable that the high storm event flow levels generated the energy needed to dislodge backfill soils used for culvert installation. Loose soil drug into fords from skidding washed from the knocked down stream banks. Pipe bundles and bridges did not have the backfill in the stream compared to culverts or have sediment remaining in the stream that was not carried away like fords. There was backfill for the pipe bundles but it was above the stream and did not come into contact with the stream even during the higher flow events. A geotextile

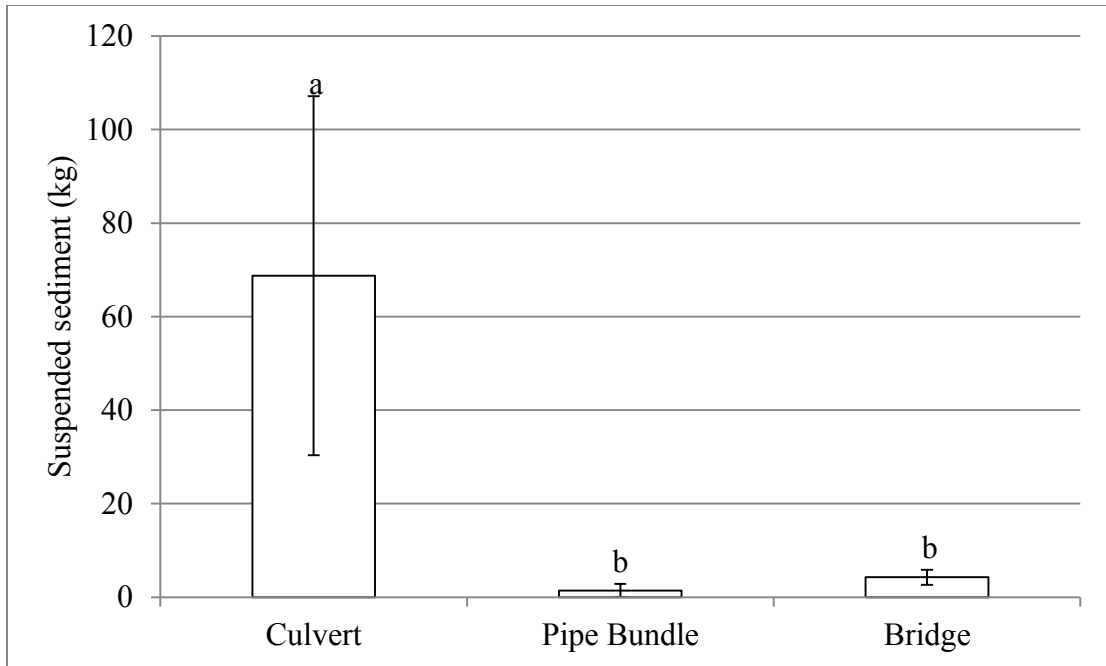
Figure 2.6. Rain event total suspended sediment (mean and standard error) produced among elevated crossing types. Different letters indicate significant differences ( $p \leq 0.05$ ) using least squares differences

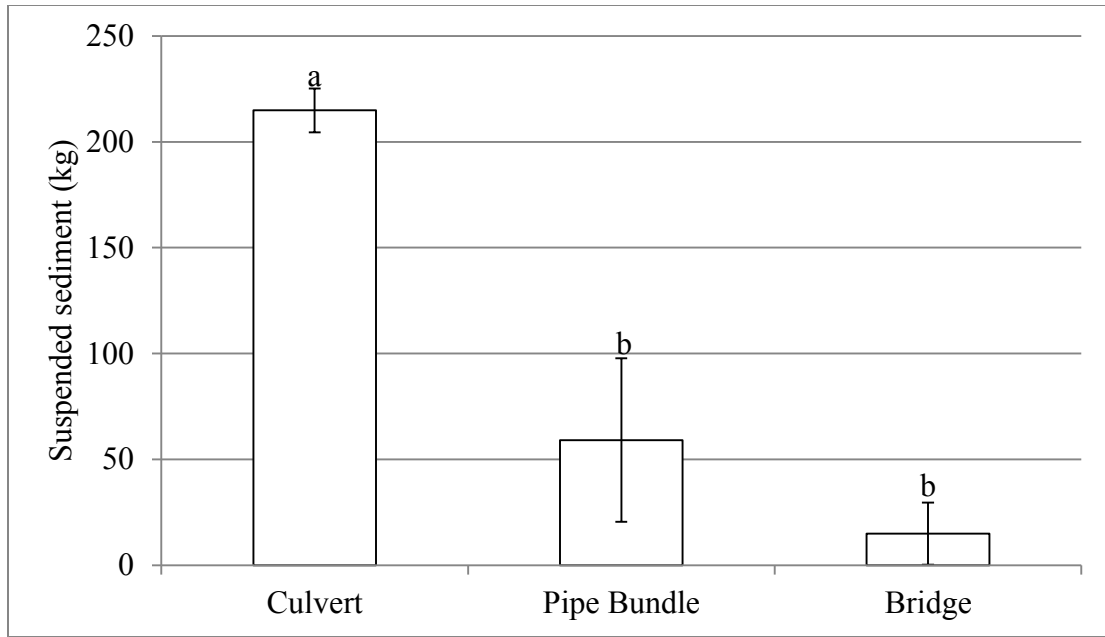
Figure 2.7. Removal and post-removal total suspended sediment (mean and standard error) among elevated crossing types. Different letters indicate significant differences ( $p \leq 0.05$ ) using least squares differences

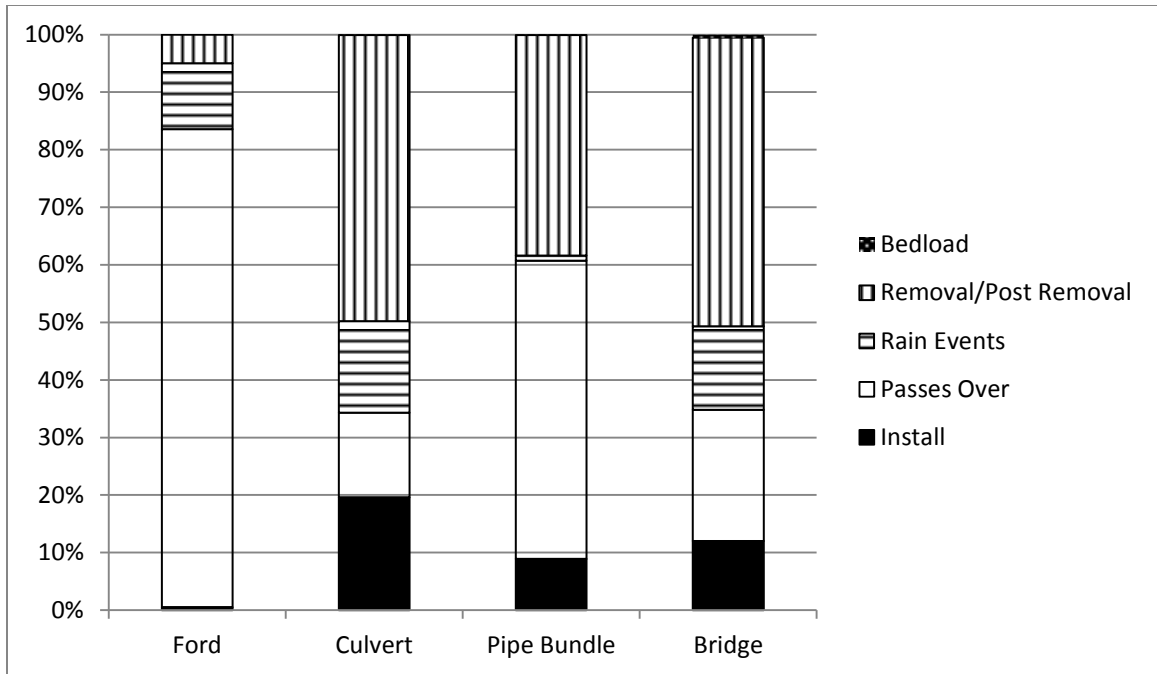
Figure 2.8. Percent of total suspended sediment by phase among all crossing types

Considering the percentage of suspended sediment generated during each phase recommendations can be made for harvest operators (Fig. 2.8). Eighty-four percent of all

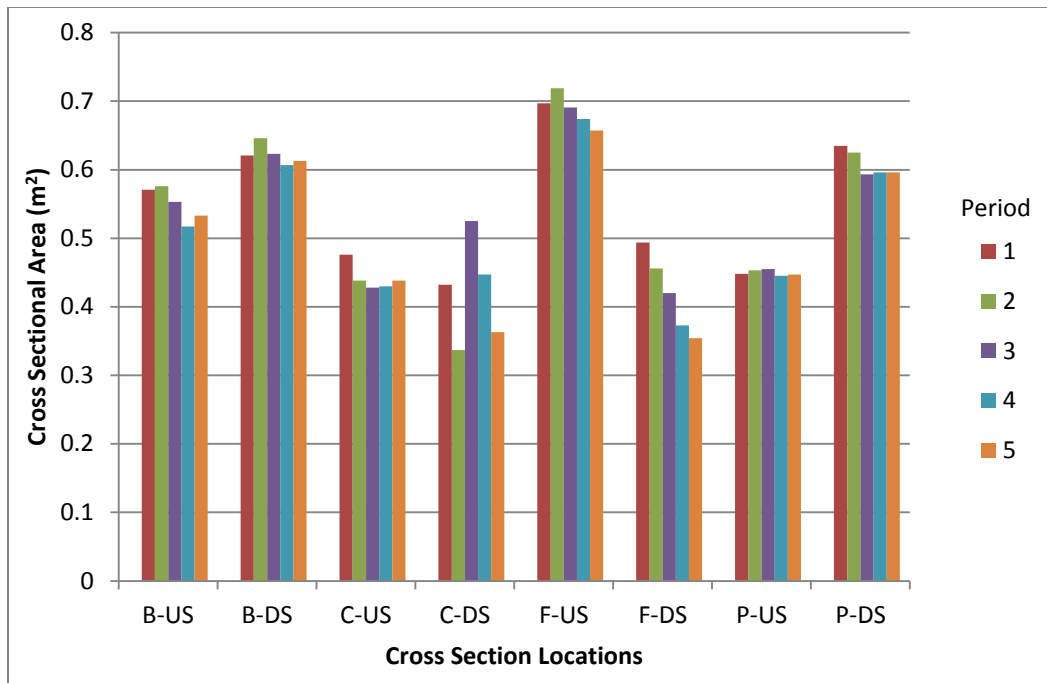
Figure 3.1. Cross sectional area for all periods for all crossing types

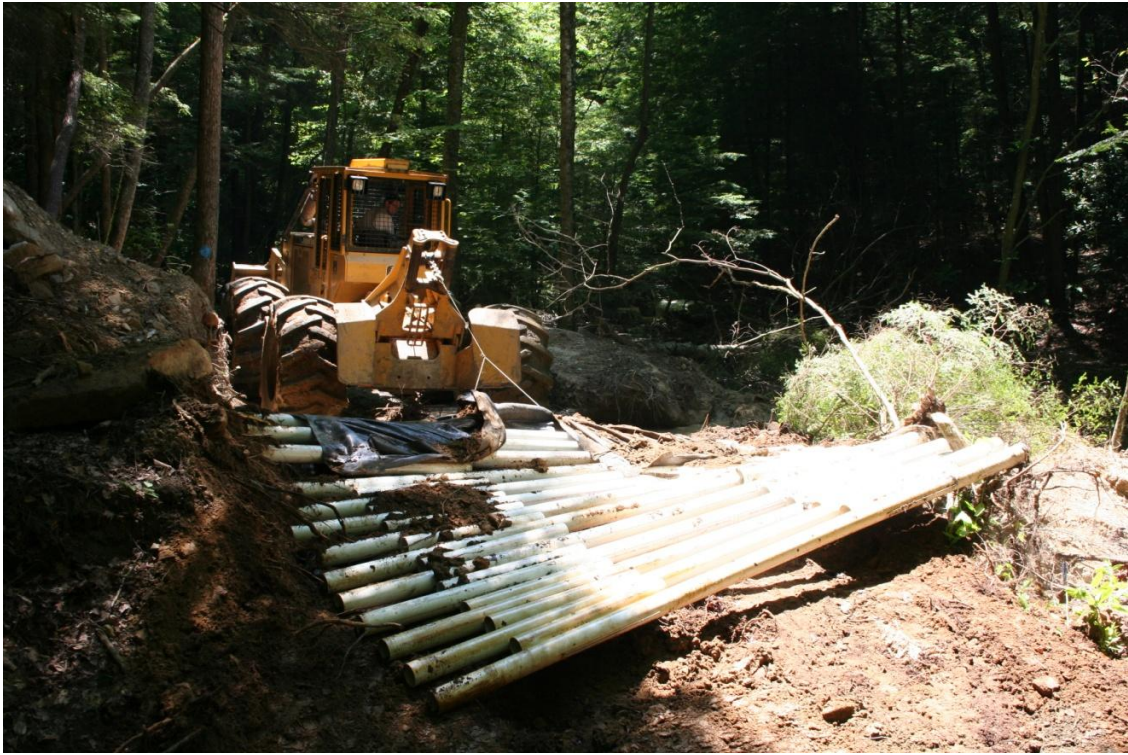
A.7. Pipe bundle after removal

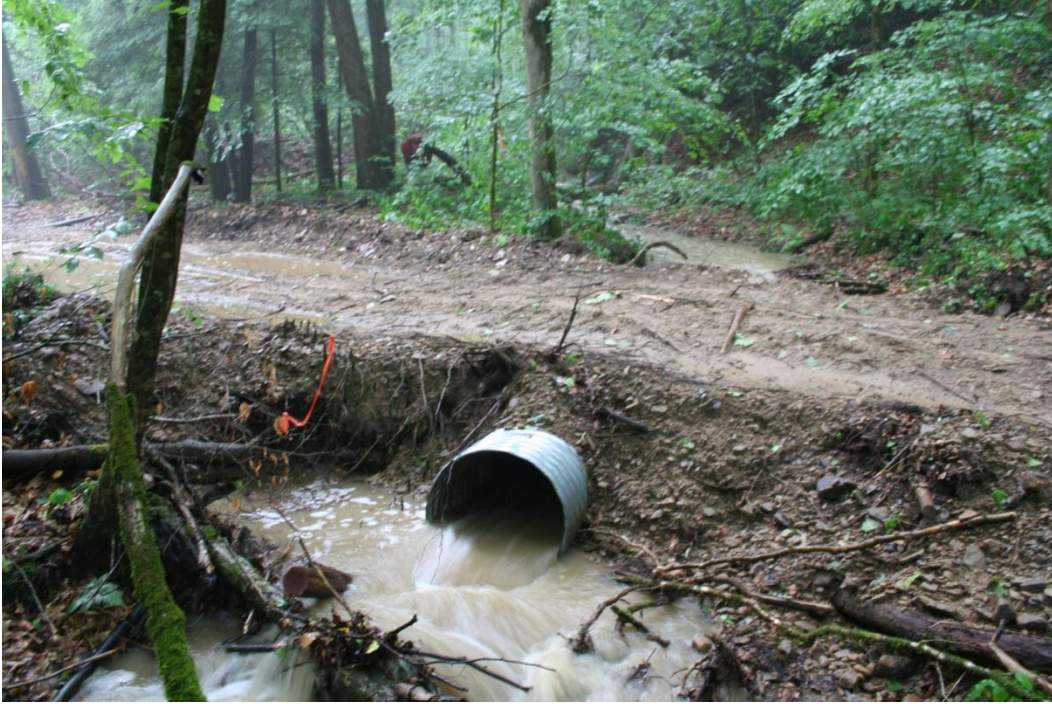
A.8. Culvert during storm event

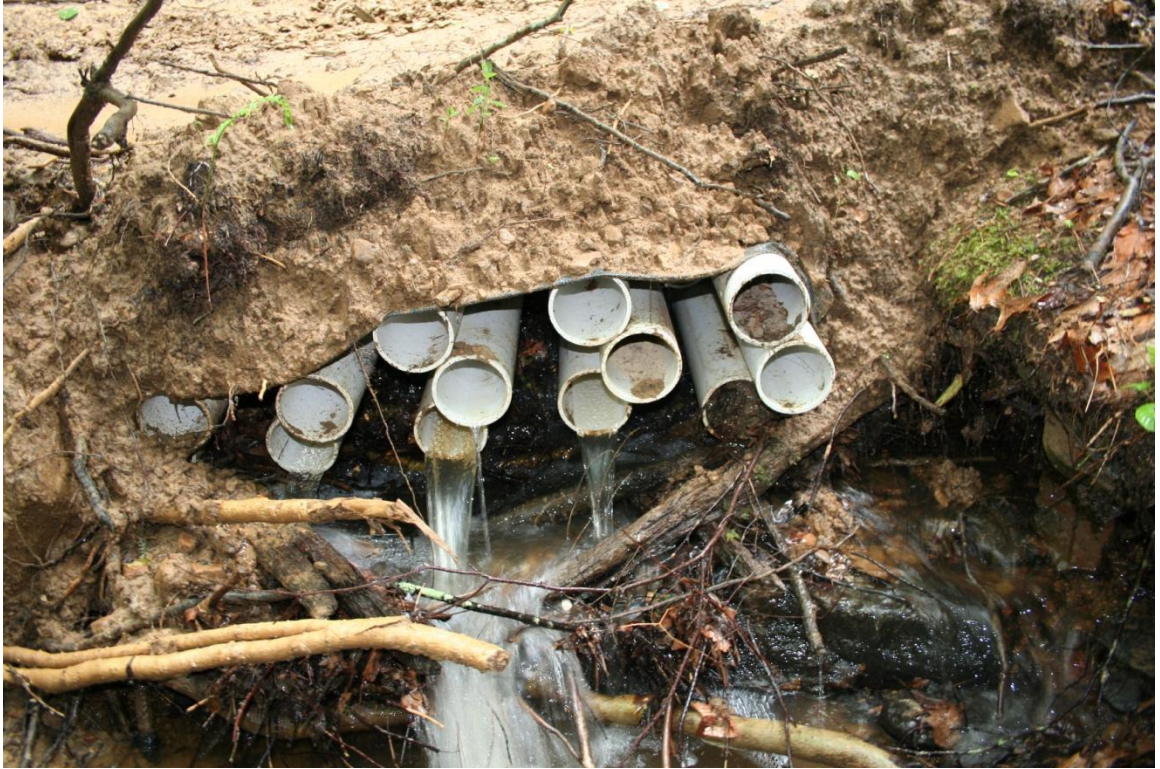
A.9. Pipe bundle during storm event

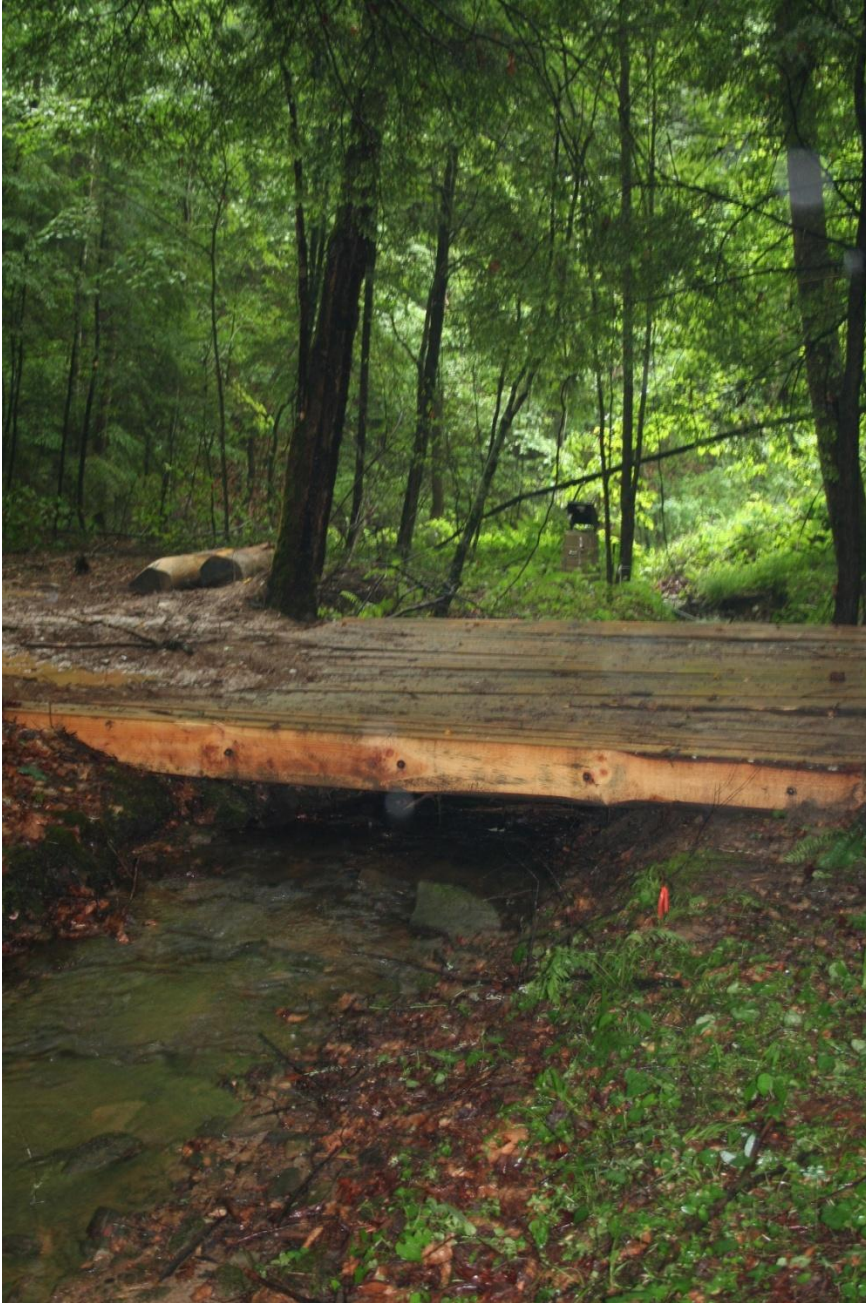
A.10. Bridge during storm event
