Research Report KTC-89-28

EARTHQUAKE HAZARD MITIGATION OF TRANSPORTATION FACILITIES FOR McCRACKEN COUNTY

June 1989

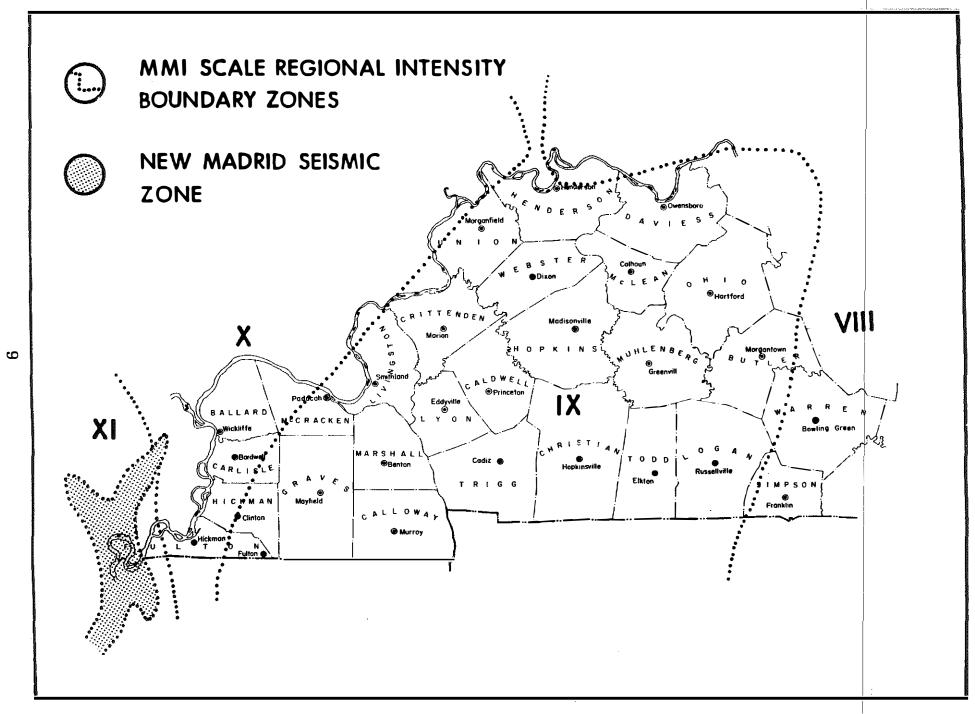
Figure 1: The twenty-six counties included in this study area.

Seismic Zone. Figure 1 indicates that McCracken County is located in the X and the IX bands of the MMI scale. This indicates considerable damage could occur in McCracken County in the event of a major earthquake.

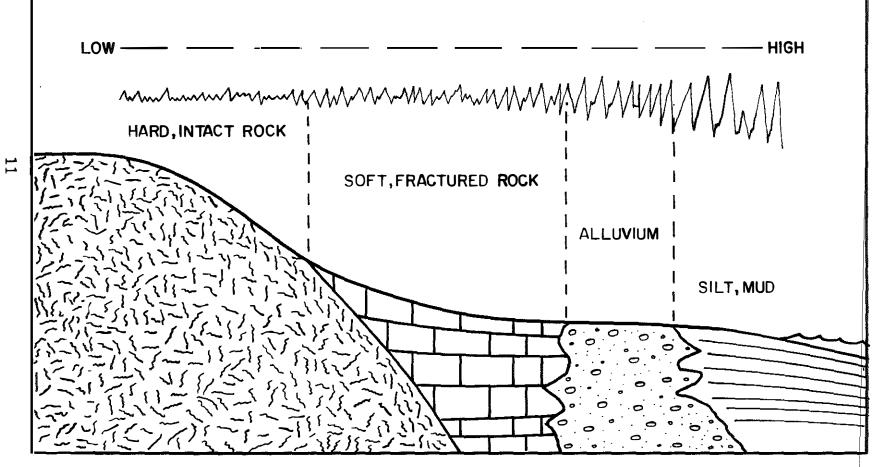
Figure 2: Amplification of shaking in softer rock 8 soil during an earthquake.

AMPLIFICATION OF SHAKING AND DAMAGE DUE TO SHAKING

Soil maps for McCracken County indicate that there are large amounts of alluvium present throughout the county. Alluvium is a loose, fine-grain soil which is deposited by flowing water such as creeks and rivers. Due to the nature of the alluvium, ground motions at the surface of the soil can be many times greater than those within the underlying bedrock and temporary liquefaction can occur (Figure 2). An alluvium map for McCracken County is shown in Figure 3.
