Research Report  
KTC-89-32

DEMONSTRATION PROJECT NO. 59  
THE USE OF FLY ASH IN HIGHWAY CONSTRUCTION

Fayette County, Kentucky

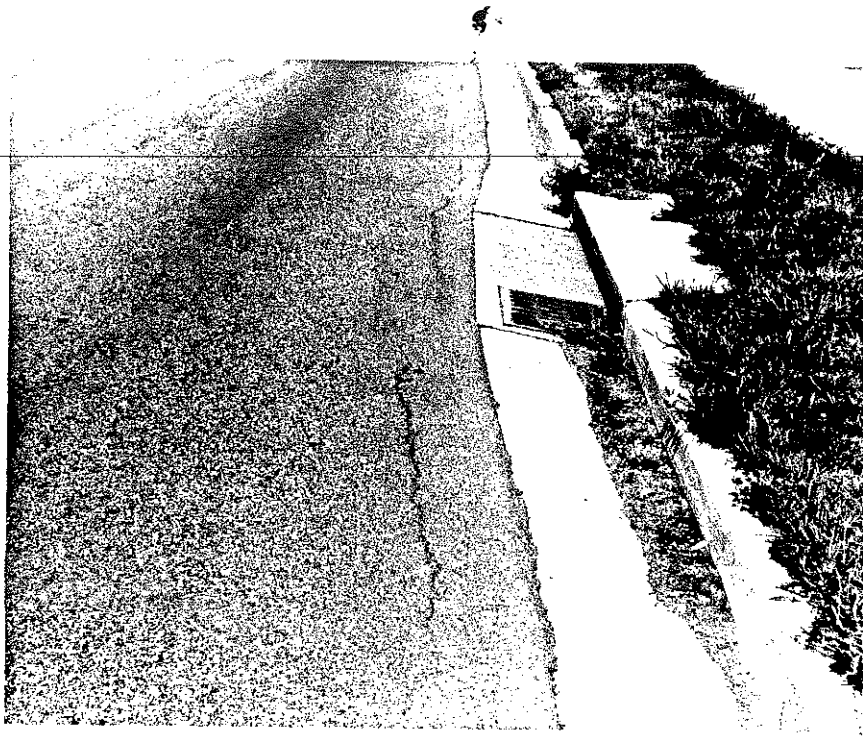
Figure 3. Shrinkage Cracking around Concrete Inlet Drain

Overall, the pavement was generally in good condition. The most notable distress observed was shrinkage cracks appearing around most curb inlet drains. From the survey data sheets in Appendix B, it may be noted that 49 drain inlets were charted, 11 of those being located in the section not receiving the stress relieving interlayer. There was a distinct cracking pattern of the asphaltic concrete around those drains that exhibited cracking. Relative to the percentage of drain inlets exhibiting cracking in the two distinct sections there was no difference. Approximately 63 % of the drain inlets exhibited various amounts of shrinkage cracking in both sections. Figures 3, 4, and 5 show this cracking pattern. Figure 3 illustrates how the concrete gutter of the curb inlet drain juts out into the paving lane. This design was observed to have contributed to problems relative to compaction of the experimental base material during construction. Field observations during the construction phase did not indicate any effort on the part of the contractor to rectify this situation (ie. use of a pneumatic tamping device). The drain in Figure 3 was located near Station 16+72. Note the fine debris that has built up in the outer area.

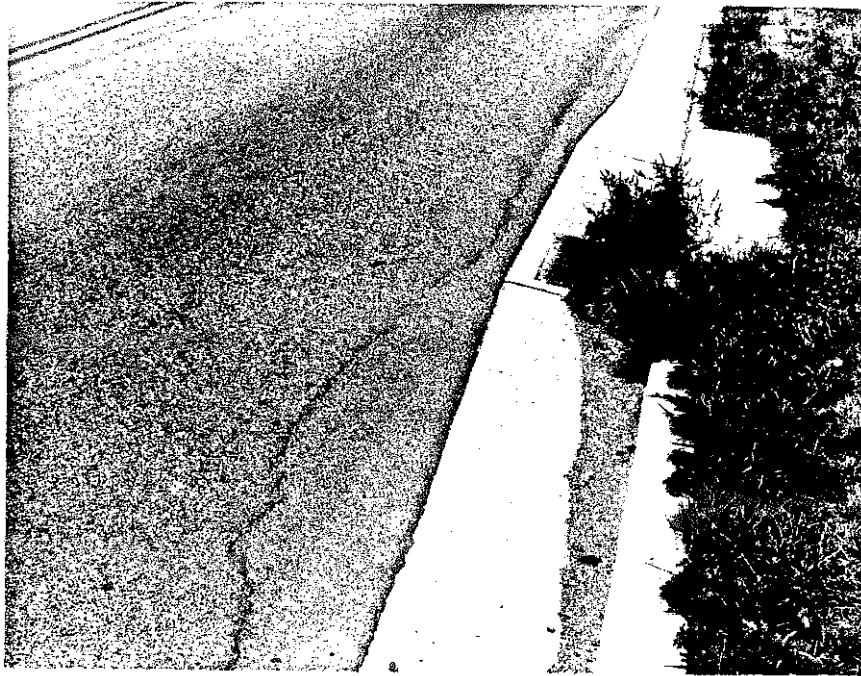
Figure 4. Shrinkage Cracking around Concrete Inlet Drain

Figure 4 shows the curb inlet drain near Station 17+88. Note the similarities of the cracking pattern when compared to Figure 3. Again, the geometry of the curb inlet drain apparently made compaction of the experimental base material difficult. Note the fine debris that has built up in the gutter area and the vegetation growing there. This obstruction in the gutter area will probably cause water to flow out onto the traffic lane. The water will most likely infiltrate the experimental base by seeping through the shrinkage cracks and the longitudinal joint at the curb gutter pavement interface. This may lead to an accelerated failure of the base material in the area of the drain inlet and result in failure of the asphaltic concrete layers. Data contained in the survey data sheets are supportive of this contention. The asphaltic concrete pavement adjacent to the concrete gutter drain located near Station 57+15 was exhibiting light alligator cracking, which is indicative of impending base failure, during the October 1987 visual survey.

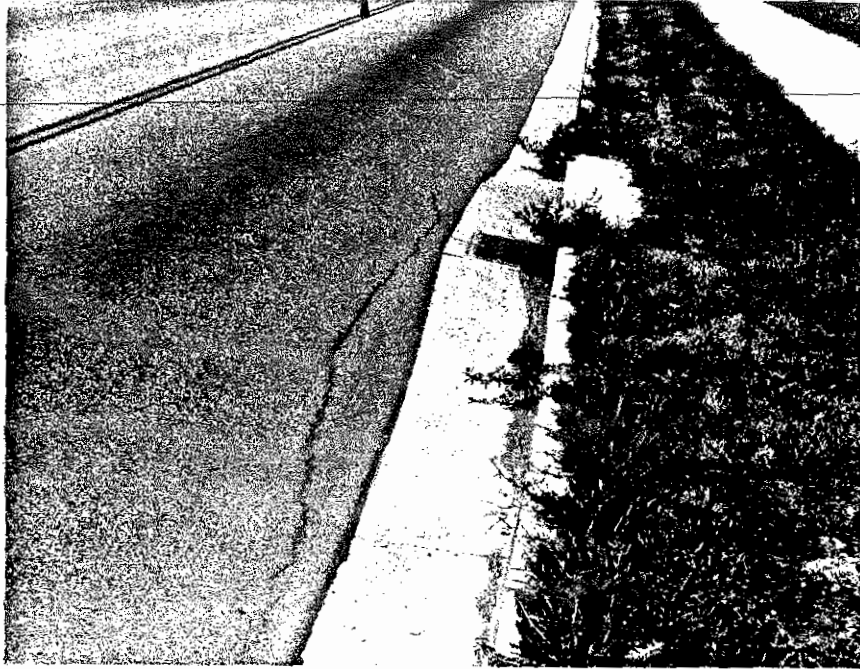
Figure 5. Shrinkage Cracking around Concrete Inlet Drain

Figure 5 shows the curb inlet drain located near Station 19+54. The similarities of the crack pattern and fine debris deposited in the gutter area are easily recognized. These figures are typical of those curb drain inlets exhibiting cracking. There were seven curb inlet drains in the section receiving the stress relief interlayer that exhibited this cracking pattern.

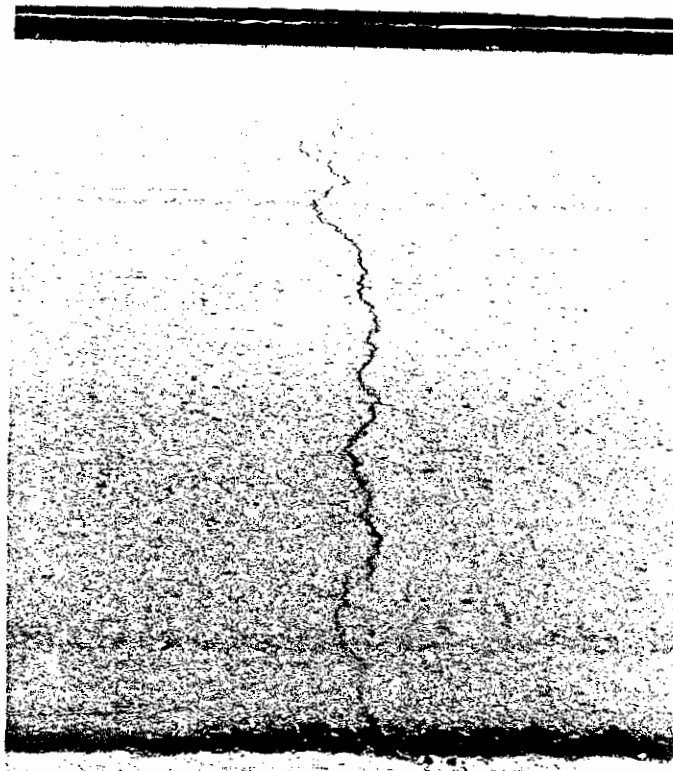
Figure 6. Transverse Reflective Cracking of Pozzolanic Base

Figure 6 is a photograph of a transverse crack located near Station 6+72 which is within a section receiving the interlayer. The crack extended from curb to curb, across both lanes and the two-way left turn lane. Another transverse crack extending from curb to curb is shown near Station 5+85 in the crack survey data sheets. Six additional transverse

cracks were located within the treated sections and were near Stations 10+38, 18+38, 19+48, 20+45, 22+03, and 60+47. These cracks were present in the eastbound travel lane only.
