# Design and Maintenance of Cisterns

AEU-43

## DESIGN AND MAINTENANCE OF CISTERNS

E. Holmes and J.L. Taraba

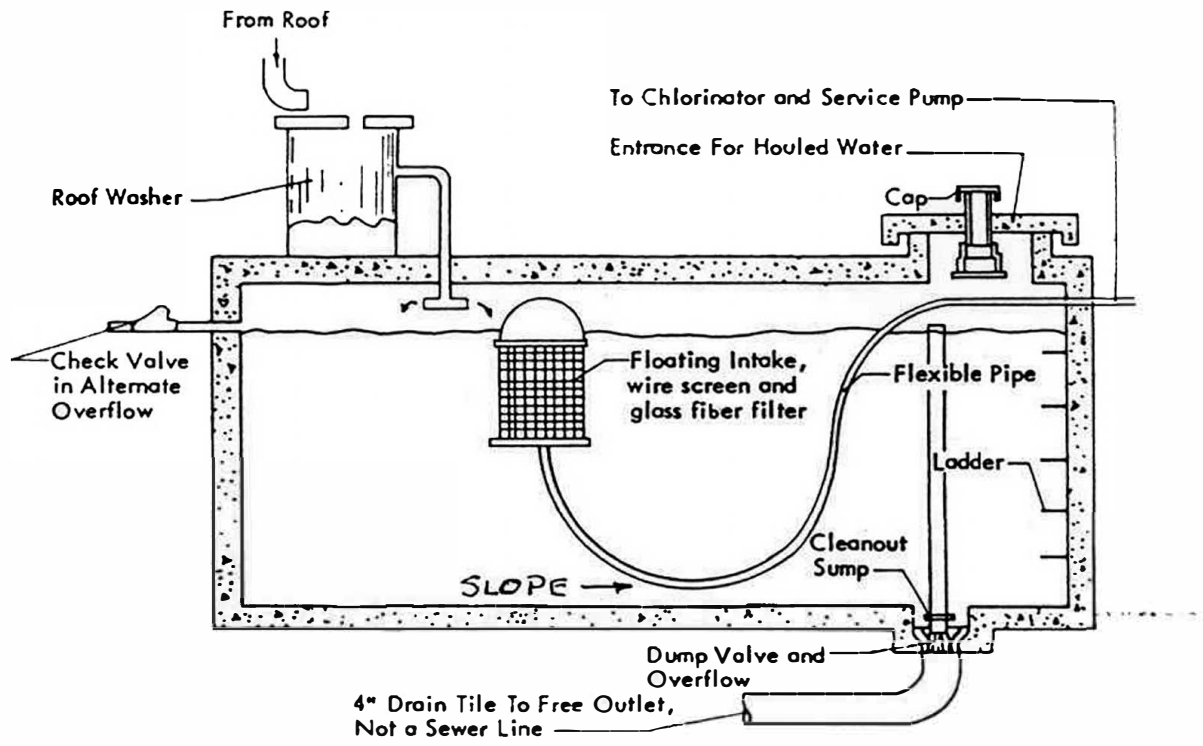
- I. Design concepts: (See Figure 1)
  1. Water tight inside and outside
  2. Manhole or other covers tight to prevent contamination with 2" raised curb
  3. Overflow with check valve
  4. Initial roof-off diverted from cistern as roof dirt is washed off
  5. Inlet pipe near the top with splash pan below or a force breaker at bottom so that floor settlements are not disturbed. No data on which is more effective.
  6. Cleanout outlet pipe to pump located in small sump area with floor sloping to sump.
  7. Placed below ground to prevent freezing
  8. Water pipe to hose from floating inlet or 4" off bottom
- II. Materials of construction
  1. Reinforced concrete
    - Select an approved cistern design of the size desired (described later)

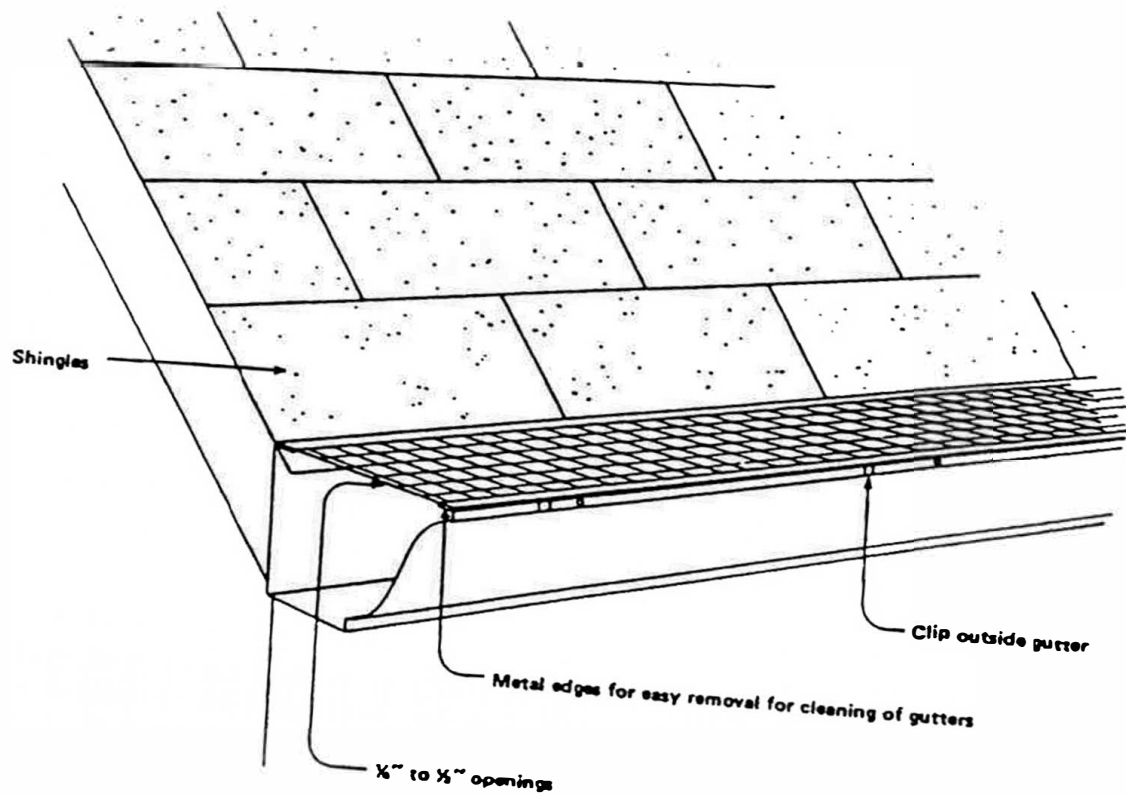
The typical family with smaller roof area will haul water when rainfall is not ample. A common mistake with roof guttering is to select gutter that is too small wasting much water during heavy rainfall. The gutter should be at least 5" and have a leaf screen over it (Figure 2). The strap gutter is more durable than the nail-spacer type. Gutter is available in galvanized metal, aluminum and plastic. Galvanized is the strongest to stand up under snow loading but will rust.

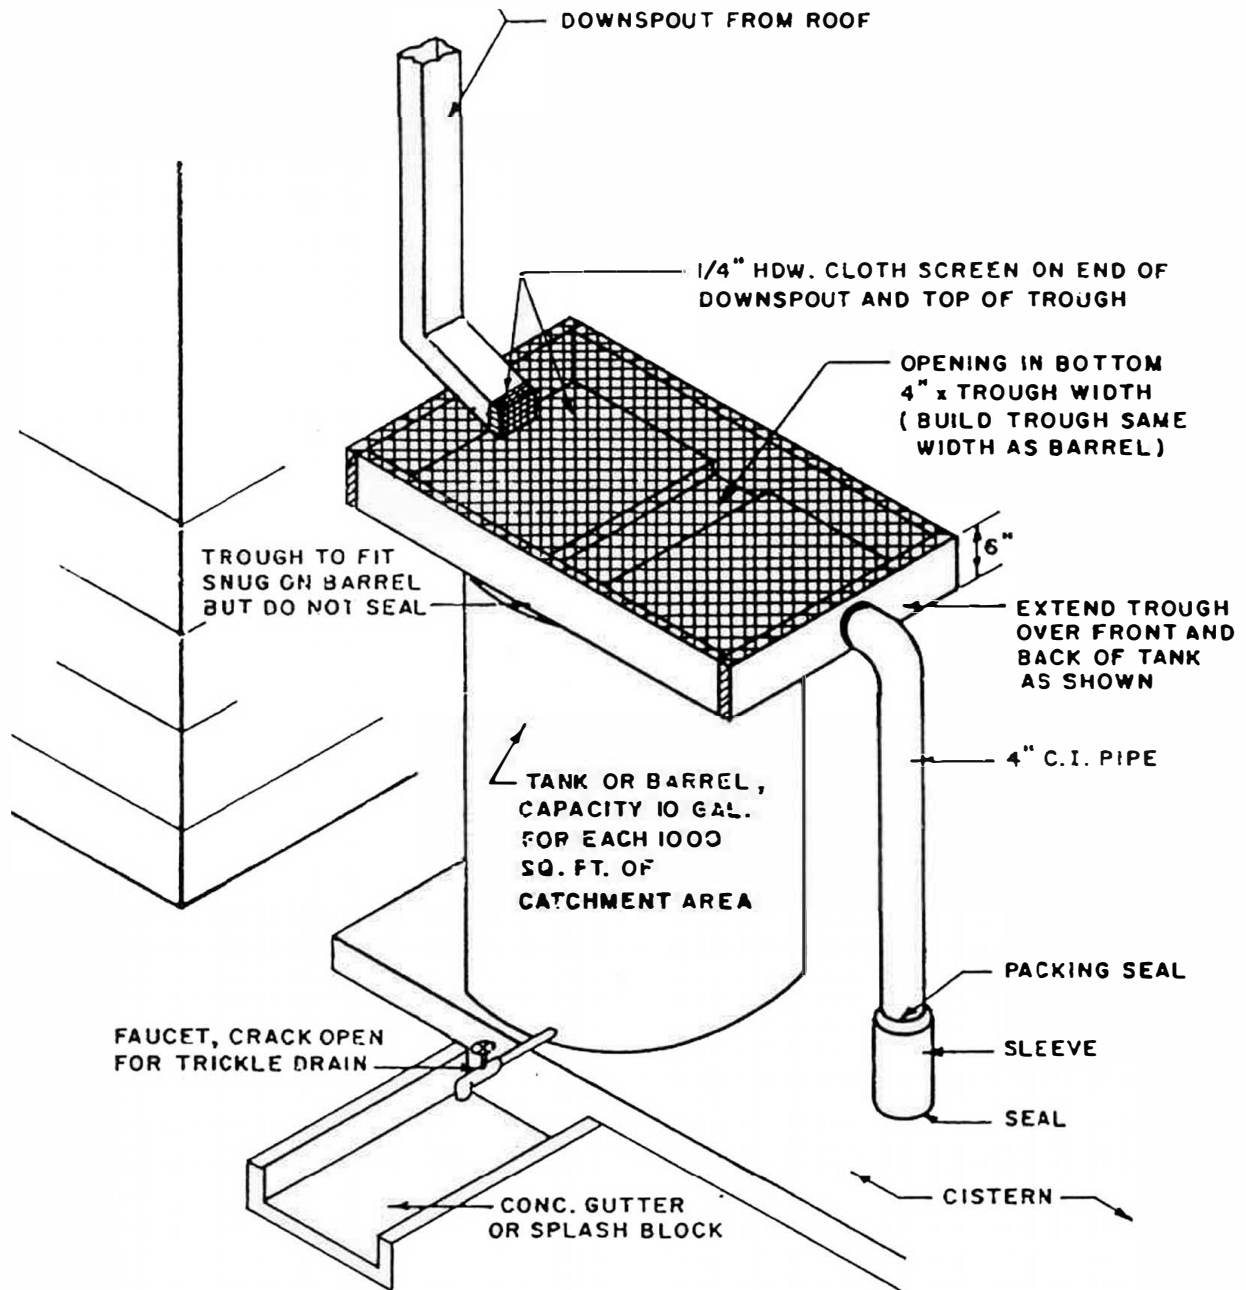
A prewash unit that eliminates the problems above is sized to 10 gal per 1000 FT<sup>2</sup> catchment and does not allow water into the cistern until the barrel is almost full. A bottom trickle drain prevents freezing (Figure 3). A sand filter (Figure 4) used with a prewasher will make for a much cleaner water. The sand filter must have at least 4 square feet of

The least cost prewash unit is a diverter valve left open to always flush off roof when a rain starts. The fault of this is its wastefulness. People may forget to close valve after the rain starts or they may be gone from home and lose the total rainfall.

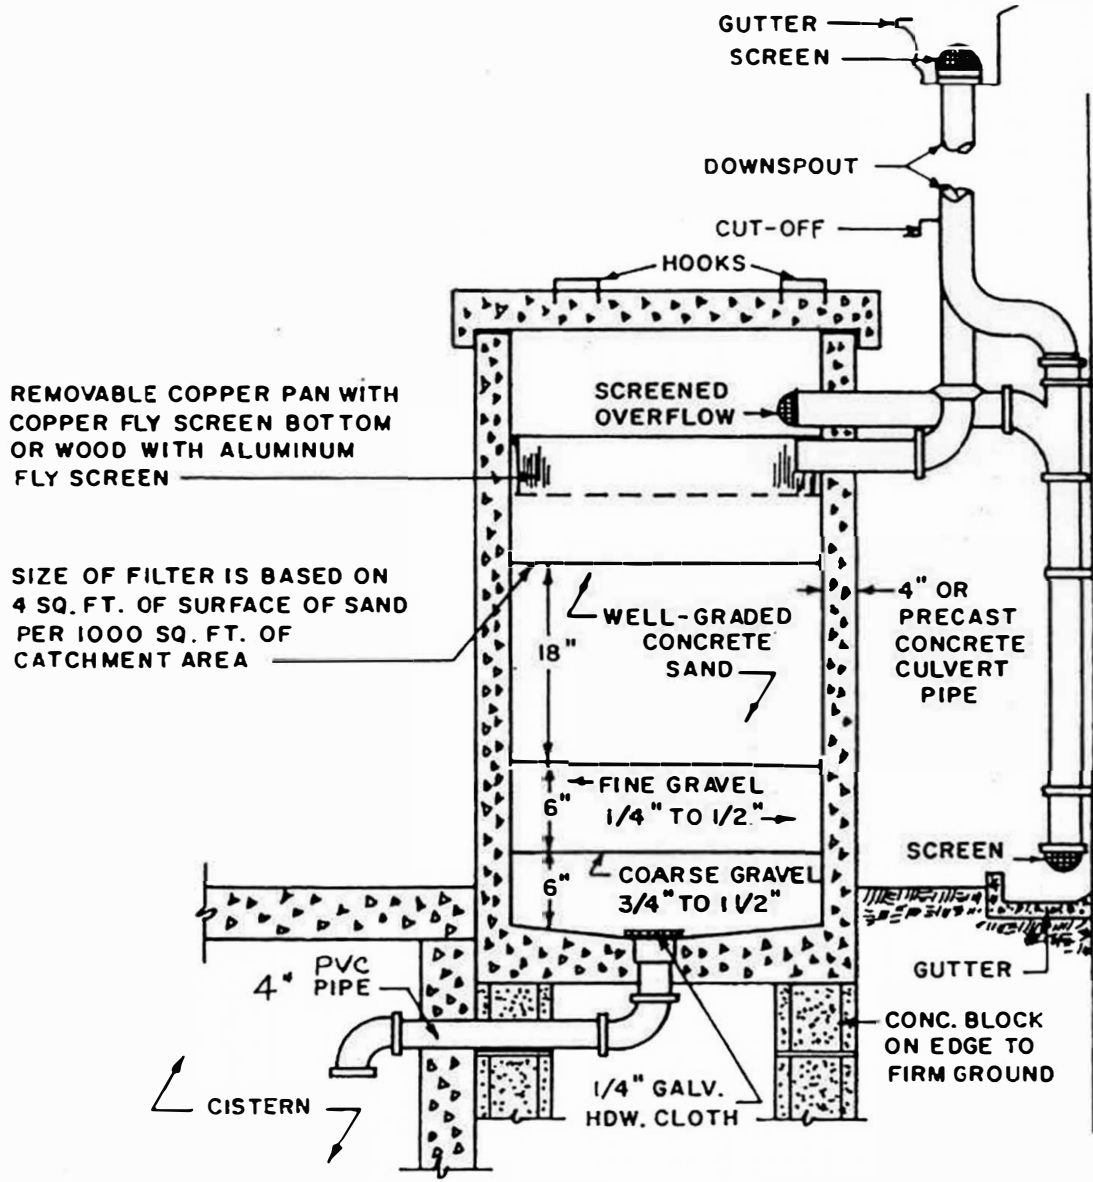
surface area per 1000 square feet of roof area to handle the rainfall. The sand filter also requires periodic maintenance by cleaning the surface and backwashing.
