Calendar Year 2007 Report to the Rio Grande Compact Commission

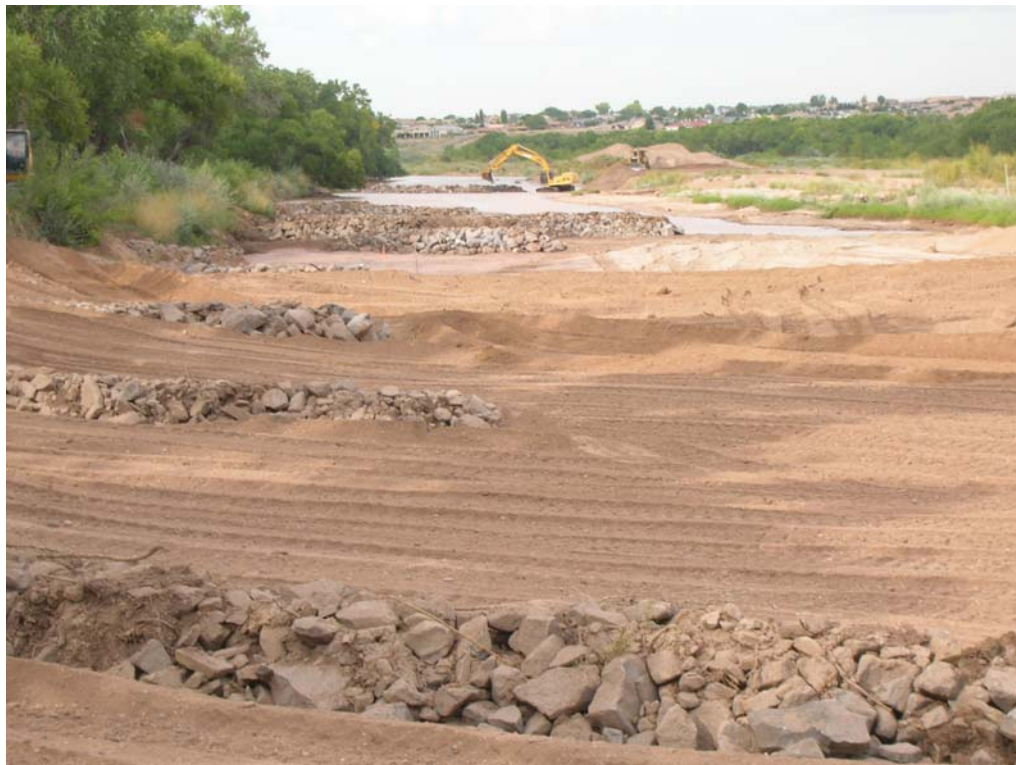
Cover photo – Installation of Bendway Weirs to prevent bank erosion at the Sandia priority site.

Photo 8. Installation of bendway weirs at the Sandia priority site (September 2007).

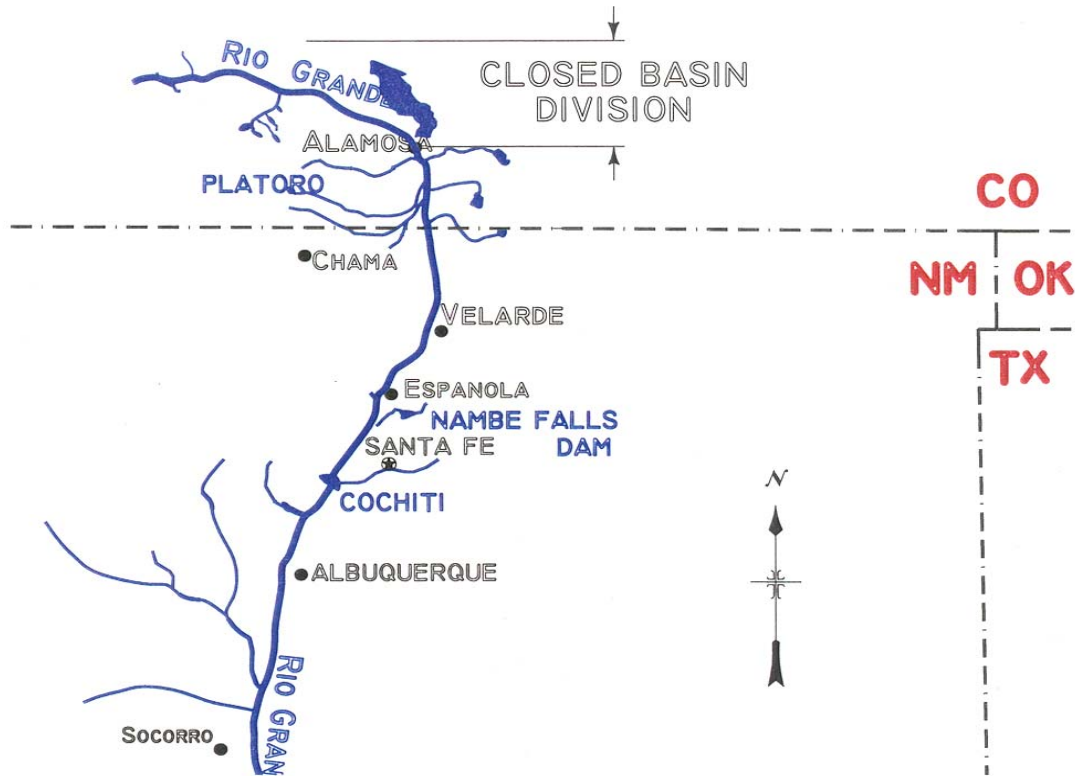
Figure 2: Area Map of San Luis Valley Project

The Alamosa Field Division of the Albuquerque Area Office operates and oversees the maintenance of a water salvage project constructed in the Closed Basin area of the San Luis Valley, Colorado (Figure 2). The purpose of the project is to salvage unconfined ground water from the Closed Basin that would otherwise be lost to evaporation and transpiration. The salvaged water is pumped from 170 salvage wells and delivered through a conveyance channel to the Rio Grande to assist Colorado in meeting its commitment under the Rio Grande Compact. The project also provides for the delivery of mitigation water to the Alamosa National Wildlife Refuge and Blanca Wildlife Habitat Area, and stabilization of San Luis Lake. Reclamation

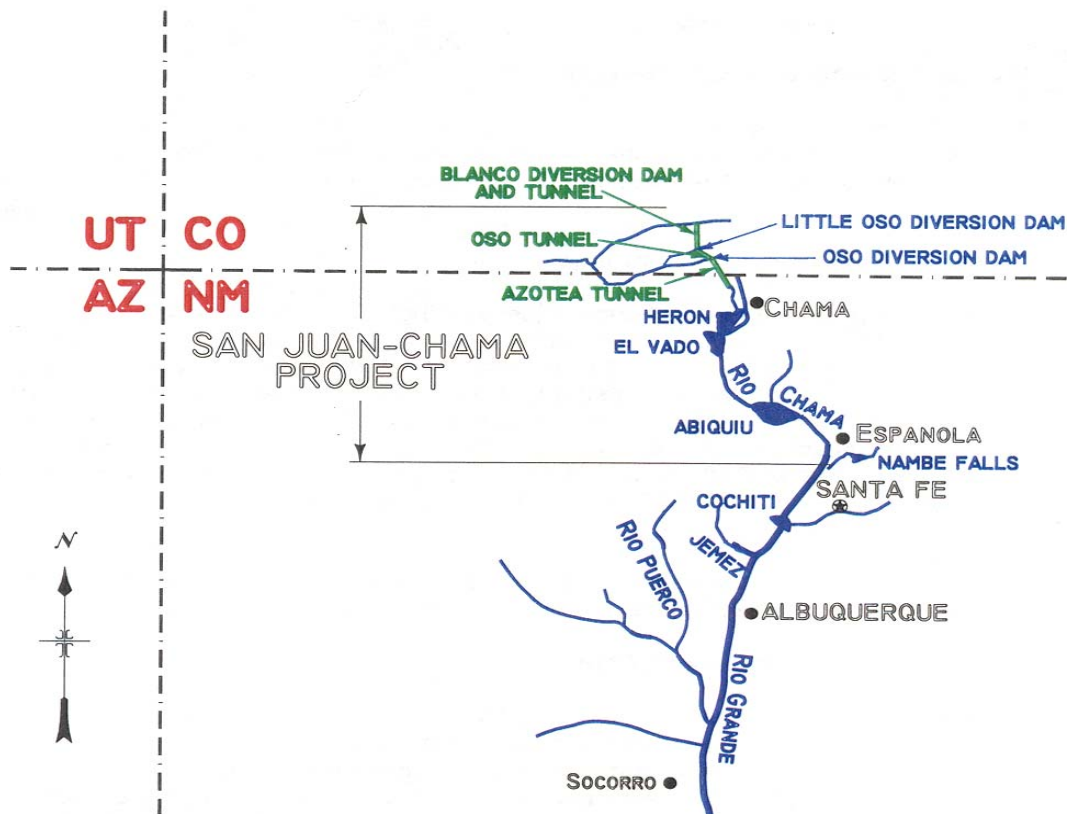
Figure 3: Area Map of the San Juan-Chama Project

Reclamation's Albuquerque Area Office Water Management Division continued to maintain its internet web page for Middle Rio Grande Water Operations during 2007. This web site provides the current year's monthly data for the operation and water accounting of the San Juan-Chama Project. To reach the internet web page, type <http://www.usbr.gov/uc/albuq/water/> into a web browser. An area map of the San Juan-Chama Project is provided in Figure 3.

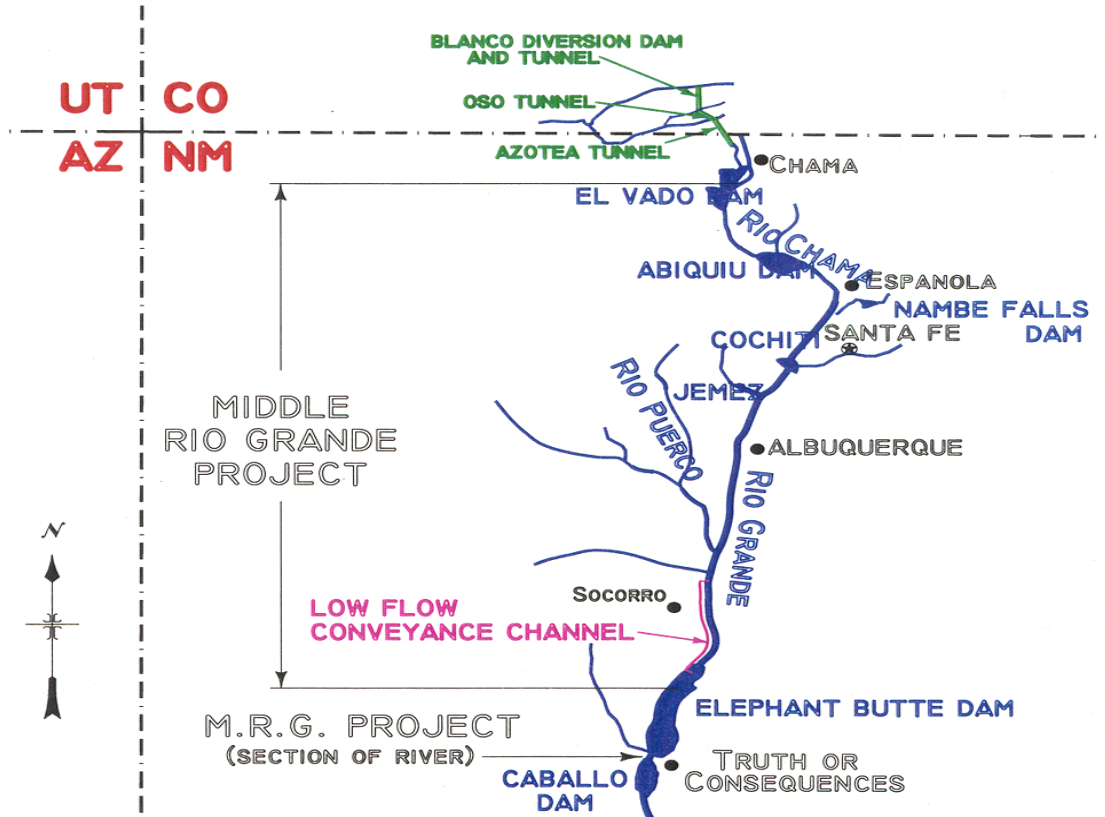
Figure 4: Area Map of the Middle Rio Grande Project

The *Middle Rio Grande Project* (Figure 4) consists of El Vado Dam and Reservoir and irrigation and drainage facilities in the Middle Rio Grande valley. The project also includes river channel maintenance from Velarde, New Mexico, southward to Caballo Reservoir, and the Low Flow Conveyance Channel (LFCC) south of San Acacia, New Mexico. Irrigation water is provided to the Middle Rio Grande Conservancy District, which can supply water to approximately 50,000 to 70,000 acres of land.

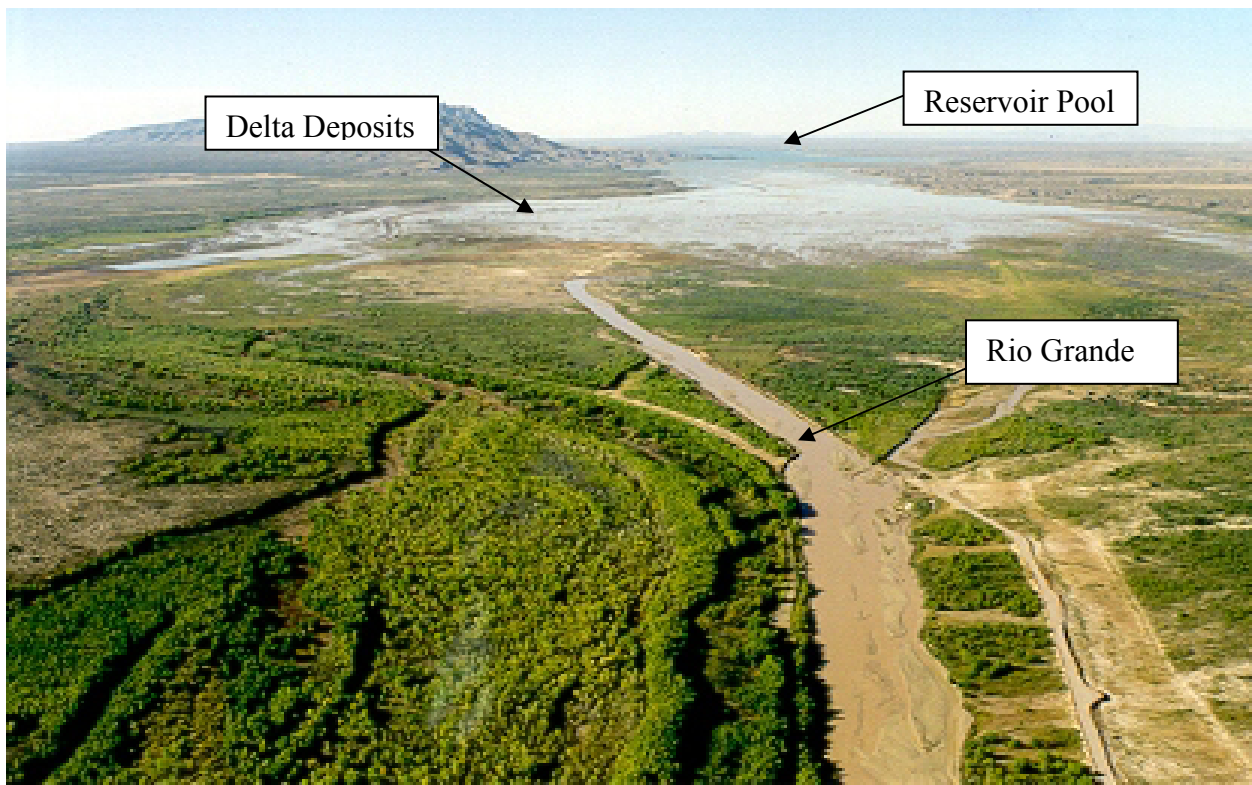
River disconnection has been an issue at the headwaters of Elephant Butte Reservoir since the early 1950s. The contributing factors for the occurrence of disconnection are many: the valley slope is very slight, the incoming sediment load is high, the clay deposits are highly cohesive, and vegetation growth is extremely aggressive. During drought periods when the reservoir pool decreases rapidly, all of these factors make it difficult for the river channel to maintain a connection with the reservoir pool (photo 1). The latest incidence of disconnection began in the

Photo 1. Headwaters of Elephant Butte Reservoir, prior to construction of the Temporary Channel (1998).

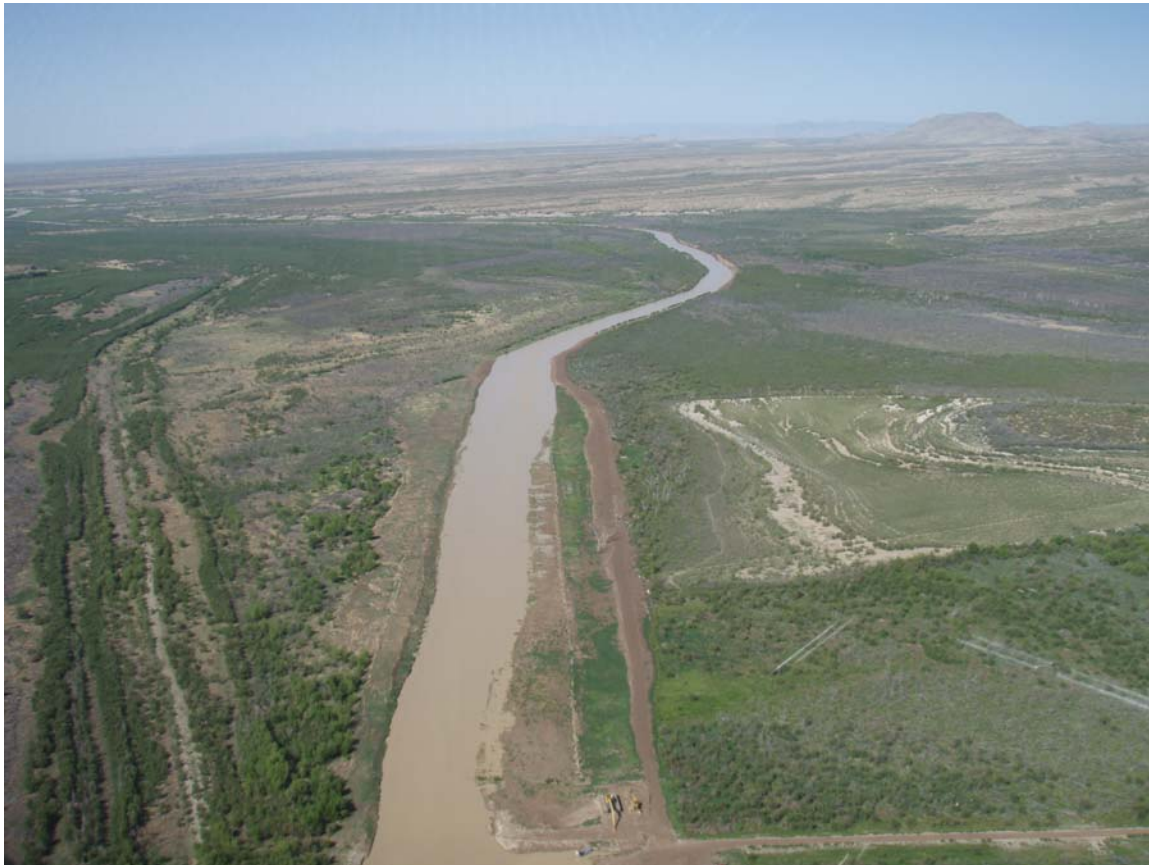
Photo 2. Temporary Channel 2000 to 2002 transition. Taken near RM 52, facing downstream (May 2007).

General maintenance work was performed on the channel in the spring of 2007, as was substantial repair work and routine grading on access roads. Unusually severe monsoon rains in August and September of 2006 caused a significant amount of damage to the roads. Channel maintenance work focused primarily on removal of sediment and debris that had accumulated in the channel, and some minor repair work was performed on the constructed berms adjacent to the

channel. Maintenance was accomplished jointly by Reclamation and NMISC, with the upper approximately 10 miles maintained by Reclamation's Socorro Field Division crews (utilizing Agreement funds), and the lower 16 miles maintained by a contractor for NMISC (photo 2). A similar division of maintenance responsibilities is planned for 2008.

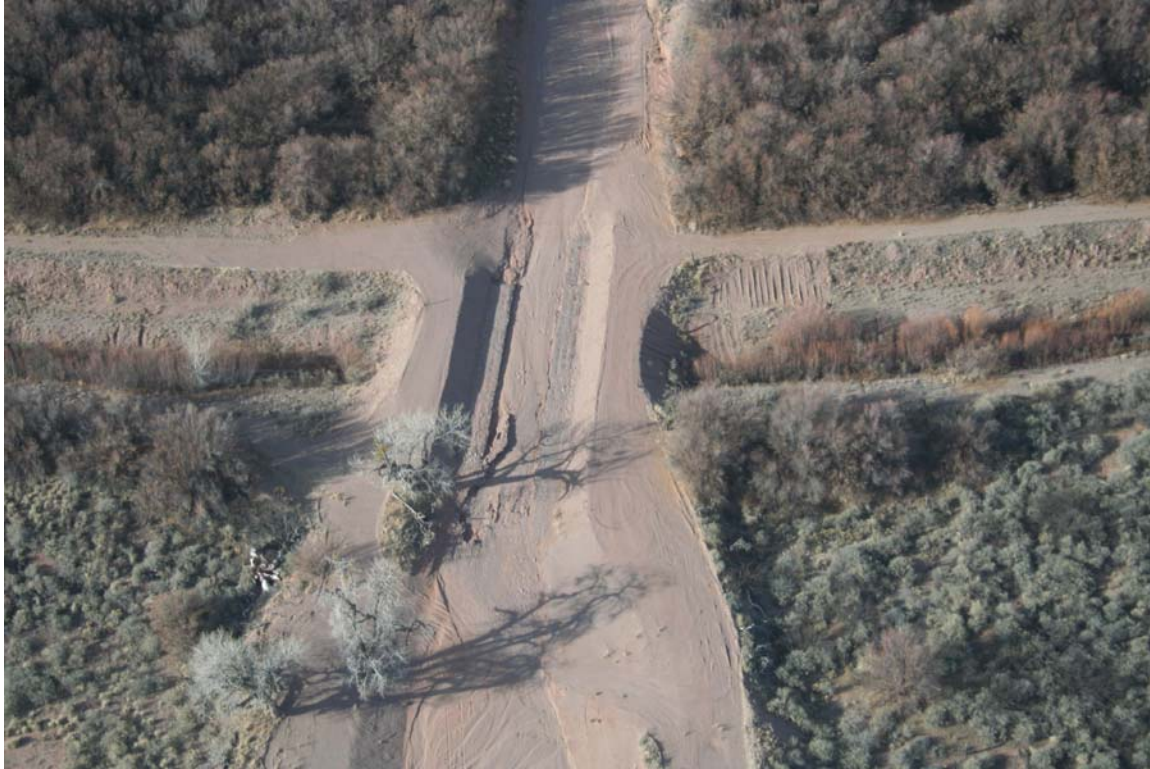
Photo 3. Completed Phase I work on Escondida Drain at Arroyo de los Pinos. Taken facing east (January 2008).

- Escondida Drain: Phase I improvements were completed in August and involved construction of rock gabions and earthwork at Arroyo de los Pinos to ensure that arroyo flows do not damage the drain (photo 3). Phase II work provides for removal of vegetation from the drain and reshaping of the drain prism from Arroyo de los Pinos to the outfall to the river. Phase II work is anticipated to begin in June 2008. These improvements are funded on a cost share basis by NMISC and Reclamation.

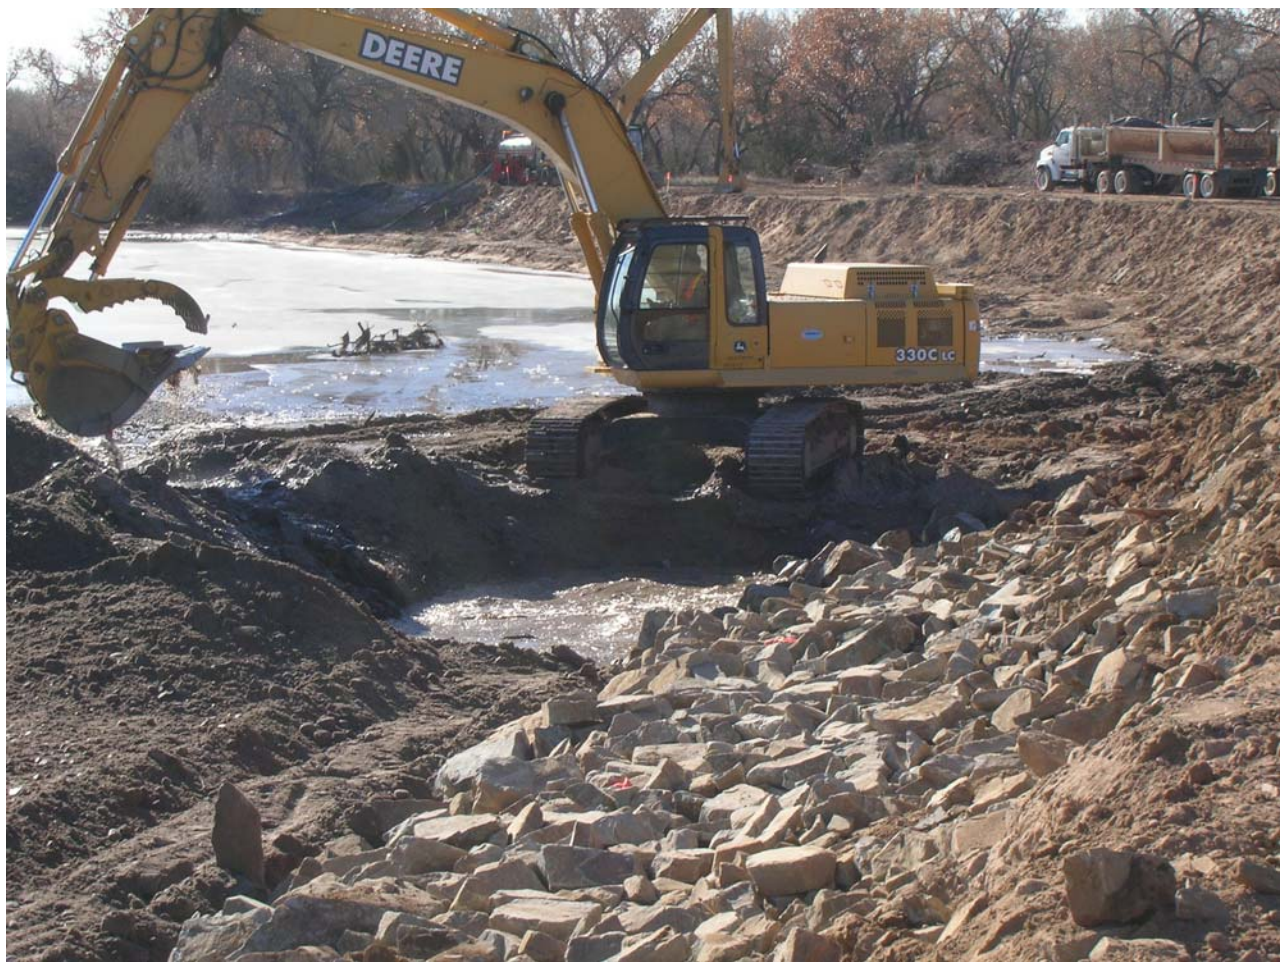
Photo 5. Installation of a riprap toe on the bankline at River Mile 231.3 (January 2008).

There are two priority sites on the Pueblo of Cochiti: one (at RM 231.3) is on the west side of the Rio Grande about 1 mile downstream of Cochiti Dam, and the other (at RM 228.9) is on the east side, about 3 miles downstream of the dam. At RM 231.3, the west bank of the channel has migrated beyond the jetty jack line and is very close to a road and some agricultural fields. At RM 228.9, the main channel is on the west side of a large island, and the secondary channel is on the east side. The secondary channel carries water year-round. The concern at this site is that the secondary channel is slowly, but steadily, migrating eastward toward the levee and riverside drain. Construction began on both sites in late 2007 and is currently underway (photo 5), with expected completion in spring 2008. Depending on the date of earthwork completion, it is possible that revegetation will be delayed until the winter of 2008–2009 to ensure that planting occurs during the dormant period.

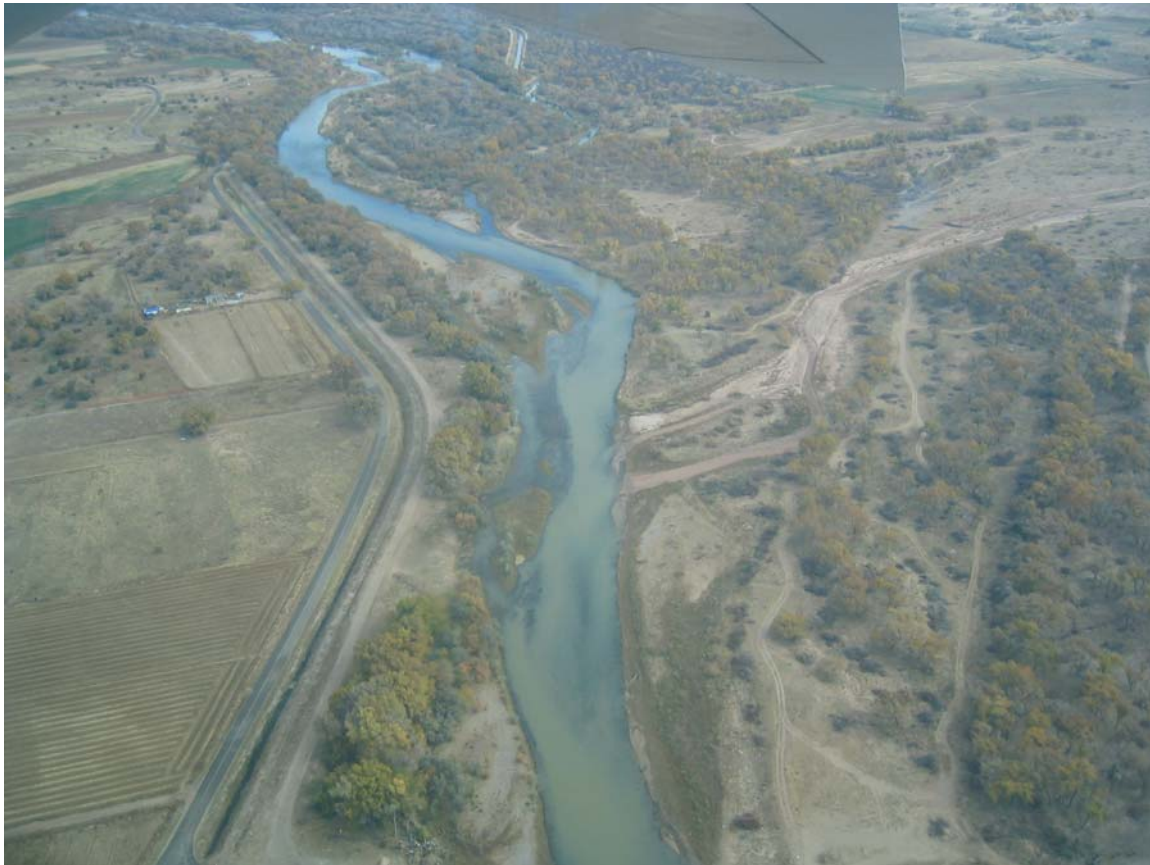
Photo 6. Santo Domingo priority site No. 2, at the confluence of Galisteo Creek. Taken facing upstream (October 2006).

There are currently three priority sites on the reach of the Rio Grande passing through the Pueblo of Santo Domingo. At these three sites, bankline erosion on the west side of the river is cause for concern because of the close proximity to the levee and riverside drain (photo 6). A Data Collection and Confidentiality Agreement was executed between the Santo Domingo Tribe and Reclamation in August 2007 to allow collection of design data for the three priority sites. Hydrographic data collection was completed in December 2007, and collection of the remaining design data and preparation of preliminary designs is anticipated in early 2008.

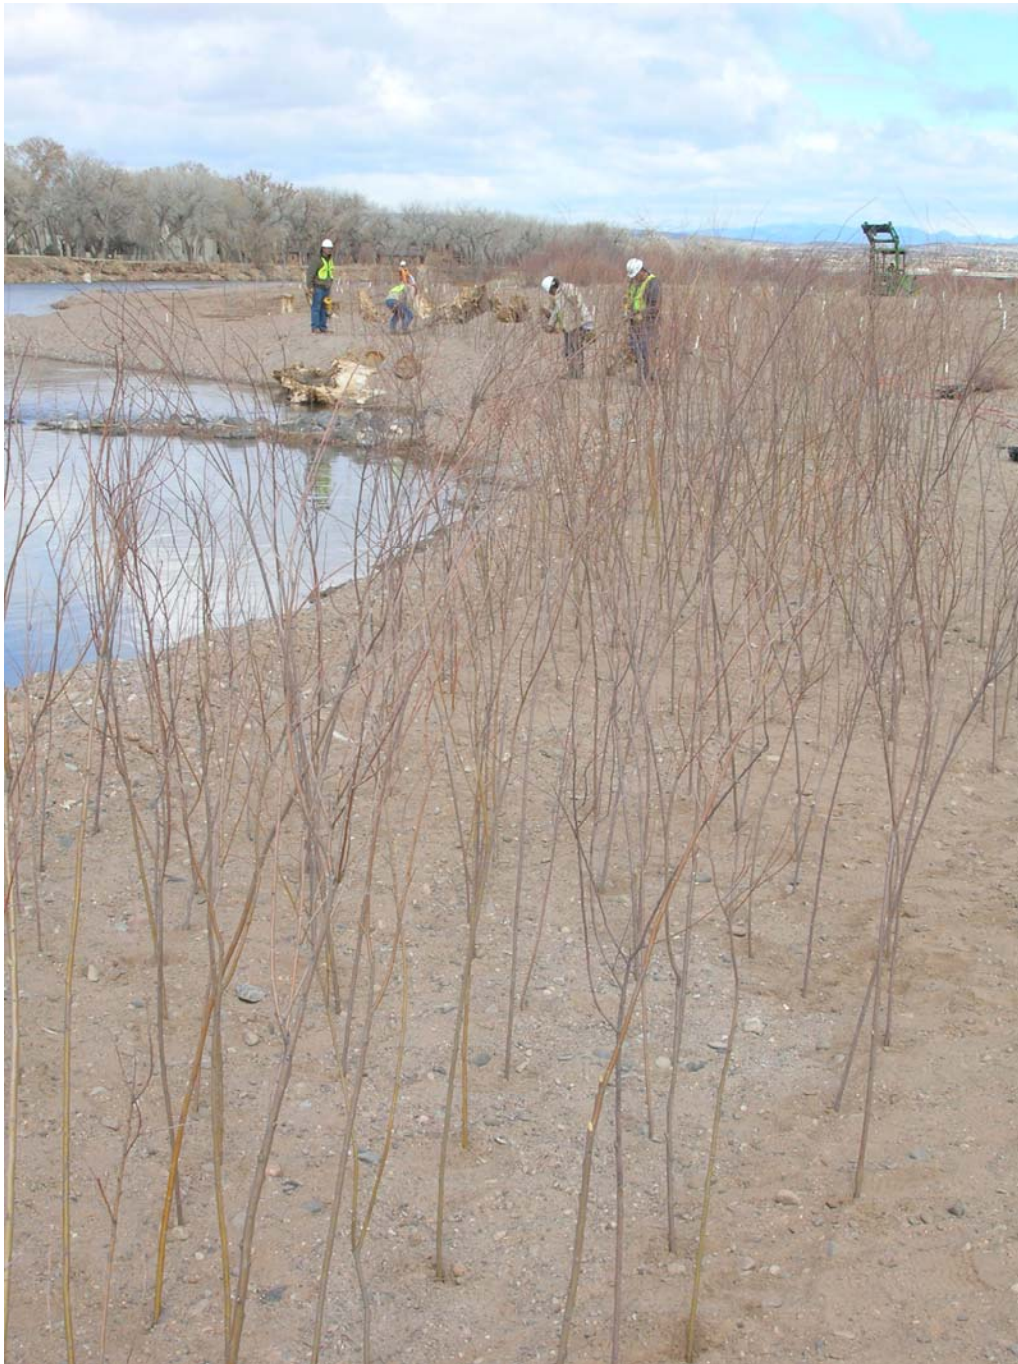
Photo 7. Installation of native vegetation at the Bernalillo priority site (February 2007).

Work at the Bernalillo priority site began in August 2006 and concluded in December. The concern at this site was that a sharp bend had developed, causing the flow of water to be directed toward the levee in an area where the bankline was only about 50 to 70 feet from the toe of the levee. To address river maintenance issues, the main channel was moved westward, a secondary channel was excavated, and bendway weirs were installed in late 2007. Planting of native trees and shrubs for increased erosion resistance and habitat improvement occurred in early 2007 (photo 7). Work at this site is complete, except for reseeding disturbed areas.

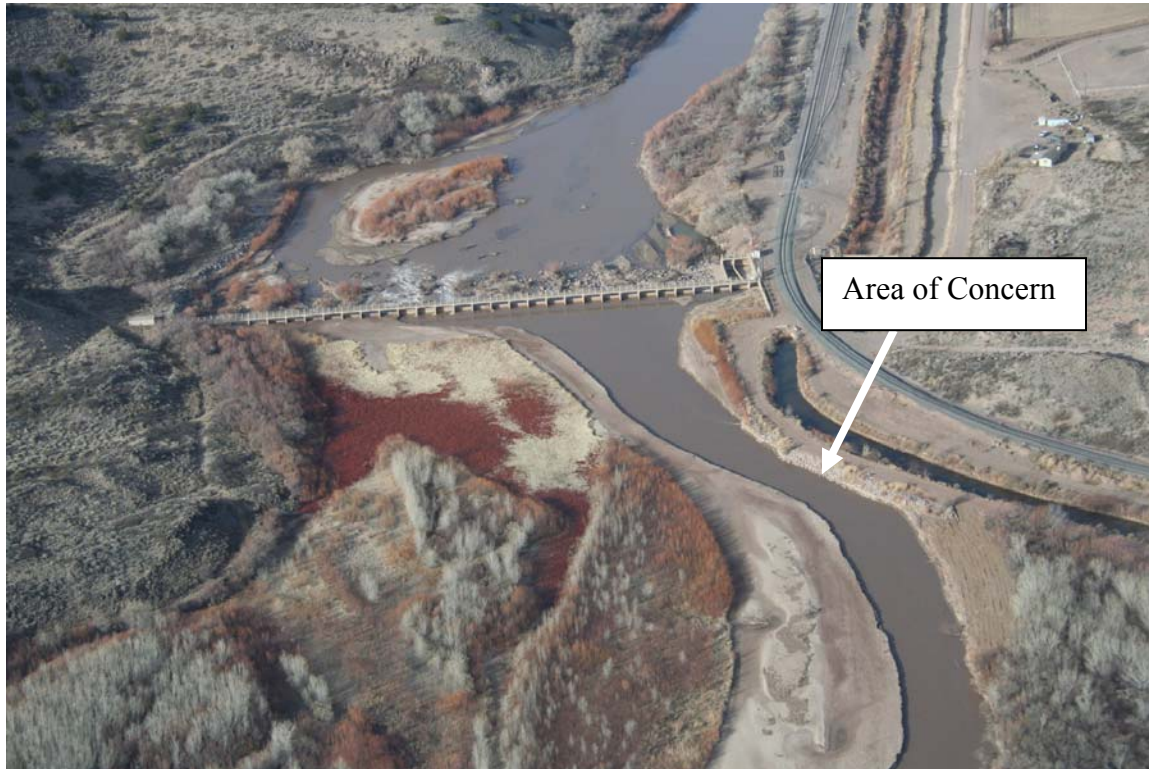
Photo 9. Drain Unit 7 priority site, looking downstream (January 2008).

This priority site is located approximately 500 feet upstream of San Acacia Dam, on the west bank of the Rio Grande (photo 9). The river is actively eroding an embankment levee that protects the Drain Unit 7 Extension irrigation structure. Pre-emergency action maintenance work was performed in May, 2005 to stabilize the eroding bankline. Approximately 900 cubic yards of riprap was placed along 200 feet of bankline at that time, but some of the riprap was displaced during the high flows of the 2006 monsoon season, and an additional 100 cubic yards of riprap was added prior to the 2007 spring runoff. A preferred alternative for a project was selected in 2007, and preliminary designs were completed for that alternative. It is anticipated that work will begin in November 2008.

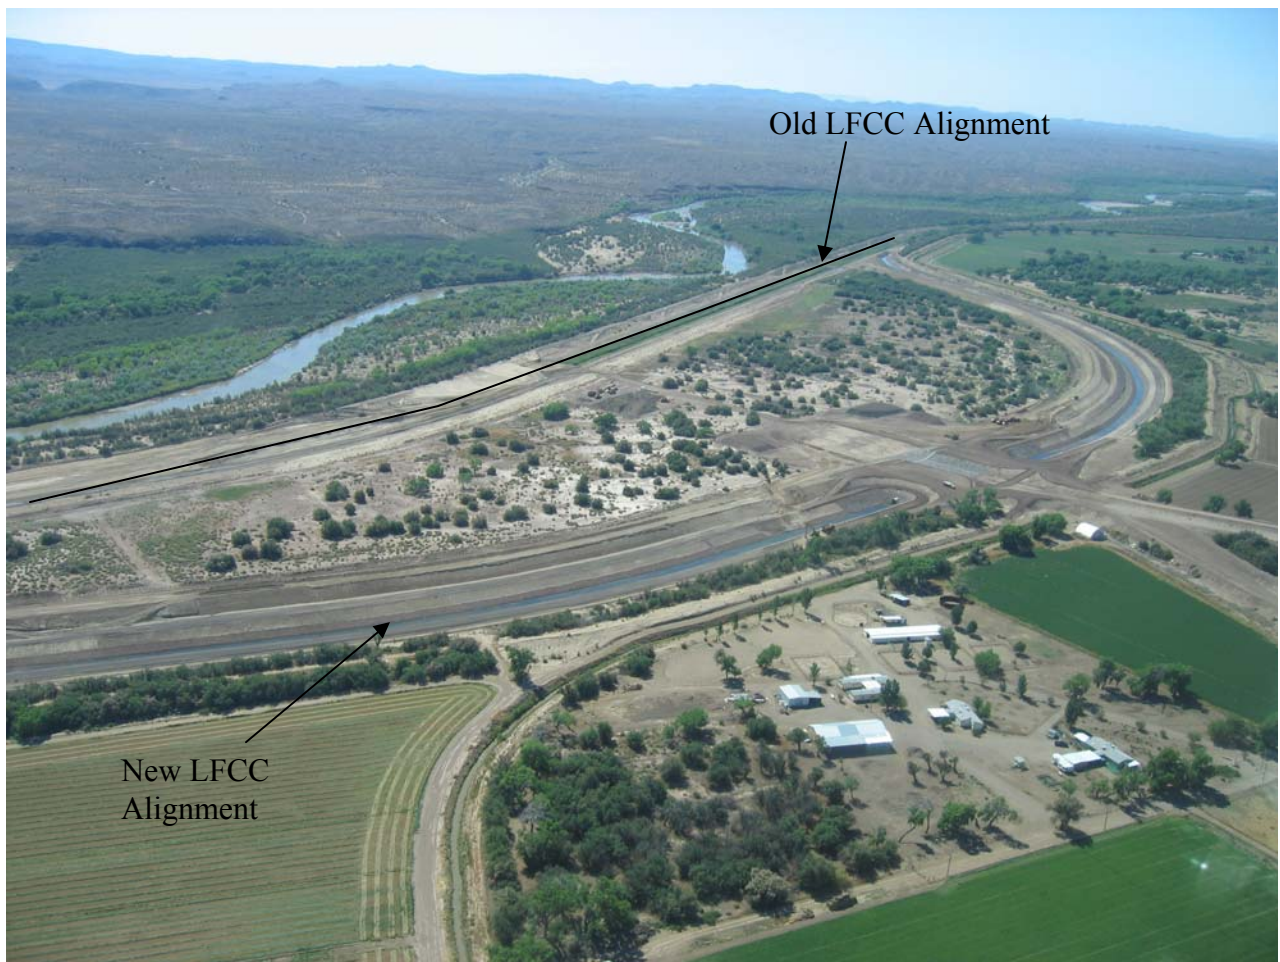
Photo 10. Looking downstream at the new LFCC in the area of River Mile 113/114 Priority Site (May 2006)

Reclamation has completed earthwork at the River Mile 114 and 113 priority sites, approximately 2 miles downstream of San Acacia Diversion Dam. Channel incision, lateral channel migration, and bank erosion previously threatened the integrity of the levee system in this area. This project involved moving the levee and LFCC approximately 1,500 feet to the west, away from the river (photo 10).

Major items of work included clearing and grubbing vegetation, excavating a new LFCC channel (approximately 10,800 feet), constructing a spoil levee (lined with waste rock salvaged from the old LFCC) adjacent to new LFCC channel, constructing a sheetpile grade control structure and a pipe crossing at San Lorenzo Arroyo, filing the existing LFCC channel, creating new potential floodplain between the new levee position and the channel, and planting cottonwood poles and other native species within the project area. The only remaining work is seeding and weed control.

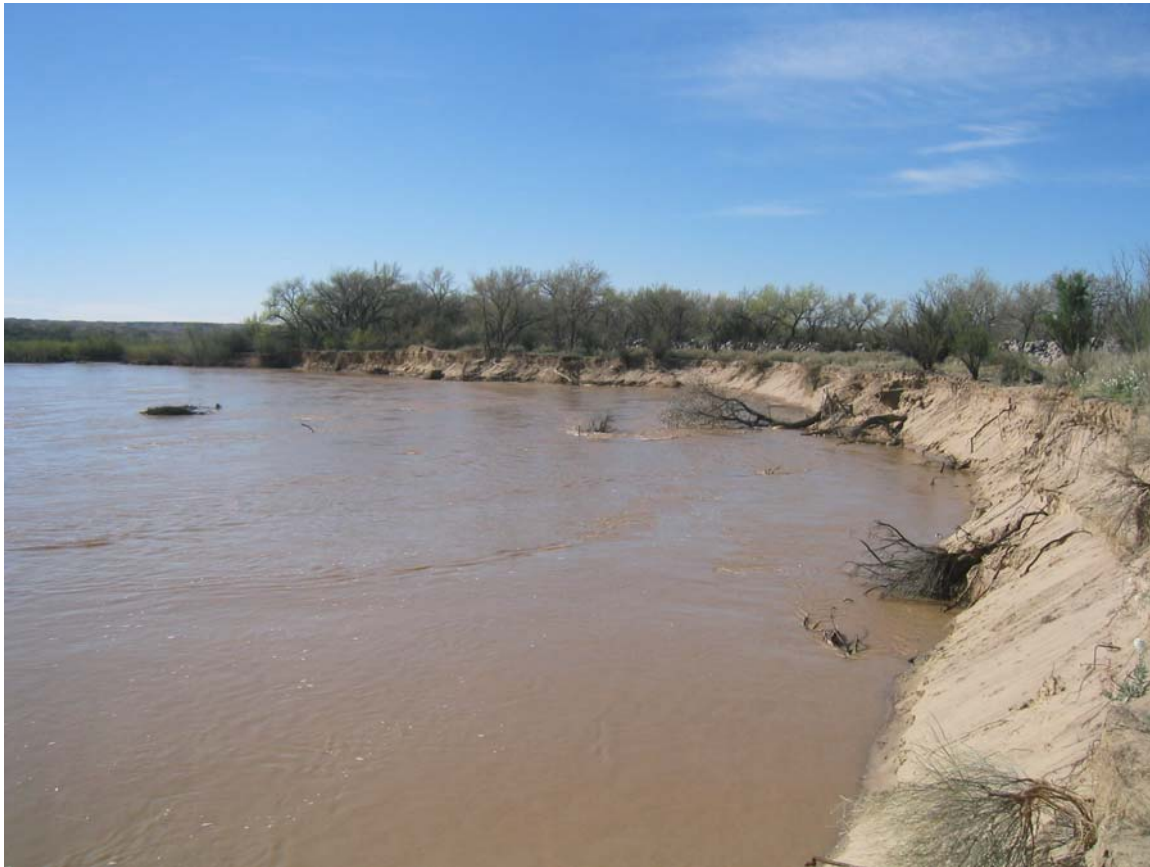
Photo 11. Looking downstream at the River Mile 111 bend (April 2007).

The San Acacia River Mile 111 priority site is located on the west side of the Rio Grande, approximately 5.5 miles downstream of the San Acacia Diversion Dam. The priority site is located at an actively migrating bend in the river (photo 11). The concern at this site is river channel migration and bank erosion towards the levee which protects the Low Flow Conveyance Channel (LFCC). The distance between the active channel bankline and the levee has been decreasing rapidly with sustained flood flows. At the RM 111, the planned maintenance project is to relocate the LFCC and the levee to the west to allow the river more freedom to move within its historic floodplain. Work on the planned RM 111 levee setback project is expected to begin in March 2008.

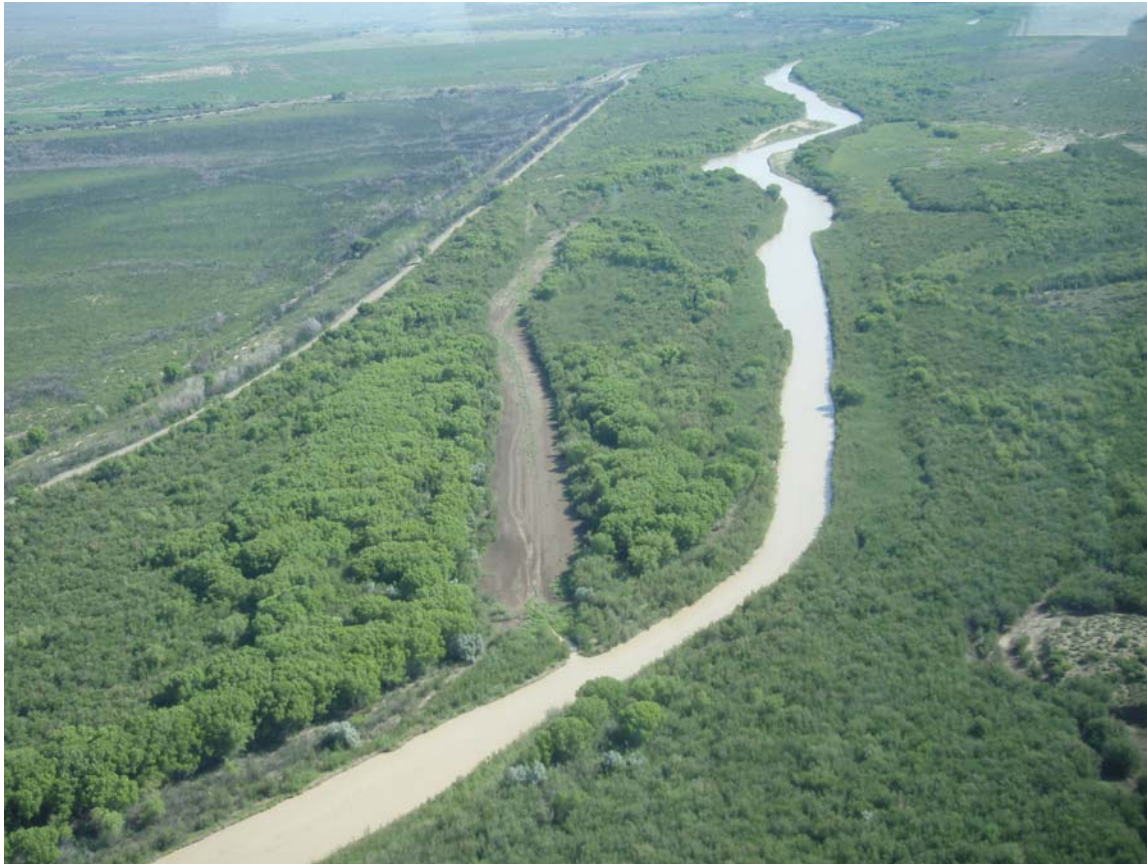
Photo 12. Tiffany Sediment Plug area, taken near RM 71, facing upstream (May 2007).

During the 2005 spring runoff, a sediment plug formed in the Tiffany area and completely blocked the main channel of the Rio Grande. The plug first formed about 1.5 miles upstream of the San Marcial railroad bridge, in the vicinity of River Mile 70, and eventually extended about 3 miles upstream. The plug caused the entire active river channel to completely fill with sediment and resulted in an alarming rise in water surface against the Tiffany Levee. In a joint effort between NMISC and Reclamation, the plug was removed in 2005. However, concerns remain that another spring runoff with sustained overbanking flows, similar to the 2005 spring runoff, could result in formation of another plug. Therefore, Reclamation is actively investigating potential river maintenance work which could reduce the frequency of sediment plugs.

Reclamation currently has environmental permits in place which will allow for the excavation of a pilot channel in this reach to reconnect main channel flows in the event that a sediment plug forms. The area (photo 12) will be monitored closely during the 2008 spring runoff.

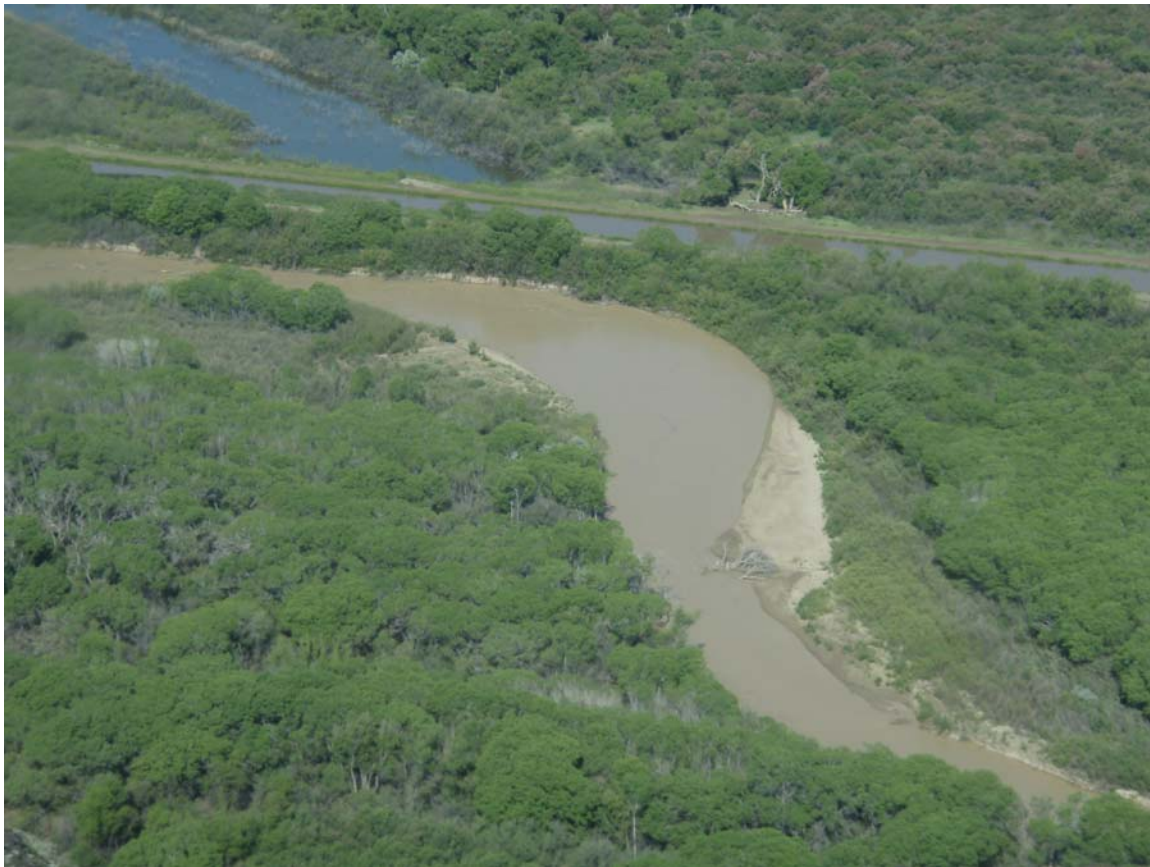
Photo 13. Fort Craig Bend priority site, taken facing west (May 2007).

This site is located on the west bank of the Rio Grande, approximately 4.5 miles downstream from the San Marcial railroad bridge. It is also approximately 0.25 miles upstream of the Fort Craig Pump Site, where water is pumped from the LFCC to the river during the dry summer months. The active bankline is currently less than 100 feet from the San Marcial Levee (photo 13), which protects the LFCC from the river. Hydrographic data was collected in 2007, and the alternative analysis process will begin in 2008.

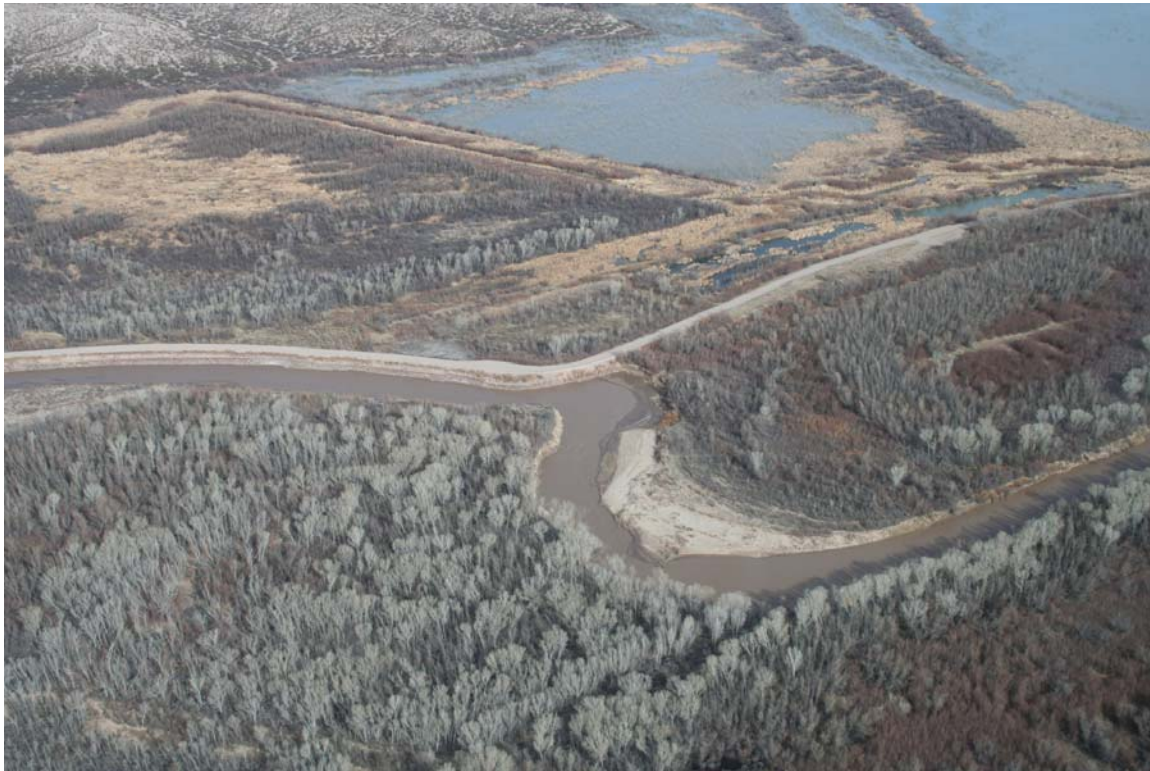
Photo 14. River Mile 60 priority site, taken facing west (January 2008)

This site is located at River Mile 60, on the west bank of the Rio Grande, approximately 8.5 miles downstream from the San Marcial Railroad Bridge. The river makes two sharp bends at the site, and at the second bend is eroding the embankment of a maintenance road that provides access to 5.5 miles of river downstream of the site, including the upper 3.5 miles of the Elephant Butte Temporary Channel. The river has been aggressively eroding the bankline adjacent to the road in the last three years, and it is now eroding the road embankment (photo 14). Predictions are that a spring runoff greater than or equivalent to the 2005 runoff could breach a section of the road. Hydrographic data for this site was updated in 2007 and the alternative analysis process is currently in progress.

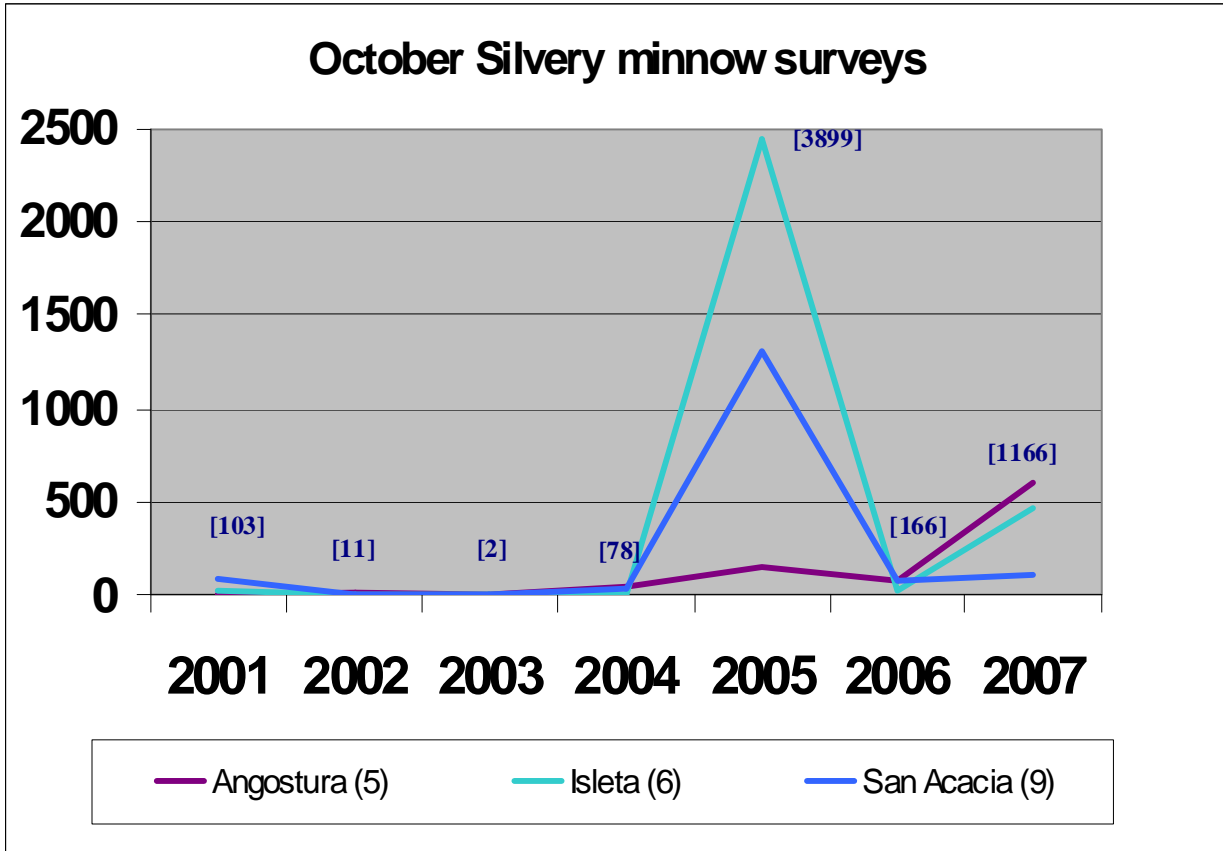
Figure 5: October Rio Grande silvery minnow survey results by reach with totals [] and number of sample sites ()

Intermittency appears to have continuing adverse effects on downstream silvery minnow populations, based on lower numbers of minnows in the intermittent areas of the Isleta Reach. Recruitment is dependent on sufficient flows during spawning throughout reaches with stable summer flows.

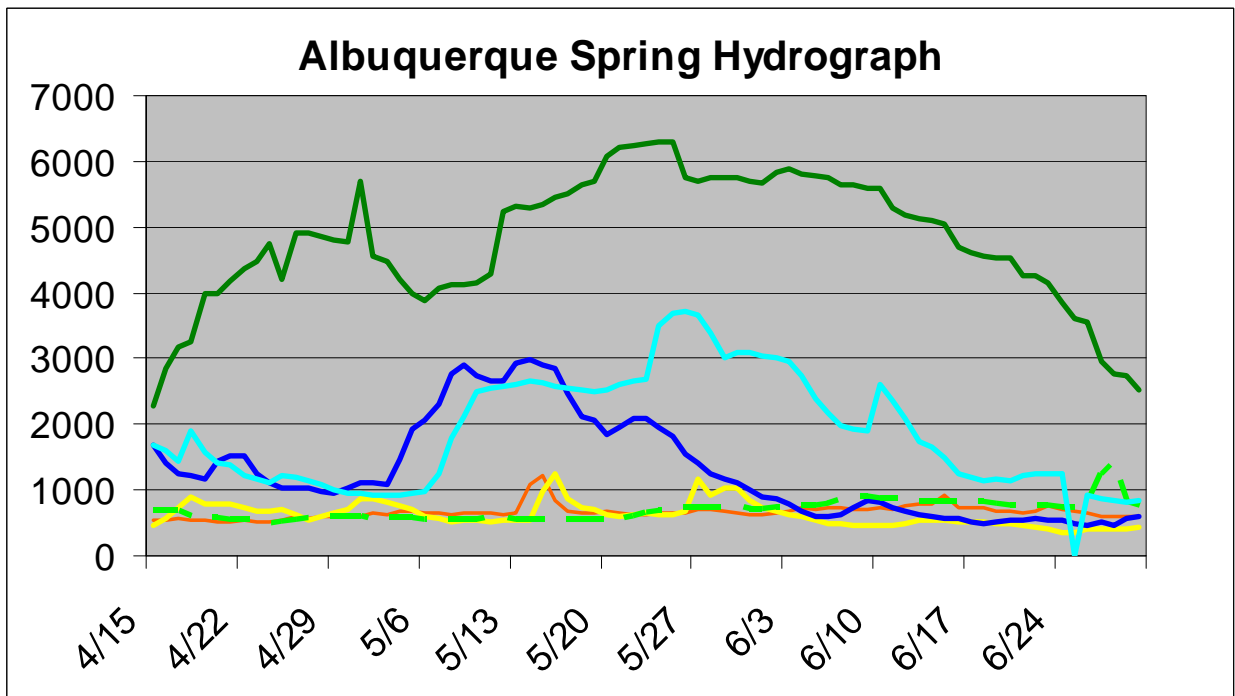
Figure 6: Albuquerque Hydrograph Comparison with flow volume in cubic feet per second (cfs).

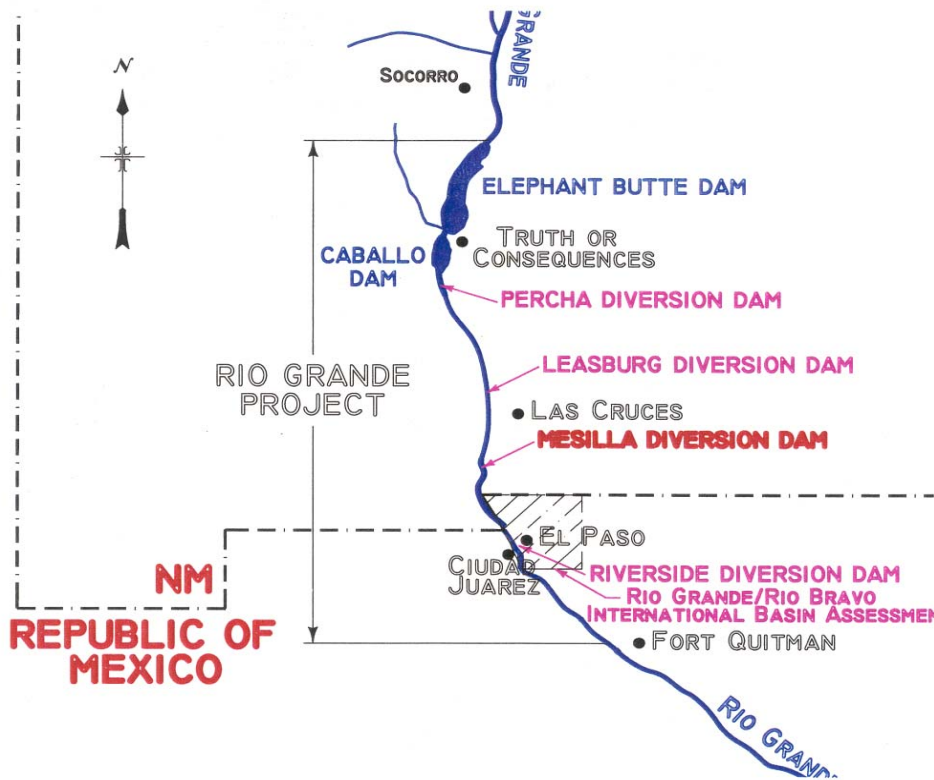
Figure 7: Area Map of the Rio Grande Project

Reclamation's El Paso and Elephant Butte Field Divisions are jointly responsible for the operations of the Rio Grande Project (Figure 8). Elephant Butte Field Division operates and maintains Elephant Butte and Caballo Dams. El Paso Field Division is responsible for scheduling releases from Elephant Butte and Caballo Reservoirs to meet irrigation demand and the delivery of Rio Grande Project water to the canal headings of Elephant Butte Irrigation District (EBID), El Paso County Water Improvement District No. 1 (EPCWID), and Mexico (under the 1906 International Treaty). EBID operates and maintains Reclamation's diversion dams on the Rio Grande, including Percha Diversion Dam, Leasburg Diversion Dam, and Mesilla Diversion Dam in New Mexico. EBID operates and maintains the three diversion dams in New Mexico under a contract with Reclamation. In September 2003, Reclamation completed work to remove Riverside Diversion Dam and the adjacent Coffey Dam, both in Texas. Riverside Diversion Dam had been inoperable since 1987, when flooding on the Rio Grande caused the structure to fail.
