Journal of  
Agricultural Science  
and Environment

## HUMAN HEALTH AND ENVIRONMENTAL RISK ASSESSMENT OF THE ALAKIA INDUSTRIAL DISTRICT OF IBADAN, SOUTH WEST NIGERIA

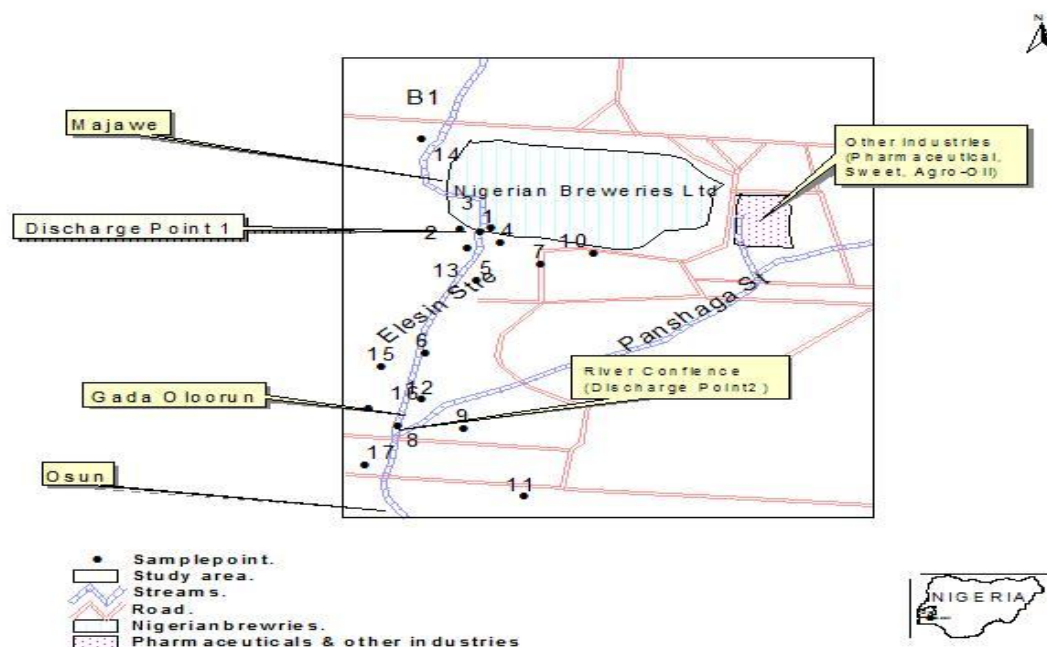
Figure 1: Study Area showing sample points

Figure 1 illustrates the site of industries in relation with the ecology and the sample points. The Brewery industry treatment plant is located at the lower end of the shaded area at point "A". The effluents from the treatment plant are discharged through two channels constructed to pass under the factory fence leading to a nearby Elesin stream. The water from the upstream (B1) appeared colorless, while water discharged from "A" had cream color. The upper stream flows slowly, but from the point of effluent discharge to the down-

stream, the water flow rapidly indicating constant discharge from the factory. The extent of assessment was about 2 km from point "A" along the downstream area.

ducing poisons such as metals at higher than safe limits into industrial effluents with adverse consequences on the ecosystem. For example, literature indicts ammonia, a major constituent of spent brewery water as causing substantial damage if not properly controlled (Ajayi and Osibanjo, 1981; Osibanjo, 1996). Similarly, the presence of heavy metals at higher than safe limits poses serious health problems (Towill, 1978). The first thing we noticed about the Elesin stream that runs a perpetual stench and the permanent brown (dirty) colour of the water starting from the point where the industrial effluents joined the stream (point A in Figure 1). Also, a walk through the streets of the three

Some of the palm trees are dead. About 5% of the area under investigation is cultivated. The cultivated area falls mainly on the extreme end of Papa Adogba (figure 1). Majawe and Osun communities are not cultivated. Cocoyam, plantain, banana, maize and vegetable crops such as lettuce, *amaranthus*, *celosia* (sokoyokoto) are cultivated. From observation, the banana fruits appeared tiny and not filled out. The land at Majawe and Osun communities was not cultivated due to low productivity of crops. Farmers therefore abandon farming in the areas. The death of the aquatic organism in the river near the brewery was traced to the effects of the untreated effluent from the industries.

Water samples from the Elesin stream were taken upstream, marked "B1" in Figure 1. Samples were also taken at point "A" where the effluent discharge from the breweries joined the body of the stream. Well water (drinkable and non drinkable) located at about 10 and 50 m away from the polluted stream in the downstream direction was also sampled. Sampling was equally made at the point of discharge directly from the factory, 5 m, away from the discharge point and at two points each in the Osun and Papa Adogba communities. The sample locations are numbered 1-17 in Figure 1. Most of the wells dug close to the stream were abandoned due to bad odour, taste and harmful effect of the well water. The odour of the polluted water was highly unpleasant and obnoxious.

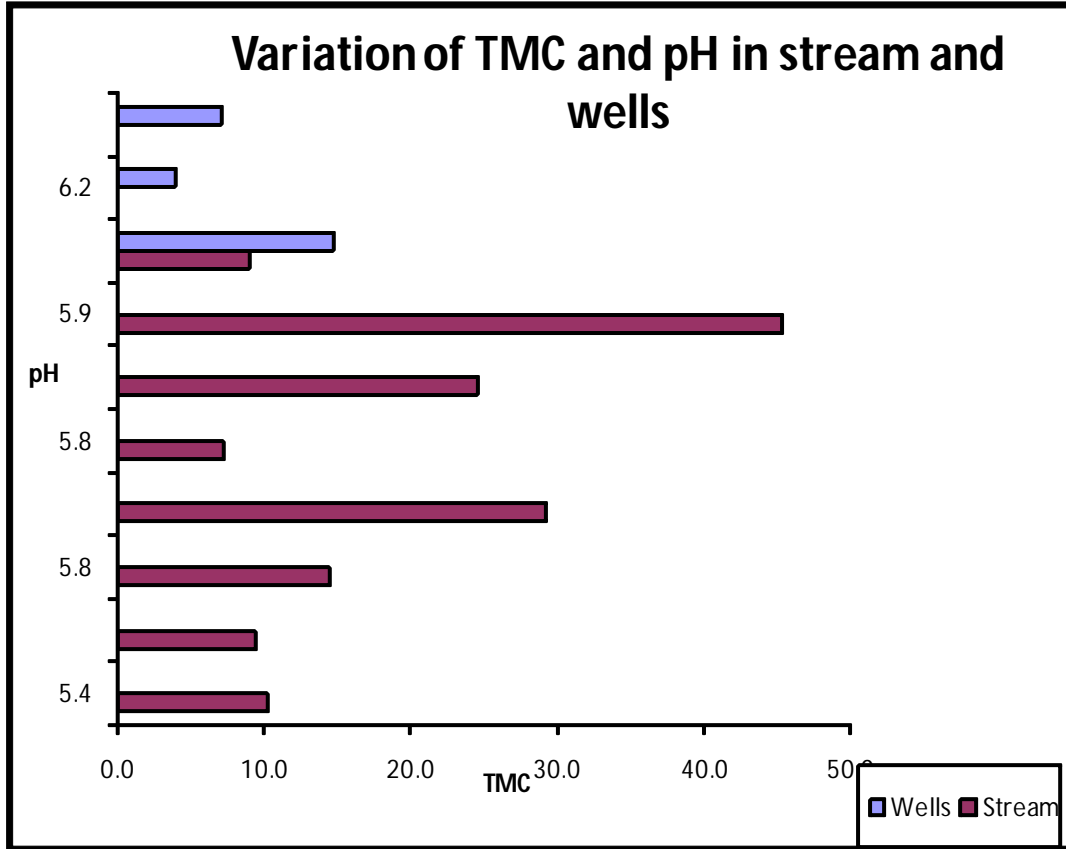
Fig. 2: The variation of Total Metal Concentration (TMC) and pH in Elesin stream and surrounding wells

Table 14 shows the results of the chemical analysis of water samples in the affected communities. The pH was acidic (5.35-6.65) which does not fall within the permissible range of between 6.5 and 8.5 (WHO, 2004) and those of control sample (Table 4). The samples showed pH > 6.5 with exception of that from Papa Adogba well (pH 6.65) which contained very high Na (315mgL<sup>-1</sup>). At the effluent discharge point, the pH was 5.6 and 300 m away from the discharge point, pH was 5.35. The well water had a pH ranging from 6 to 6.65 while that of stream water ranged from 5.60 to 5.80. In all cases, the stream water had a pH > 6 (Table 14).

water samples than WHO standards and those of control sample (Table 4). Iron concentrations on the other hand, were high and those of Cd were above the permissible level of 0.01 mgL<sup>-1</sup> of WHO. The high metal content (Table 1) observed was due to low pH values recorded for the samples. This is because acidic medium indicated by low pH generally leads to the release of metals, which are otherwise immobile. Most of the well water samples contained metal in concentrations lower than the stream water. This is expected because the higher the pH values, the lower the release of metals.

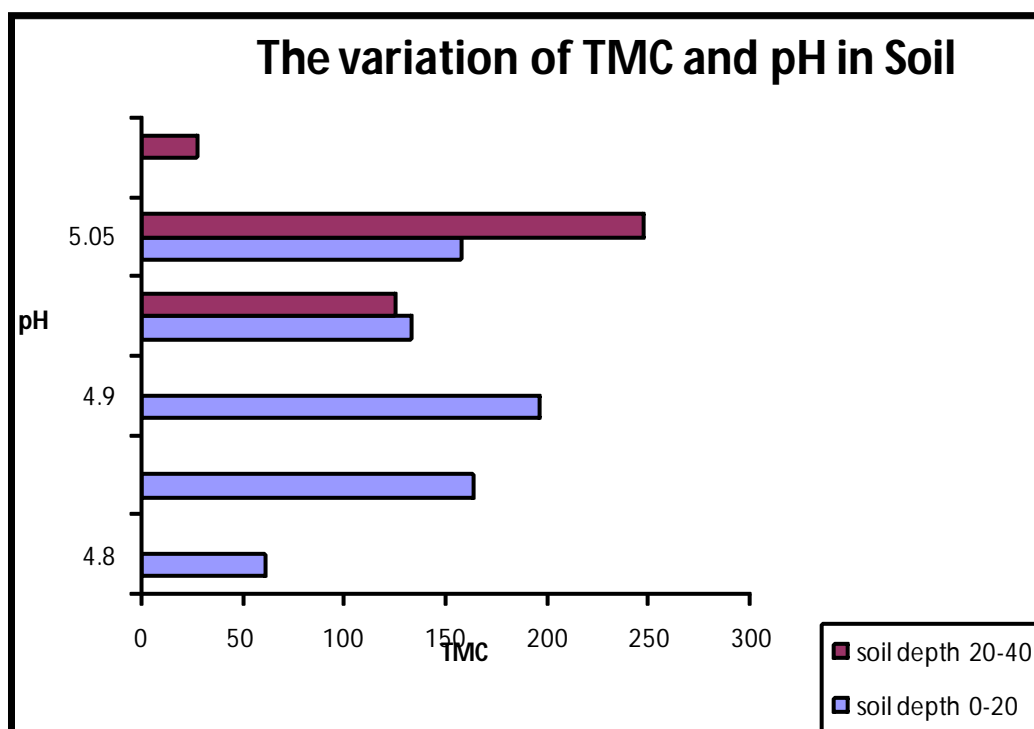
Fig. 3: The variation of TMC and pH in soil

The average pH of the soil samples was close to 5, ranging from 4.75 to 5.35 indicating strong acid medium (Table 2 and Fig. 2). The soil at 3 and 100 m from the point of effluent discharge downstream contained high concentrations of heavy metals such as Pb (10.65 mg l<sup>-1</sup>) Cr (12.37mg l<sup>-1</sup>), Cu (13.8mg l<sup>-1</sup>) and Ni (5.5mg l<sup>-1</sup>) as compared

with the reference soil (Isebo sample) with Pb (4.02 mg L<sup>-1</sup>), Cr (6.25 mg L<sup>-1</sup>), Cu (3.10 mg L<sup>-1</sup>) and Ni (3.85 mg L<sup>-1</sup>). This behavior confirms the high mobility of heavy metal cations under acid conditions. The heavy metal profile further downstream of effluent discharge point (e.g., Gada Oloorun, about 150 m from effluent discharge point) was still lower with the following Figures: Pb (303 mg L<sup>-1</sup>), Cr (3.10 mg L<sup>-1</sup>) and Ni (2.25 mg L<sup>-1</sup>).

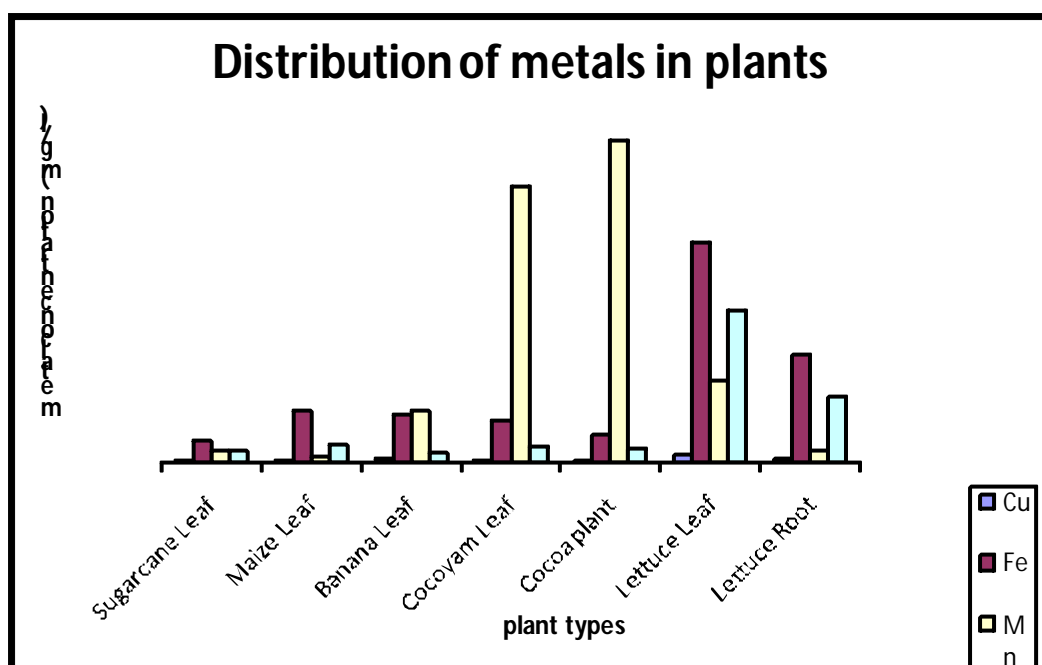
Fig. 4: Distribution of heavy metals in plants

Figure 3 shows the concentration of macro- and micronutrients including heavy metals in plant tissues of various crops. Pb, Cu, Cr and Ni were not detected in the plant/root tissue partly due to selective absorption of the heavy metals. The concentrations of Zn, Fe and Cu ranged from moderate to high in the tissue while potassium was moderate. The highest level of Mn was detected in cocoyam grown close to the effluent discharge point. It was followed by that grown on the vegeta-

ble farm. The lettuce contained the highest level of Cu and Fe, the accumulation of which can be toxic to man and animals. Figures 3, 4 and 5 showed the distribution of metals, % total metal and cations in the plants.
