EXPERIMENTAL STUDY OF BAMBOO AS A HOUSE RETROFITTING MATERIAL FOR DEVELOPING COUNTRIES

ABSTRACT

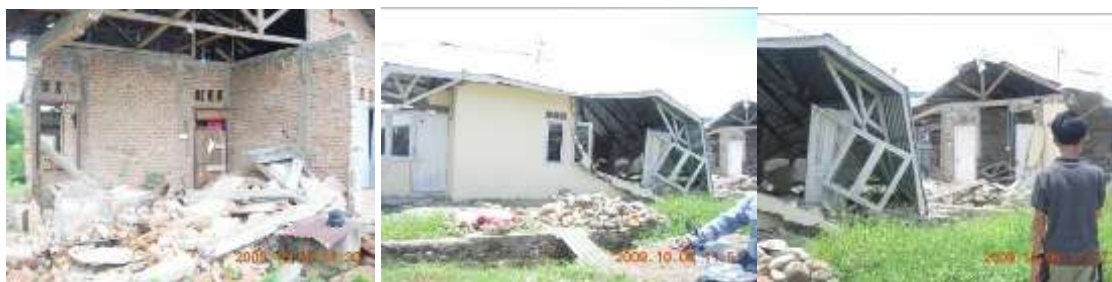
Survey were conducted a few days after the earthquake 30 September 2009 shows variety of conditions the collapse of several masonry

Figure 1. Condition of Masonry Houses after earthquake

construction authorities do not pay attention to the correct building code in construction practices. In fact, many people do not learn from the experiences and only a moment's attention to get more profits. Based on a field survey to several buildings and masonry houses in Padang, various damages were obtained (Figure 1 and Figure 2).

Types of collapse that occurred in these buildings due to earthquake 30 September 2009 include; beam-column joint failure, soft story effect, short column effect, joint failure, and overturning

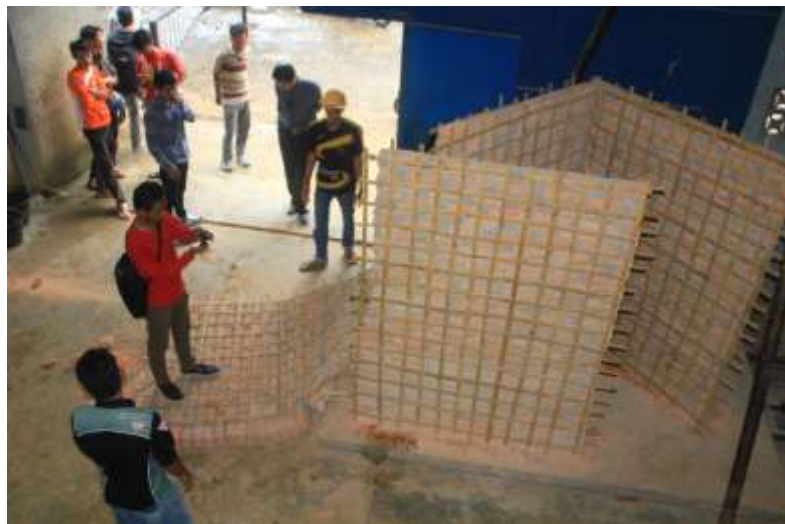
Testing bamboo as retrofitting material on the wall is made from brick masonry with measurement 1.5 m in width and 2 m in height. Two models of retrofitting walls are tested which angle of 90° and 60° (Fig. 6). It can be seen in Figure 7, bamboo wall at angle of 90° had more crack and collapse first than bamboo wall at angle of 60° angle.

Figure 7. Bamboo wall after shake table testing
