A Case Study on Blowout and Its Control in Krishna-Godavari (KG) Basin, East Coast of India: Safety and Environmental Perspective

C.K. Jain^{1*}, S.S. Yerramilli², R.C. Yerramilli²

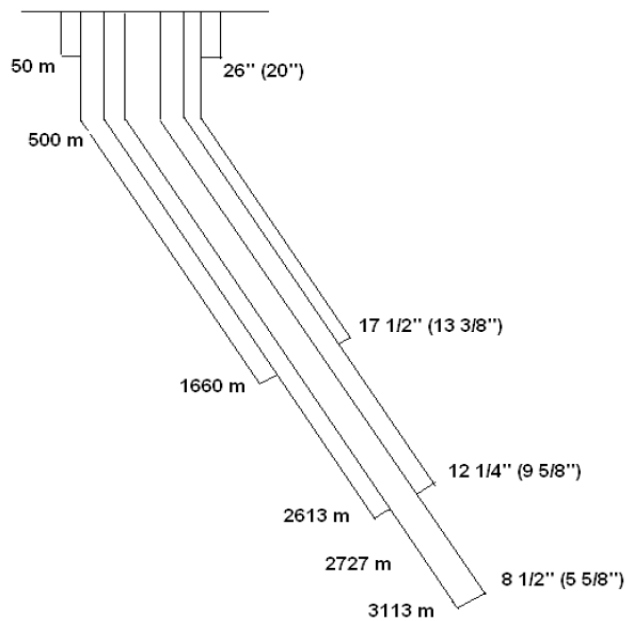
Figure 2. Schematic of well configuration (Jain 1995).

A raging blowout (Bhaskar, 2005) occurred in an exploratory well in the East Godavari District of Andhra Pradesh in Jan'95. The well was spudded in Sep'94. The bit sizes and the casing details of the well were given in (Table 1) and the well configuration is shown in (Figure 2). The drilling progressed with 8.5 inch bit and with a drilling mud specific gravity of 1.3 ± 0.1 . The bit had stuck at the depth of ≈ 2727 m MD which was confirmed by conducting a stretch test. The stuck up might be due to many reasons which were discussed in the coming sections. An attempt has been made to retrieve the drill rods by unscrewing, which was successful. Unfortunately, they were unable to retrieve the drill bit and drill collars and were left in the well bore. It was reported no kick off pressure recorded until this stage.

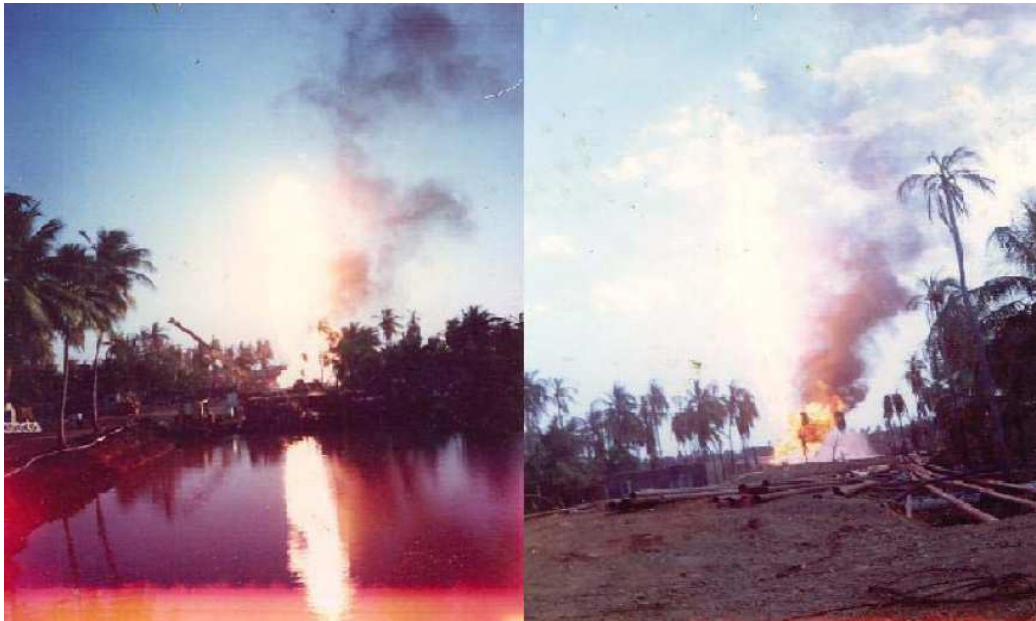
Figure 3. Real photograph showing the height of the flame and the spewing gas.

As alleged, in the evening, uncontrolled flow of gas to surface at high pressures led to a blowout. The spewing gas caught fire immediately. The remaining pipes inside the bore were thrown out by the enormous pressure of the gas. The derrick and the surrounding equipment were gutted after the blowout. The pressure (Jain, 1995) of the gas was estimated around 281.2 ± 0.5 kg/cm². The sound resembled like a rocket engine and the level was so high that none can hear anything up to 700 m distance from the site, necessitated the use of ear plugs. In the night, the intensity of the light caused by the flame was so high that it is visible up to a distance of more than 2 km from the well site. The gas flames (Pantulu, Satyanarayana, 2005) were about 200 feet high with temperature shooting to more than 50°C. About 1 million m³/day of gas spewed out with a deafening sound as shown in (Figure 3).

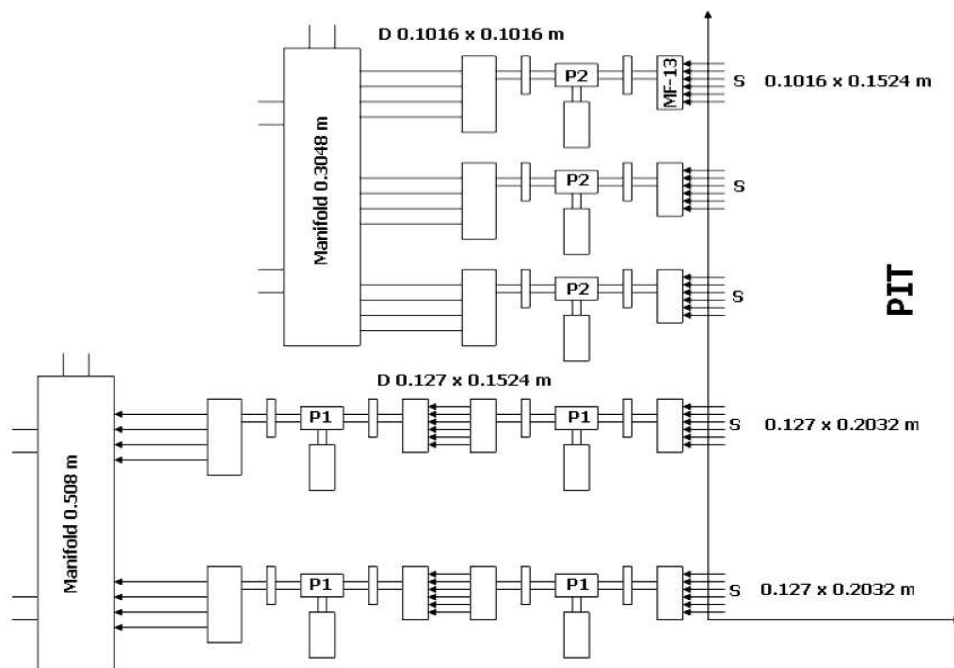
Figure 4. Arrangement of water pumps to create a water umbrella over the flame (Jain, 1995).

- Six pumps of 20,000 gal/min total capacity were used for spraying of water and to create a water umbrella over the flame to reduce the temperature of the flame and surroundings for approach of the safety rescue personnel and for clearing the debris at the site. To prevent the damage of the pumps, they were placed in the well site. A schematic of the pumps arrangement used for combating the blowout is shown in **(Figure 4)**. The details of the pumps used for pumping the water are given in **(Table 2)**.

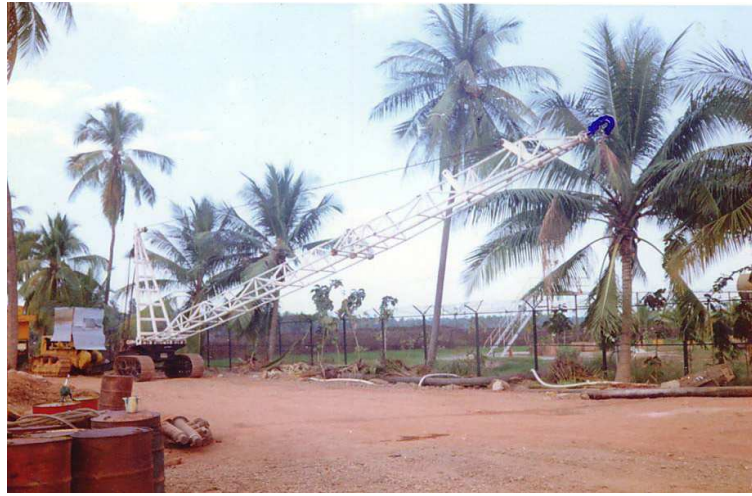
Figure 5. Athey Wagon clearing the debris at the well site.

- Athey wagon **(Figure 5)** was employed (Kelly, 1993) to clear the debris at the well site so that it was easier for the safety rescue personnel to reach within 20 m radius of the blowout area.

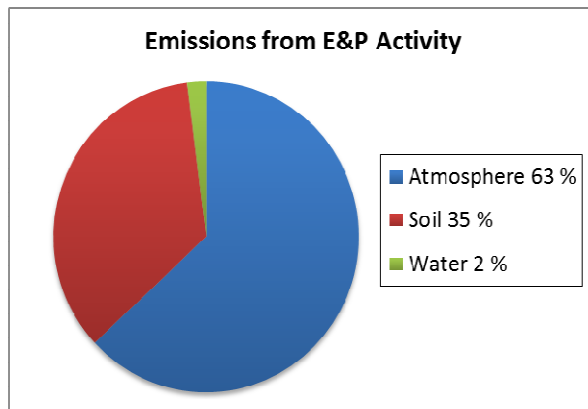
Figure 6. Relative contribution of emissions from E&P activity to Atmosphere, Soil and Water.
