Trace Metals and Hydraulic Characterization of Soils and Groundwater Around Ajakanga Dumpsite in Ibadan Metropolis, Southwest Nigeria.

Abstract

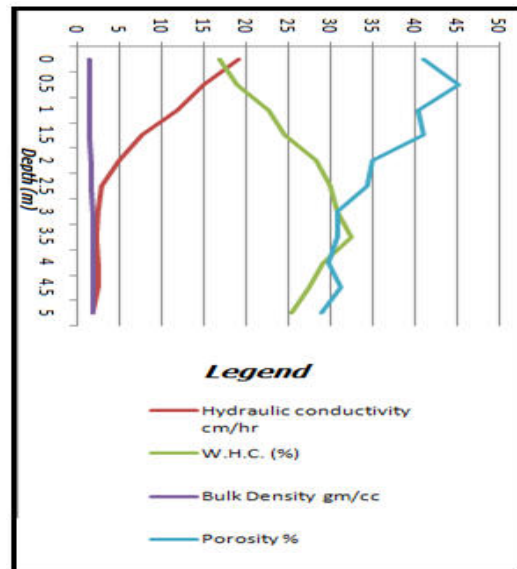
Figure 6 : Plot of Hydraulic Properties at Pit A (Up-slope) Based on Core Samples of Ajakanga Dumpsite

The raw data of the hydraulic properties consisting of hydraulic conductivity, water holding capacity, bulk density and porosity of undisturbed samples of the soil profiles at Ajakanga dumpsite are presented in Tables 4 and 5 while the graphical illustrations are contained in Figures 6 and 7 respectively. The raw data (Tables 4 and 5) show a general decrease in the trend of hydraulic conductivity and porosity from the top soil (A –Level) to the bottom of the soil profiles (Figures 4, 6 and 7) probably due to increase in soil compaction from the top to bottom (USAID, 2008). The bulk density increases from the top to bottom of the vertical soil profiles. This is attributable to increase in soil compaction as a result of increase in overburden

from the top to the bottom (Tables 4, 5 and Figures 4, 6 and 7). The water holding capacity however shows higher values in the B-level than in A and C levels across the two pits (Tables 4, 5 and Figures 4, 6 and 7) possibly due to relatively higher abundance of clay size materials in B-levels compared to the A and C-levels (Table 3 and Figure 5).

The results of the water holding capacity from the undisturbed samples (Tables 4, 5 and Figures 6 and 7) show that B-level has higher water holding capacity than the A and C levels in the area possibly due to its higher contents of clay sized materials (Table 3 and Figures 4 and 5). The bulk density increases with depth due to increase in compaction while hydraulic conductivity and porosity decrease downwards (Tables 4, 5 and Figures 6 and 7) mainly because of increase in compaction with depth (Mitchell *et al.*, 2005).
