# GIS Based Surface Irrigation Suitability Assessment and Development of Map for the Low Land Gilo Sub-Basin of Gambella, Ethiopia

## Abstract

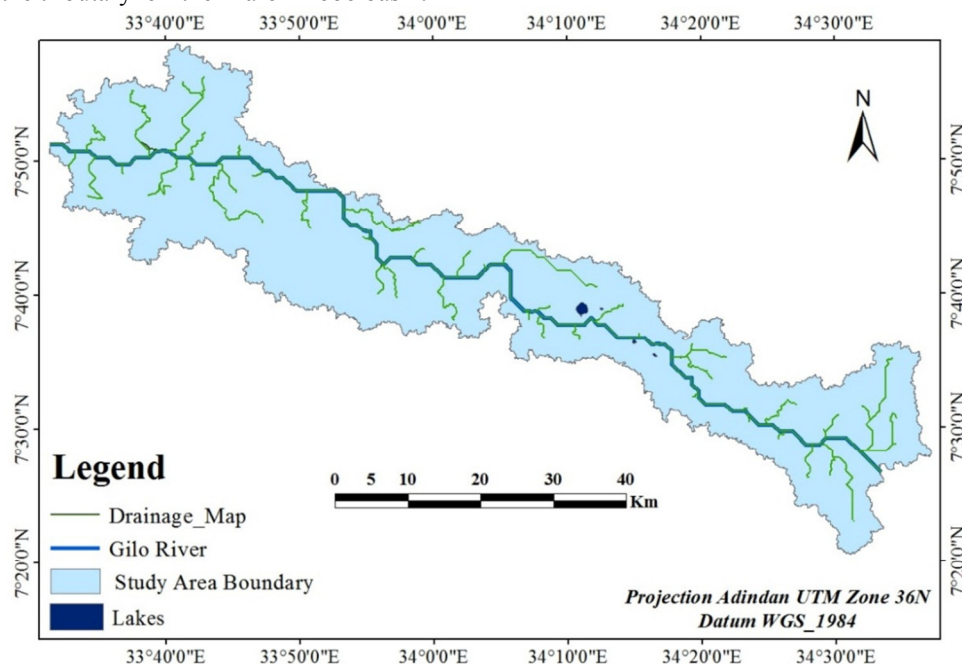
Figure 1. Surface drainage distribution and location map of Lowland Gilo Sub basin

The irrigation suitability study was conducted for lowland Gilo sub basin which located in the lowland Gilo sub basin of Gambella regional state in between the geographical coordinates of 7°20'34.8" to 7°58'48" N latitude and 33°31'12" to 34°37'8.4" E longitude. The total area coverage of the sub basin that obtained through watershed delineation is 197,124 ha, of the Goge, Jore and partially Dima administrative woredas. The sub basin is one of the tributary of the Baro Akobo basin.

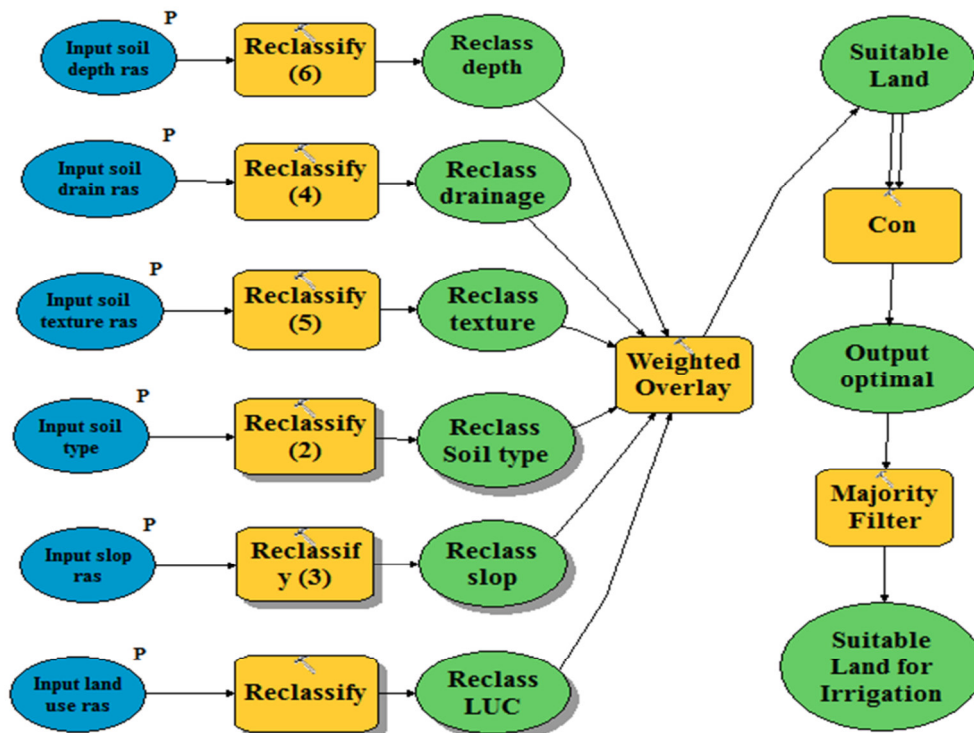
Figure 2. Irrigation suitability model

After irrigation suitability of each parameters were assessed and their suitability map layer of each criteria were developed separately, an overlay analysis was done to generate one suitability map using “model builder” in Arc tools box and tools from spatial analysis tool sets. An overlay analysis in Arc GIS.

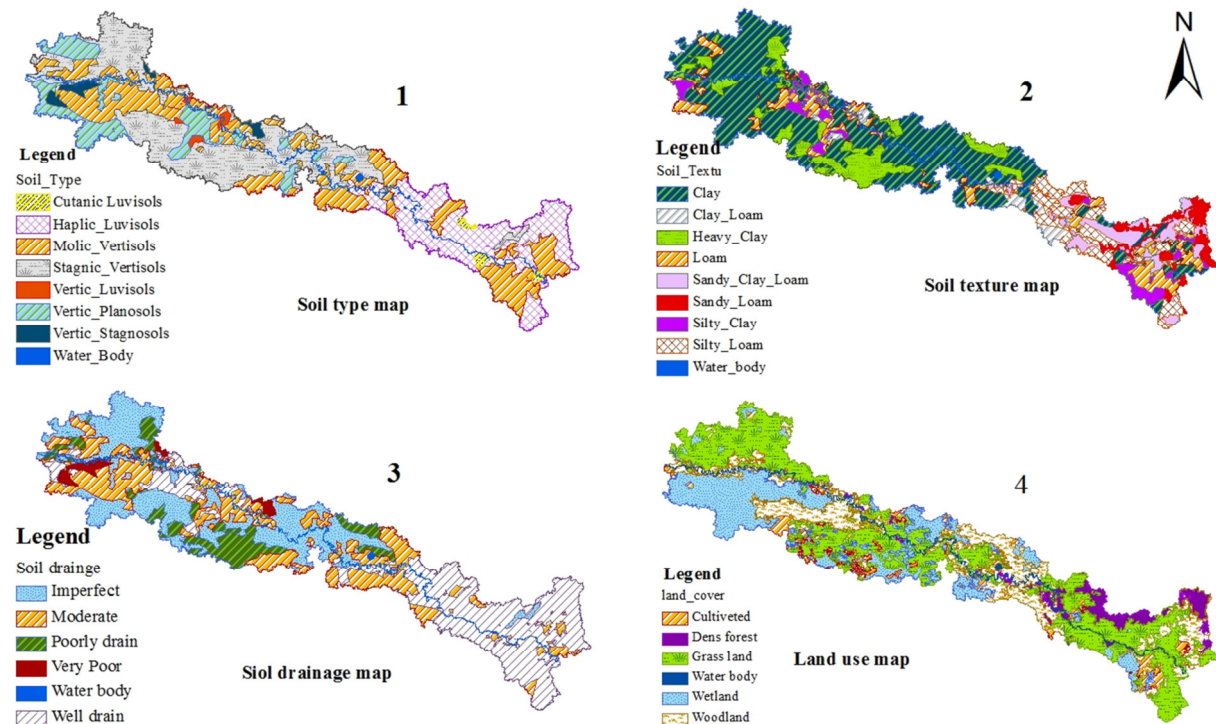
Figure 3. GIS based Irrigation suitability factors distribution map in the study area.

The dominant soil types obserbed on the lowland Gilo sub basin were majorly classified as Luvisols, Vertisols, Planosols and Stagnosols as shown on Figure 3 (1). Luvisols which are fertile and suitable soil for a wide range of agricultural uses are obserbed on the alluvial plains of upper Gog and some part in Dima woredas. they developed on residual colluvial and volcanic basalt parent material and dominated by Haplic Luvisols, Cutanic Luvisol and Vertic Luvisol. those soils well to moderate soil drainage condition and laid on 2-5% slope range.

According to FAO soil permeability evaluation techniques the soil drainage of the flat and alluvial flooded plains of lowland Gilo sub basin was falls under well, moderately well, imperfectly, poorly and very poorly drained conditions (Figure 3.3). The lower part of the study area were dominated by imperfectly to very poorly drained soil drainage condition (Figure 4.4). In relation to agricultural crop production this soil drainage condition is the most limiting factors in most soil types of the study area, which further need special attention to address such problems through improvement of soil drainage

(lake and river) and residences (Figure 3.4), were derived from the Land sat ETM+5 image based on the supervised classification classified with over all accuracy of 87.29% and Kappa coefficient of 0.846, where it indicated the land use/cover classification have a strong agreement according to Rahman *et.al.* (2006).

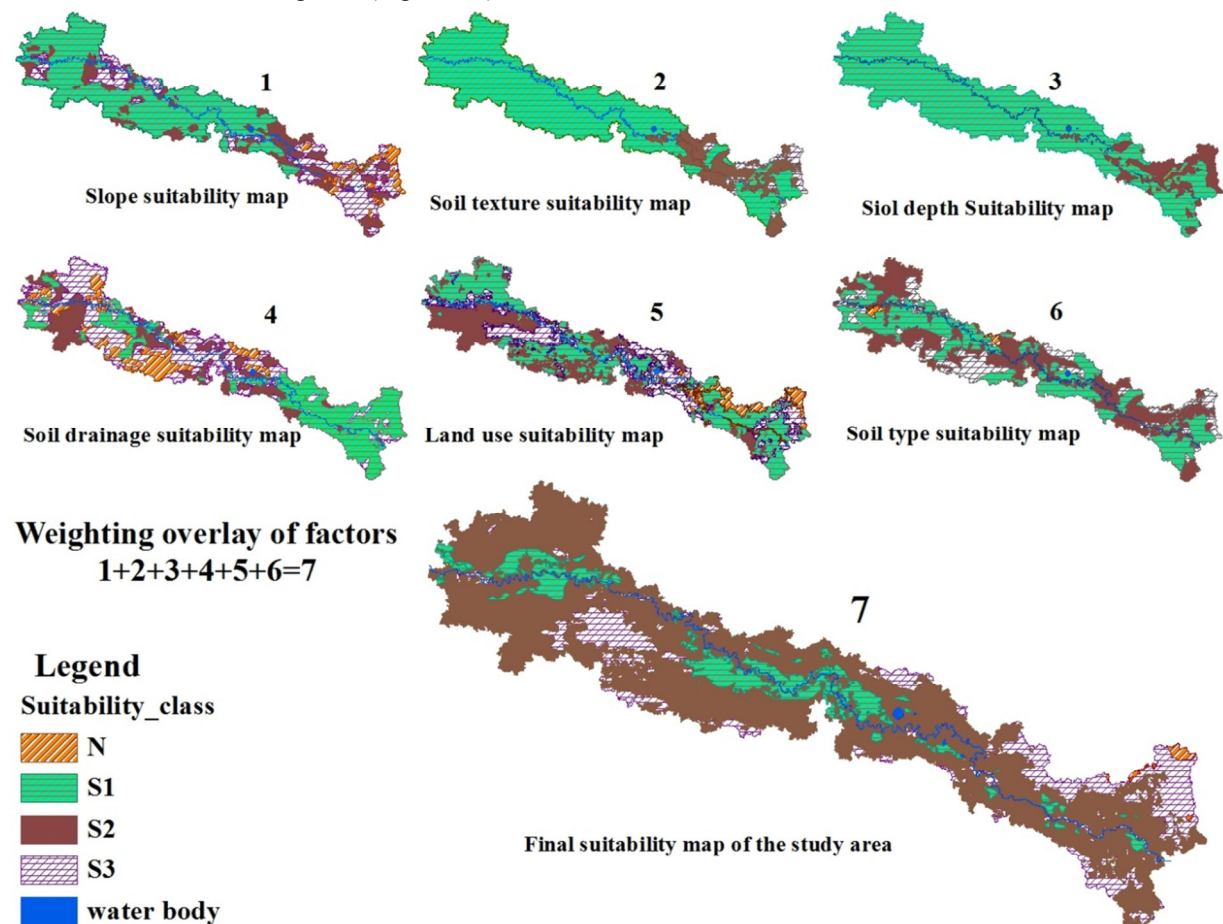
Figure 4. Reclassified factors and final irrigation suitability map of the study area

based on the interperation of pyisical and chemical characteristics of the parameters, the qualitative land evaluation for irrigation suitability implies that majority of the lower part of the study area identified as highly suitable for surface irrigation inrespect to slop, soil depth and soil texture as shown on number 1, 2, 3 of figure 4, where some limitations are obserbed on soil drainage condition (Figure 4.4.).

The final result of irrigation suitability model analysis which involved weighting values of each data sets implies that large portion of the lowland Gilo sub basin was classified under potentially suitable for the application of surface irrigation where about 9.1% (17874.5 ha) of the total area coverage in the study area was found to be existing suitable and only about 1.3% of the area coverage classified as marginally and permanently not suitable for surface irrigation (Figure 4.7).
