Development of Structurally Improved Erosion Control Dam Models for Ecosystem Connection in Mountain Streams

Abstract

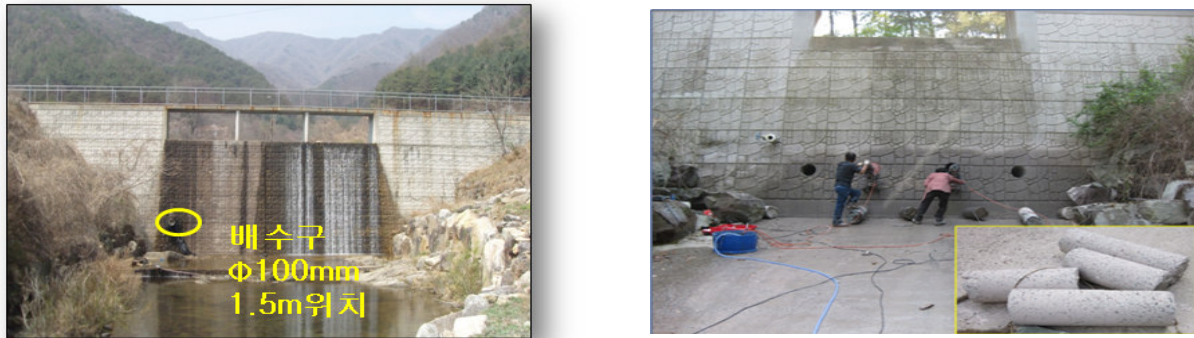
a) Front and side view of non-permeable dam b) Front and side view of dam with structural improvement
Figure 1. Example of on-going structural improvements of non-permeability Erosion Control Dam via drilling of four drainage holes.

Structural improvements of concrete check dams were carried out for 2 check dams, located in Sacheon, Gyeongsangnam-do. Figure 1 shows a non-permeable check dam with the top left and right side view and front view of check dam. At a height from the base of 1.5m is inserted a $\Phi 100$ mm pipe for water passage (Fig. 1a), while as seen in Figure 1b, a structural design and improvement has been carried out at a second level of the dam.

The non-permeable check dams with $\Phi 100$ mm pipe at a height from the base of 1.5m does not properly enhance movement of materials downstream as the passage is narrow. More sediments and dead leaves accumulated in the upstream section of the dam. Leaves and other waste also accumulated in the pipe further blocking the passage of materials. After increasing the pipe size by using $\Phi 300$ mm pipes inserted on 4 drilled holes on the check dam wall at a reduced height from the base (Fig. 1b), downstream movement of materials, and passage of animals was improved and enhanced as the pipes served as ecological corridors. Upstream water pollution was thus minimized with easy water flow enhanced.

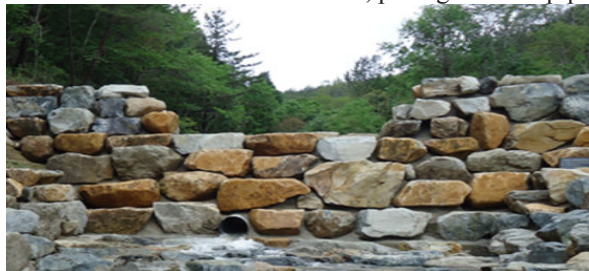
Figure 2. A check dam with structural improvement to enhance drainage

The check dams were constructed with stone boulders, with narrow drainage pipe of $\Phi 100$ mm inserted close to the base, thus with the accumulation of fallen leaves and rocks, passage via the pipe was difficult.

After installing $\Phi 300$ mm drainage pipes at the lower part of the check dam base (Fig. 2), water passage was enhanced via the pipes during summer rains as well as downstream movement of materials, and also in the dry season were the pipe continuously served as ecological corridors.

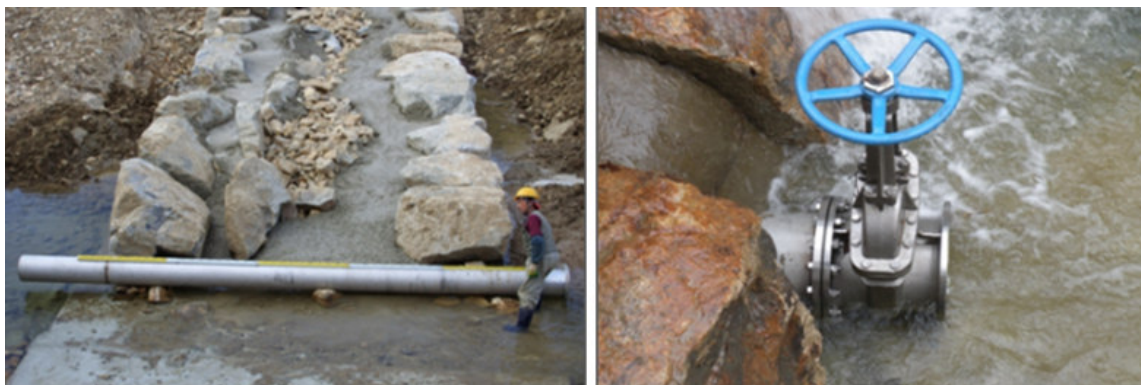
Figure 3. Improved drainage practices (water pipe $\Phi 100\text{mm}$ \Rightarrow replaced by $\Phi 300\text{mm}$ at the base area)

As seen in Figure 3, attached to the $\Phi 300\text{mm}$ water pipe is a facility with an adjustment valve. This enables adjustment to enhance a water storage function when necessary, and the passage of water via the dam to prevent accumulation/clogging in the inlet pipe with L, T type connection. Figure 4 shows an improved check dam with $\Phi 300\text{mm}$ drain valve that can be regularly adjusted. When the upstream is full to capacity, water drains downstream via the overflow drain halfway of the dam, and in the dry season, the drainage valve serves as ecological corridor to regulate movement of aquatic organisms.

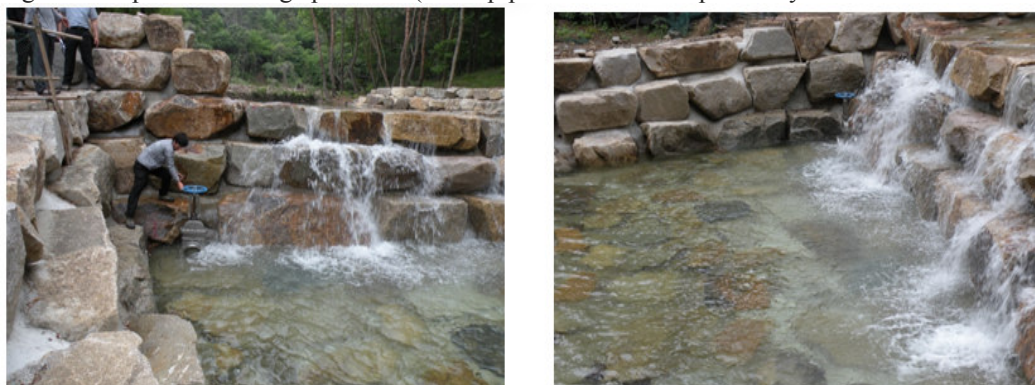
Figure 4. Structurally Improved check dam ($\Phi 300\text{mm}$ drainage valve and half way fresh water overflow).

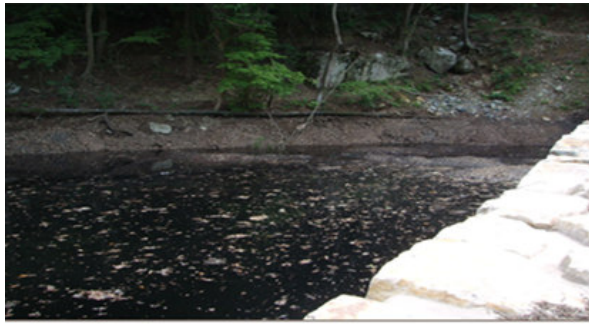
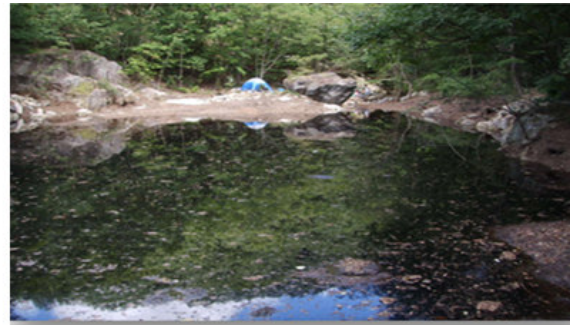
Figure 5. Water pollution caused by litter accumulation in a non-permeable check dam

Figure 5 shows the water highly polluted as a result of the non-permeability of the check dam while the right picture shows dark leaves, with bad odor perceived in the area. When the reservoir water within the check dam area became stagnant for a long time, it eventually deteriorated and the polluted water generated odor perceived by local residents and visitors to the mountain area. This thus conforms to the fact that, the damming of rivers or streams provides a dominant human impact on river or stream environments, with subsequent ecological impacts in the stream which can be extensive (Jeffrey et al., 2008; Nilsson et al., 2005; Palmer, 1991).

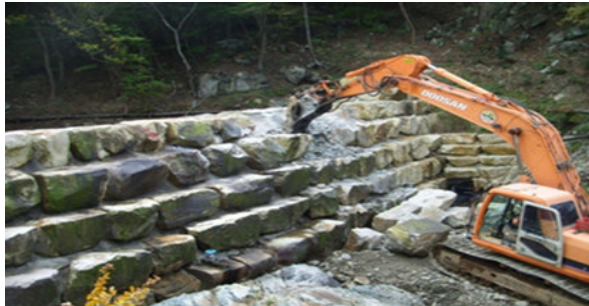
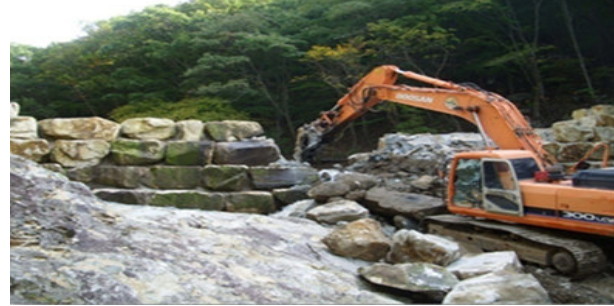
Figure 6. On-going structural improvement of check dam via demolition to create passage way

Figure 6 shows on-going structural improvements being carried out at the check dam via demolition of target boulders. Improving the dam structure eases downstream water flow thus accumulated sediments upstream are eventually cleaned-up (Figure 7). Thus when non-permeable dams are improved structurally (Figure 7), water pollution is minimized as downstream movement of sediments, animals and plant materials from upstream is enhanced, with the creation of ecological corridors.

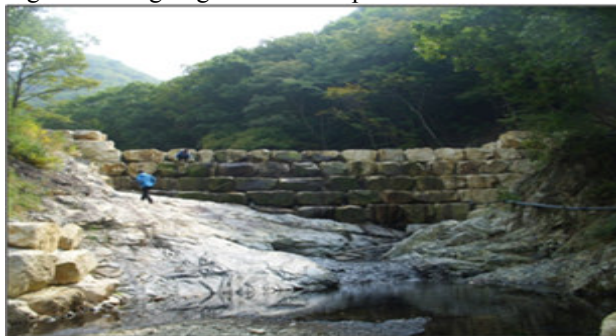
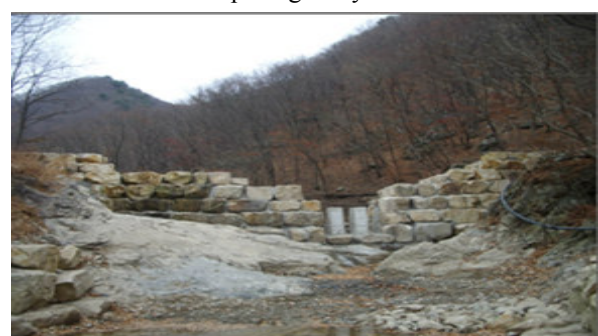
Figure 7. Structurally improved check dam showing visible passage ways from upstream to downstream. Water pollution is mitigated as water easily flows and carries materials along.

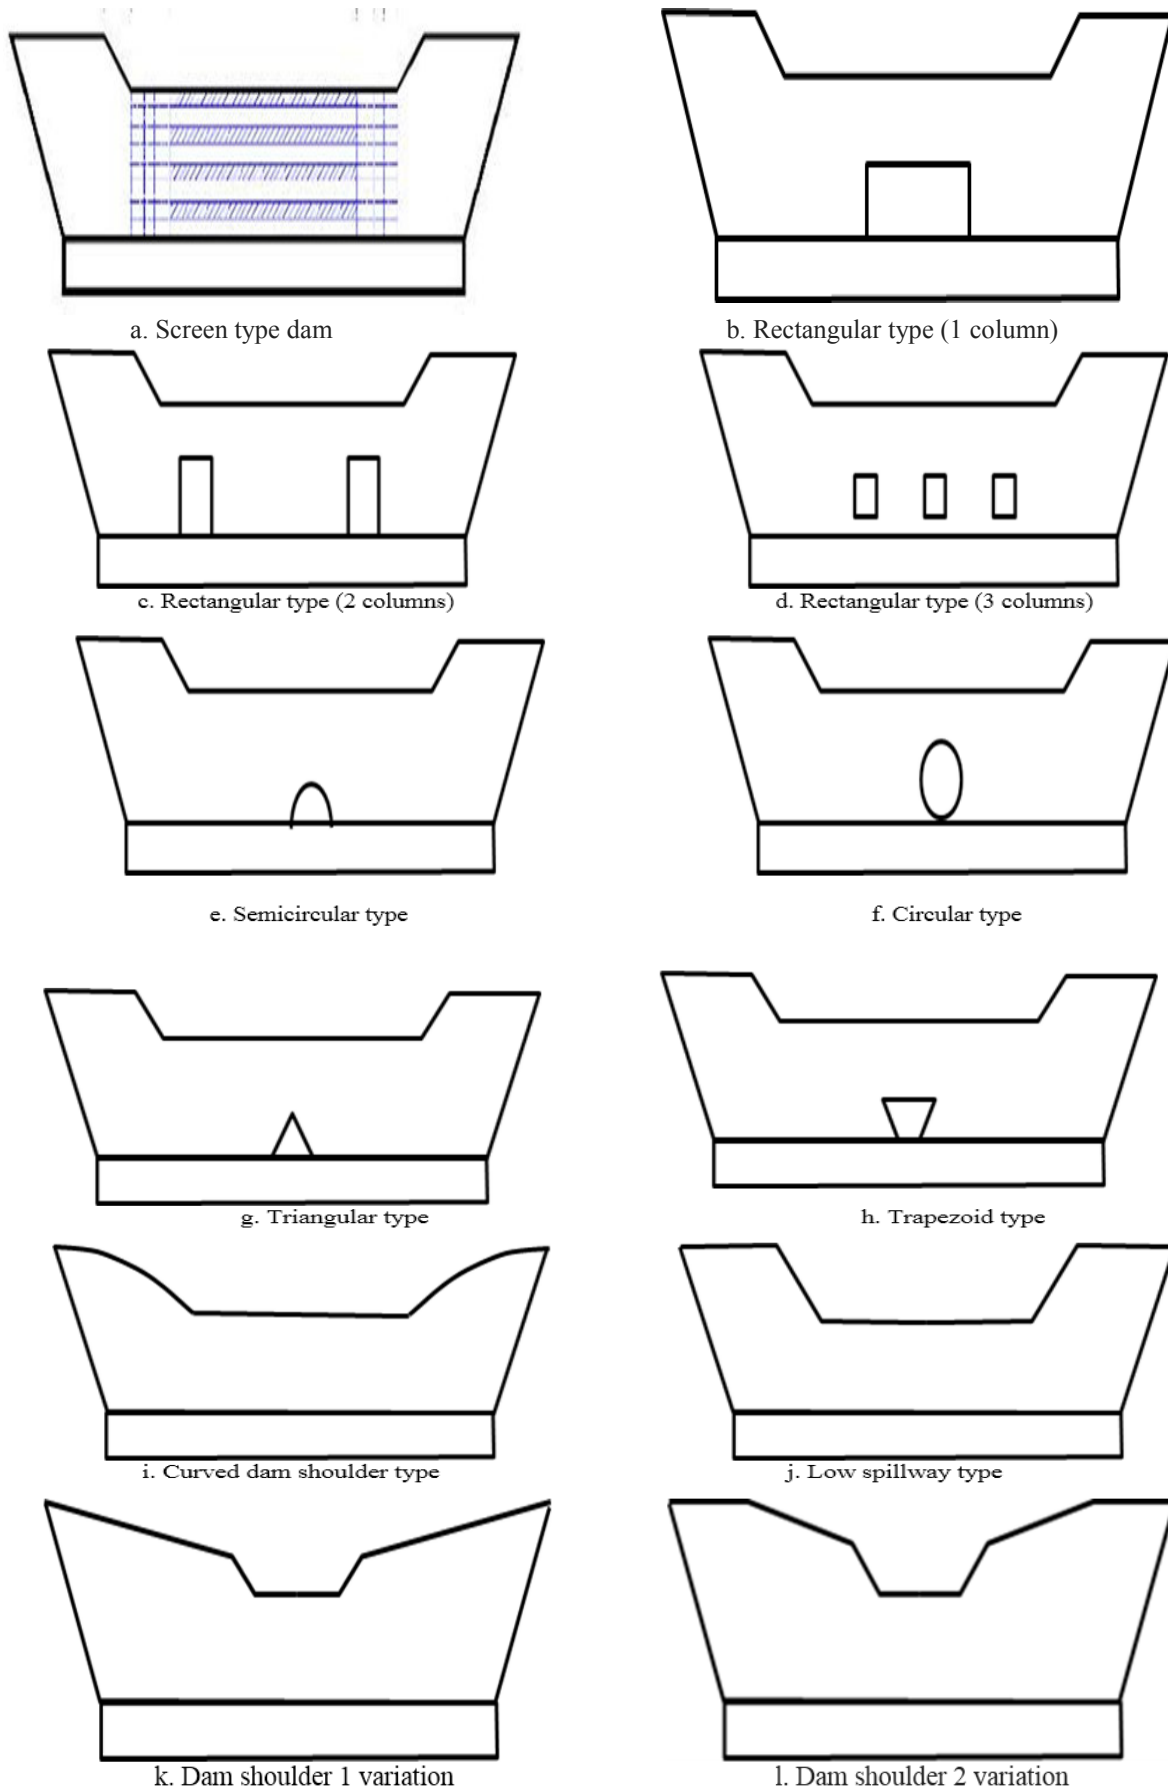
Figure 8. The new mini-type check dam models with different designs.

Generally, bigger and much higher check dams are constructed to manage debris flows in mountain valley areas, but considering small private houses or shallow landslide vulnerable areas, mini-type check dams with narrow widths and heights are more adapted, to serve as relatively improved check dam models in such areas. Figure 8 shows the 12 different types of mini-type check dams with varied permeability, ecological barrier height and spillway area.

These mini-type check dams are less expensive, and should be constructed very firm enough for sustainability. When detailed studies are conducted in the area, the position and design of the mini-type check dam which is best suited for the area is determined, considering the environmental conditions and ecological diversity of the area.

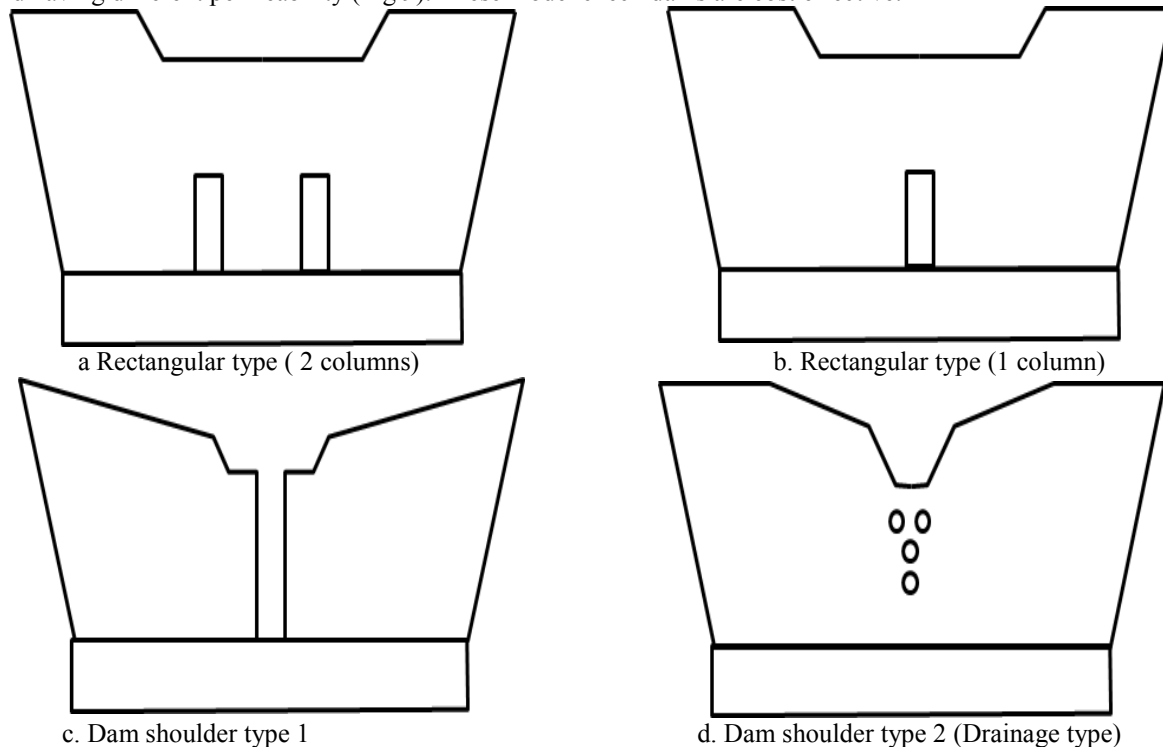
Figure 9. Check dam models having different permeability suited for shallow landslides

In vulnerable landslide areas with smaller material mass especially around private houses close to small cities, four different check dam types are proposed with the heights and forms taking into consideration the location and having different permeability (Fig 9). These model check dams are cost effective.

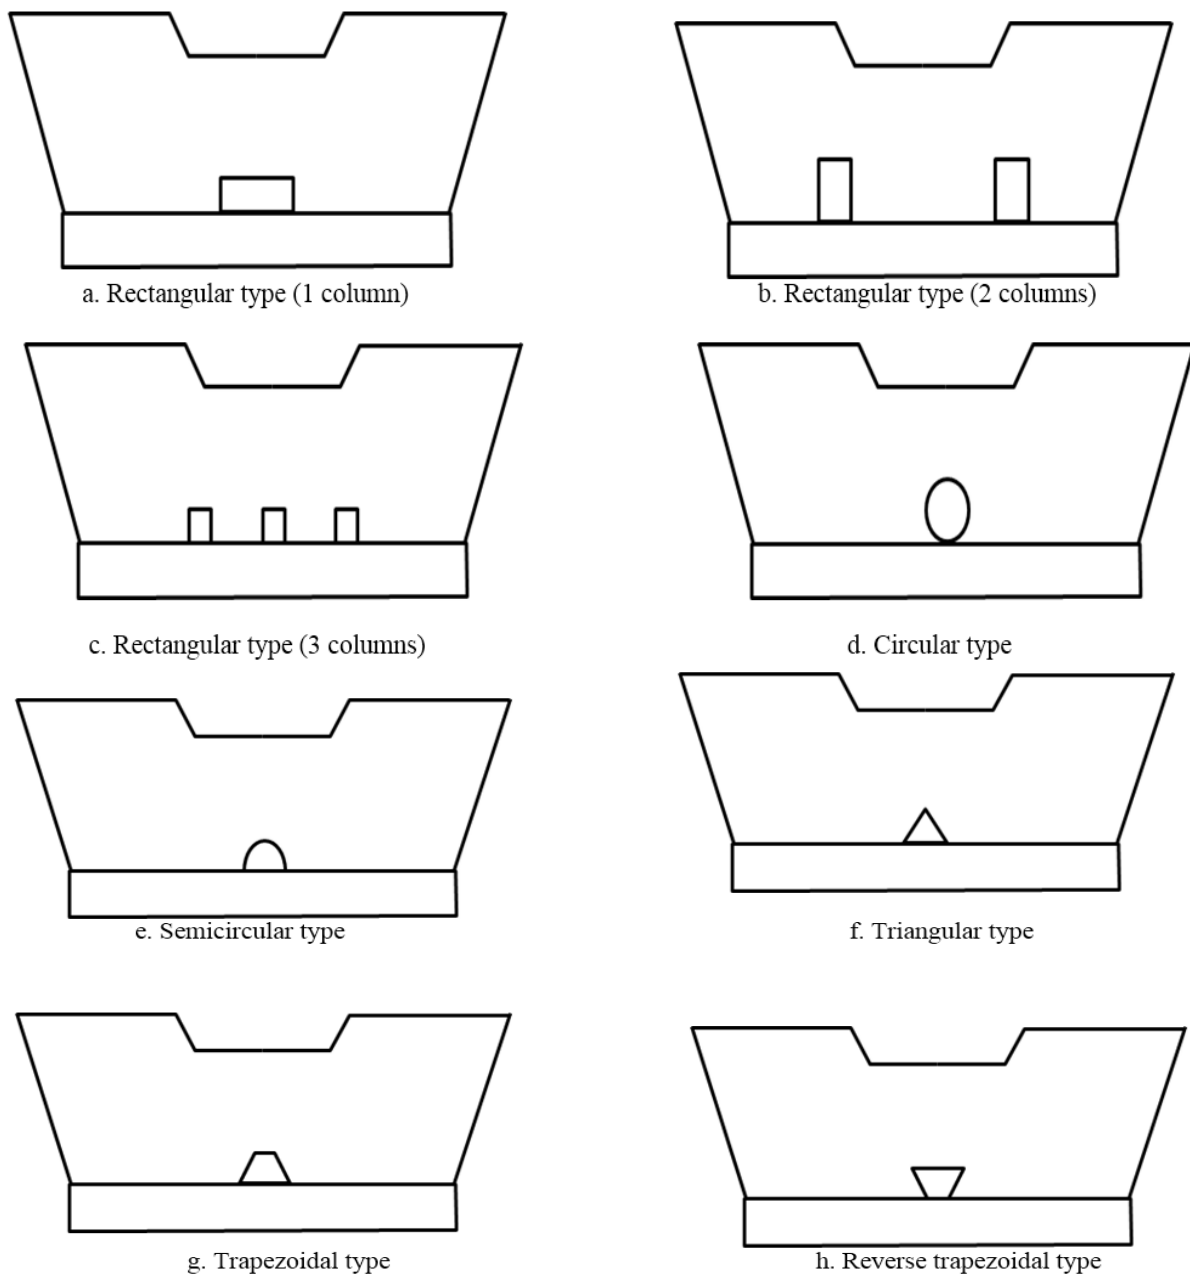
Figure 10. Drainage hole insertion model check dams. The drainage holes enhance upstream to downstream connectivity, thus mitigating pollution and water degradation as well as ease movement of animals. The biodiversity and water volume will guide the selection of the dam type needed for the area.

Model check dams to enhance ecological permeability by improving non-permeable check dams with drainage holes are shown in Figure 10. Figure 10 shows improvement of non-permeable check dams while maintaining its initial functions, but as well providing additional functions of enhancing ecological permeability as with rectangular, triangular, semicircular, circular, and trapezoidal check dams.
