Parametric Evaluation of the Stability of Natural Slopes

Yousef M. Massanat

Professor, Faculty of Engineering and Technology, University of Jordan, Amman, Jordan

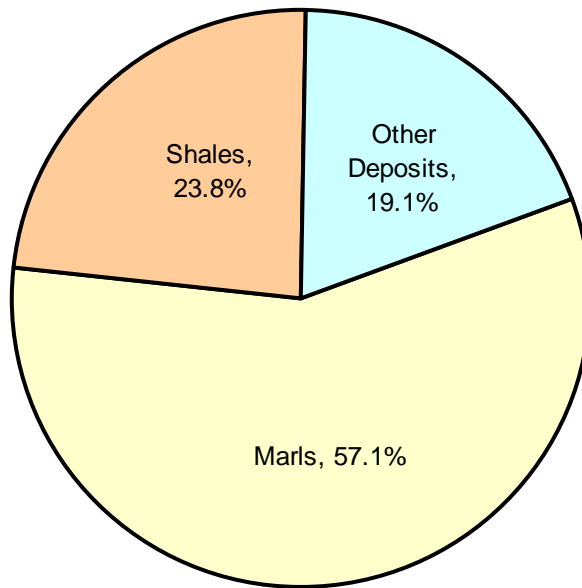
Figure 1: Frequency distribution of the dominating materials in 42 landslide areas

The dominating material that was encountered in the 42 landslide areas studied by the author was marl, followed by laminated shales (Figure 1). The characteristics of marl were comprehensively studied by the author (Masannat, 1988). They range from being of low plasticity classified as ML and CL – ML according to the Unified Soil Classification (USC) system to being of high plasticity classified as CH according to the same

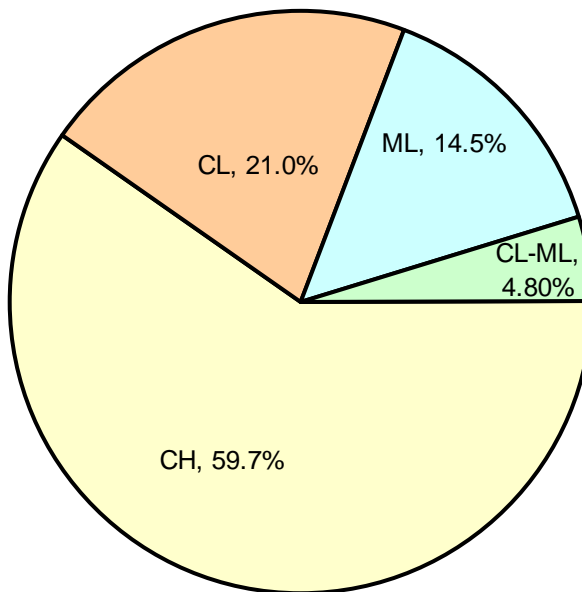
Figure 2: Frequency distribution of 62 samples from the landslide areas according to the unified soil classification system

system. The shales are generally of lower plasticity than the marls. Most of the samples recovered from the landslide areas are of high plasticity (Figure 2). Most of the marls and shales in the landslide areas are highly overconsolidated. The highly plastic clayey marls mostly belong to the Lower Ajlun Group of Upper Cretaceous, while the shales mostly belong to Kurnub Sandstone Formation of Lower Cretaceous (Figure 3).

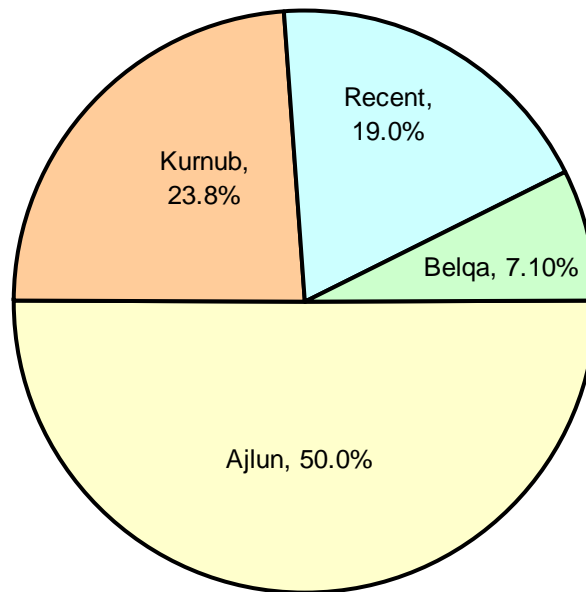
Figure 3: Frequency distribution of the geological formations in 42 landslide areas

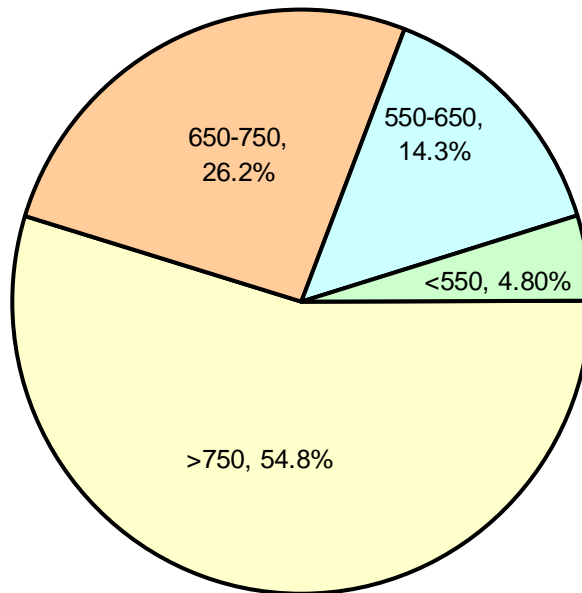
Figure 4: Frequency distribution of 42 landslides according to the total annual rainfall (mm) in the years of their occurrence

Most of the landslides occurred in the years of high rainfall (Figure 4), particularly in the year 1991/1992, where the annual rainfall exceeded 850 mm in the west and northwest of Jordan (Salt, Ajloun and Irbid Governorates).
