AGEING CHARACTERIZATION OF EXHAUST FLEXIBLE COUPLINGS

Francesca Curà^(*), Andrea Mura, Raffaella Sesana

Department of Mechanics, Politecnico di Torino, Torino, Italy

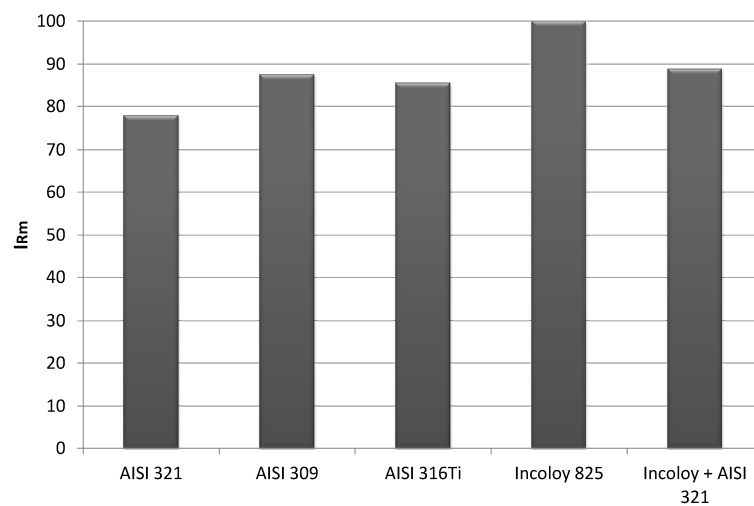
Fig.6 Tensile strength index I_{Rm}

$$I_{Rm} = (R_{mTe} - \sigma_{ref}) + (R_{m500} - \sigma_{ref}) \quad (1)$$

where: R_{mTe} is the ultimate tensile stress of the material at room temperature, R_{m500} is the ultimate tensile stress at 500°C temperature, and σ_{ref} is the stress applied at the component during the ageing procedure.

Figures 6 to 10 show respectively the tensile strength, the yield strength, low cycle fatigue, corrosion, and cost normalised indexes.

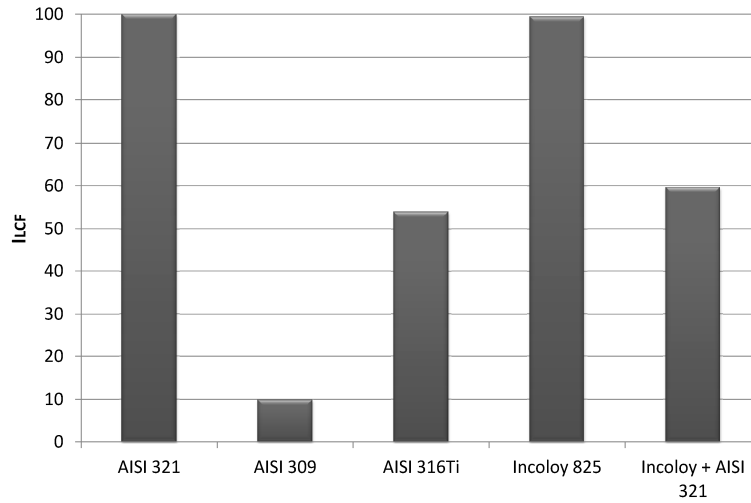
Fig.8 Low cycle fatigue index I_{LCF}

$$I_{LCF} = 3.5 \left(\frac{R_{mTe}}{E} \right) N^{-0.12} + \Delta Z \cdot N^{-0.6} \quad (3)$$

where E is the young's modulus of the material, ΔZ is the necking deformation of the material and N is the number of cycle when the component presents any mechanical failure.

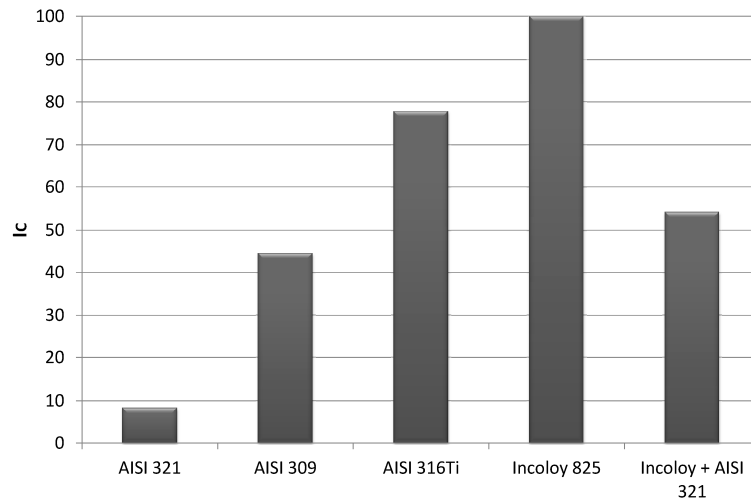
Fig.9 Corrosion index I_C

The corrosion index I_C has been obtained considering four kinds of corrosion phenomena: general corrosion, intergranular corrosion, pitting corrosion and hot salt corrosion. For each corrosion phenomena, two penalties have been assigned: one representing the level of danger related to the corrosion and the other concerning the entity of the corrosion attack, according to Table 2.

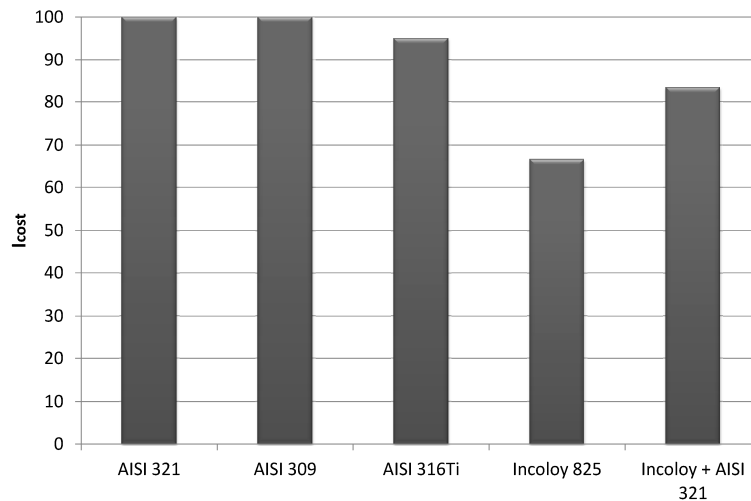
Fig.10 Cost index I_{cost}

The cost index I_{cost} has been obtained considering the material costs and normalising by the maximum cost value.
