# American Communal Societies Quarterly

## Room(s) for More: A Communal Dwelling or Family Home at Ephrata

Jeff Bach

Nick Siegert

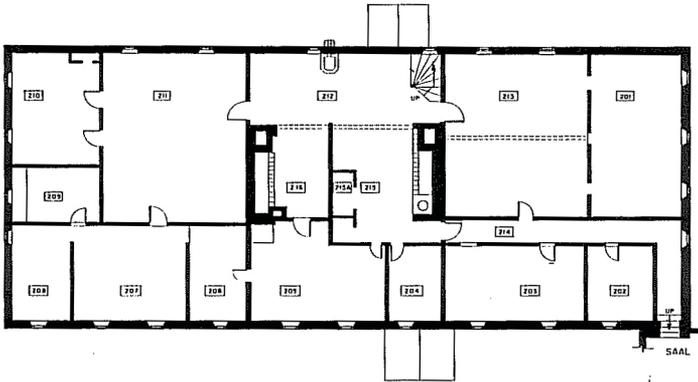
Figure 1. Second floor of Saron.<sup>42</sup>

The sizes of cells on the second and third floors of Saron vary widely. Although no two cells are exactly alike on these floors, strong similarities persist. In some cases, the width of the cells is very similar. Some of the cells on the east and west ends of the structure are parallel, sharing almost identical length dimensions. Below are diagrammatic reconstructions suggesting the original sizes of cells on the second and third floors of Saron (figures 1 and 2).

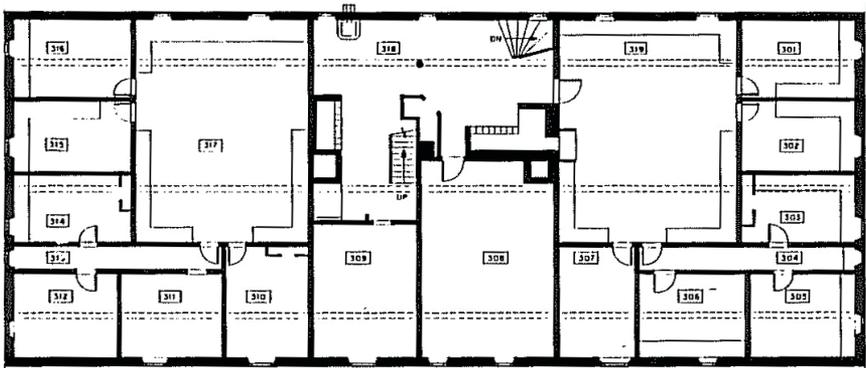
Figure 2. Third floor of Saron.<sup>43</sup>

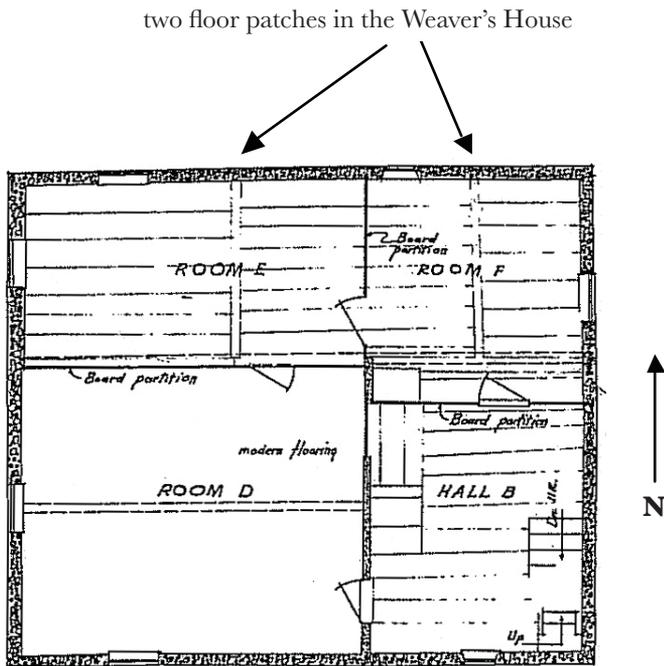
Figure 3. Brumbaugh plan of the second floor existing floor conditions in 1948.<sup>45</sup>

On the second floor of the Weaver's House, the lengths of the two floor patches are 103" and 103½" in length. These two floor patches are easily visible on the north end of the building. In the second floor of the Weaver's House on the floor of the north side of the building, the comparable floor patches where dividing walls were removed in Saron are 113½", 94½", and 100½" in length. The patches in the Weaver's House are pictured on a diagram (figure 3) drawn around 1948 by G. Edwin Brumbaugh, the first restoration architect, hired by the State of Pennsylvania to restore the Cloister buildings.<sup>44</sup>

Returning to the sketch in figure 3 (reduced below) one can plot possible room divisions in the second floor of the Weaver's House. If the two floor patches in this figure represent dividing walls for small rooms, we can determine the former size of these two rooms:

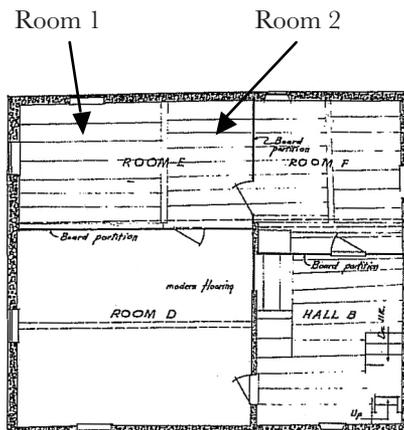
Room 1 would have been 128<sup>3</sup>/<sub>4</sub>" wide by 103<sup>3</sup>/<sub>4</sub>" deep. Room 2 would have been 128<sup>1</sup>/<sub>4</sub>" wide by 103" deep—nearly identical. (The scale of the drawing is not precise. Room 2 appears wider, but it is not.) This would indicate two fairly large rooms, much bigger than all the individual sleeping cells measured in the Saron. We don't allow for the possibility of a third room to the right of the right floor patch in this configuration because it would have been too narrow (only about 60").

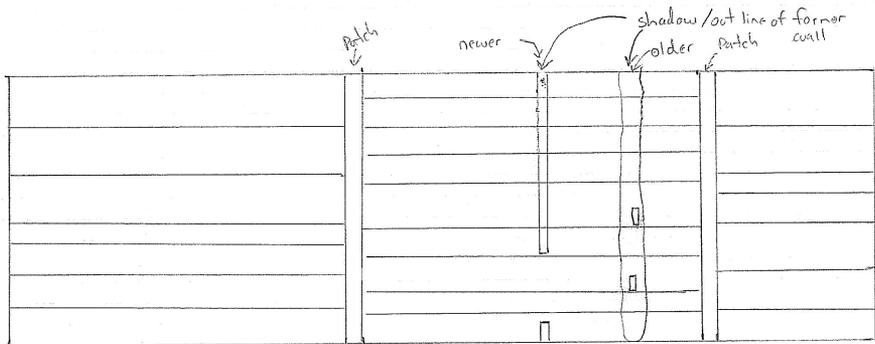
Figure 5. Diagram of north portion of second floor of Weaver's House.

Figure 5 represents a scale drawing made from measurements taken during research for this paper. This drawing represents the northern portion of the second floor of the Weaver's House (the original flooring, as best as can be determined). The two floor patches noted earlier in figure 3 are apparent and noted in this drawing. However, in this drawing there is a shadow outline of a former dividing wall. Mortise holes also appear in this old outline. This feature does not appear on the Brumbaugh drawings of 1948 or 1953, but it appears to be very old. The mortise holes are 20<sup>1</sup>/<sub>4</sub>" apart, and represent a possible doorway, the same door opening size of most of the cell doorways in the Saron. If this dividing wall was the original, and the patch to its right represented a later addition, then this would allow for three possible rooms with the following dimensions:

Room 1 - 128<sup>3</sup>/<sub>4</sub>" wide by 103<sup>1</sup>/<sub>4</sub>" deep

Room 2 - 99" wide by 103" deep

Room 3 - 93" wide by 103" deep

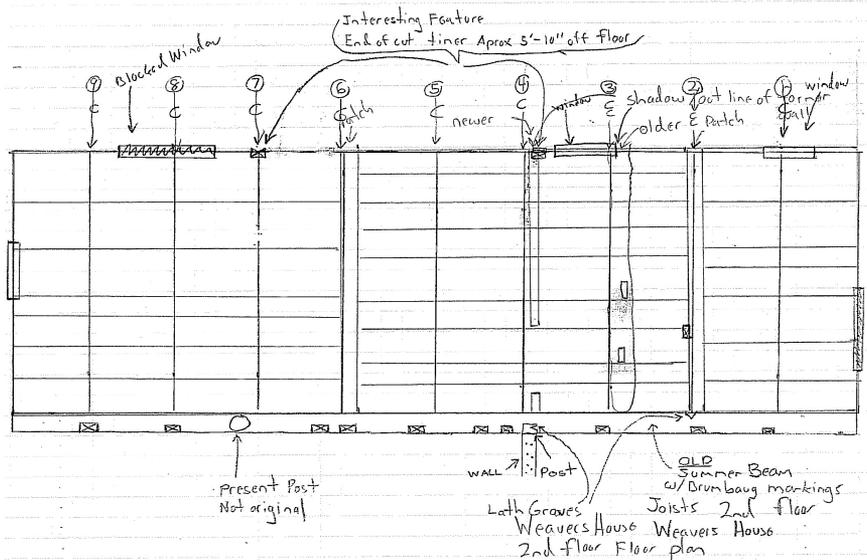
Figure 6. Diagram of north portion of second floor of Weaver's House with ceiling joists, window openings, and summer beam mortise marks imposed above.

The features numbered 1-9 represent the ceiling joists. This scale drawing shows that the joists above and below the three dividing walls would present solid fastening surfaces for the dividing walls. According to the fenestration in this scale drawing, each of the three rooms would have had a window. The dimensions of the rooms in this plan would be more similar to those in Saron. One of the rooms would have been considerably larger than the cells in the Saron, and the other two rooms slightly larger than most of those in Saron. However, it is not necessary for the dimensions of these small rooms to match more closely with those in the Saron for them to qualify as rooms for celibates.

If the outline of the joists above the floor and the northern summer beam mortise marks indicating the plaster wall, along with window openings, are imposed on top of figure 5 above, it results in figure 6 below:

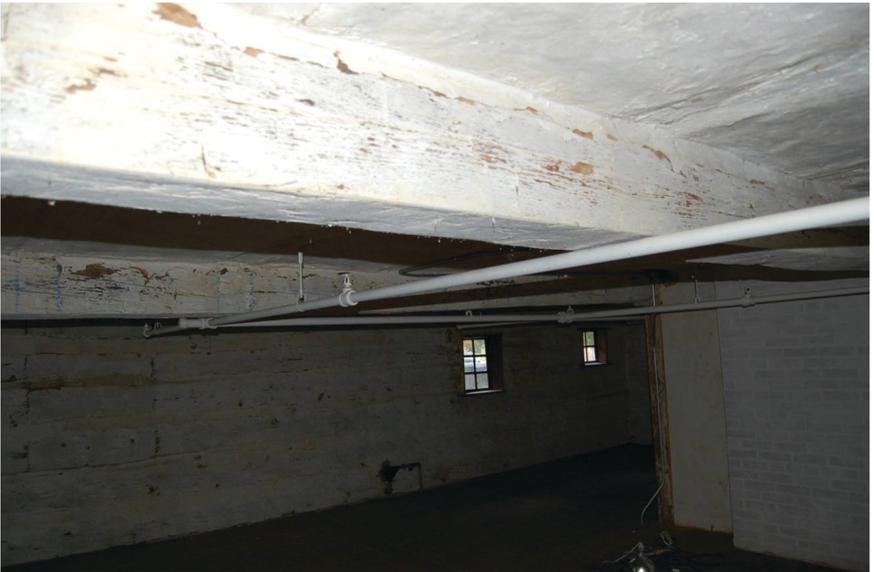
Figure 10. First floor of Weaver's House looking north showing both summer beams.

One of the most unusual structural features of the Weaver's House is its two summer beams. Typically a single-family home contained only one summer beam in the center of the house.<sup>29</sup> A summer beam is commonly defined as a major, and usually massive, horizontal timber that spans the plates of a structure from gable end to gable end. Its purpose is to carry the load of the joists above it.<sup>30</sup> The use of two summer beams does not appear in any other surviving historic structures at Ephrata, nor in comparable Germanic residential buildings of the same era. As a comparison, the Hans Herr House, a 1719 historic Germanic single family home, has only one summer beam.<sup>31</sup> There are a number of old homes that use two or more summer beams in their construction but they tend to be larger homes with more complicated structures. Many barns with three bays have two summer beams.<sup>32</sup> The Weaver's House offers no internal evidence today for why two summer beams were used. Could the sheer size of this building along with the use of two summer beams imply that it had another purpose? Determining exactly how the original summer beams functioned in this structure is also complicated by the fact they were replaced during the 1963 restoration.<sup>33</sup>

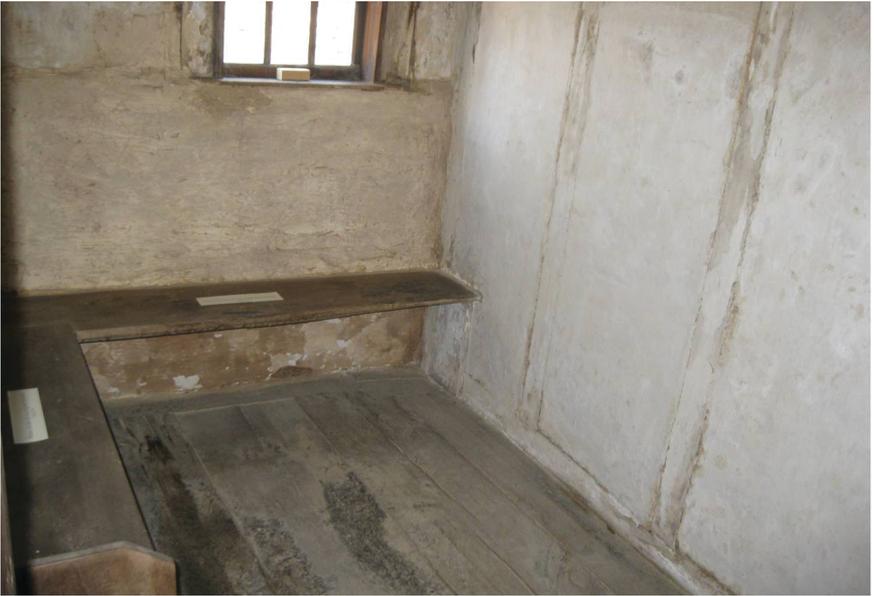
Figure 11. Third floor of Saron showing original cell, bench, and wall construction.

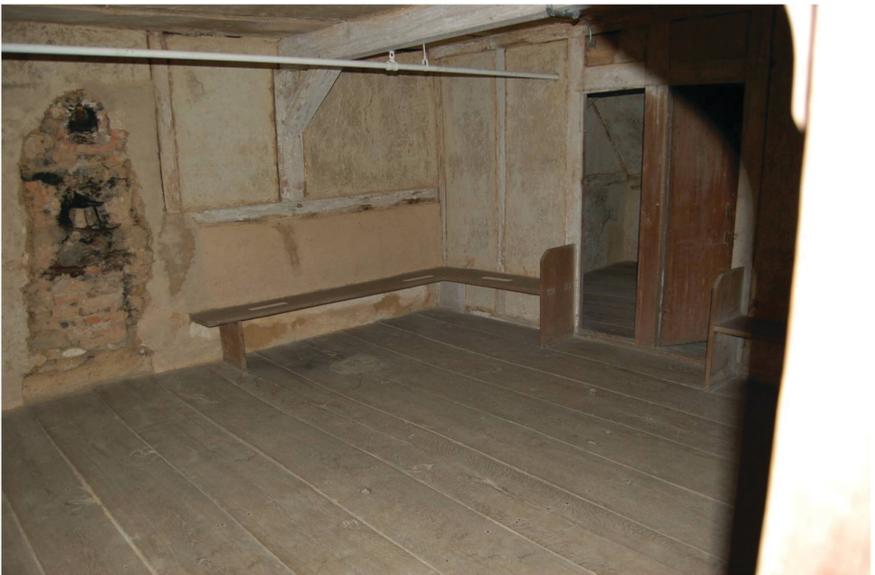
Figure 12. Second floor of Weaver's House showing both summer beams.

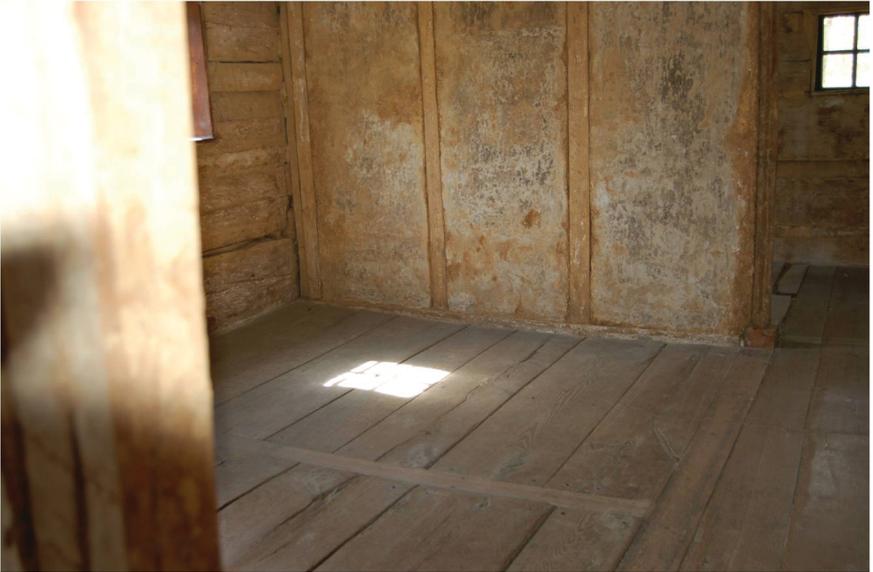
Figure 13. Second floor of Saron showing area where cell wall was removed forming larger room. Notice patch on floor where wall used to stand.

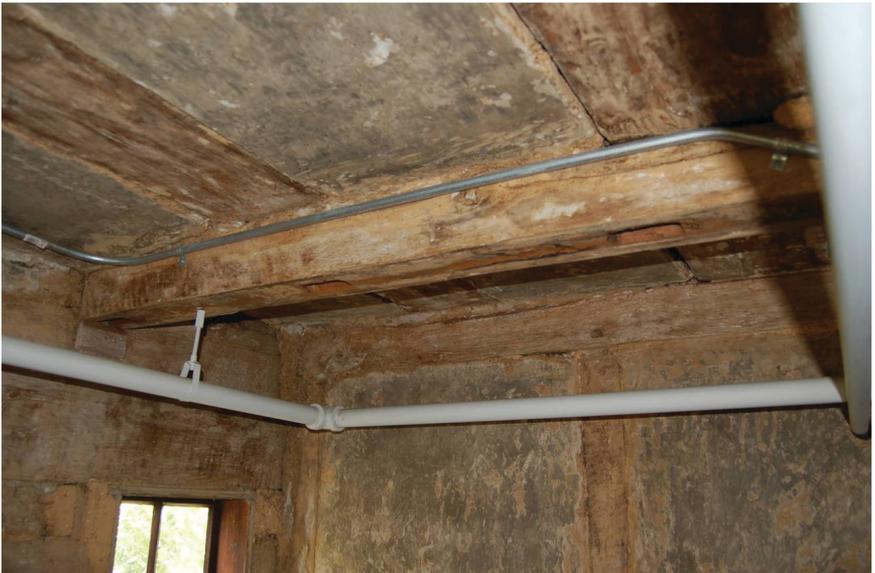
Figure 14. Second floor of Saron with ceiling joist and mortise holes where wall studs used to be. Also notice back wall with joist and stud locations.

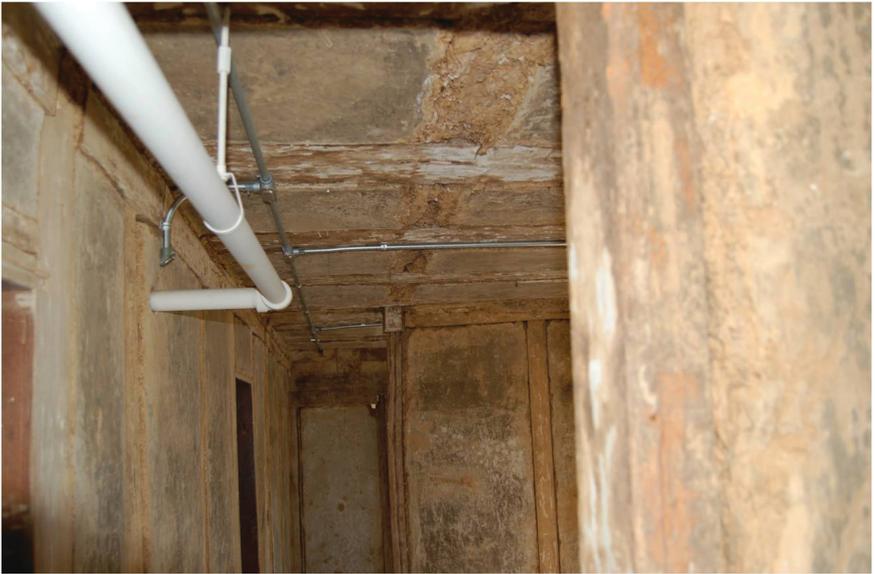
Figure 15. Second floor of Saron. Former hallway and wall have been removed. Notice where joist running along ceiling has been removed. Notice vertical groove running up vertical stud to hold lath.

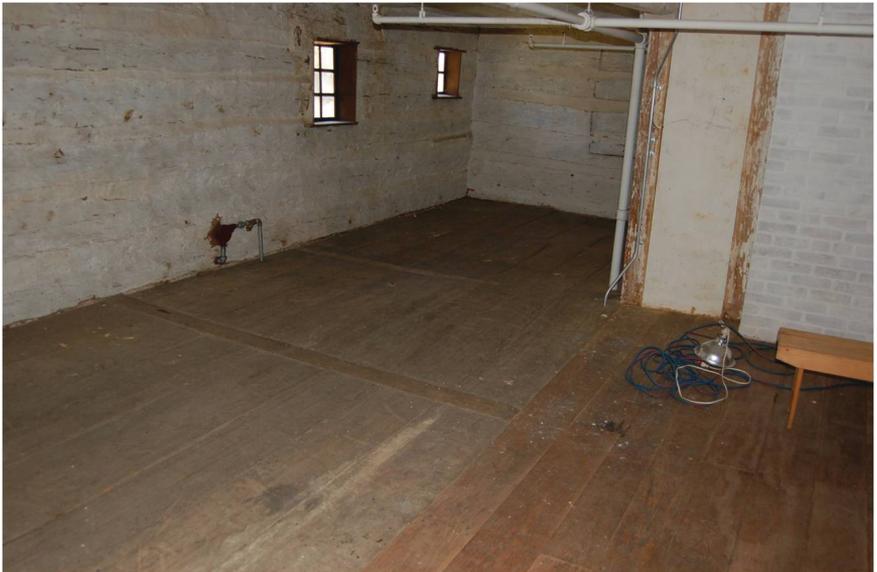
Figure 16. Second floor of Weaver's House showing floor patches where cell walls used to stand.

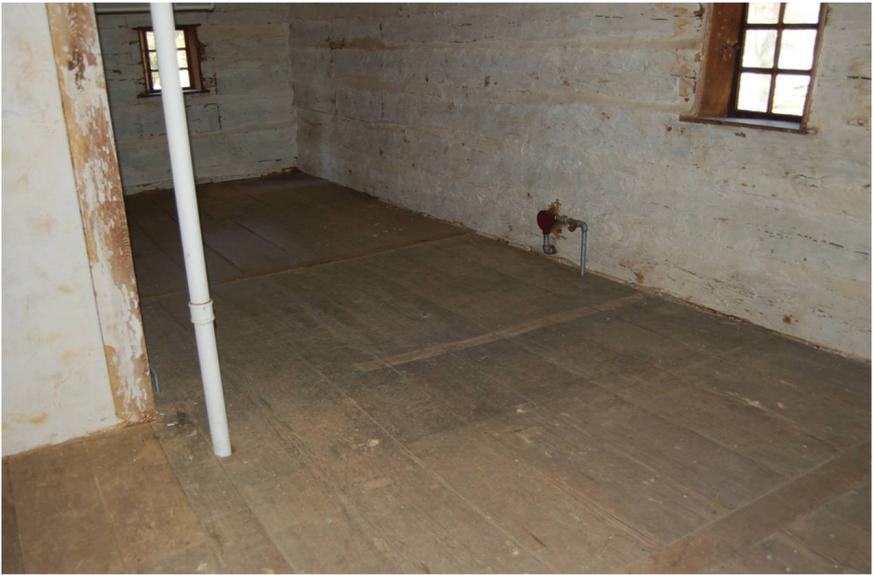
Figure 17. Second floor of the Weaver's House from the opposite angle showing floor patches denoting possible location of cell walls.
