TREATED VERSUS UNTREATED AGGREGATE BASES FOR FLEXIBLE PAVEMENTS: A NATIONWIDE COMPARITIVE STUDY

A thesis submitted in partial fulfillment
of the requirements of the degree of
Master of Science in Civil Engineering
Department of Civil Engineering and Construction Management

The University of Texas at Tyler
Dec 2018

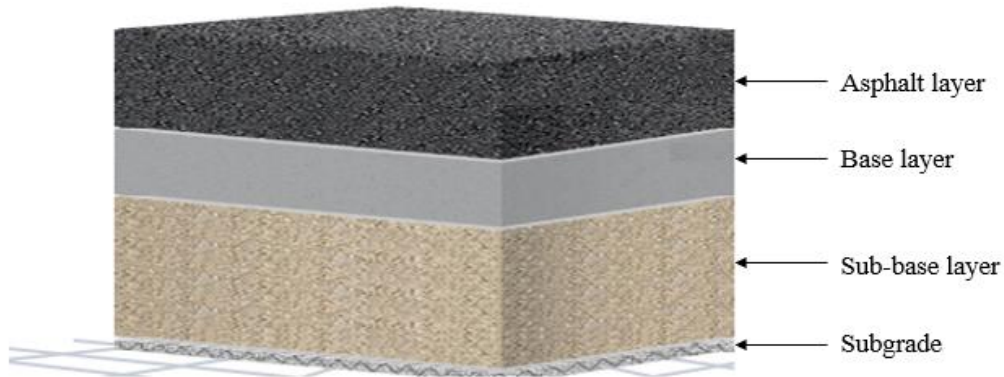
Figure 1. Layers of Flexible Pavement (3)

Traffic volume has increased rapidly throughout the United States. This has led to increased load applications on pavement roadways. Heavy traffic causes the most common failures in pavement structures producing fatigue cracking and rutting, ultimately decreasing the service life of the pavement (1). With the increasing traffic, pavement structures are subjected to higher stresses and more frequent loading cycles. High interparticle stresses lead to particle breakdown, reducing permeability and causing permanent deformations in granular bases and asphaltic concrete (2). This has led to the use of stronger bases to provide better stability against the heavy loads that the pavement is subjected to. Figure 1 represents a typical flexible pavement structure. A typical flexible pavement structure consist of a top surface asphalt layer, which is in direct contact with the traffic loads. The layer beneath the asphalt layer is base layer. Base layer provides support to the top layer and effectively distributes the load beneath it. The sub-base layer is the layer in between the base layer and subgrade. This layer provides structural support and improves drainage. A sub-base layer is not always needed if the other layers are good enough to support the loads. The bottom most layer is the subgrade layer, which receives the loads from the layers above it.

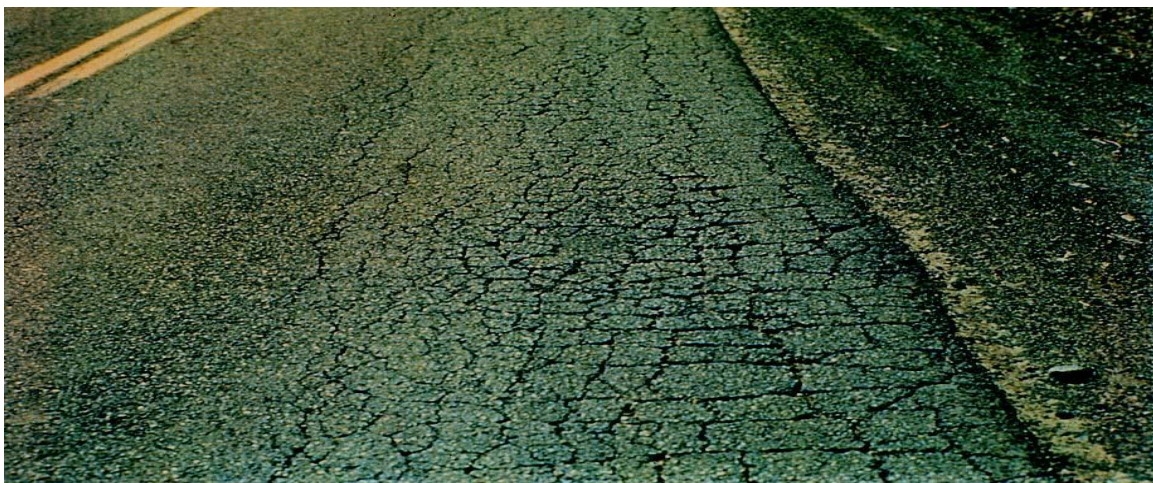
Figure 2. Fatigue Cracking in Flexible Pavement (6)

Fatigue cracking and rutting are the major distresses occurring in flexible pavement structures. Fatigue cracking is a series of interconnected cracks initiated from the bottom of the hot mix asphalt (HMA) to the surface under repeated traffic loading. These cracks are formed due to the tensile stress occurring at the bottom of HMA due to the heavy loads (6). Figure 2 shows the fatigue cracking occurring in the asphalt pavement.

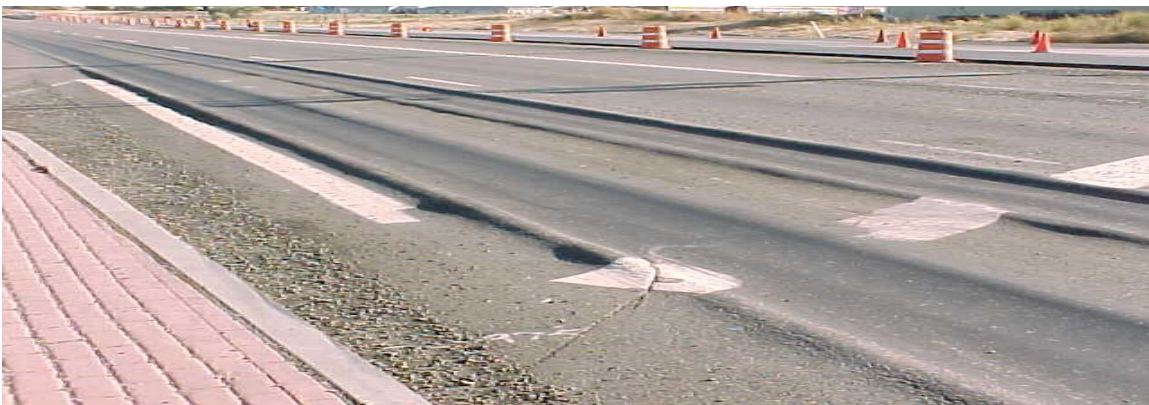
Figure 3. Rutting in Flexible Pavement (6)

Rutting is characterized by longitudinal depression on the pavement surface. Two basic types of rutting are observed in pavements: Mix rutting and Subgrade rutting. Mix rutting occurs when the pavement surface exhibits deflection because of compaction/mix design problems. Subgrade rutting occurs when deflection occurs on the subgrade due to loading. Therefore, the pavement settles into the subgrade ruts that causes surface into deflection in the wheel path (6). Figure 3 shows the rutting occurring in the wheel path of the road.

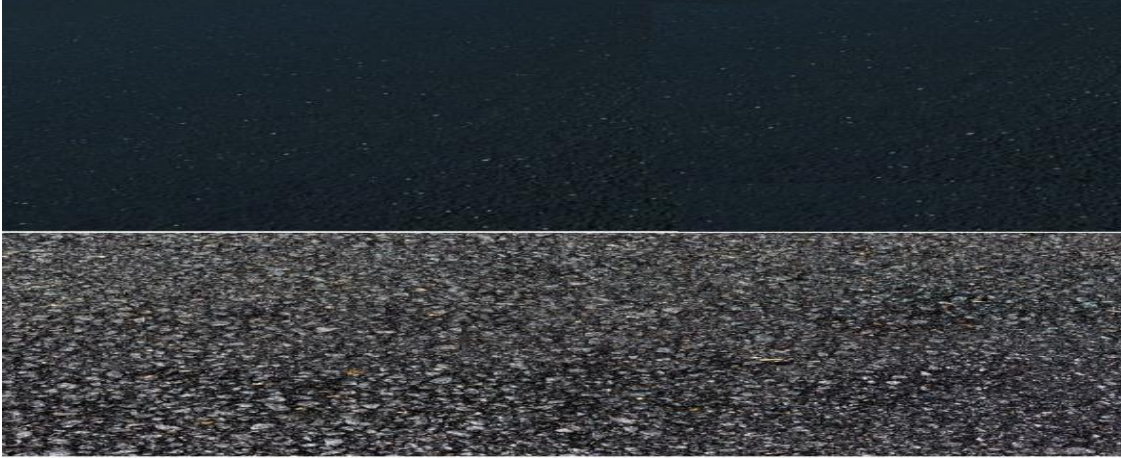
Figure 4. Surface Roughness (6)

In addition to Fatigue cracking and rutting, pavement roughness is the irregularities in the pavement surface that affects the ride quality of a vehicle. Surface roughness is an important pavement characteristic because it affects not only ride quality but also vehicle delay costs, fuel consumption and maintenance costs. Roughness is measured in International Roughness Index (IRI). Its unit is in/mile. It is the slope of a road profile. Pavement performance is determined by the amount of distress observed in the pavement. Figure 4 shows two different asphalt pavements with different roughness. One with very smooth surface and the other with a rough surface.

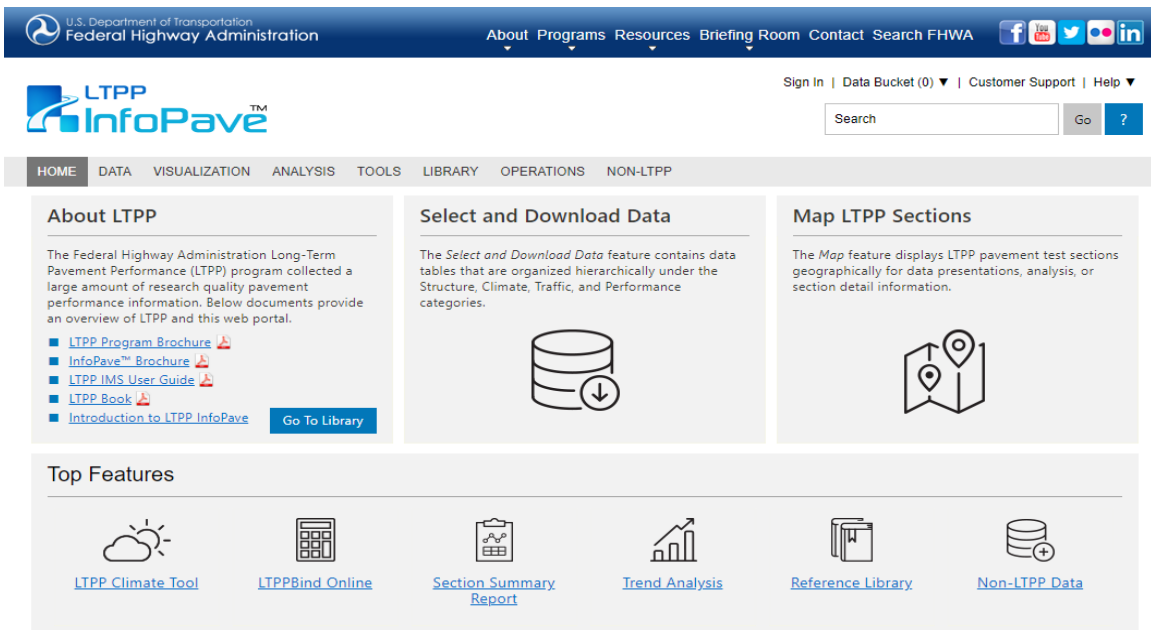
Figure 5. LTPP INFOPAVE DATABASE (1)

Long Term Pavement Performance (LTPP) database is a part of the Strategic Highway Research Program (SHRP) to study the performance of in-service pavements. Performance data is collected using standard procedures and protocols for different pavement types. Figure 5 shows the LTPP database, which was utilized to download the data for performance comparison. The data section in the LTPP database contains the input and distress data required for the analysis. The information collected is stored on the database for use. LTPP database contains around 2509 pavement test sections throughout United States and Canada (1).

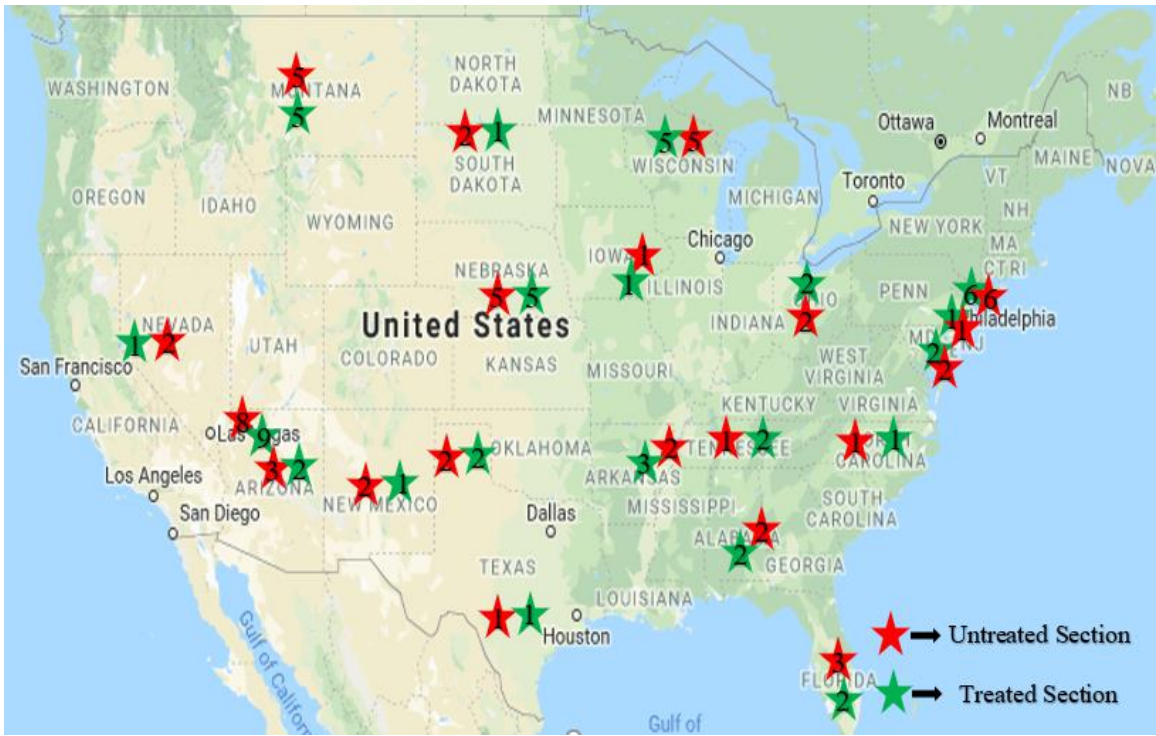
Figure 6. Map showing location of Treated and Untreated Sections considered for study

Flexible pavement sections from twenty-two different states were utilized to understand the effect of the stabilizers all across United States. Figure 6 shows the location of flexible pavement sections that were utilized for data analysis. 110 flexible pavements consisting of 56 untreated base and 54 treated bases were chosen such that all selected pavement sections contained data of all three above mentioned distresses. The green star in the figure represents the treated section and the red star represents the untreated section. The number inside the star represents the number of those sections utilized in analysis at that specific location.

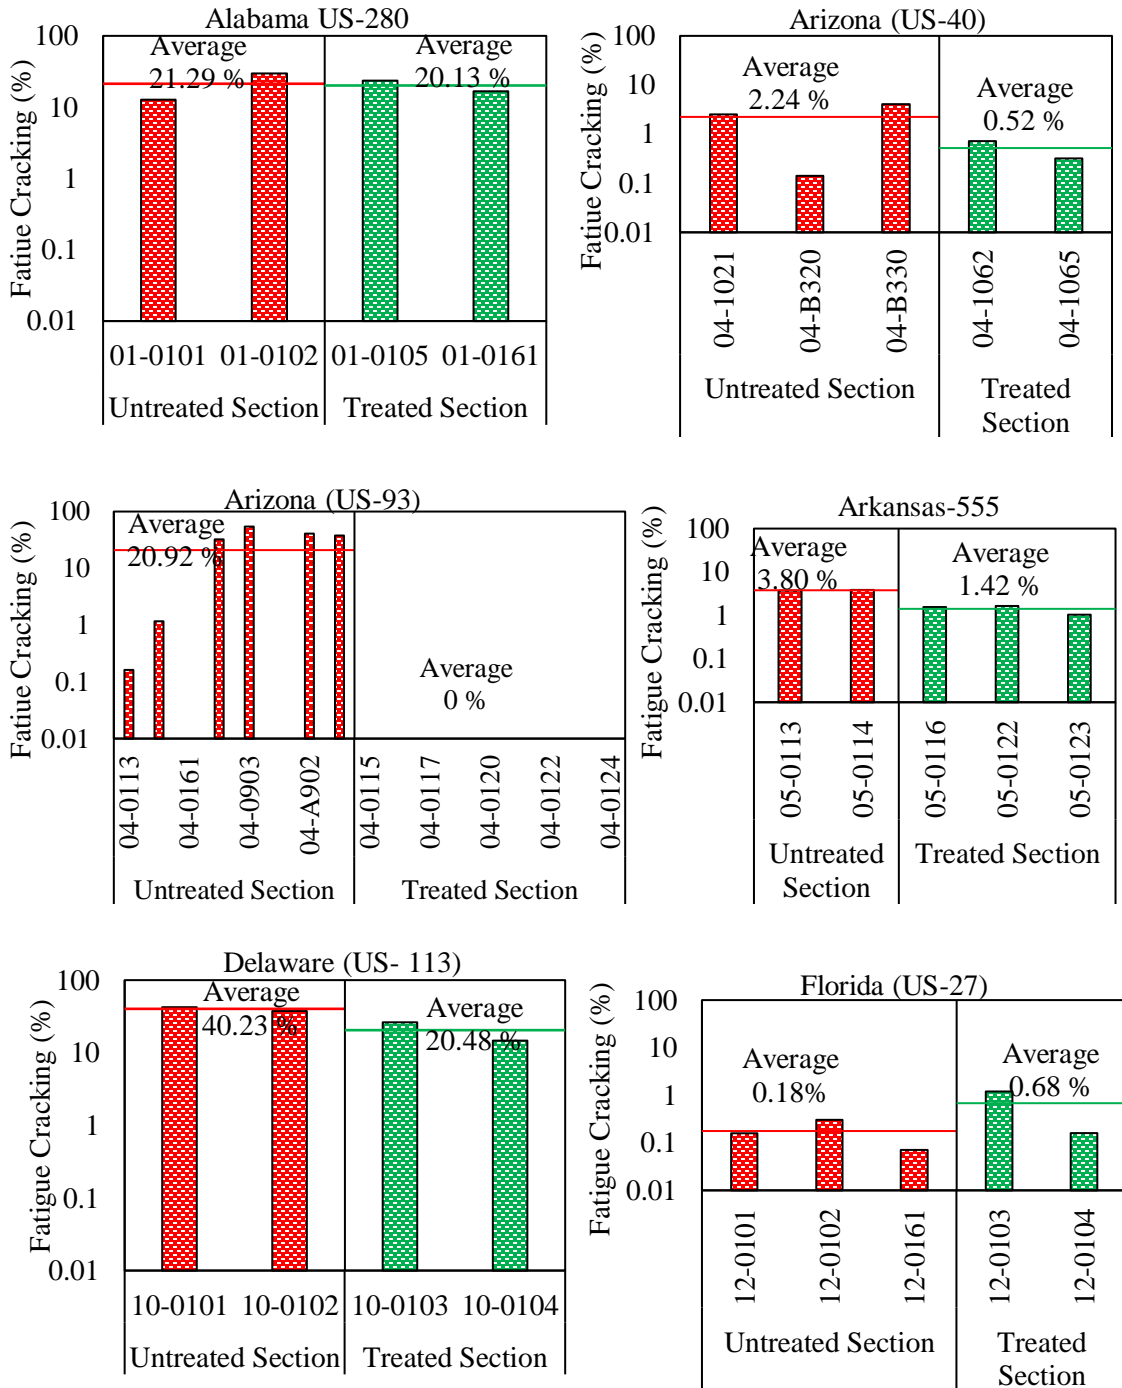
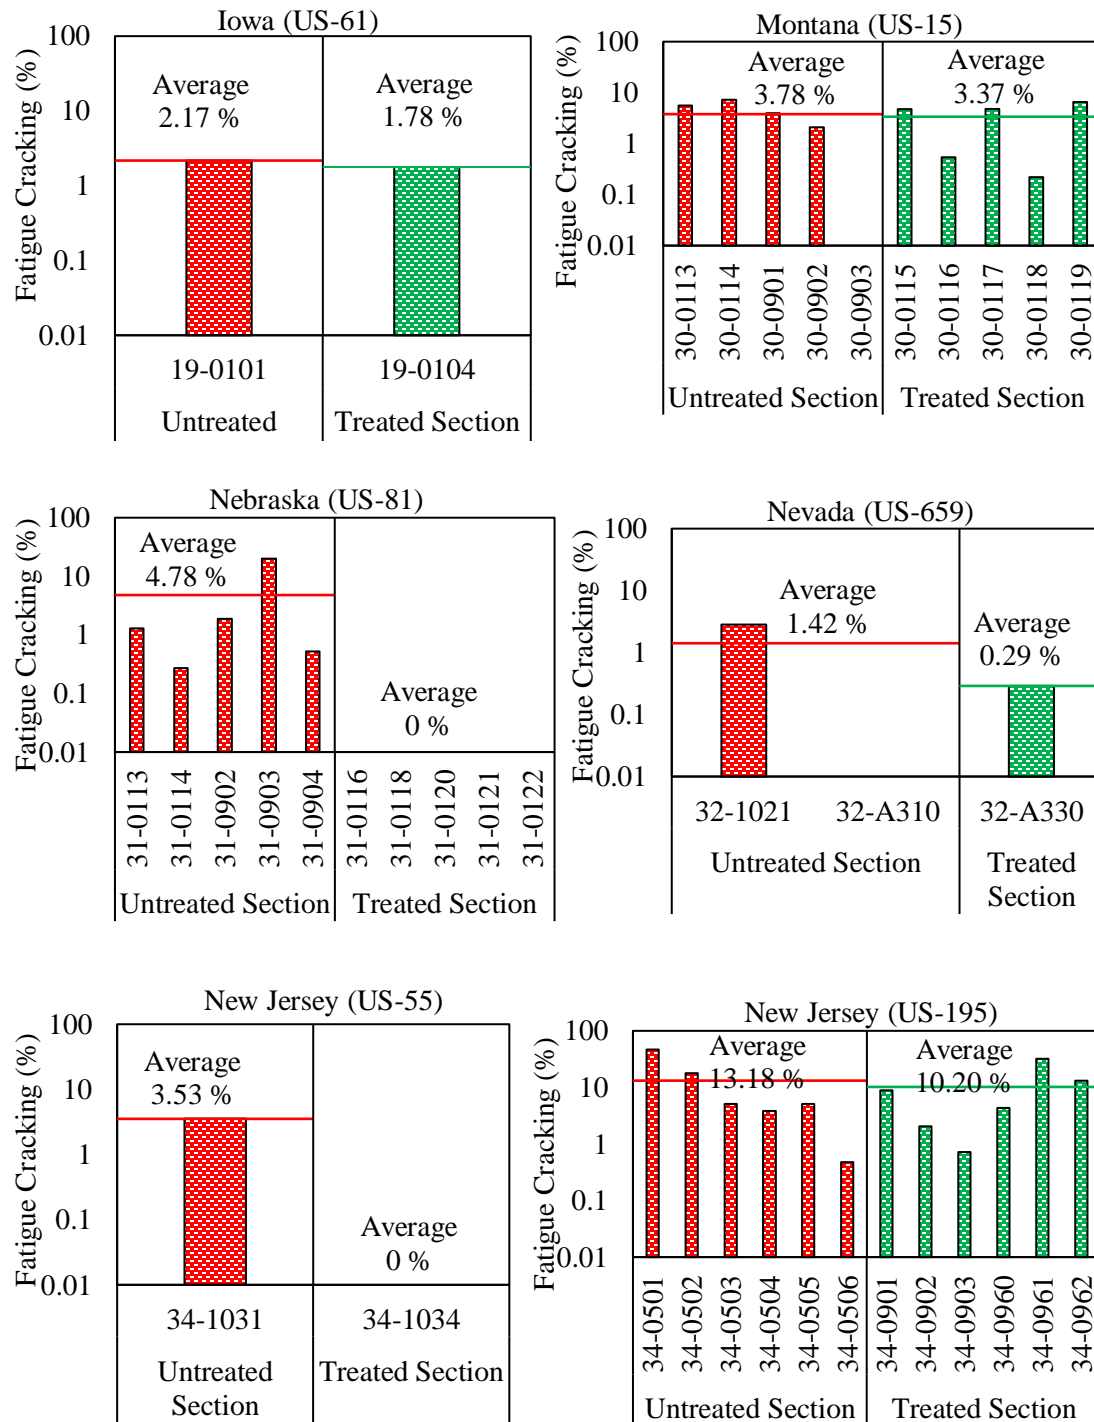
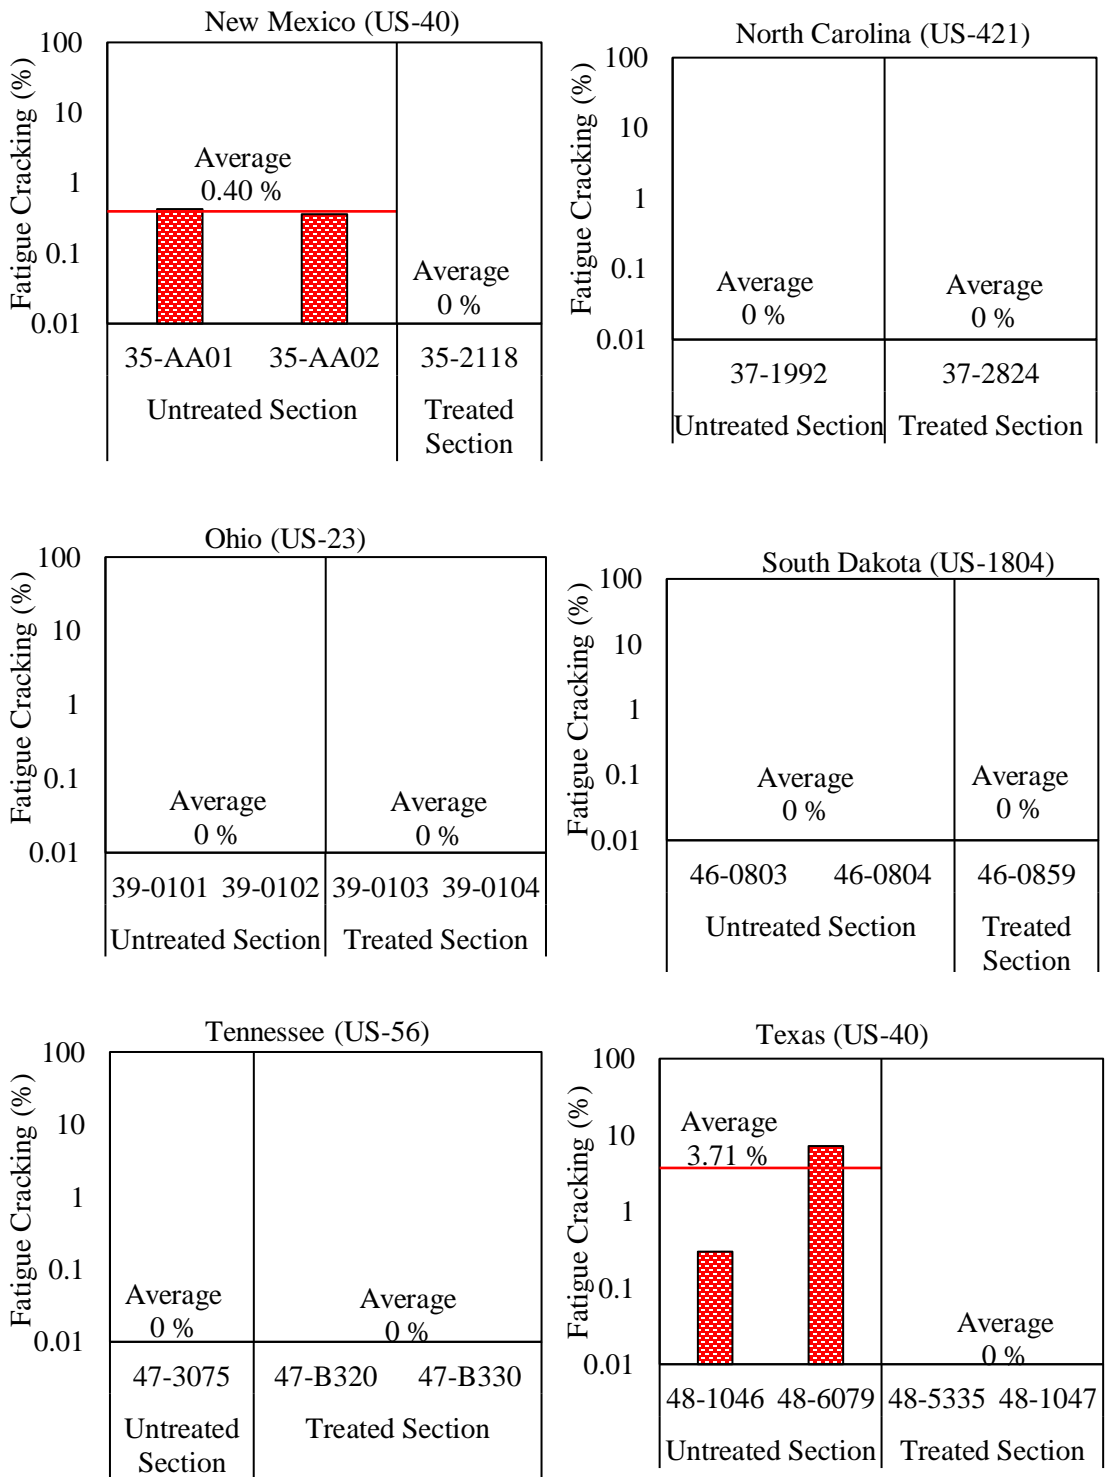
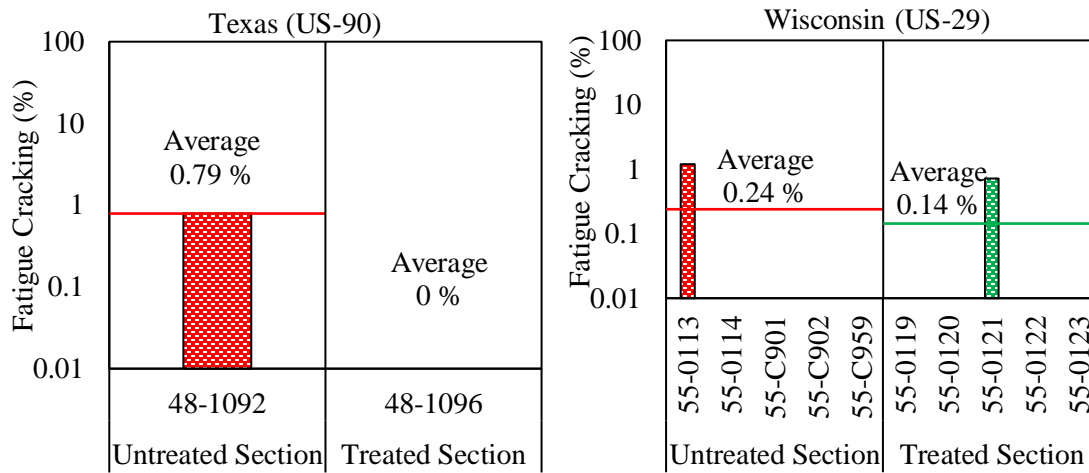
Figure 7. Average Fatigue Cracking of Treated and Untreated sections of states under study (LTPP Data)

Figure 7 shows the average fatigue cracking of treated and untreated sections for each state. Treated and untreated section were present on the same highway undergoing similar climatic effect and traffic conditions. Except for highway US-27 in Florida, the overall field performance of treated sections in all other states in terms of fatigue

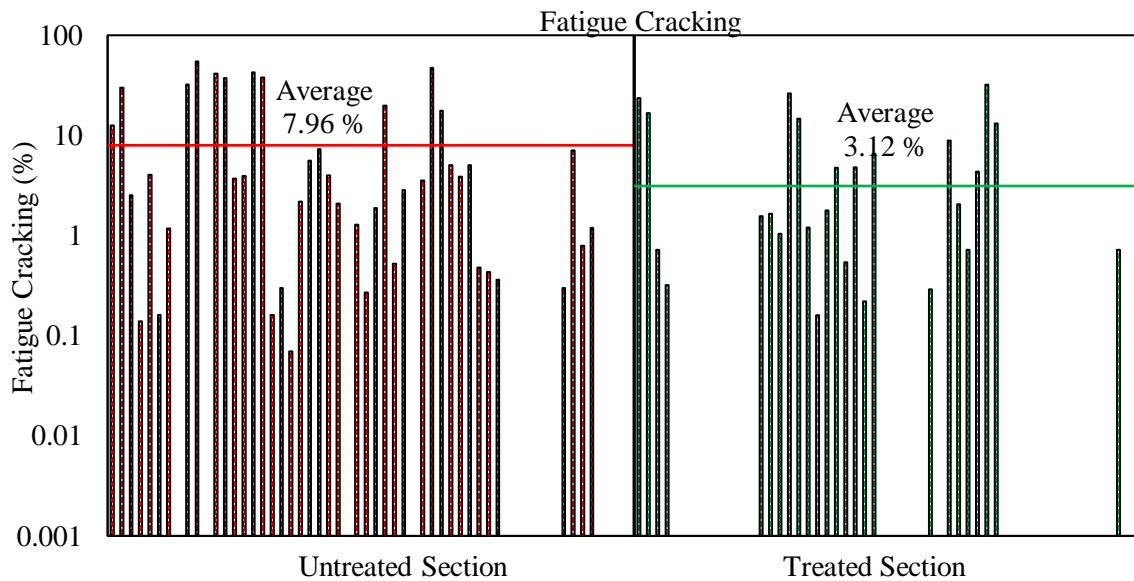
Figure 8. Combined Average Fatigue Cracking of Treated and Untreated sections (LTPP Data)

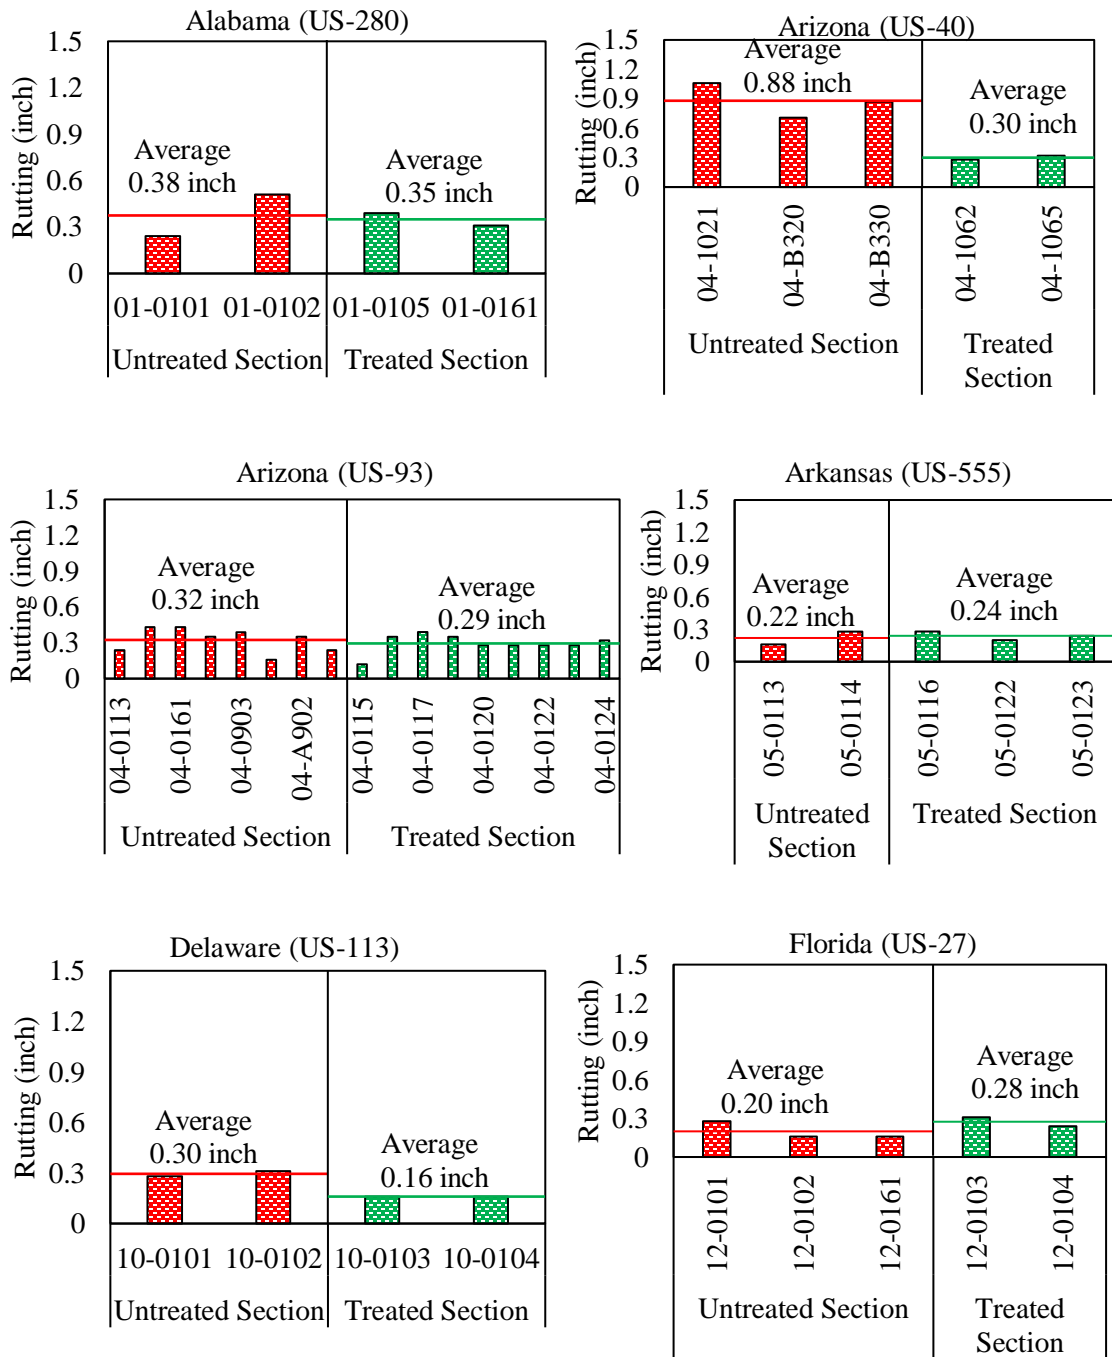
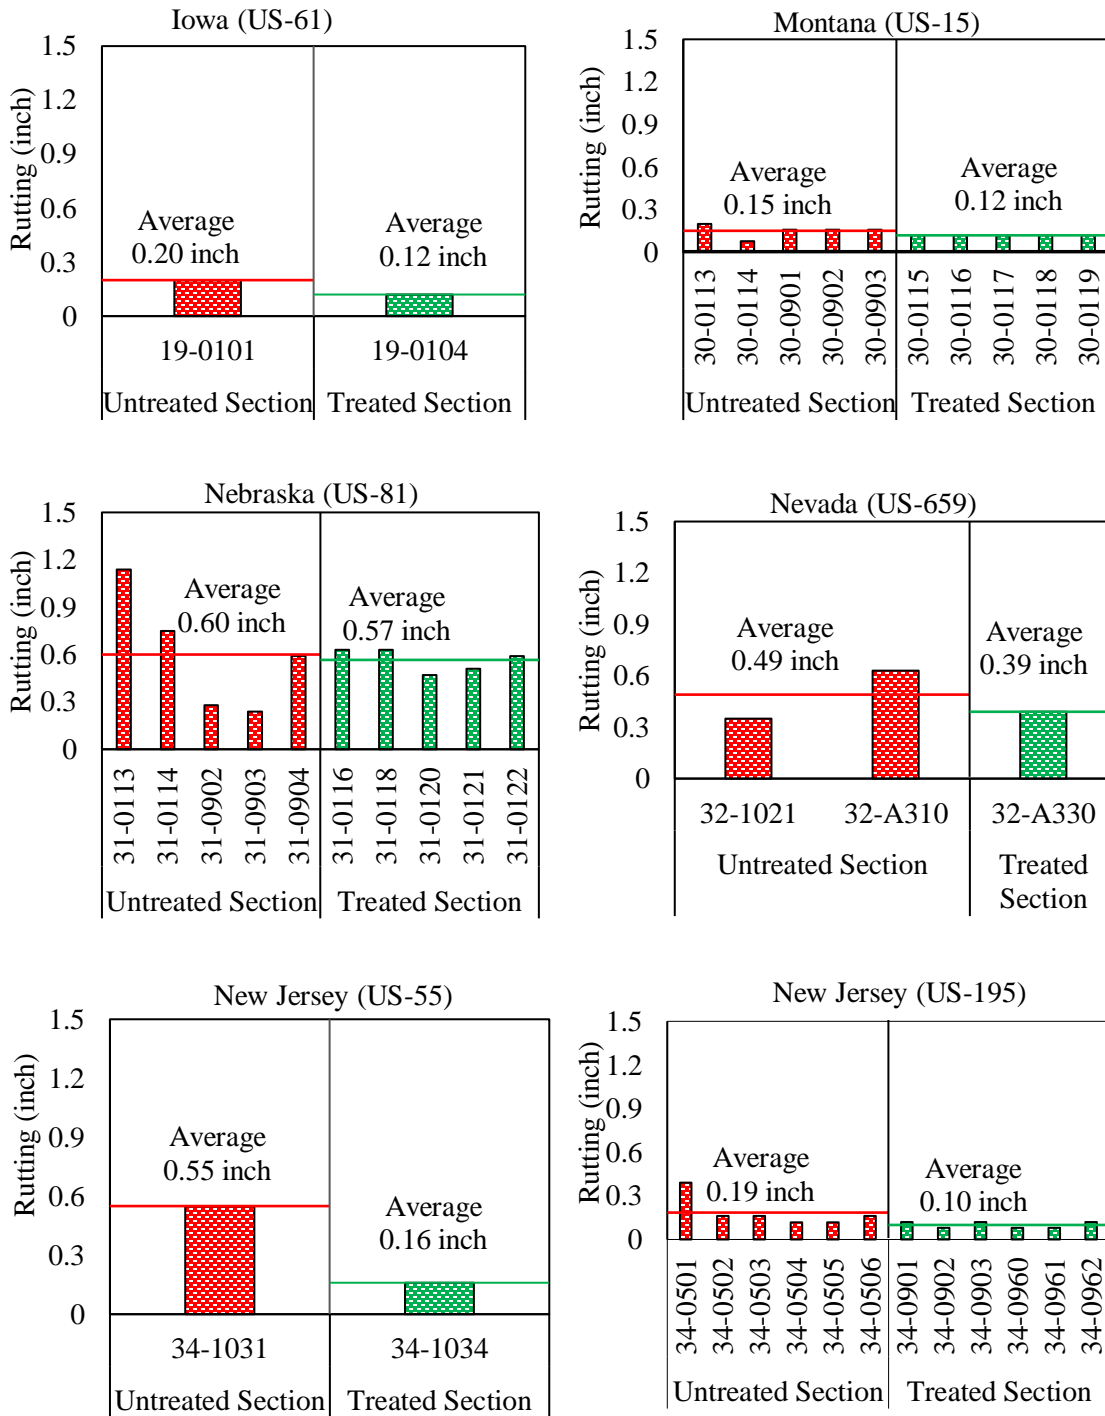
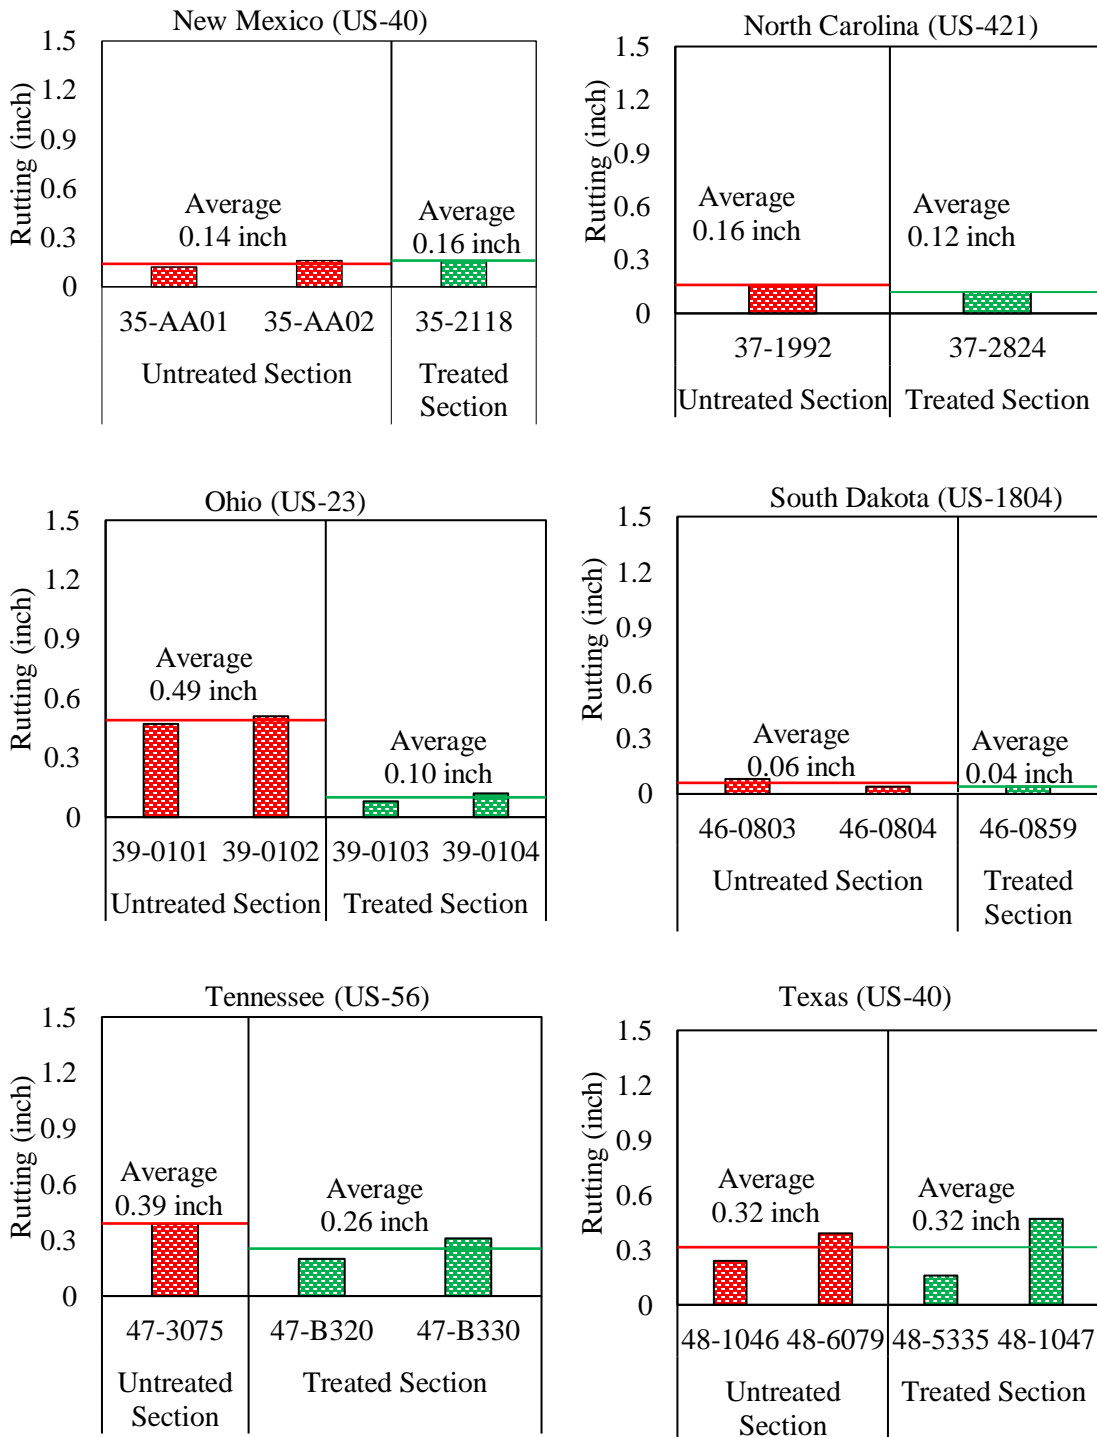
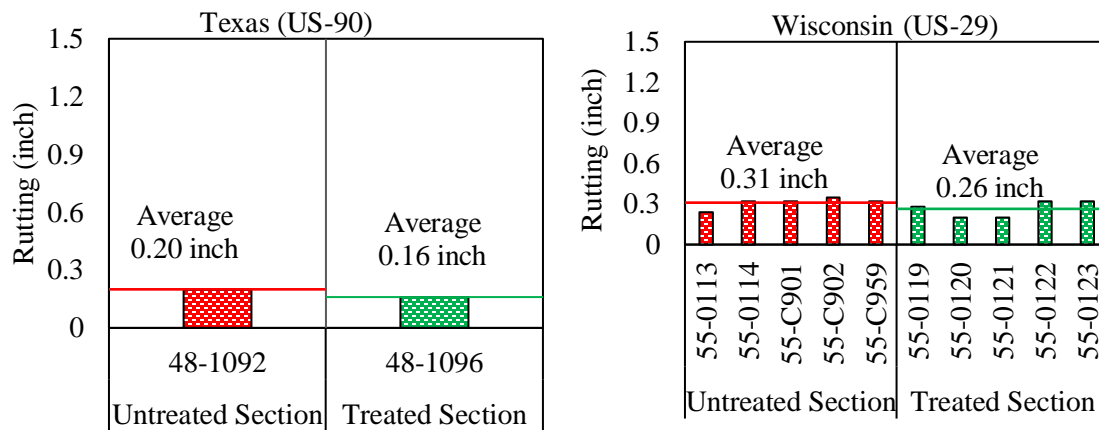
Figure 9. Average Pavement Surface Rutting Comparison between Treated and Untreated sections under study (LTPP Data)

Figure 9 shows the comparison of treated and untreated sections in terms of pavement surface rutting for each state. The average pavement surface rutting of treated and untreated sections are compared for all 17 states. Except for highways on three different states: Arkansas US-555, Florida US-27 and New Mexico US-40, the treated

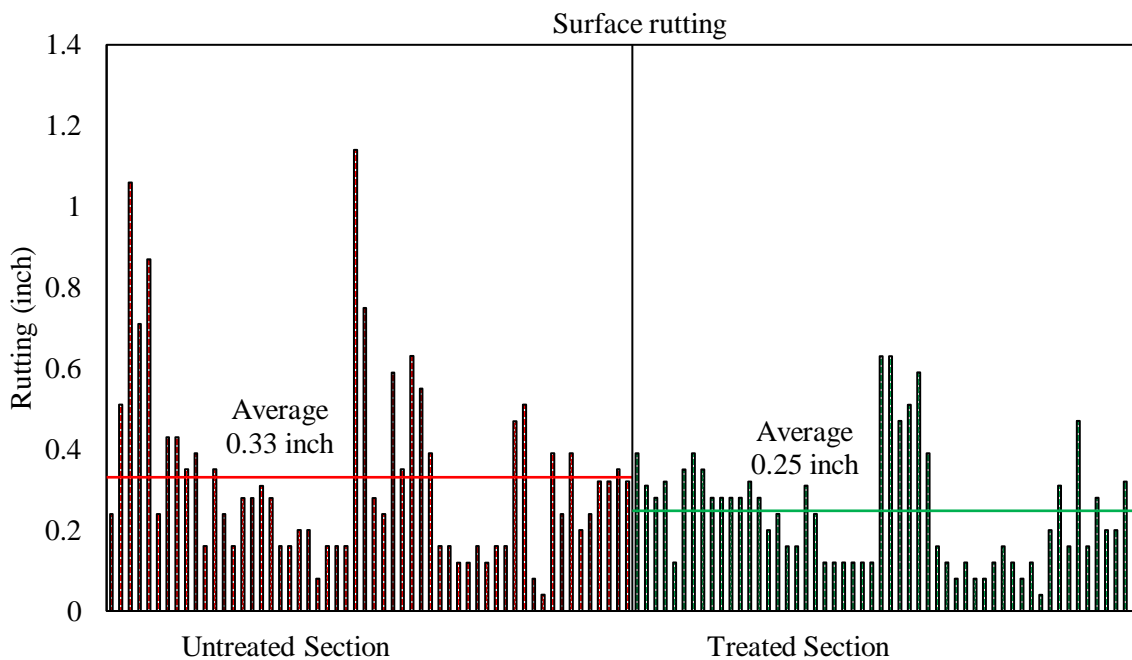
Figure 10. Combined Average Pavement Surface Rutting of Treated and Untreated sections (LTPP Data)

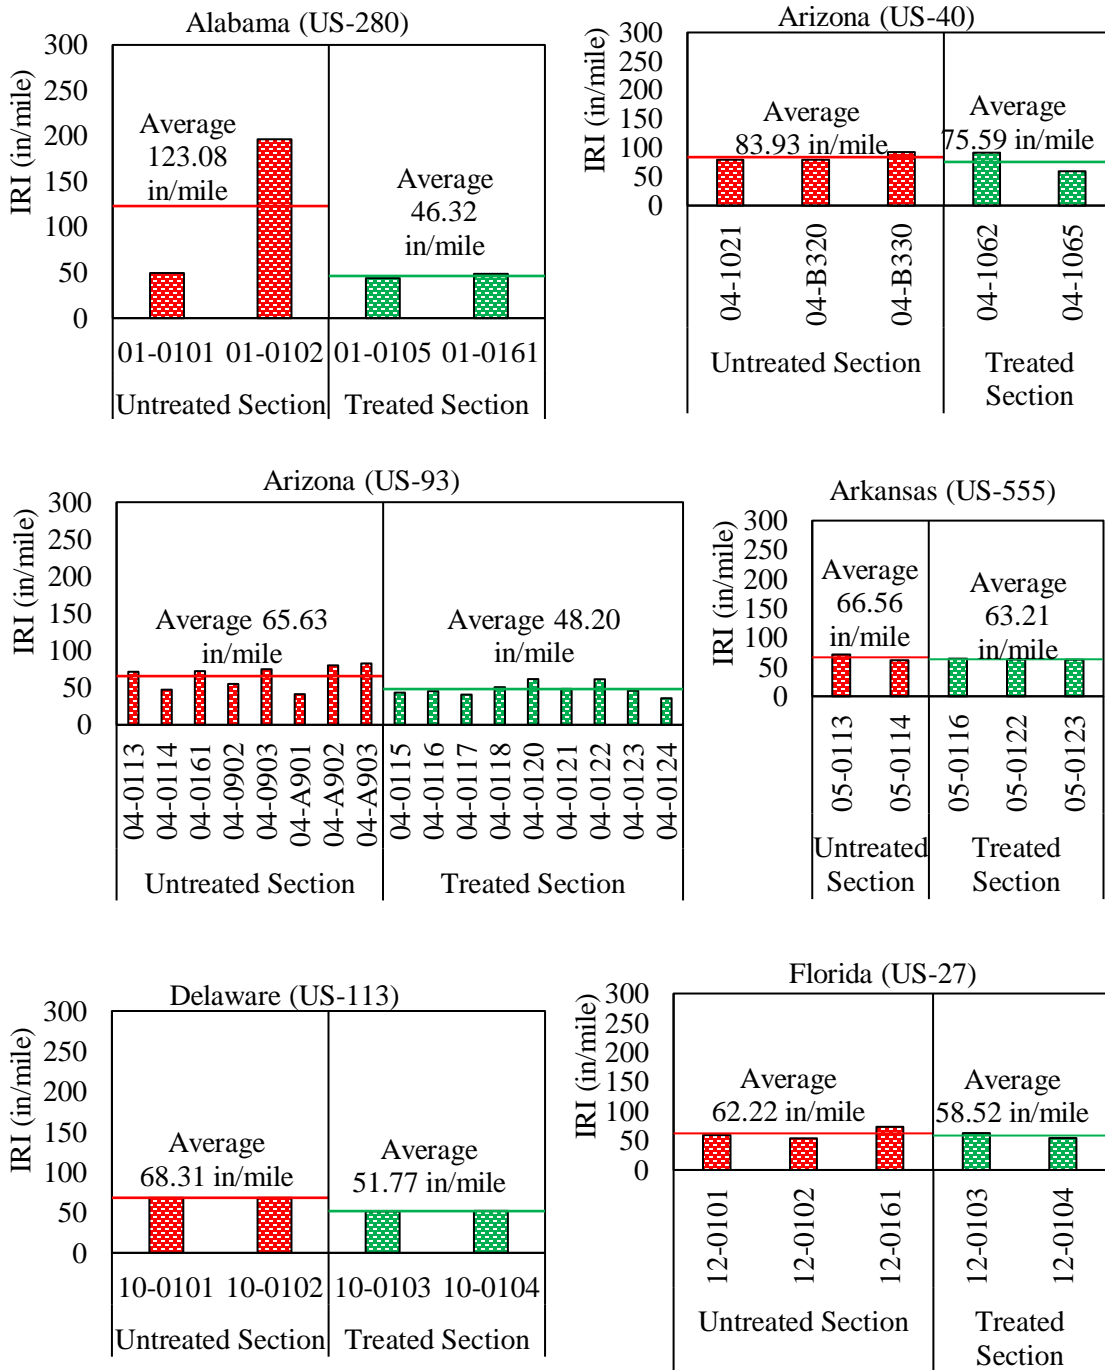
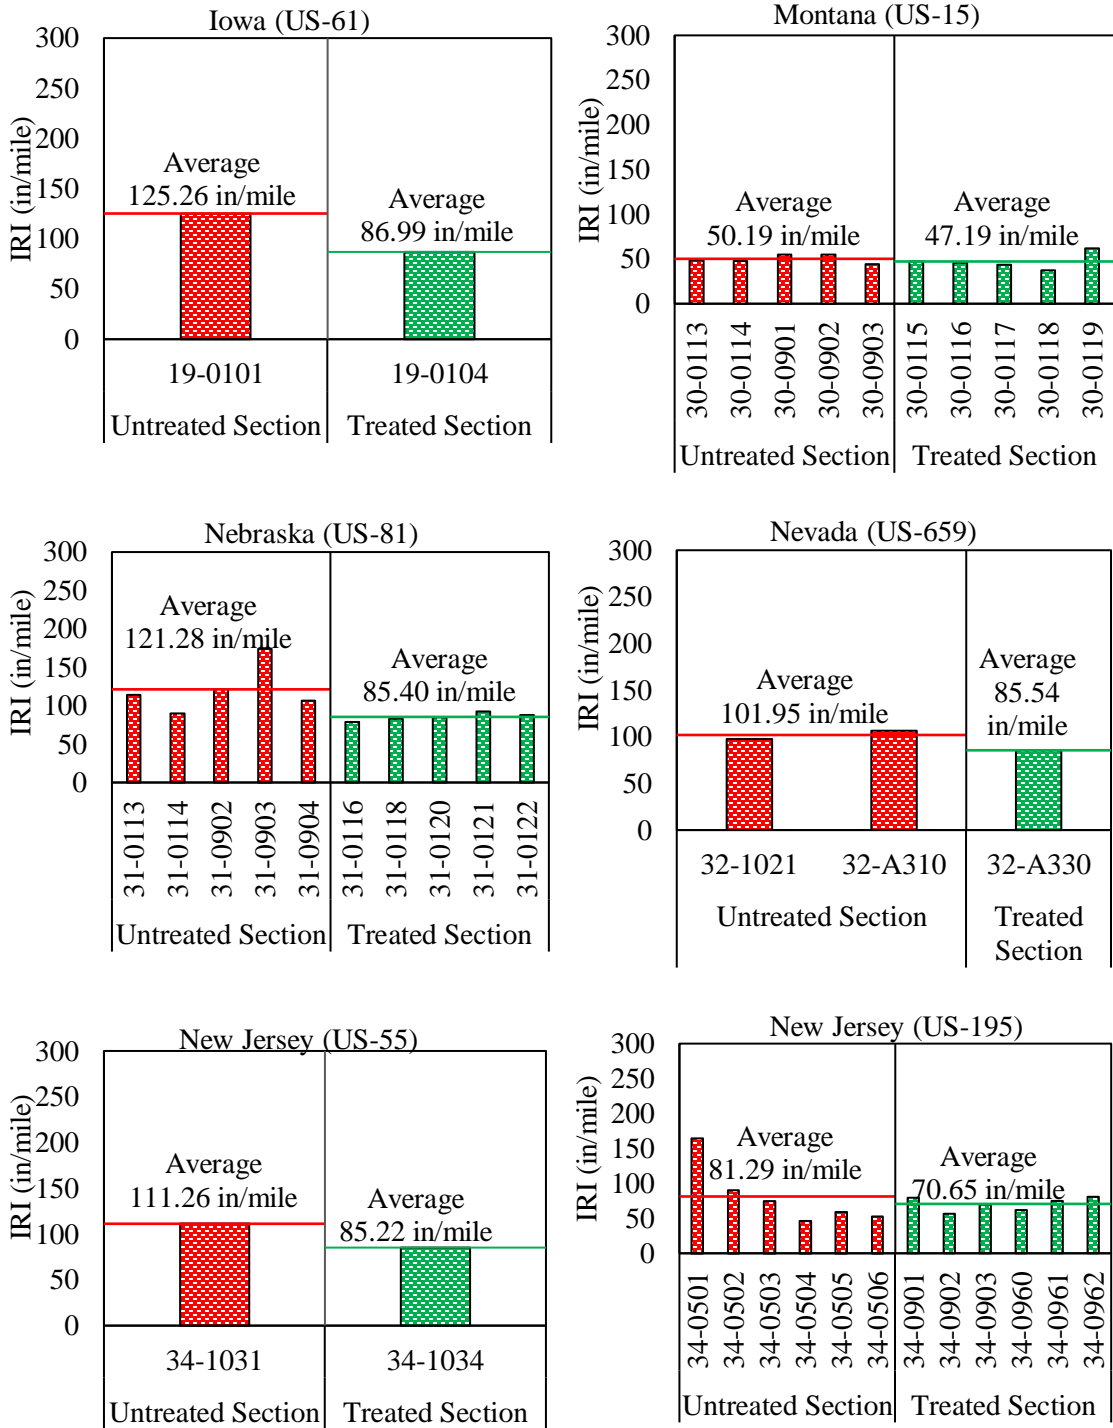
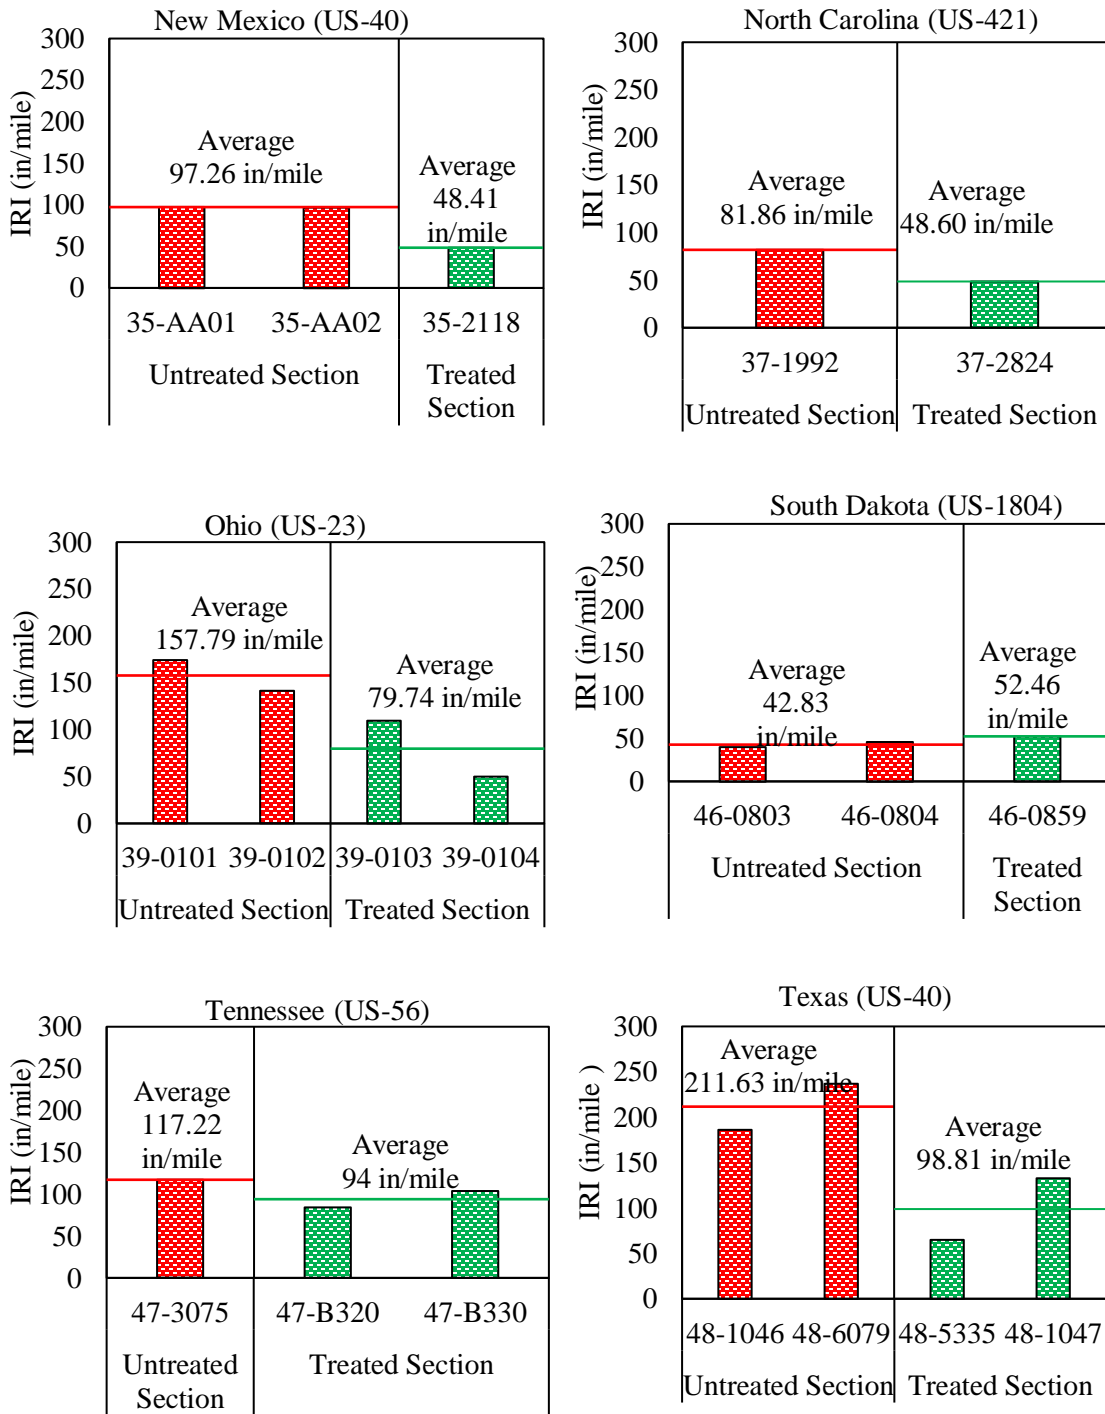
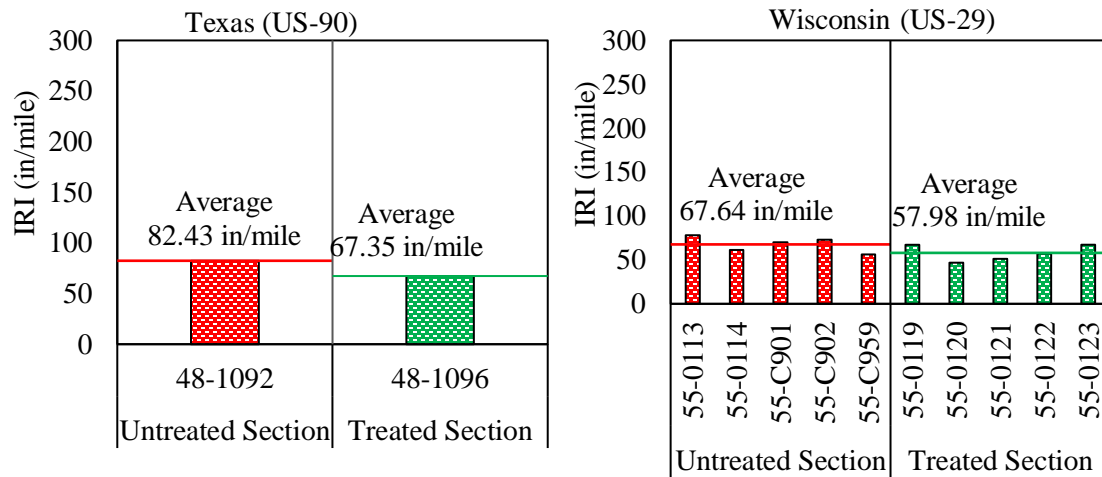
Figure 11. Average Pavement Surface Roughness (IRI) Comparison between Treated and Untreated sections under study (LTPP Data)

Figure 11 shows the average pavement surface roughness (IRI) of the treated and untreated sections for each state. For most of the states, the field performance of treated sections was superior. In the case of South Dakota highway US-1804, the untreated

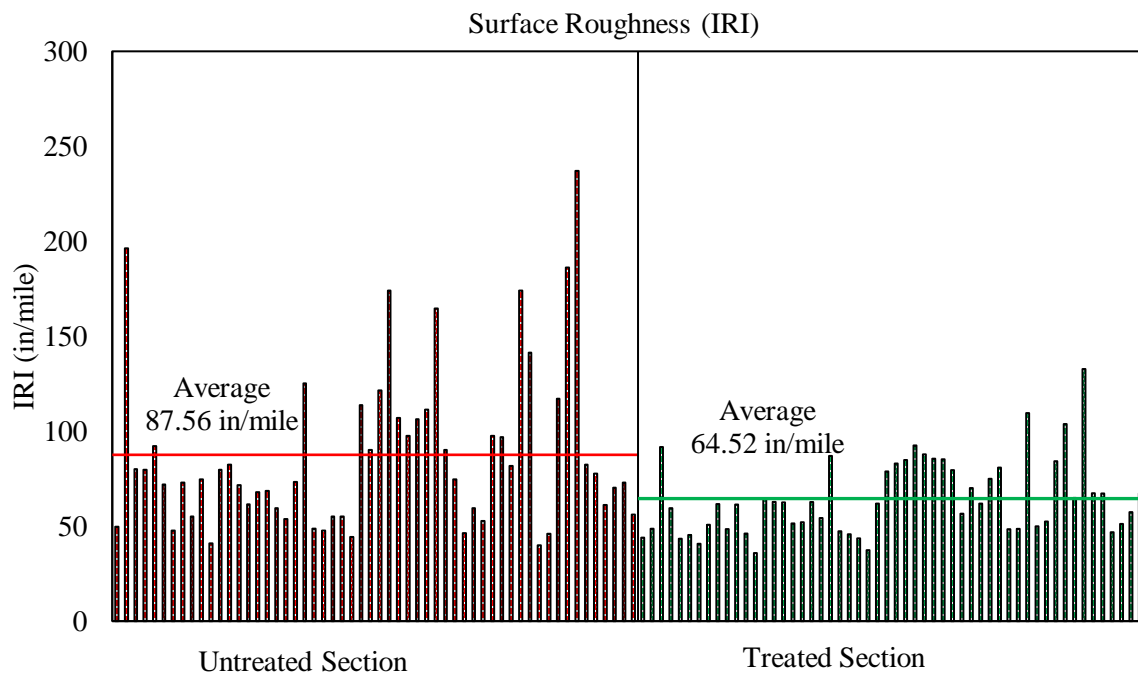
Figure 12. Combined Average Pavement Surface Roughness of Treated and Untreated sections (LTPP Data)
