TREATED VERSUS UNTREATED AGGREGATE BASES FOR FLEXIBLE PAVEMENTS: A NATIONWIDE COMPARITIVE STUDY

A thesis submitted in partial fulfillment
of the requirements of the degree of
Master of Science in Civil Engineering
Department of Civil Engineering and Construction Management

The University of Texas at Tyler
Dec 2018

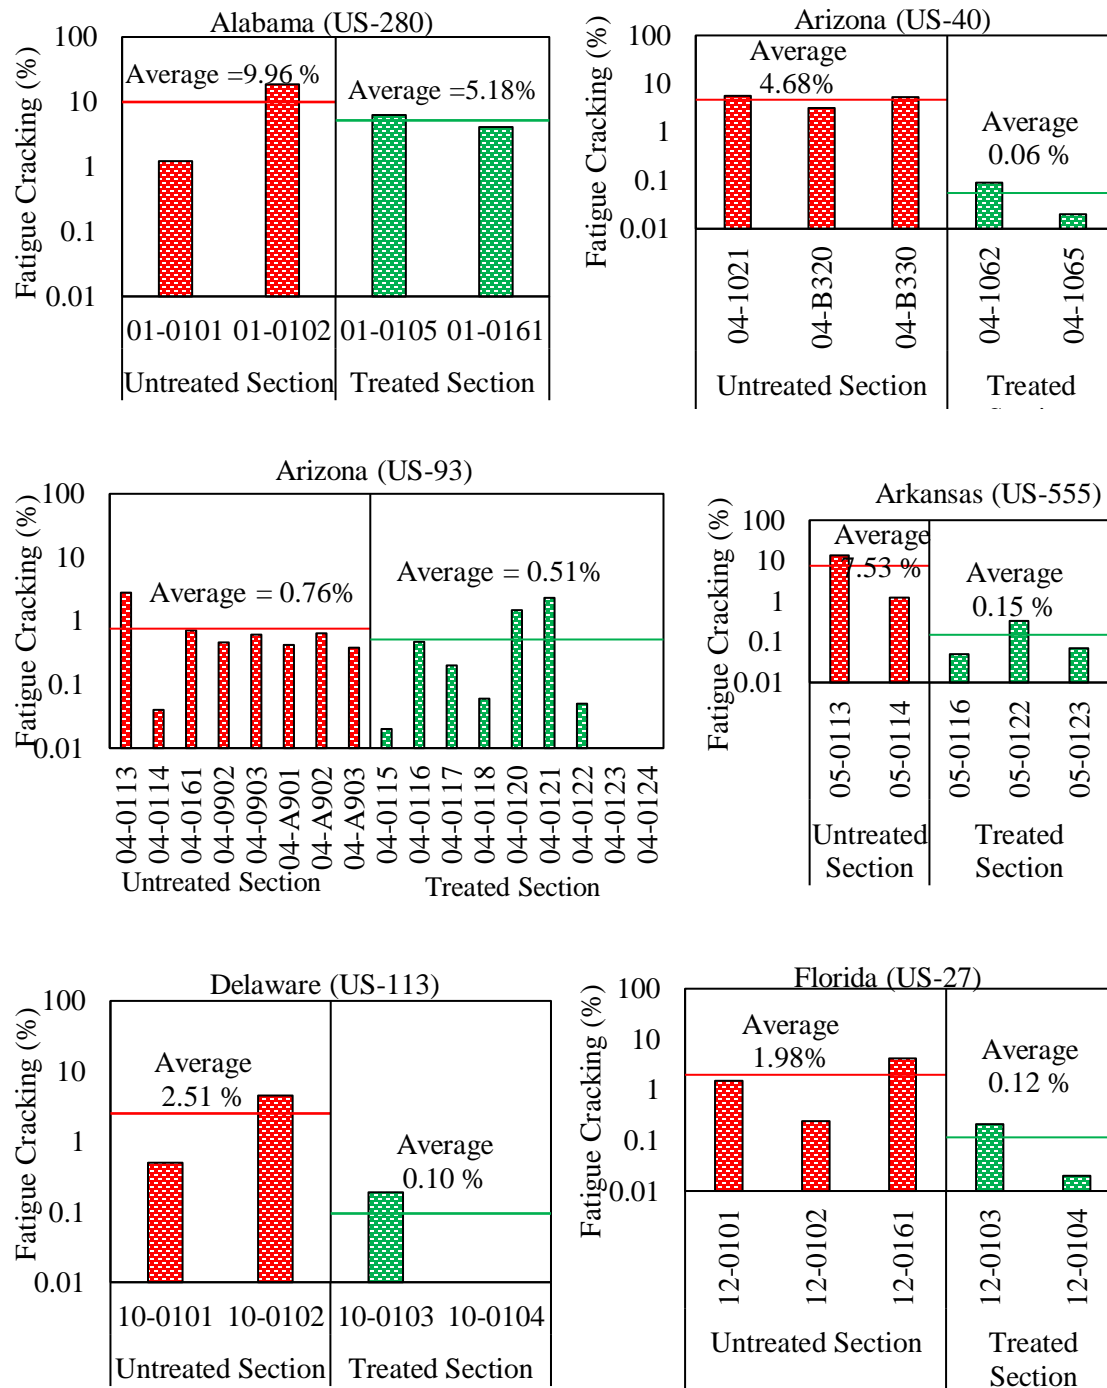
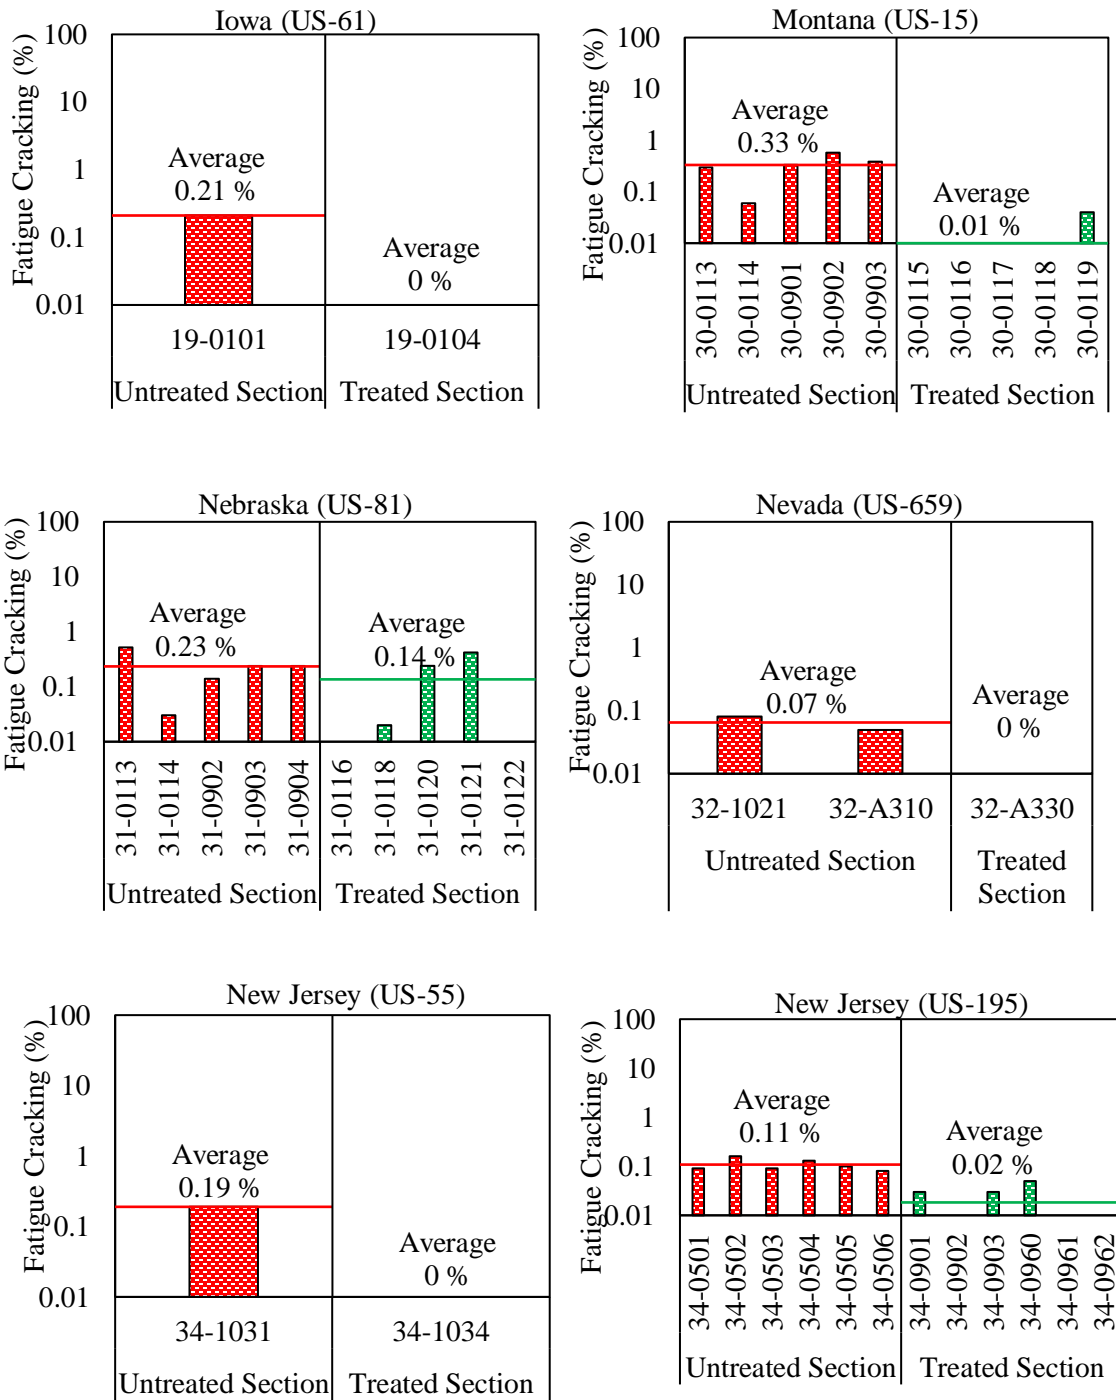
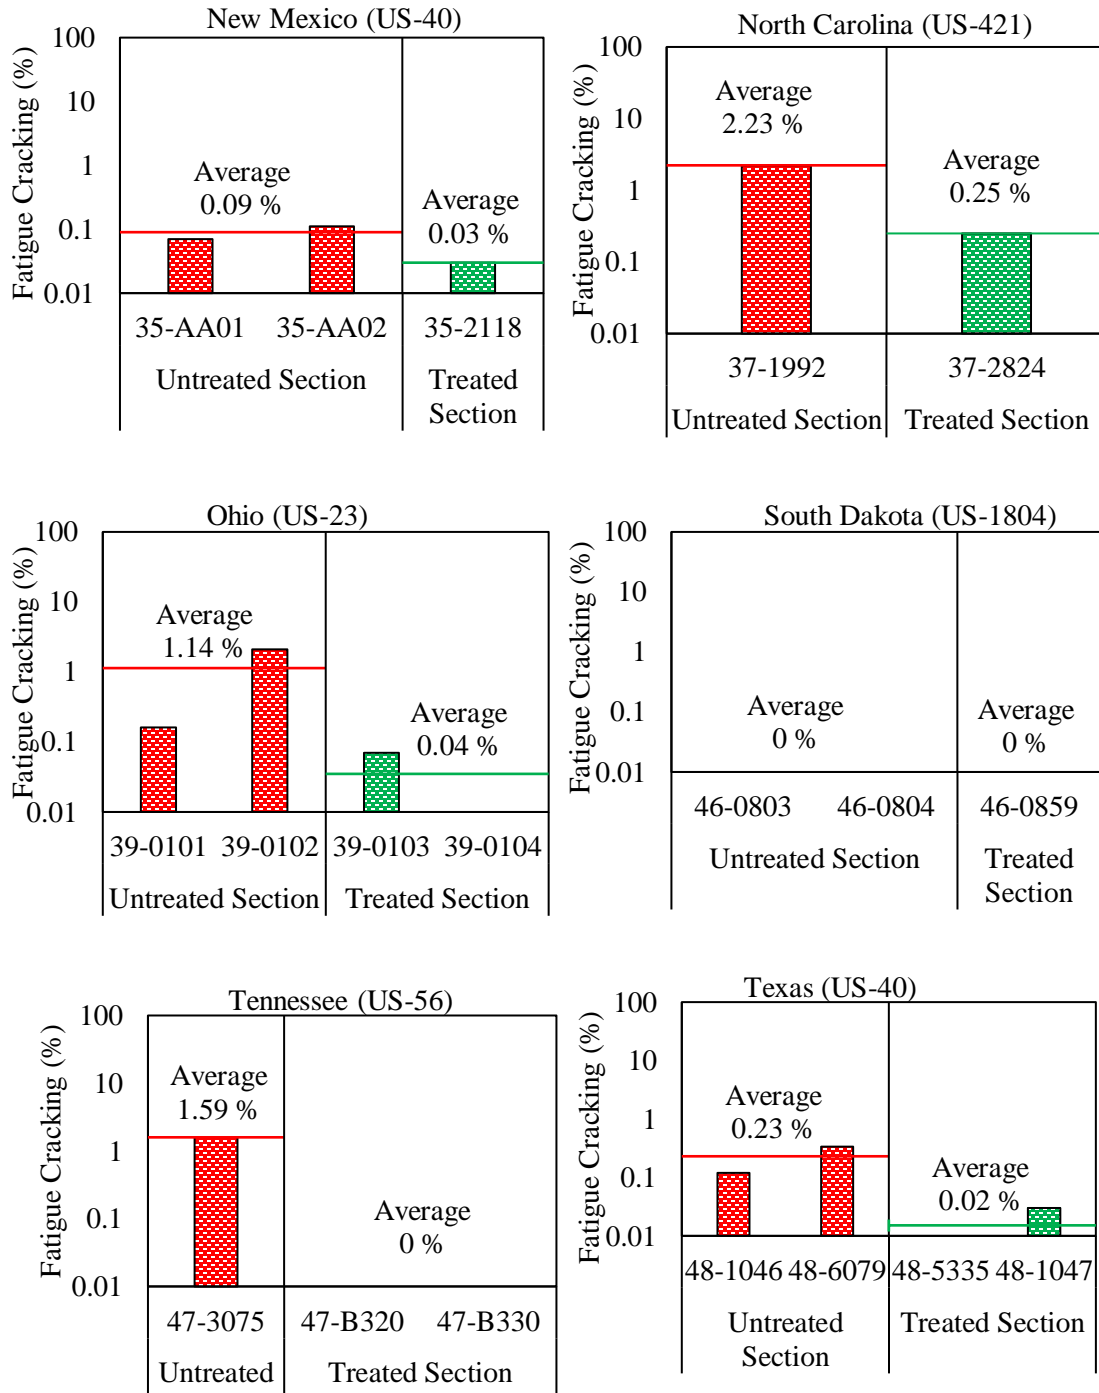
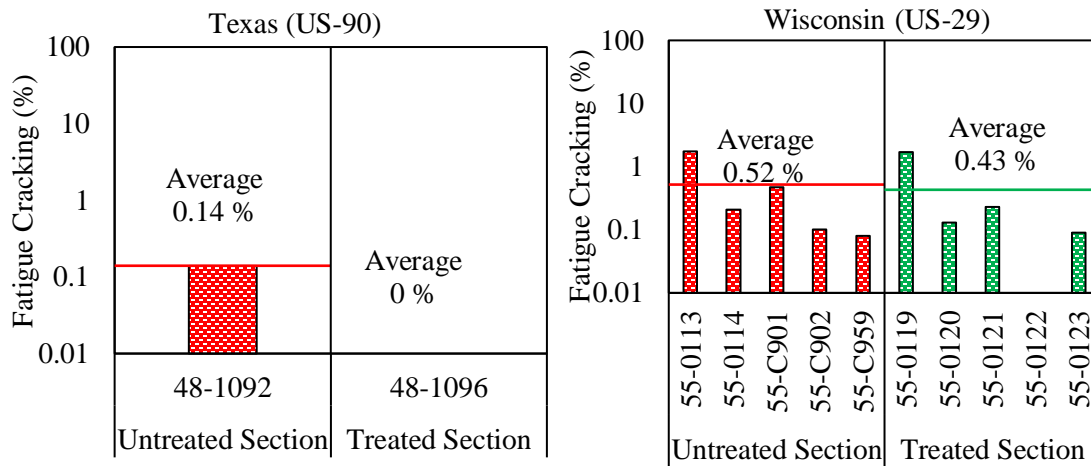
Figure 13. Predicted Average Fatigue Cracking Comparison between Treated and Untreated sections of states under study

Figure 13 represents the average fatigue crack of treated and untreated section for each state using data from MEPDG. Fatigue crack data from MEPDG was utilized to compare the performance of treated and untreated section. The average performance of the treated section was found to be better than the untreated section for all the states under study. Figure 14 represents the combined average fatigue crack of treated and untreated sections of all the collected sections.

Figure 13 shows the average fatigue crack of treated and untreated sections for each state. The performance of the treated sections was better for all the states with some

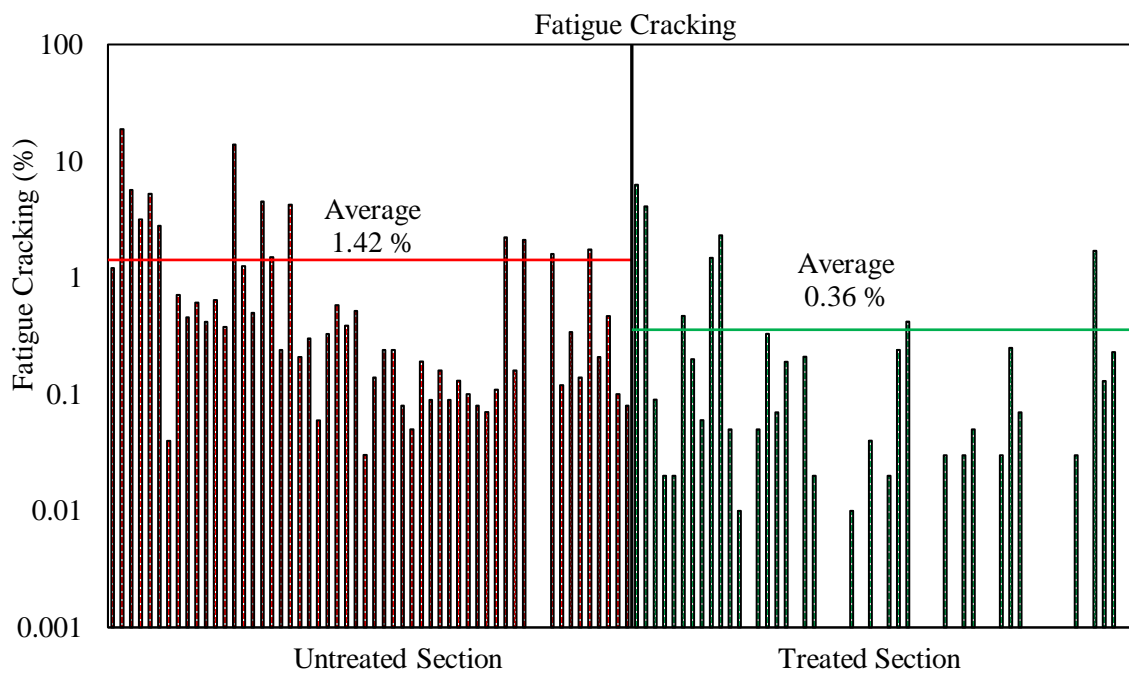
Figure 14. Combined Predicted Average Fatigue Cracking of Treated and Untreated sections

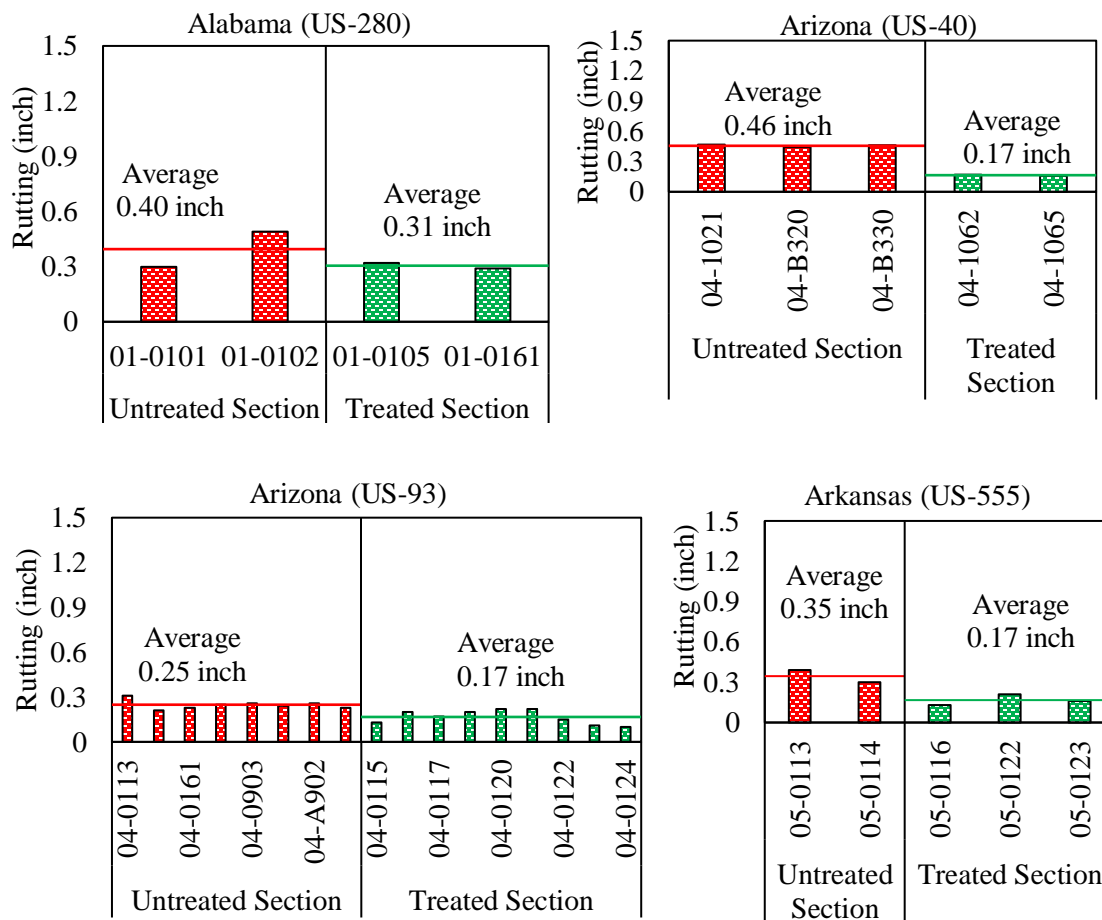
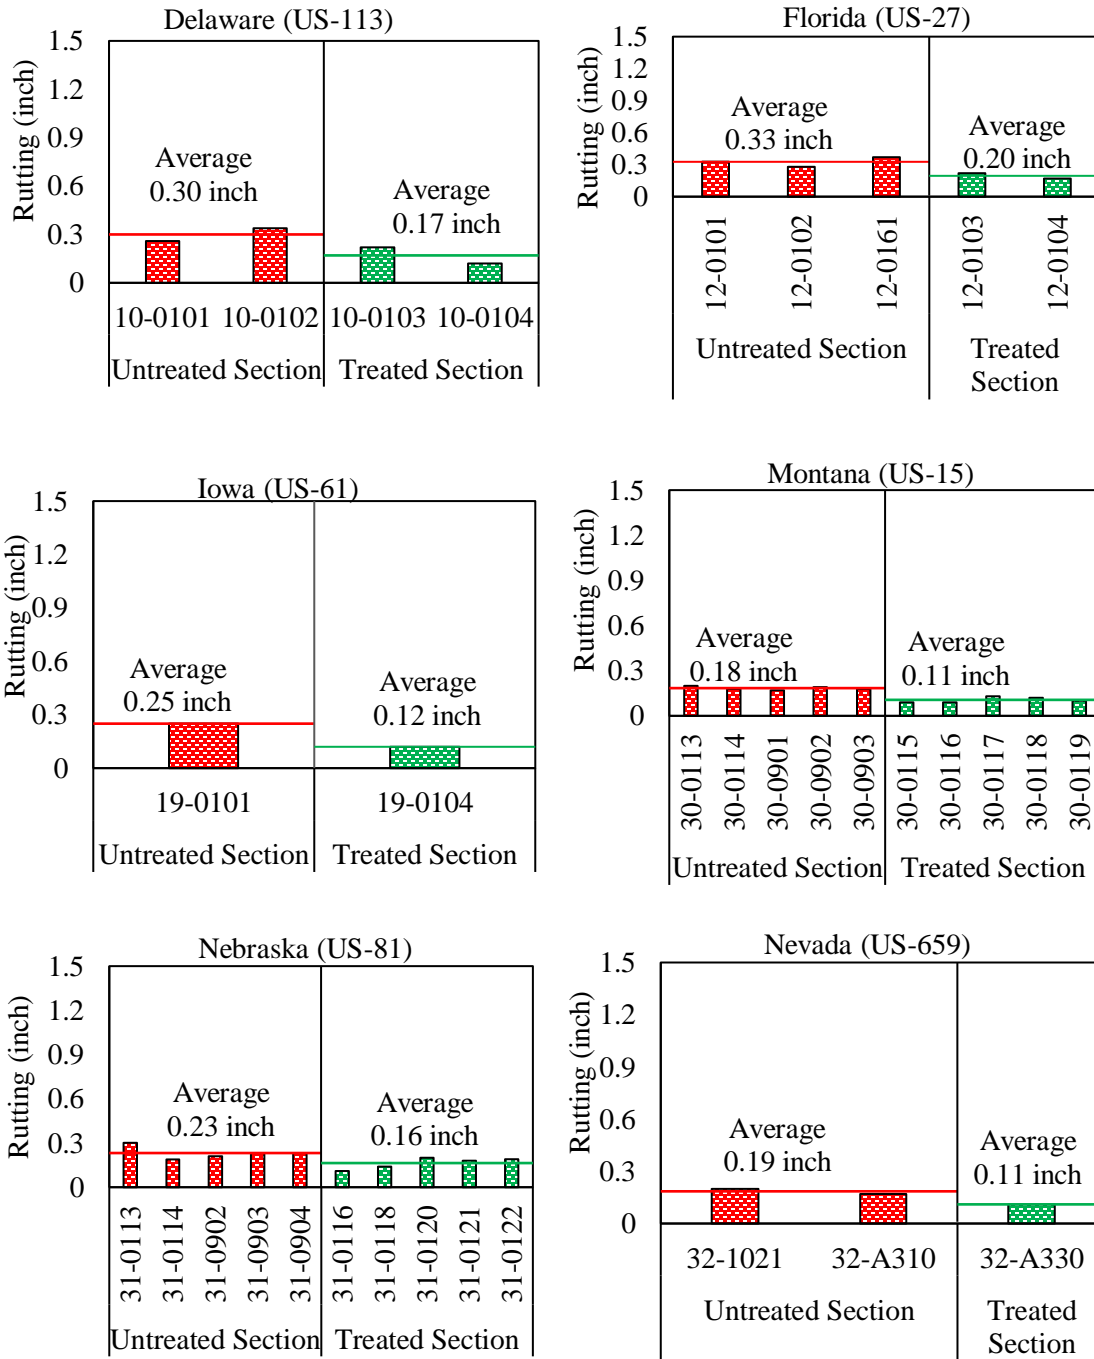
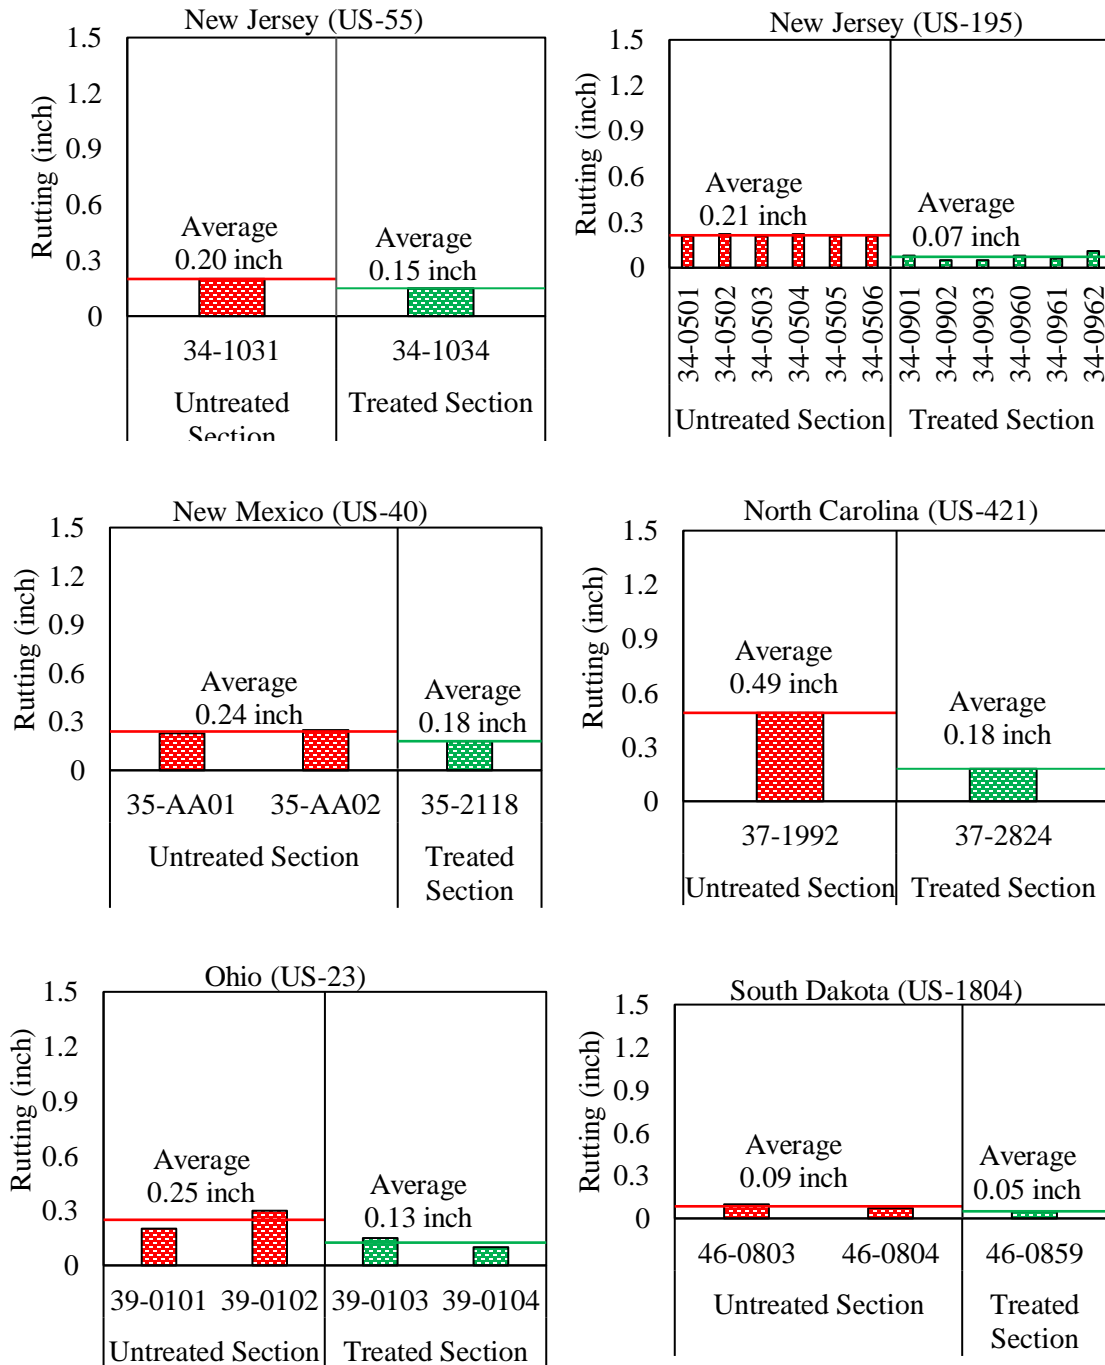
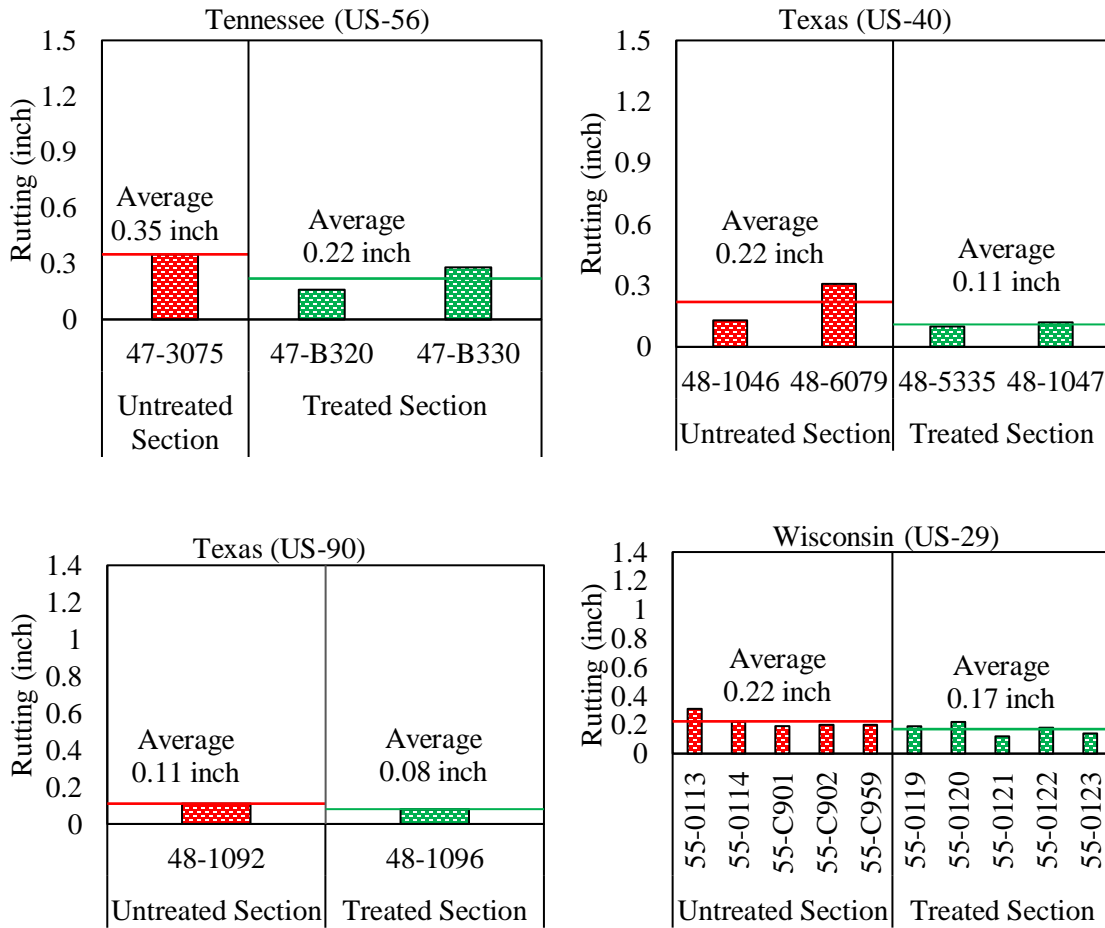
Figure 15. Predicted Average Pavement Surface Rutting Comparison between Treated and Untreated sections under study

Figure 15 shows the average surface rutting value of treated and untreated section for each state. The surface rut values were obtained from MEPDG analysis. This value was utilized to compare the performance of the treated and untreated aggregate bases. Analysis shows that the pavements with treated bases had performed better in all the states in terms of pavement surface rutting.

Figure 15 shows the average pavement surface rutting of treated and untreated sections for each state. The predicted performance of the treated section was better for all the states. Similar performance was predicted in some of the states. A summary of the rutting data is as follows:

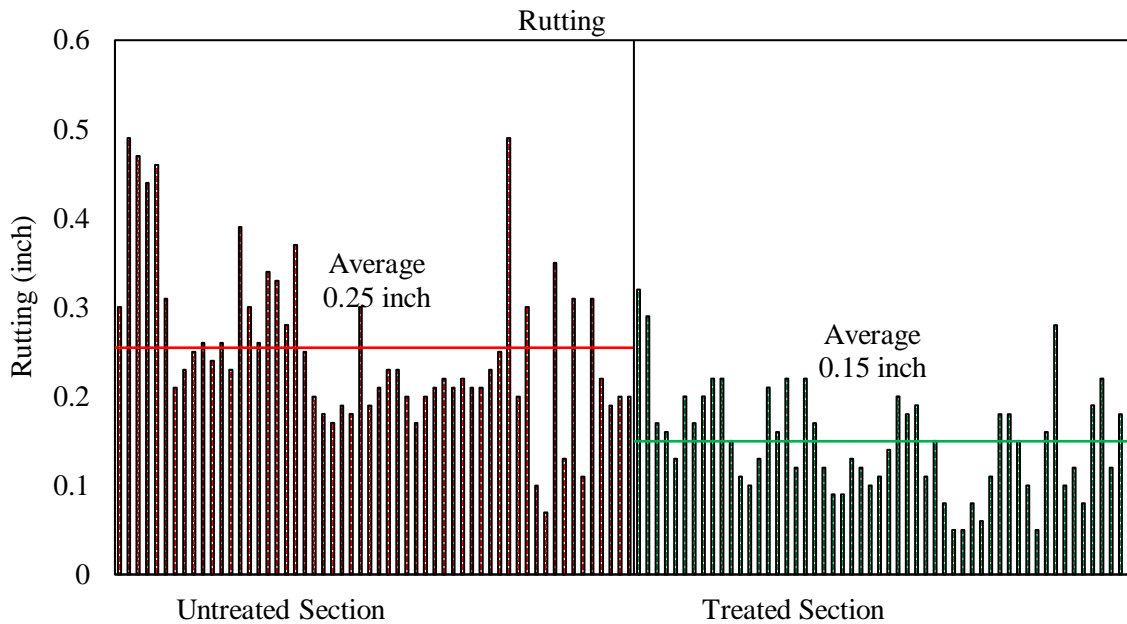
Figure 16. Combined Predicted Average Pavement Surface Rutting Comparison between Treated and Untreated sections under study

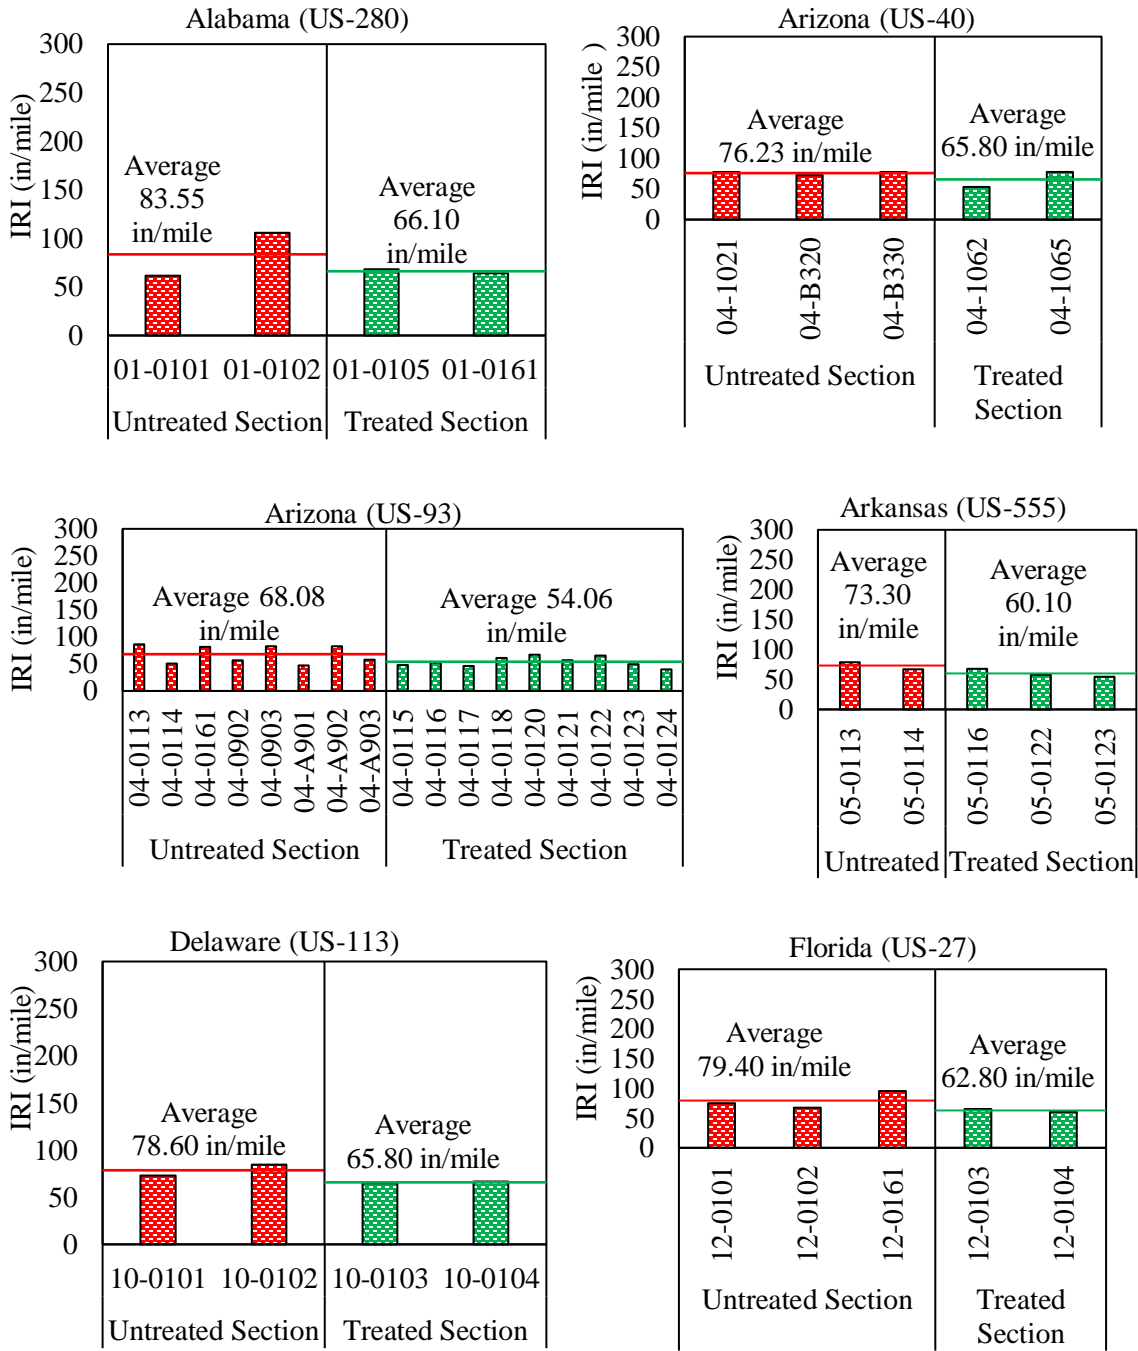
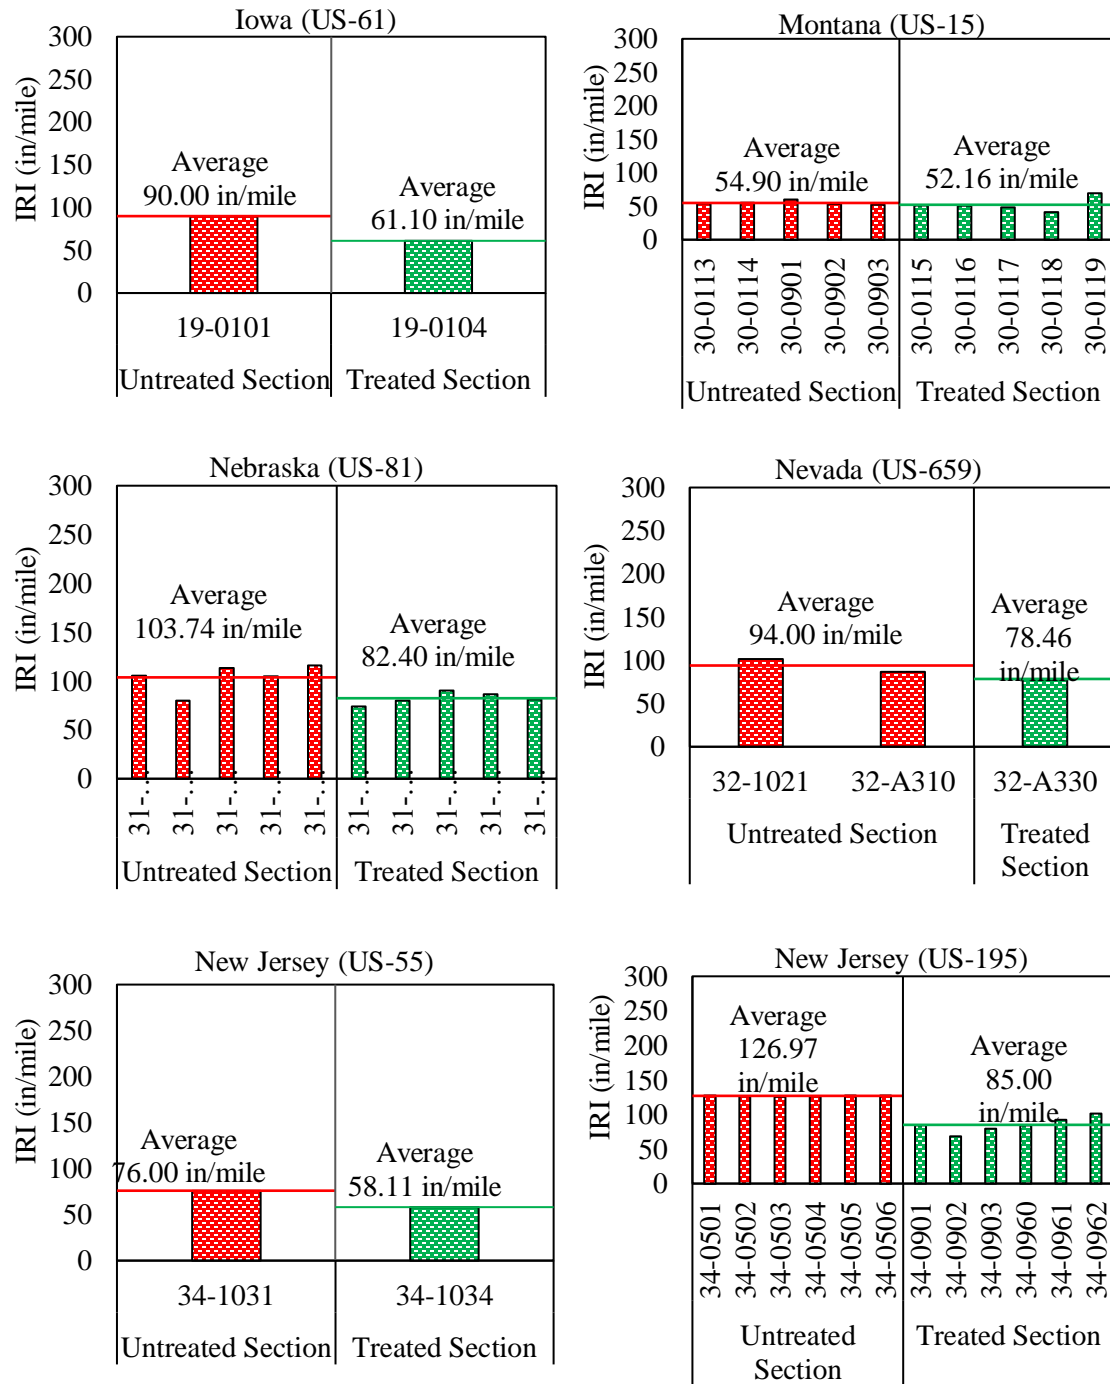
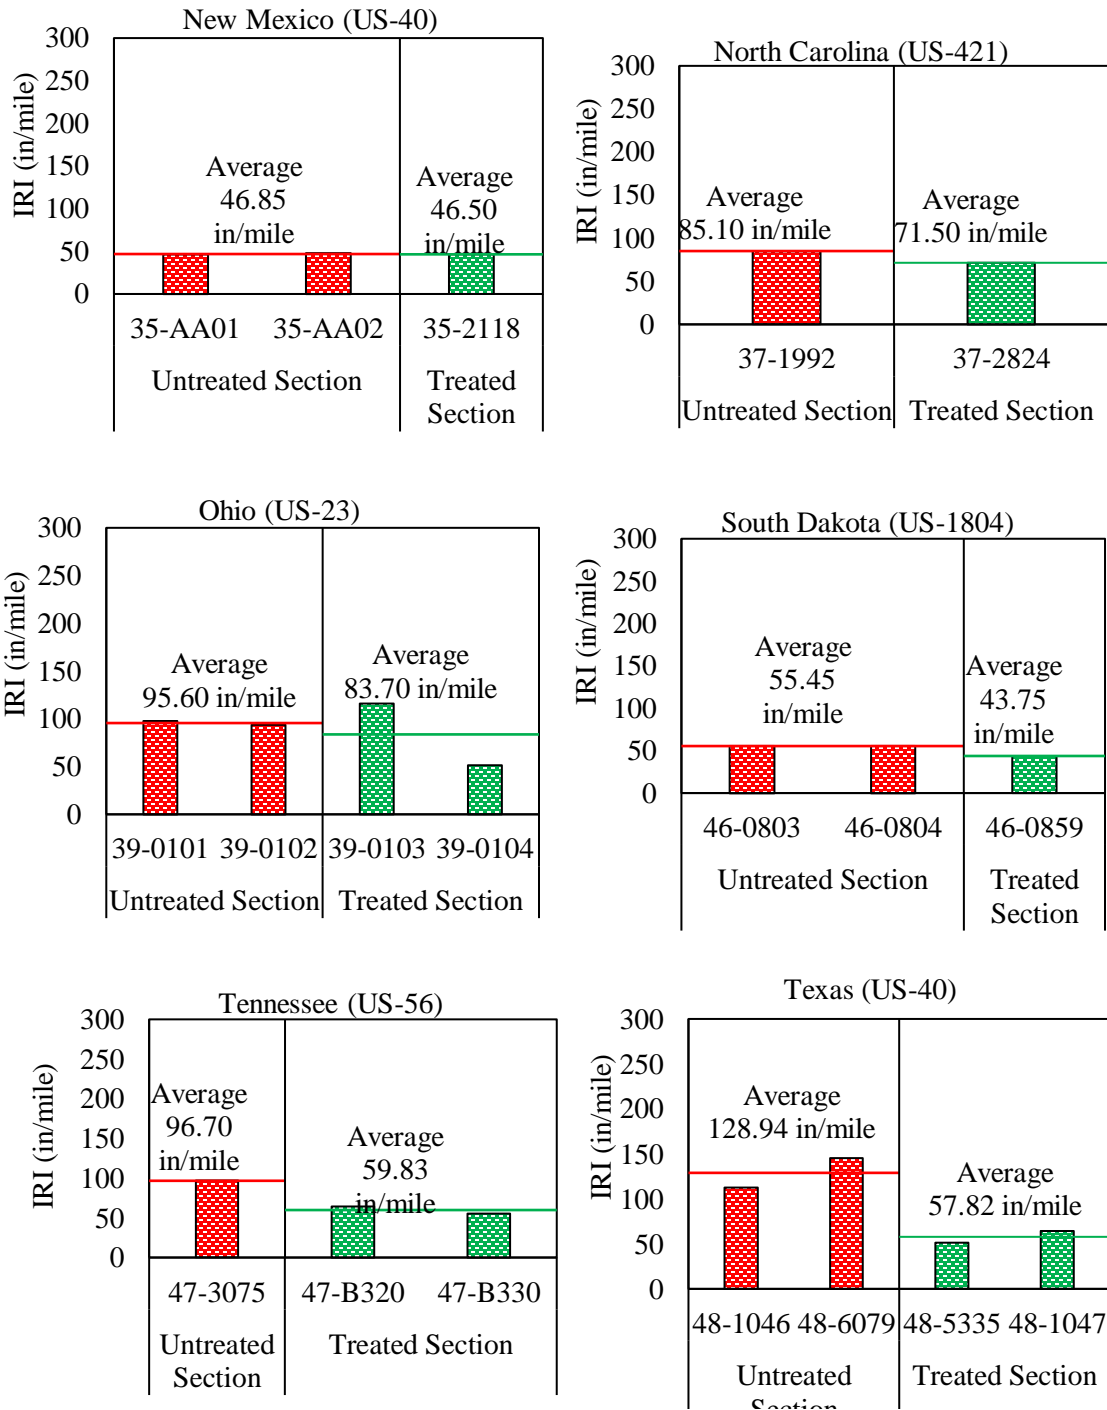
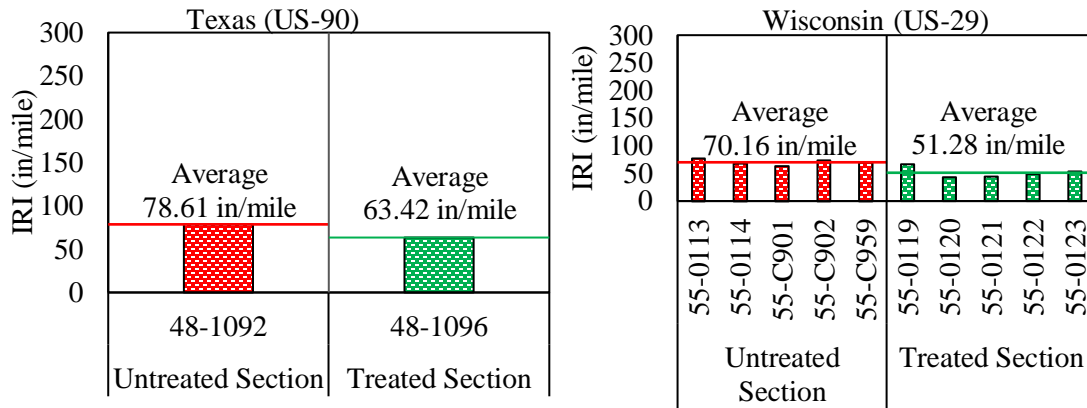
Figure 17. Predicted Average Surface Roughness (IRI) Comparison between treated and untreated sections under study

Figure 17 shows the average pavement surface roughness of treated and untreated section for each state. The overall performance of all the treated sections were better in all the states. The average value of pavement surface roughness for the treated section were lower than untreated section for all the states. Figure 18 shows the combined overall average pavement surface roughness of treated and untreated sections of all the collected sections. It was observed that the combined average of treated section is less than that of the untreated section.

Figure 17 shows the predicted average surface roughness of the treated and untreated sections for each state. The average predicted performance of the treated sections is better than the untreated section for all the states. Similar prediction of the

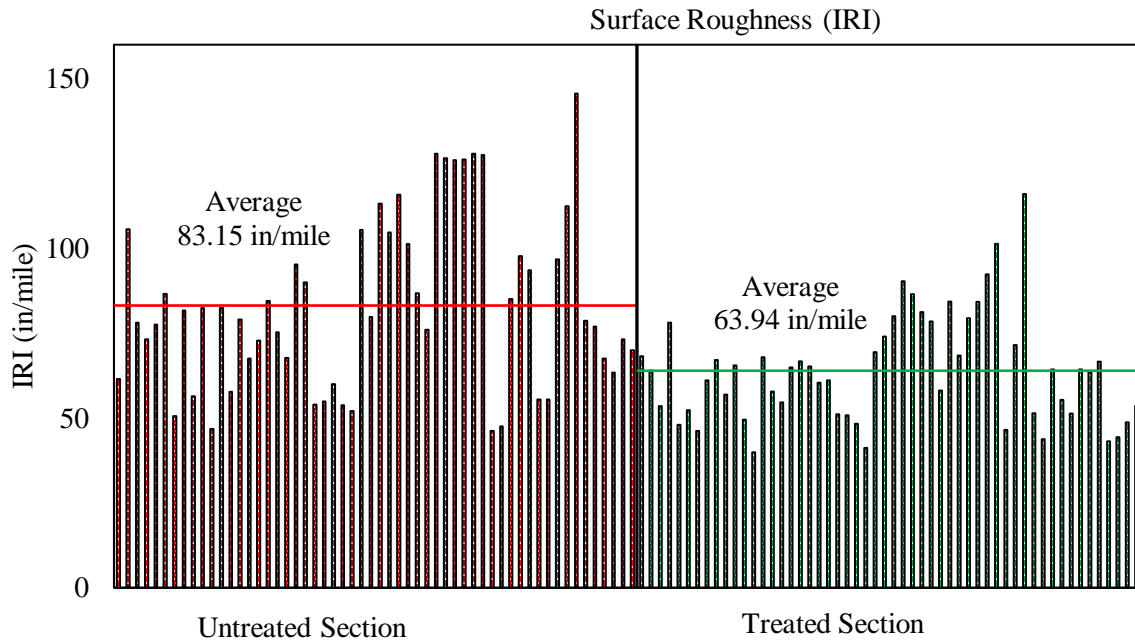
Figure 18. Combined Predicted Average Pavement Surface Roughness of Treated and Untreated sections

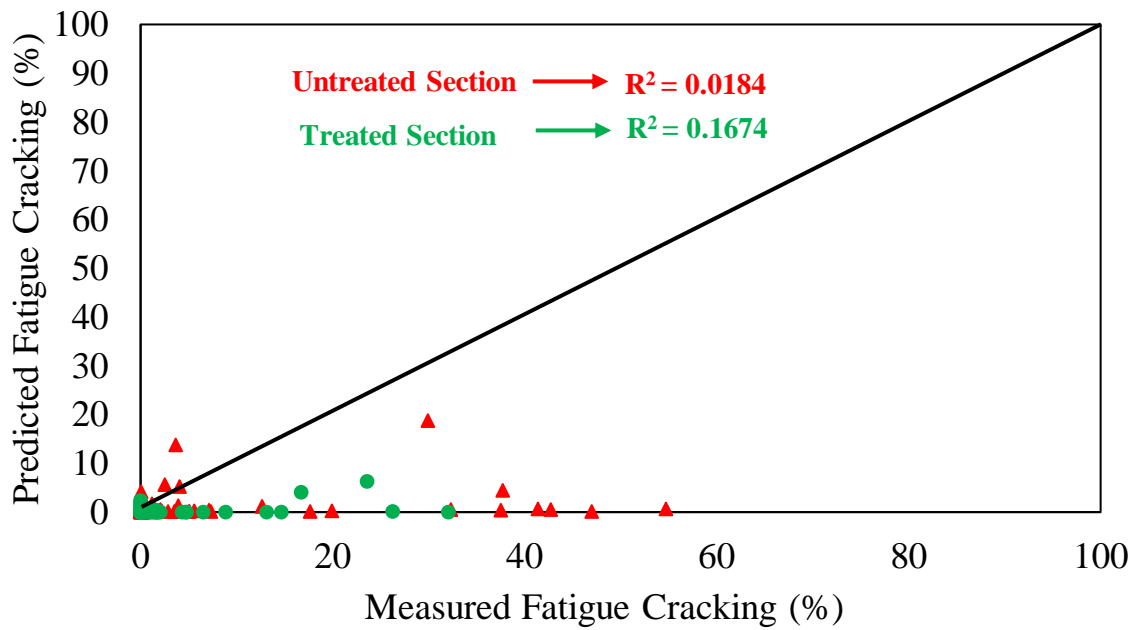
Figure 19. Measured versus Predicted Fatigue Cracking

Figure 19, 20, and 21 shows the measured versus predicted value for all three distresses. The red star represent the untreated sections and the green circle represent the treated sections. Figure 19 shows the measured versus predicted value for fatigue cracking for treated and untreated sections. The fatigue cracking model has R^2 value of 0.0184 for untreated section and 0.1674 for treated sections. This is a very low value and shows the fatigue cracking model in MEPDG does not properly represent the field performance. For better representation of the model, local calibration coefficients must be determined for untreated and treated sections separately. This will help in better prediction of fatigue cracking. Similarly, figure 20 shows the measured versus predicted value of surface rutting. The R^2 value obtained for treated and untreated sections are very low. Better prediction can be achieved by calibrating the rutting model in MEPDG. Figure 21 shows the measured versus predicted surface roughness. The R^2 value of surface roughness for the untreated and treated section was 0.3996 and 0.3339 respectively. The R^2 value was better for the surface roughness than the other two distresses. The R^2 value was not good enough to predict the distresses precisely. Overall analysis shows that distress models in MEPDG needs to be calibrated for better prediction. Calibration for treated and untreated sections must be done separately for better prediction of distresses. Table 6 shows the type of prediction of distress for treated and untreated section by MEPDG. For the same state, treated and untreated sections had different prediction rate. This shows that there is need to calibrate the treated and

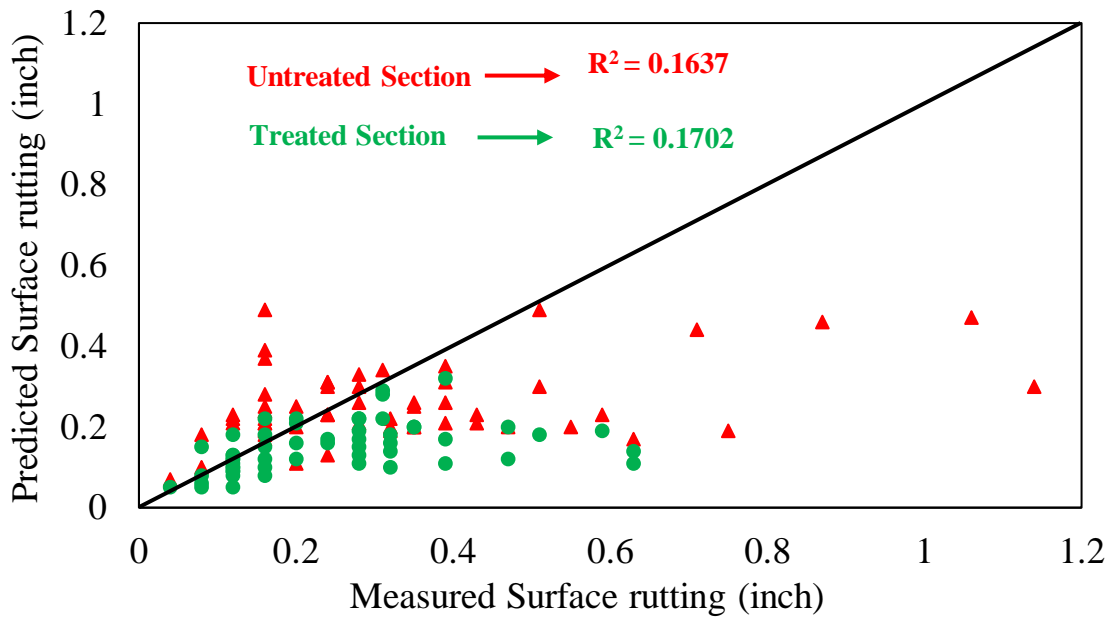
Figure 20. Measured versus Predicted surface rutting

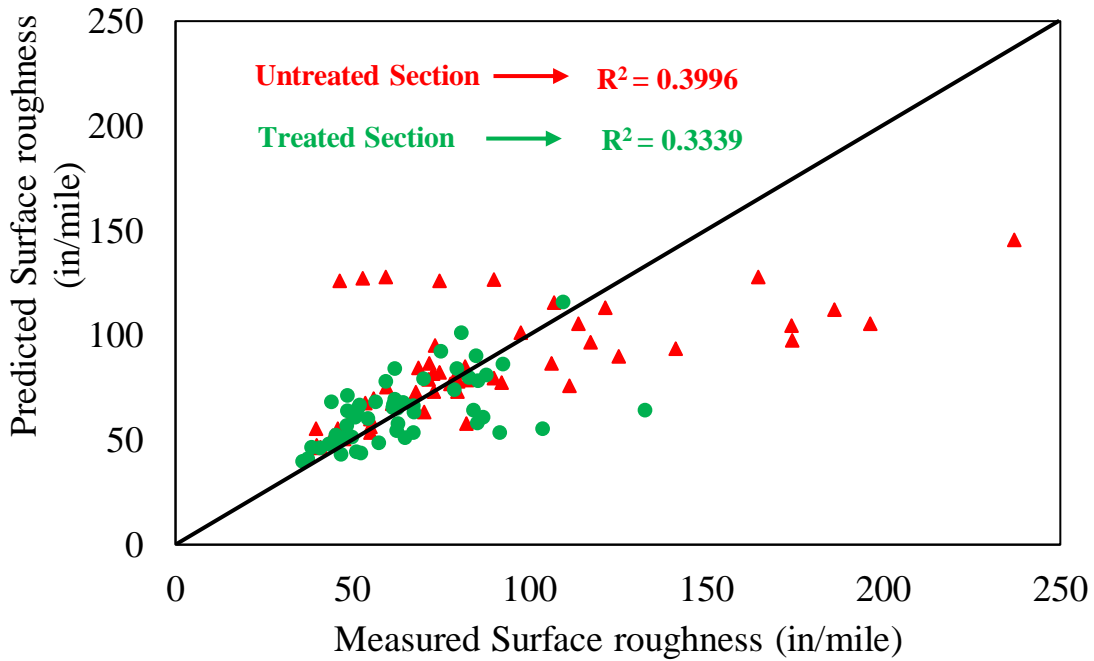
Figure 21. Measured versus Predicted surface roughness

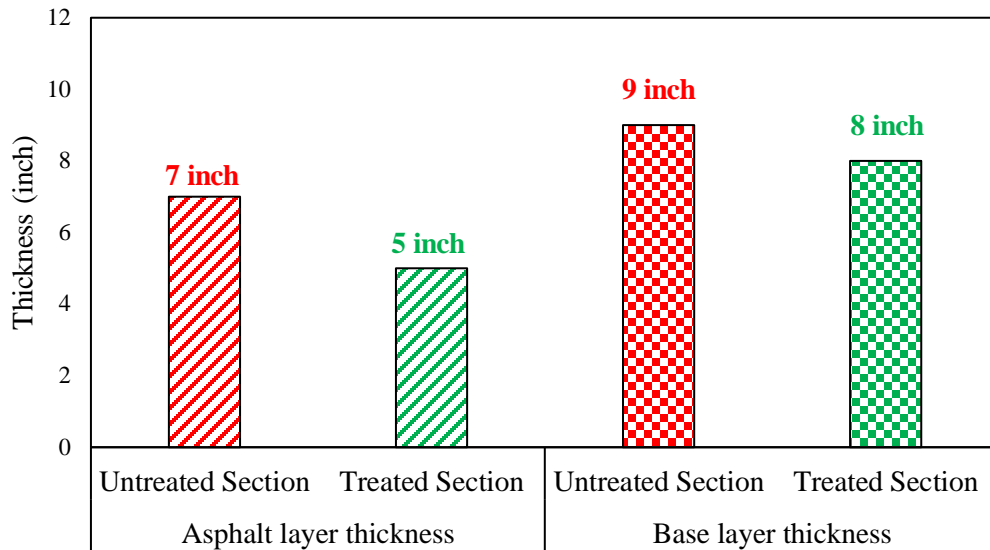
Figure 22. Average layer thickness of treated and untreated sections

Figure 22 shows the overall average asphalt layer thickness and base layer thickness of the treated and untreated sections. The average asphalt layer thickness and base layer thickness of the untreated sections was found to be 7 and 9 inches respectively. Similarly, for the treated section, the overall average asphalt layer thickness was 5 inches and base layer thickness was 8 inches. The reduction in pavement layer thickness was observed. This was followed by the high performance for the treated section. The overall asphalt layer was reduced by 2 inches and the base layer was reduced by 1 inch. A decrease in the thickness of the pavement layer will decrease the overall cost of construction.
