Shoreline Management In Chesapeake Bay

Special Report in Applied Marine Science and Ocean Engineering Number 356

Virginia Sea Grant Publication VSG-99-11

October 1999

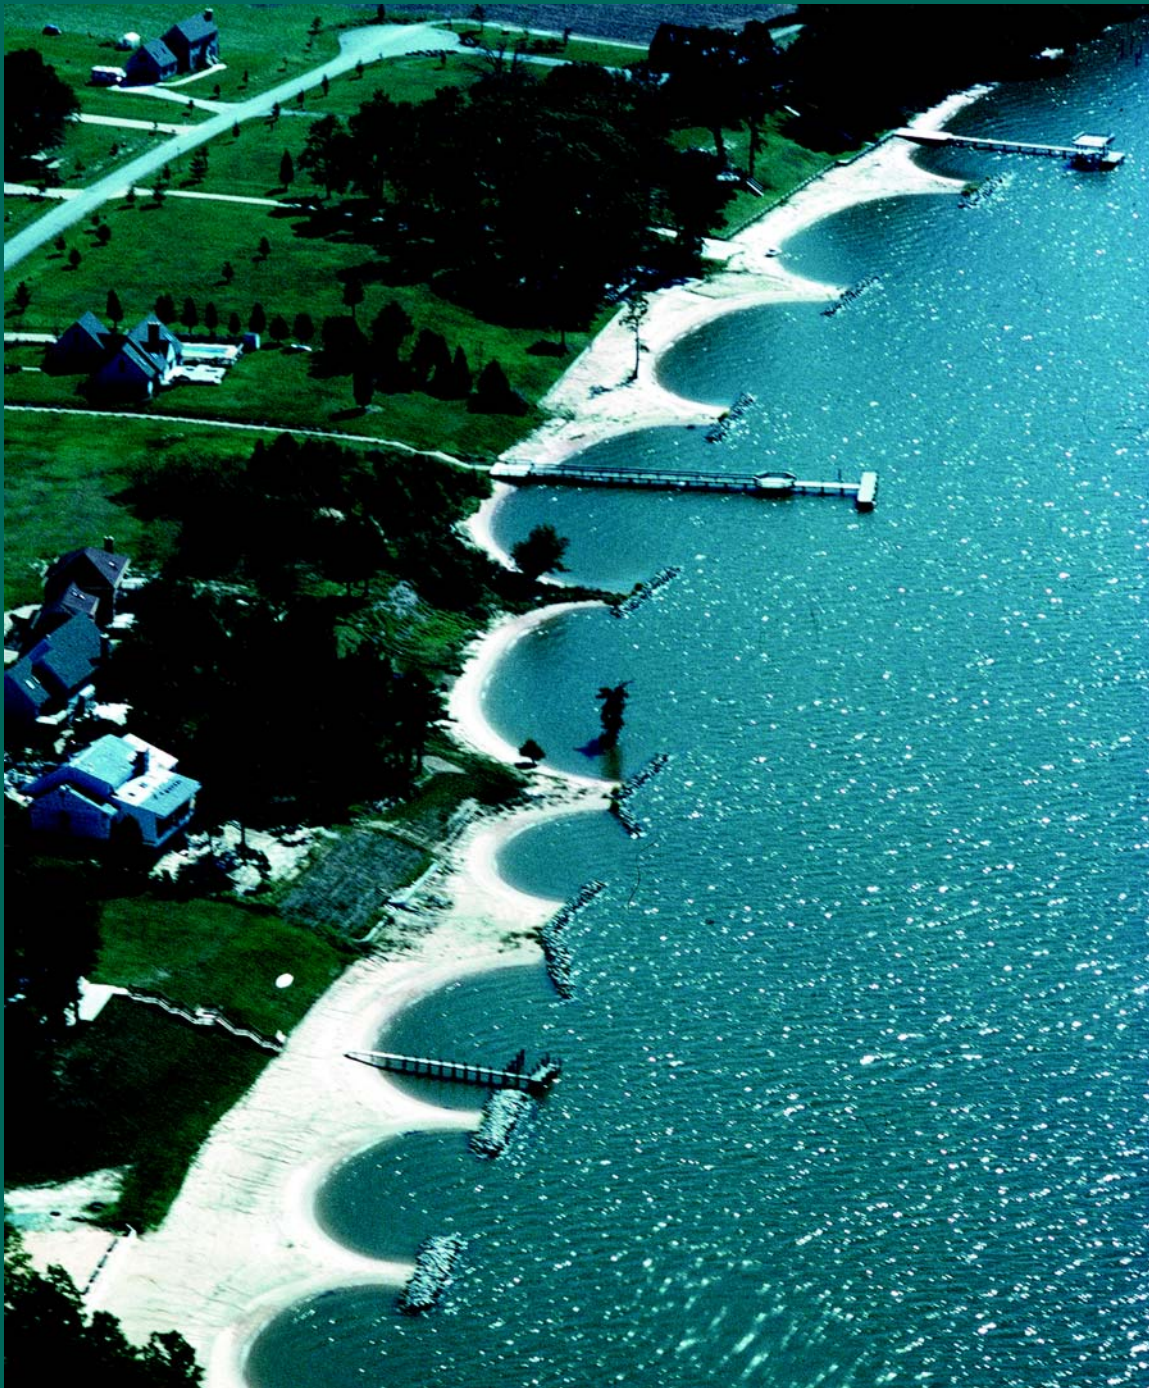
Cover Photo:

*Drummond Field,
Installed 1985,
James River,
James City County,
Virginia.*

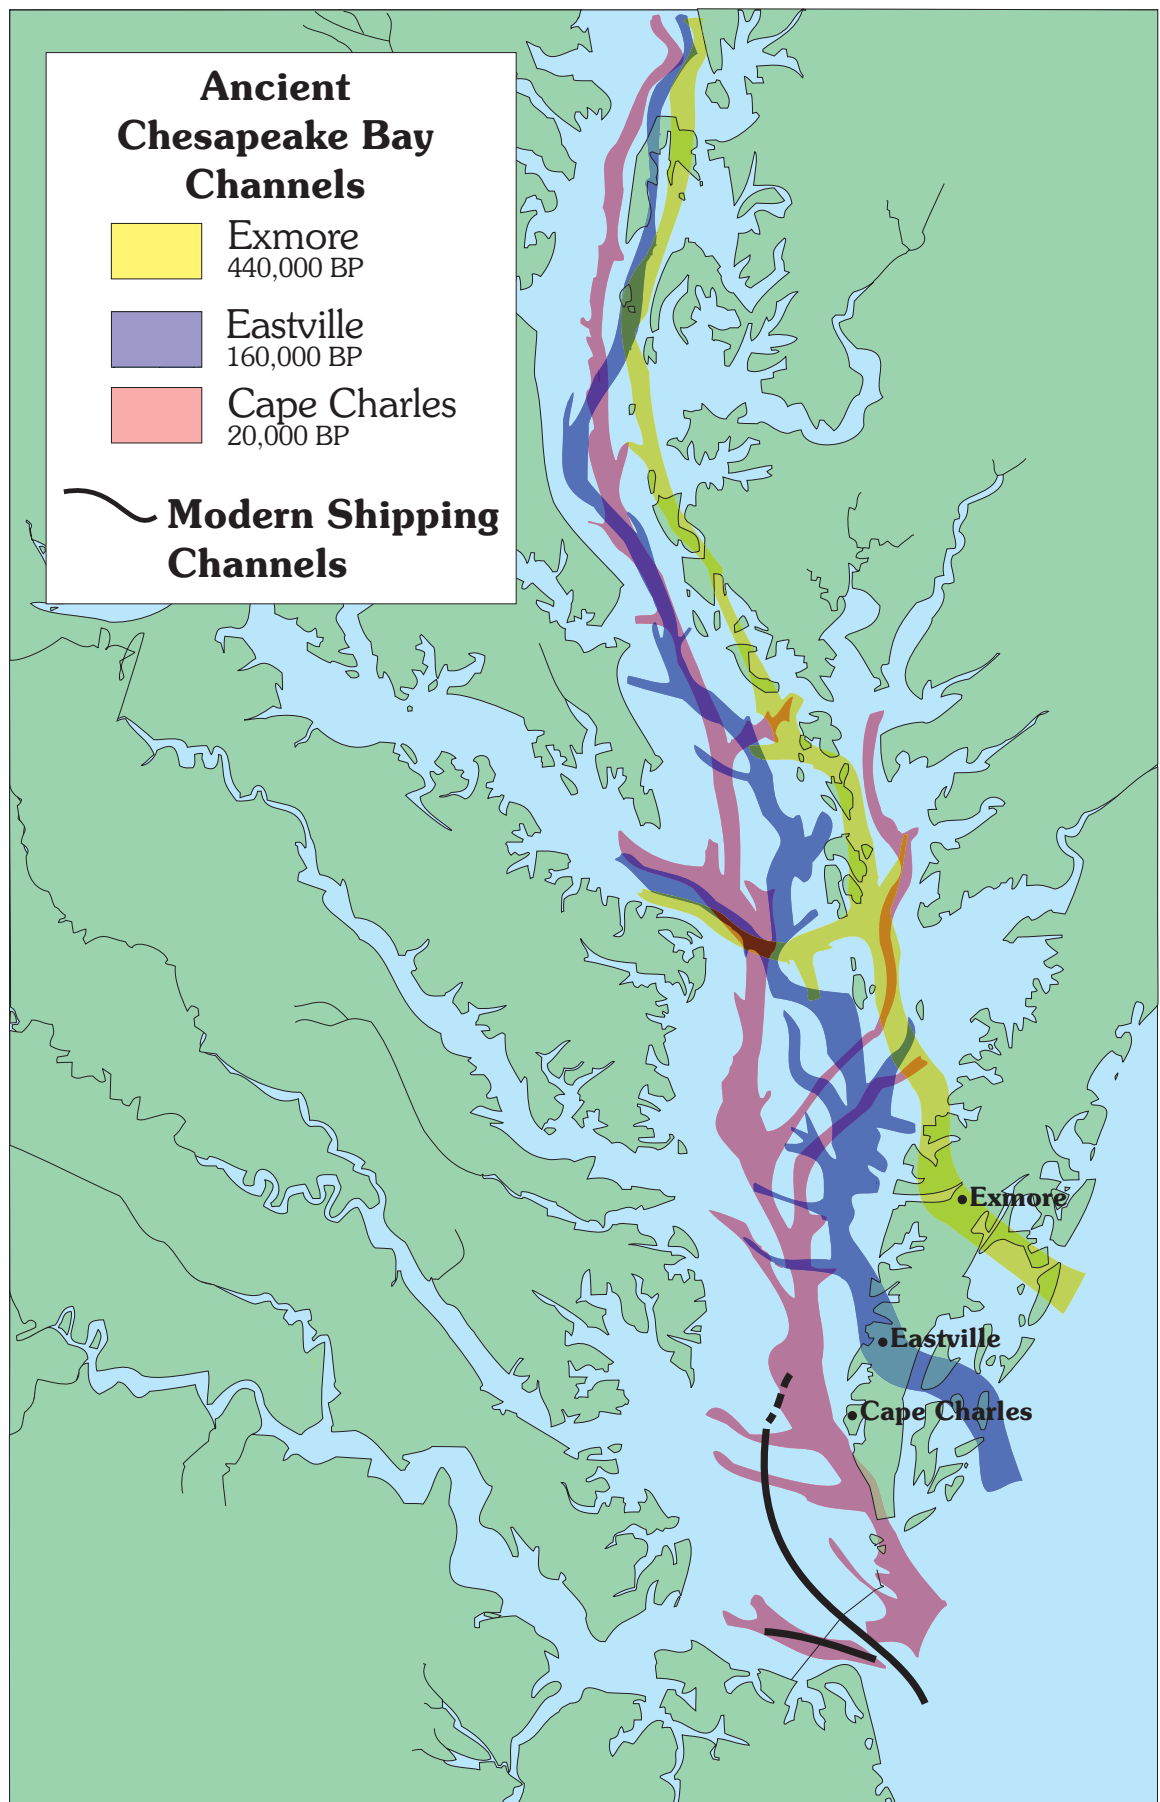
Figure 1
Map of the Chesapeake Bay today showing shifts in the Susquehanna River drainage. The Cape Charles channel formed about 20,000 years BP (before present); the Eastville channel formed about 160,000 BP; and the Exmore channel formed about 440,000 BP.

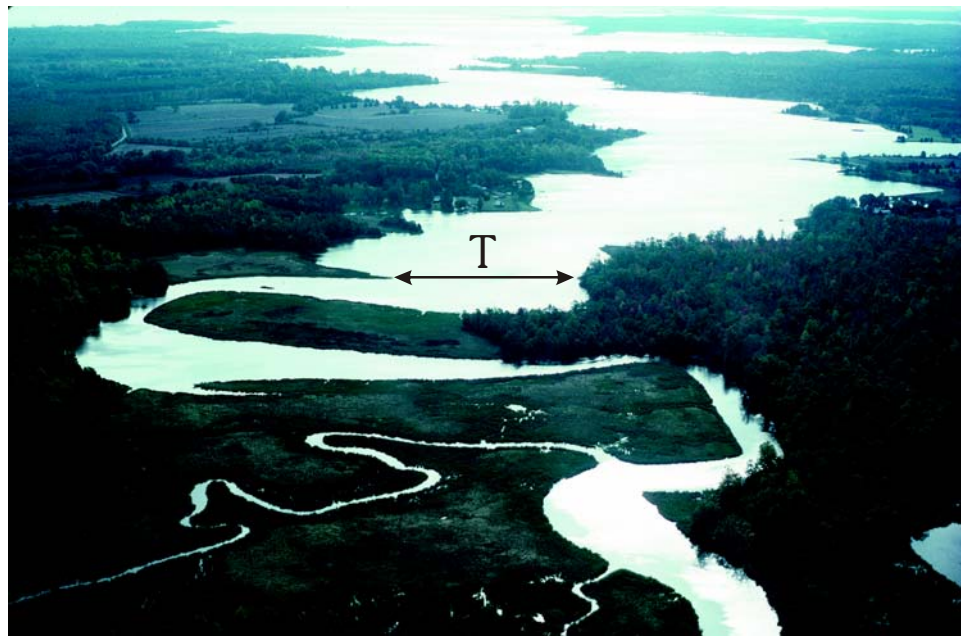
Figure 2
Broad marshes in foreground give way to fringing marshes downstream where there is greater fetch exposure. At the transition point (T), shoreline processes go from tidally dominated to wave dominated (Ware River, Va).

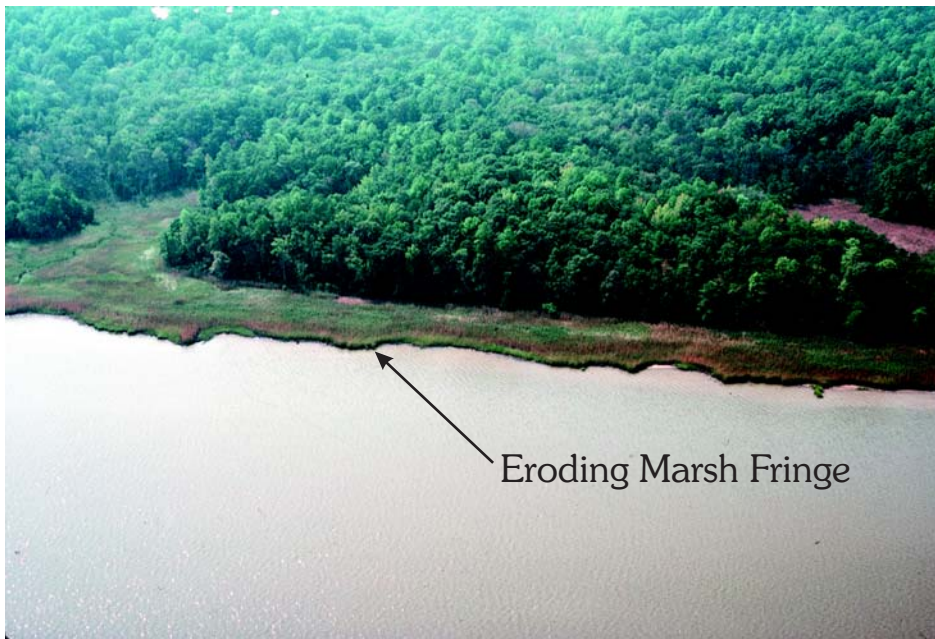
Figure 3

This marsh fringe along the York River (James City County, Va.) is eroding on the water side, but it is wide enough to protect the upland region from wave attack.

The major shore types associated with the oceanic transgression include marsh and upland banks with fronting sand dunes, beaches, and spits. Marshes occupy the fringes of watersheds and low regions in front of uplands (Figure 2). Marshes and their associated peat substrates are important features. Marshes grow vertically and laterally landward in response to sea level rise. Although the face of the marsh may erode in response to wave action, the remaining marsh fringe protects the upland areas from erosive forces (Figure 3).

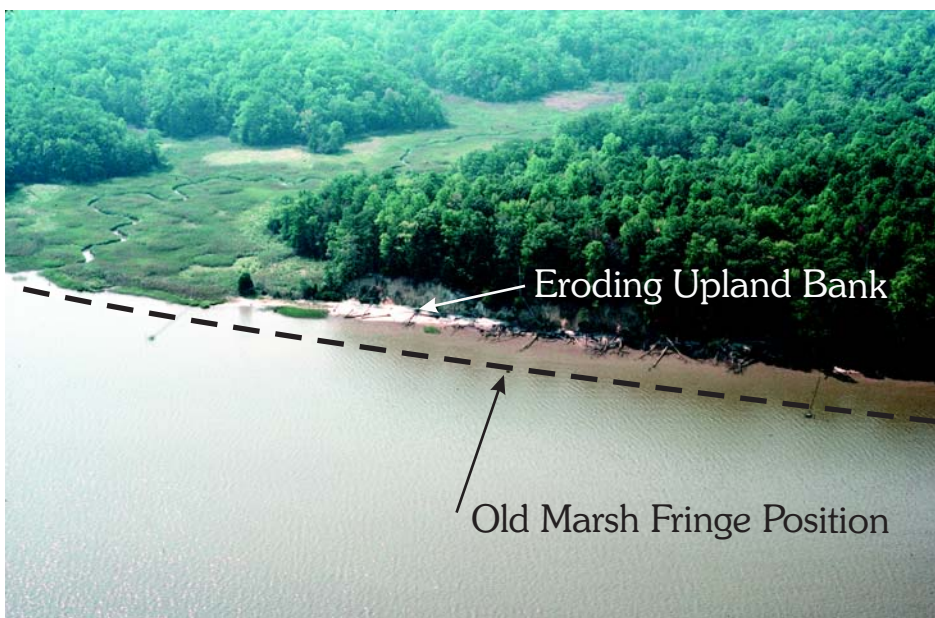
Figure 4

York River shoreline with fringe marsh absent due to erosion. The upland banks are directly exposed to the force of the waves. The result: eroding upland banks.

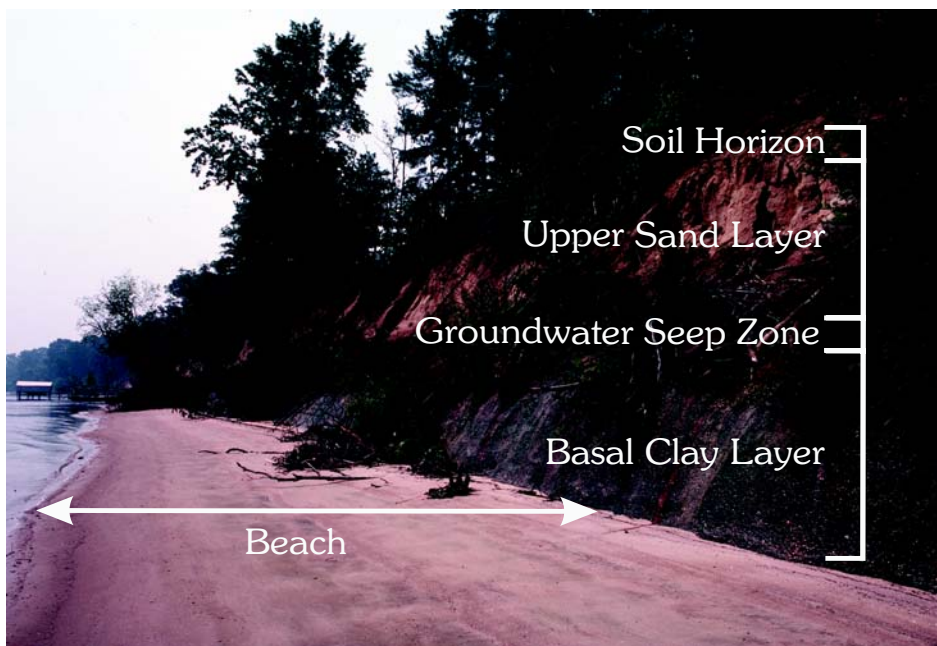
Figure 5

*Exposed and eroding upland banks along the Rappahannock River, Va.
Note: Basal clay acts as a groundwater perch causing the upper layer of sand to slump.*

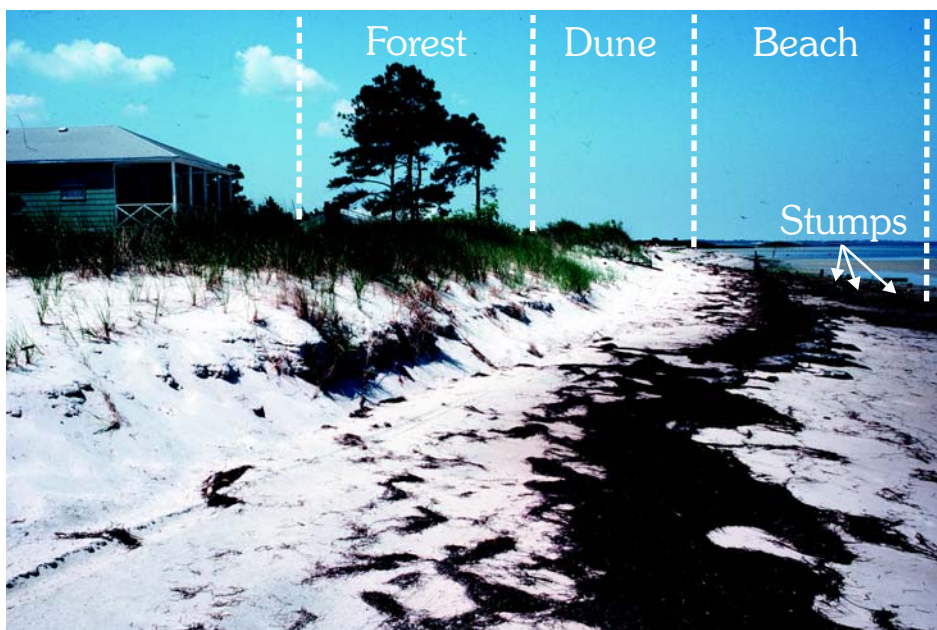
*Dune and beach system along the Chesapeake Bay, Mathews County, Va.
Old stumps in the nearshore area are evidence of landward migration of dune and beach systems.*

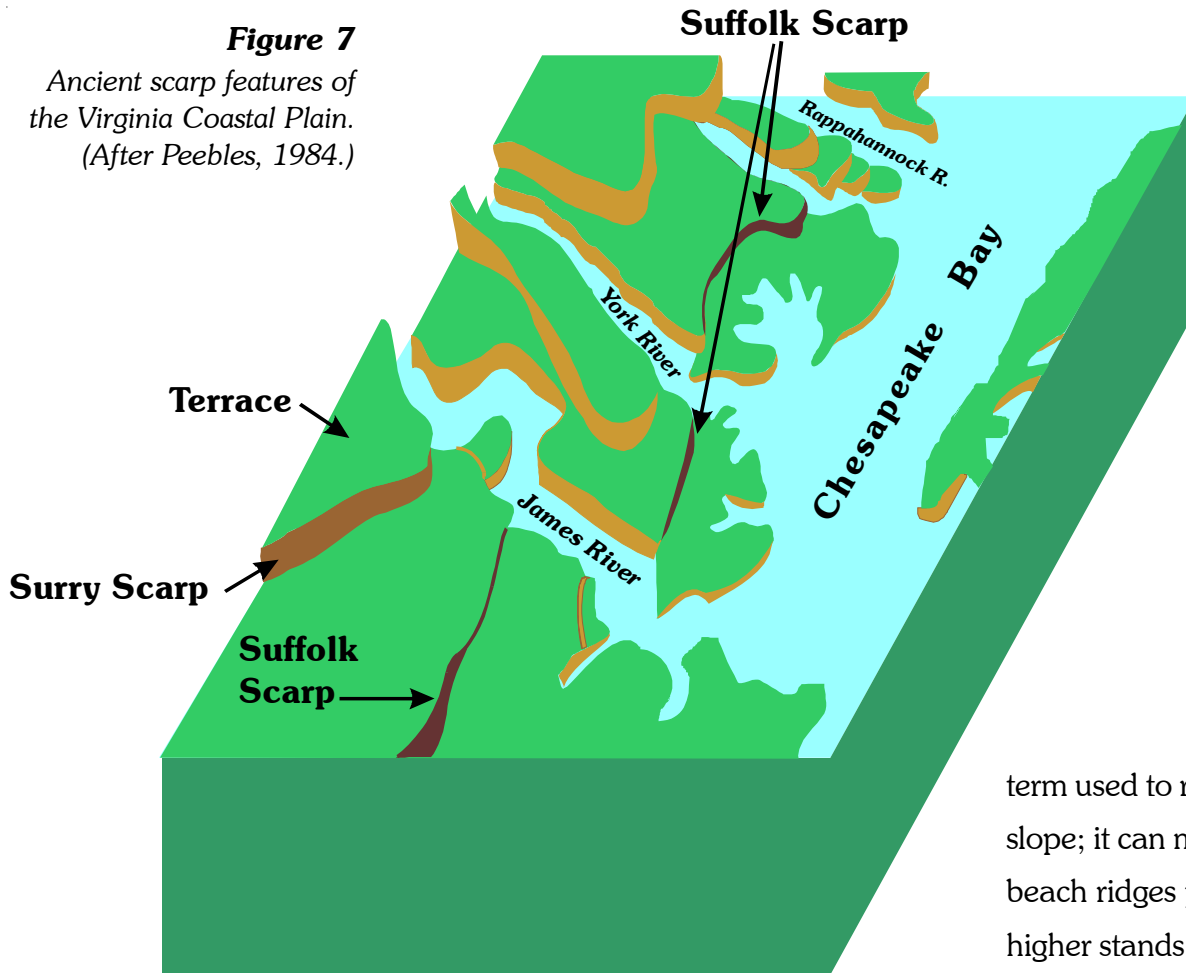
Figure 7
Ancient scarp features of
the Virginia Coastal Plain.
(After Peebles, 1984.)

term used to refer to a steep slope; it can mean a series of beach ridges produced by higher stands of sea level, or simply a low, steep beach slope caused by wave erosion. In Virginia, the Suffolk Scarp, which runs the length of the Virginia Coastal Plain along the

Further from the shoreline, and on a larger scale, some of the most significant coastal features are scarps. Scarp is the

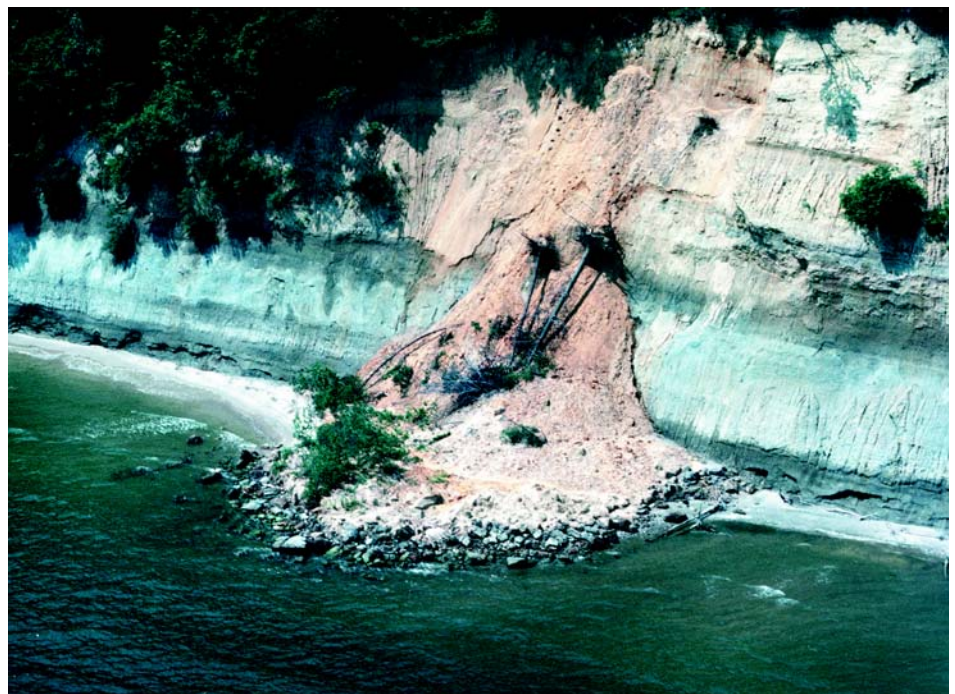
Figure 8
Major slump feature along Nomini
Cliffs in Westmoreland County.

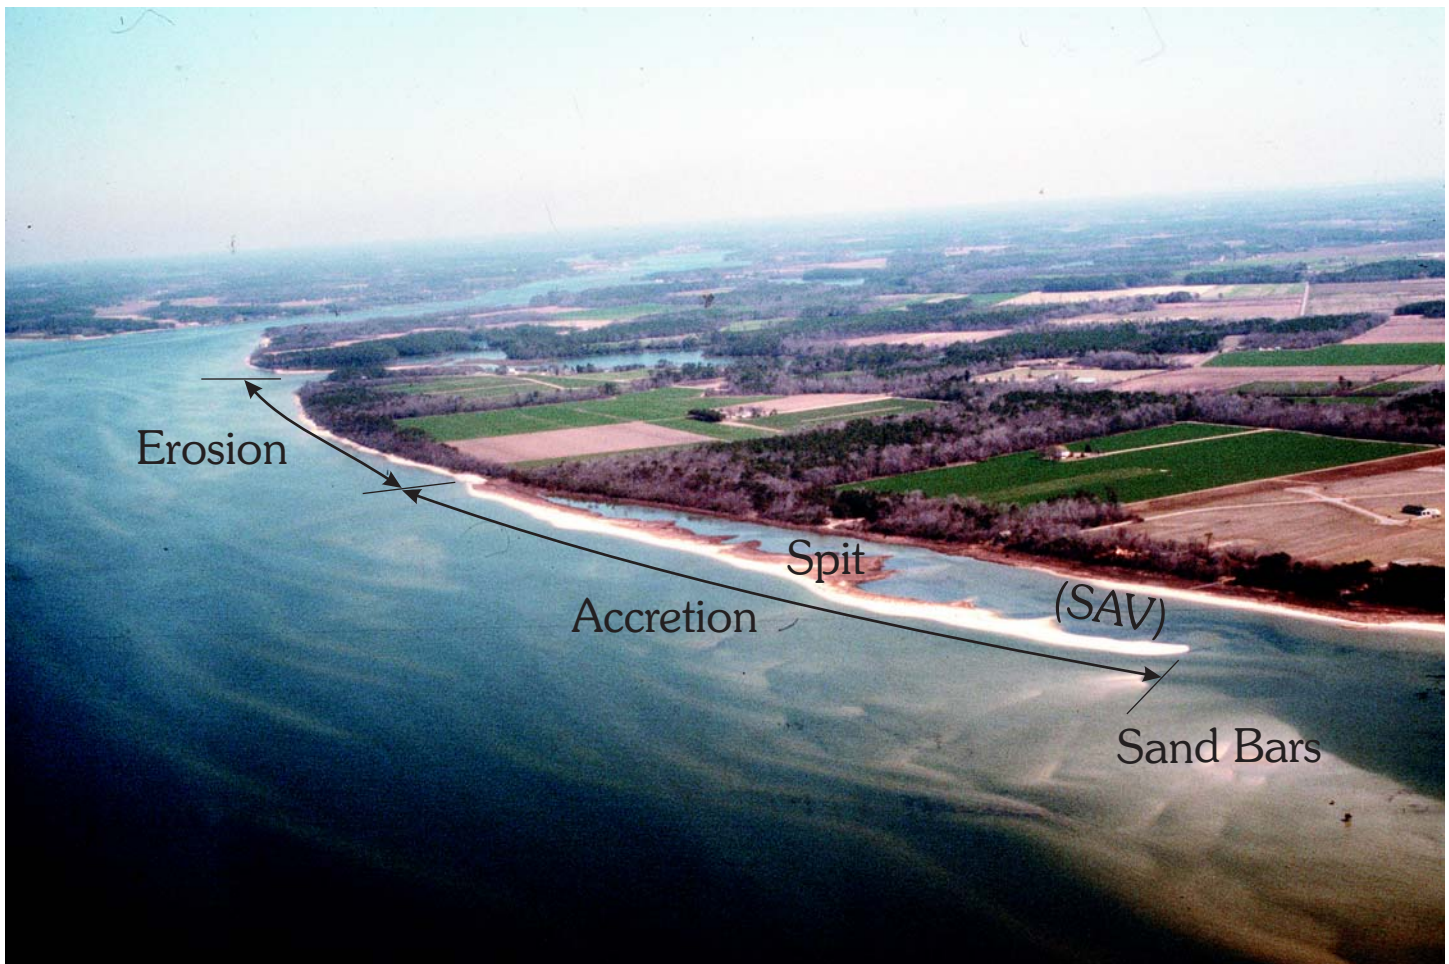
Figure 9

Erosion of sandy upland banks along the Eastern Shore provides significant sediment to create spits and offshore sand bars that protect the “mainland” from wave attack in addition to providing a haven for submerged aquatic vegetation.

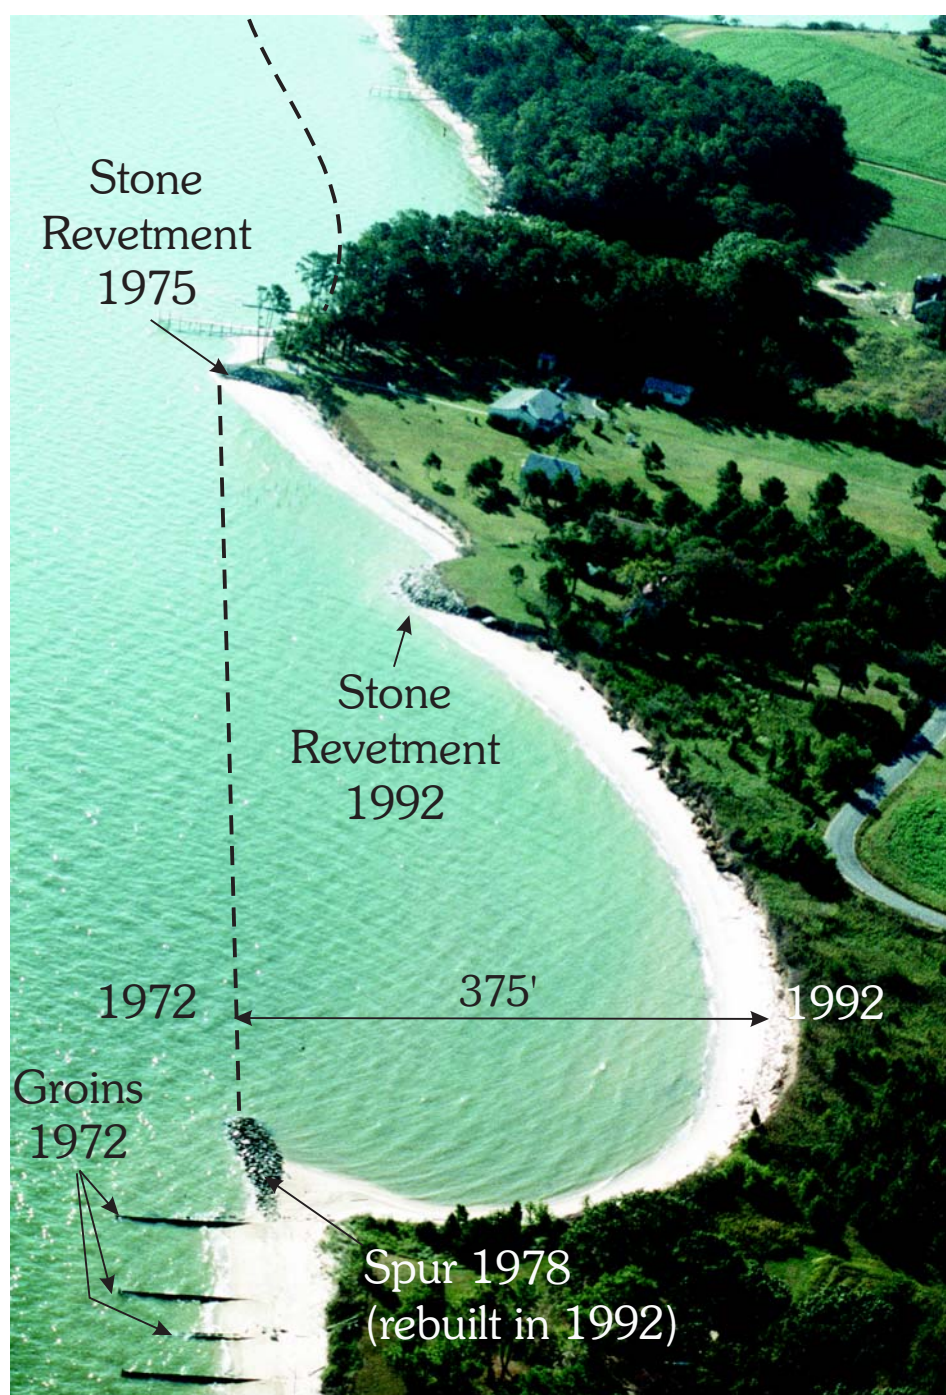
Figure 10
 Shoreline evolution in Northumberland County, Va.
 Note: Groin field in foreground was upland in early 1970s. Spiral shaped embayment formed between the groin field built in 1972 and a revetment installed in 1975 such that the maximum offset was 375 feet by 1992.

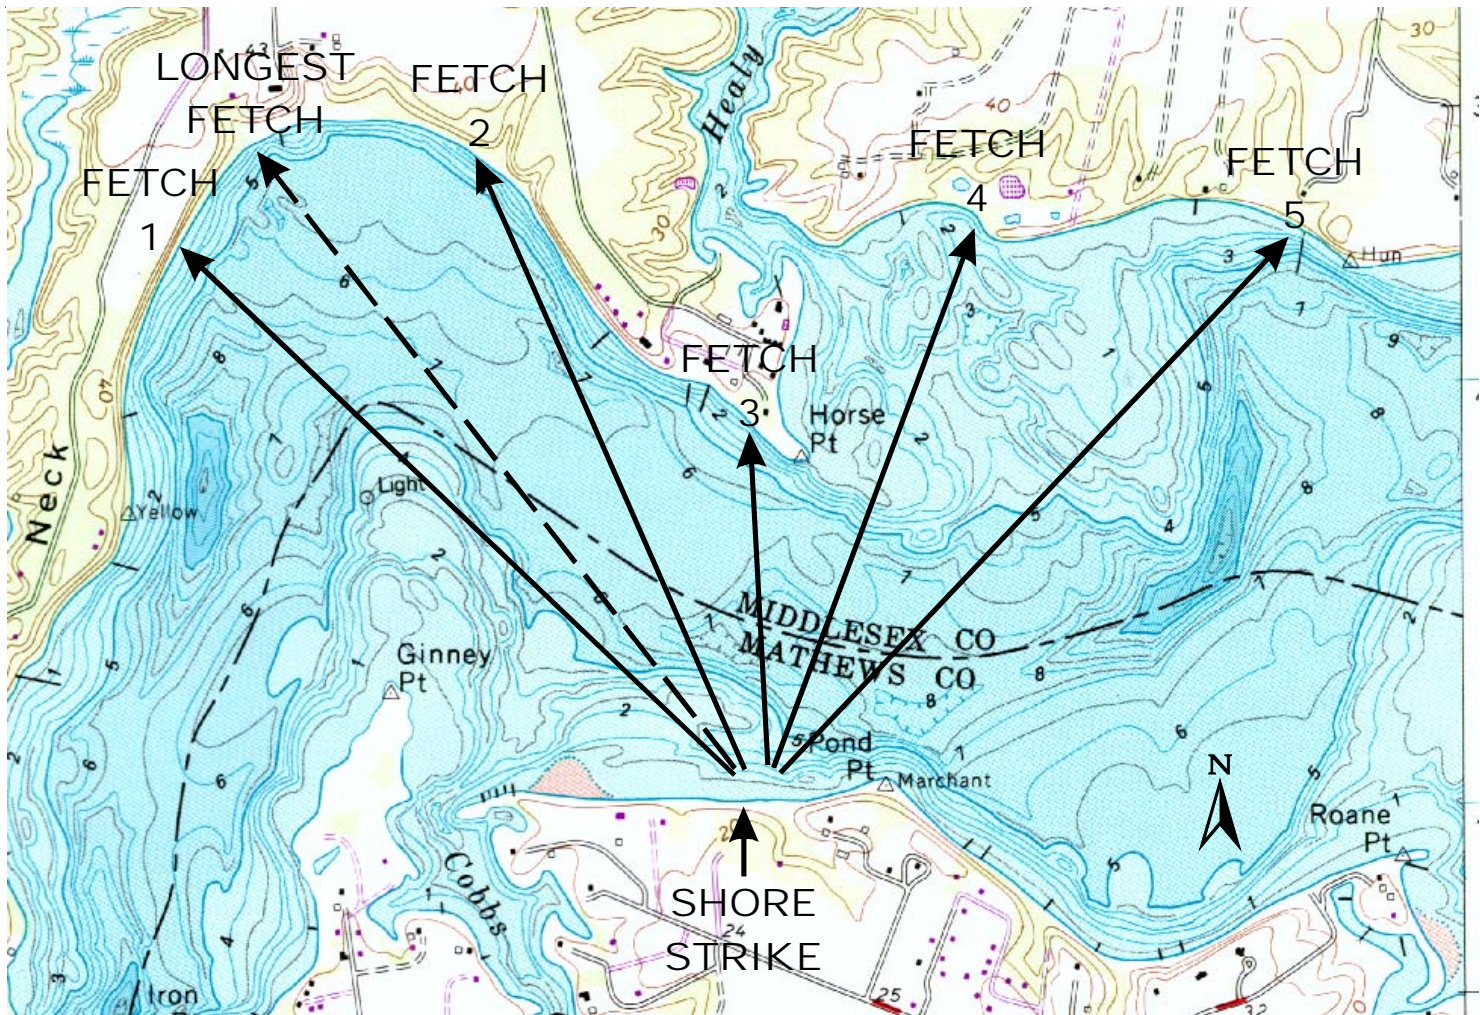
Figure 11

Measured parameters include average fetch ($AF = (F1 + F2 + F3 + F4 + F5) / 5$), and longest fetch. Also shown is shore strike from which the wind/wave window for fetch and shore orientation are established (After Hardaway et al. 1992). Shore orientation in this case is about due north.

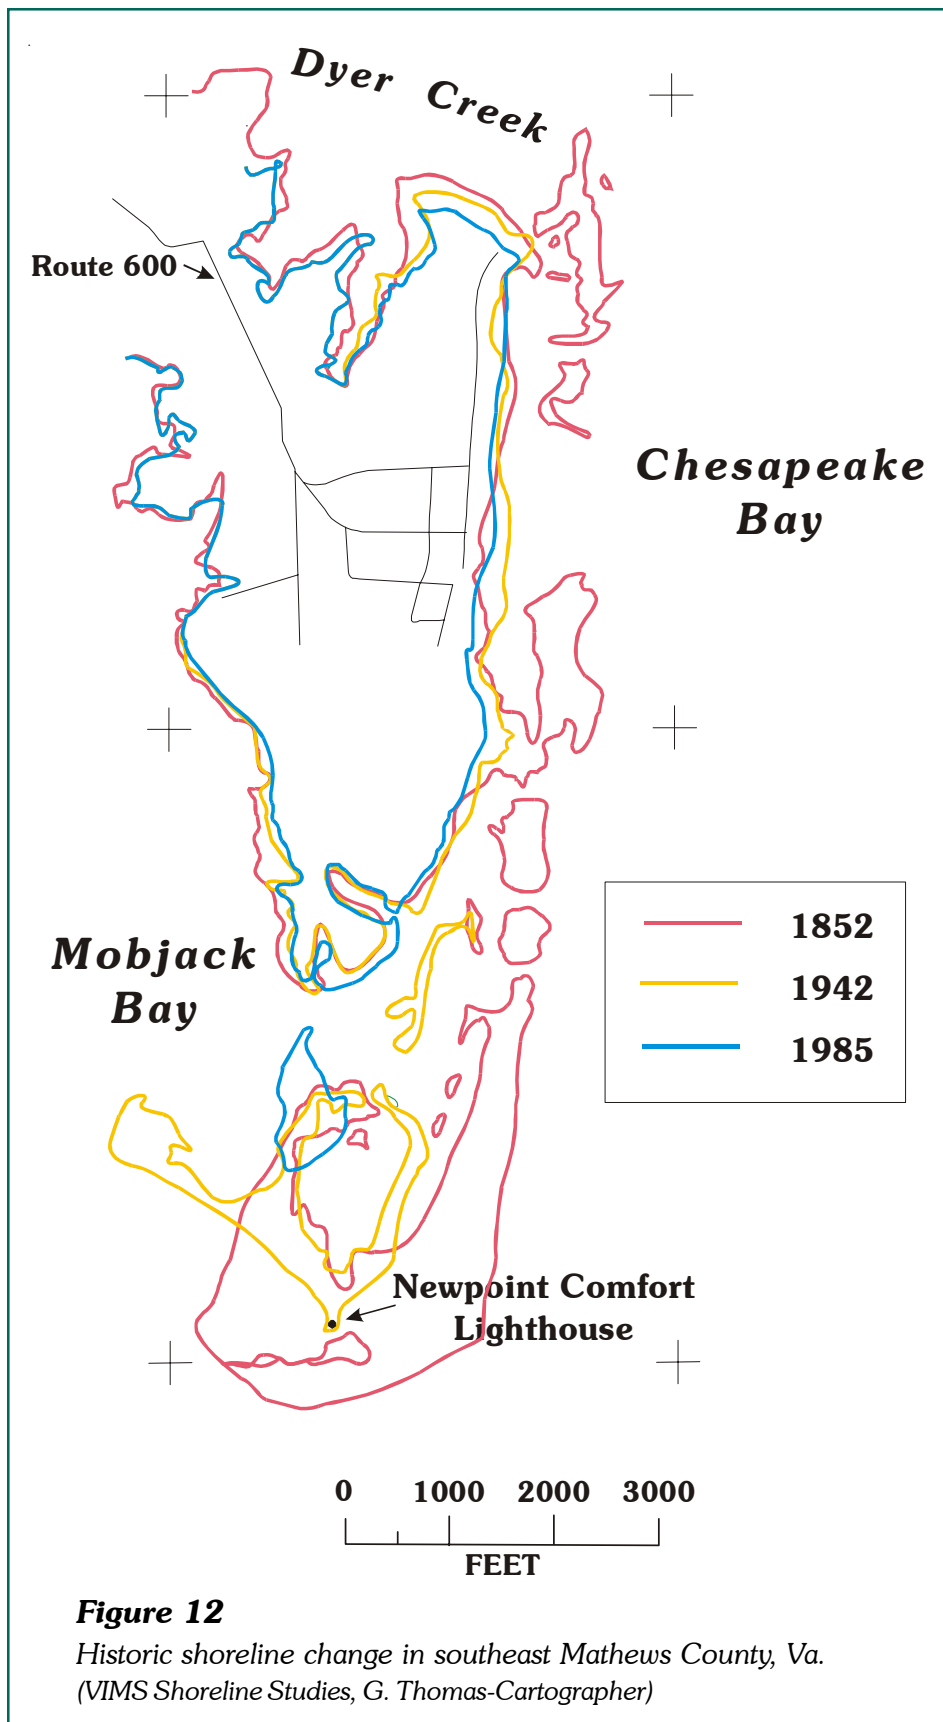
Figure 12
 Historic shoreline change in southeast Mathews County, Va.
 (VIMS Shoreline Studies, G. Thomas-Cartographer)

The tidal shoreline of the Chesapeake Bay extends for about 9,000 miles, and is roughly evenly divided between Maryland and Virginia. During the period 1850-1950 assessments indicated a loss of about 47,000 acres of land along this shoreline due to erosion (22,000 acres in Virginia; 25,000 acres in Maryland) (Byrne and Anderson, 1978; Singewald and Slaughter, 1949; U.S. Army Corps of Engineers, 1973). Most of this erosion occurred along less than 1,000 miles of the shoreline, along the main stem of the Chesapeake Bay. [Figure 12](#) shows how a bay shoreline in southeast Mathews County, Va., has evolved. The 1852 shoreline includes the marsh islands in the Chesapeake Bay; notice the extent of New Point Comfort at that time.

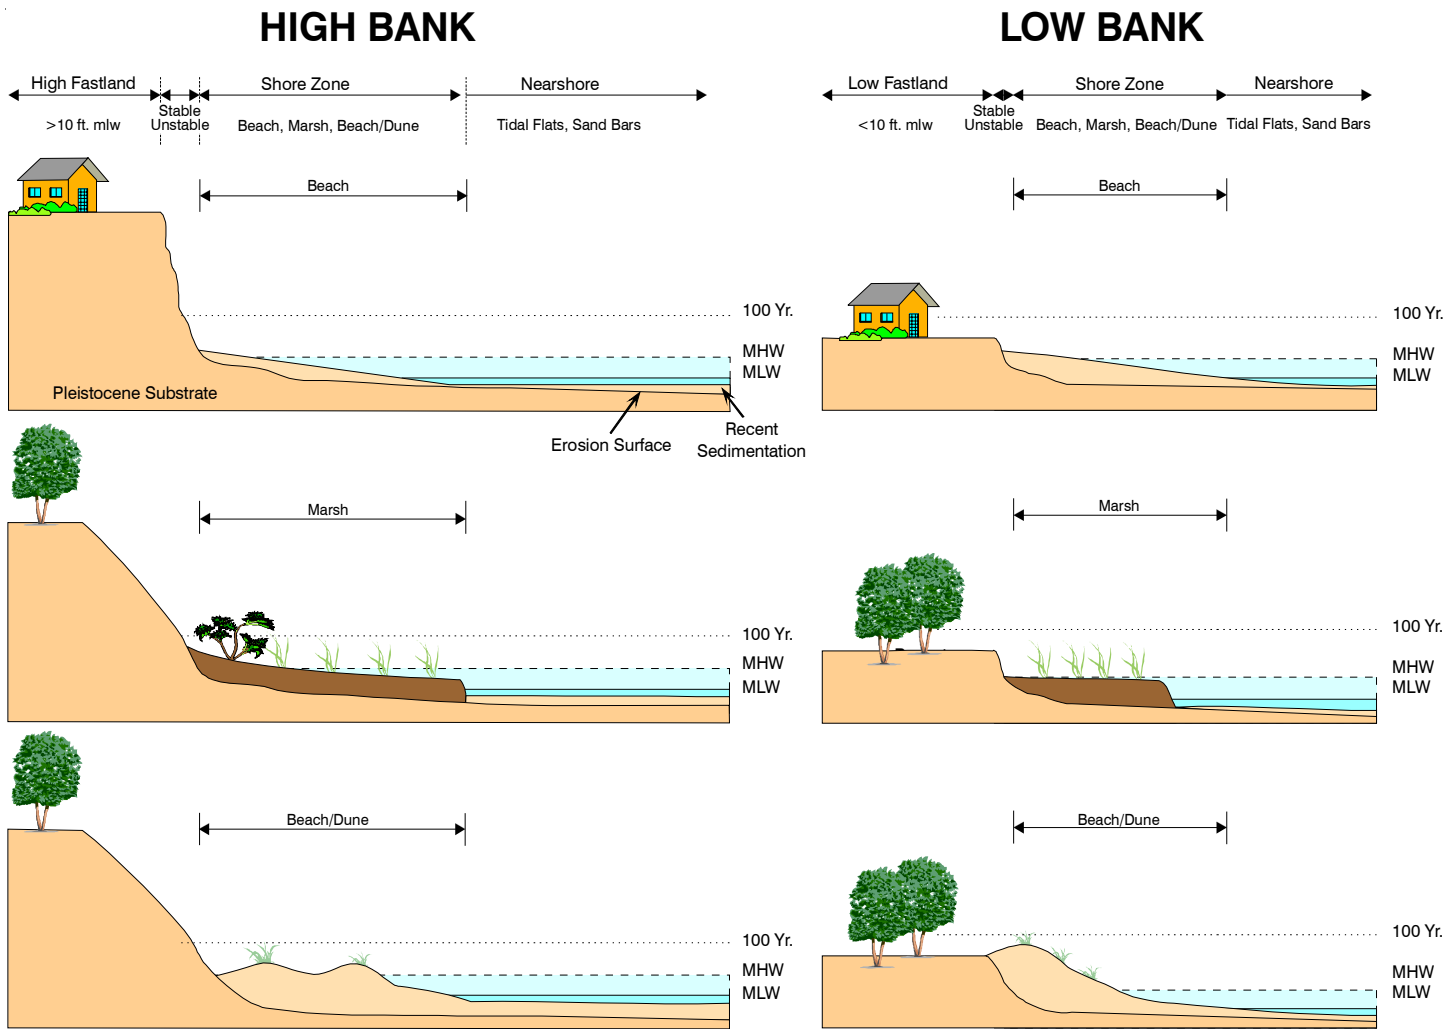
Figure 13

Six typical shoreline profiles around Chesapeake Bay. The stability of the bank face is dependent upon the width and type of shore zone features. Wide beaches/dunes and marsh zones can offer significant wave protection even during storms. (Mean high water (MHW), mean low water (MLW), and 100-year storm surge elevation.)

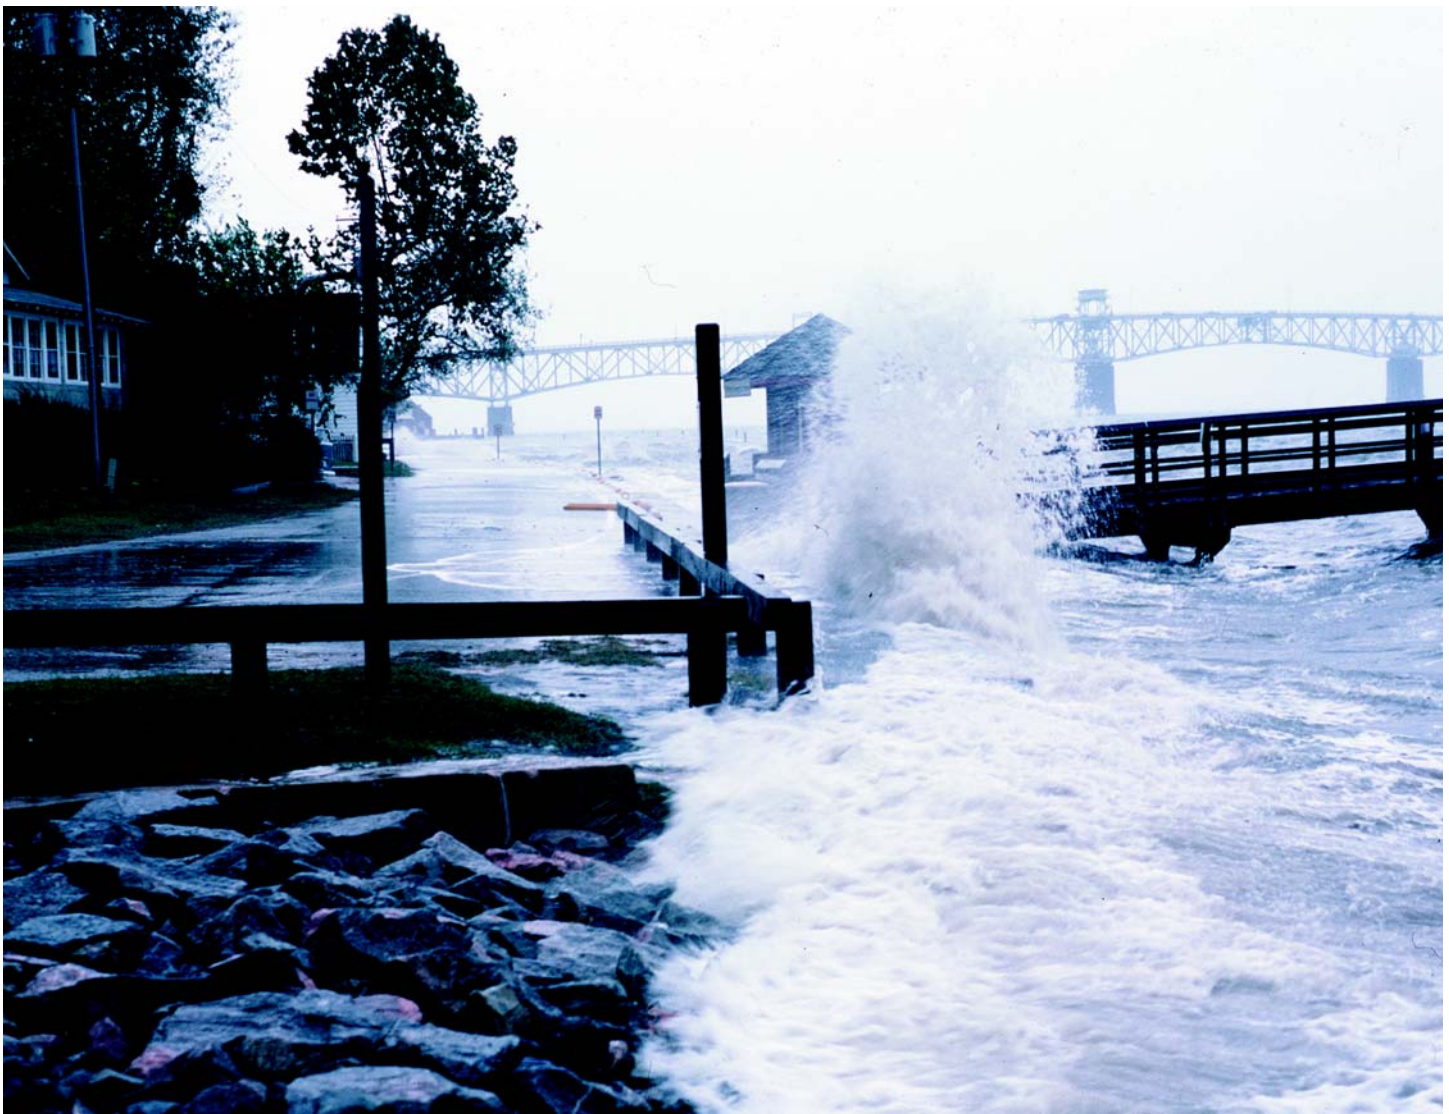
Yorktown waterfront adjacent to Cornwallis's Cave during a Northeaster, October 22, 1985.

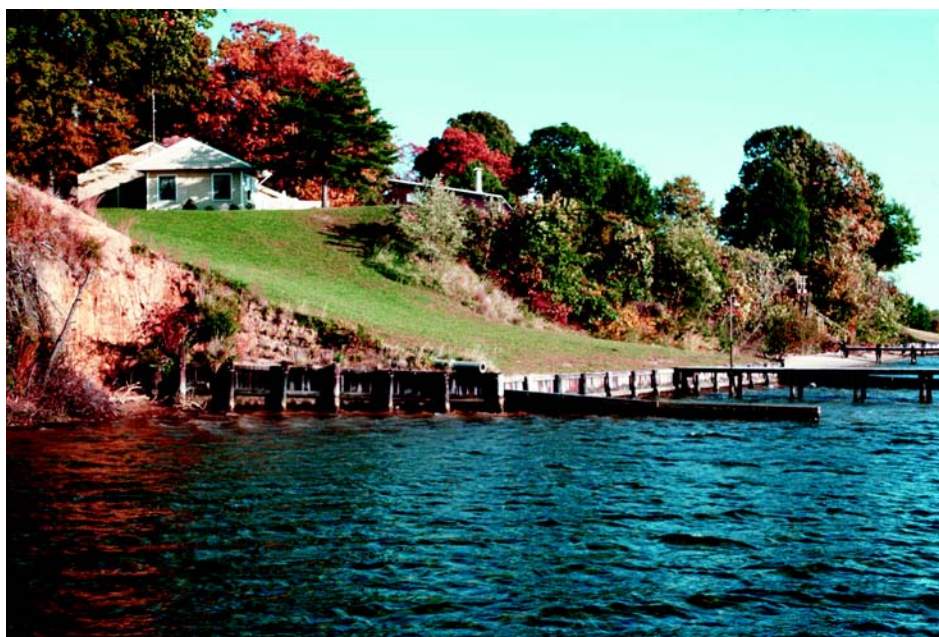
Figure 14A Bulkhead and graded bank.

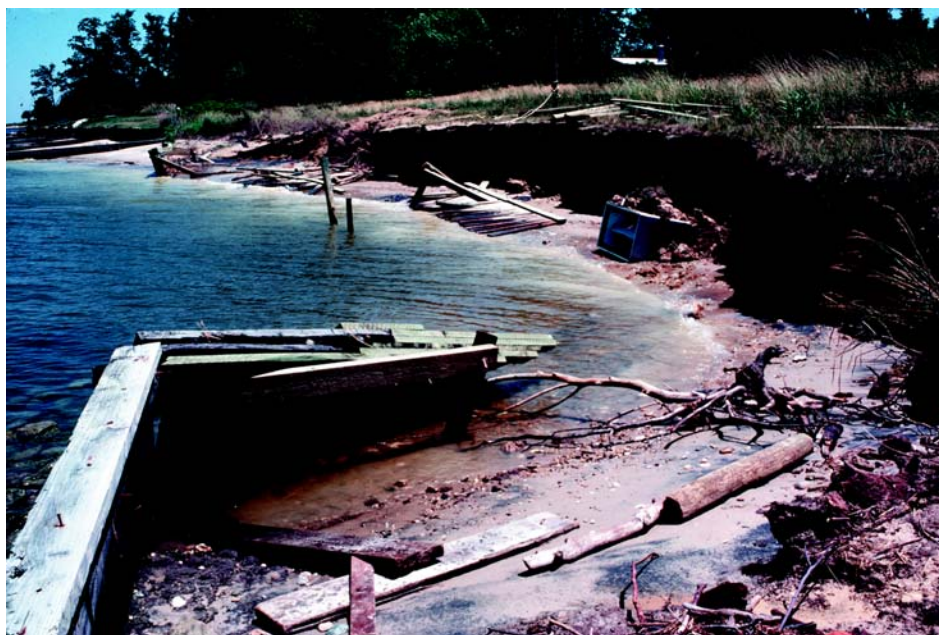
Figure 14B
Results of "short sheeting" and flanking resulting in loss of backfill in bulkhead construction. This particular structure was less than 2 months old.

Figure 14B depicts the results of “short sheeting” on the Potomac River where sheet piles were too short for site conditions.

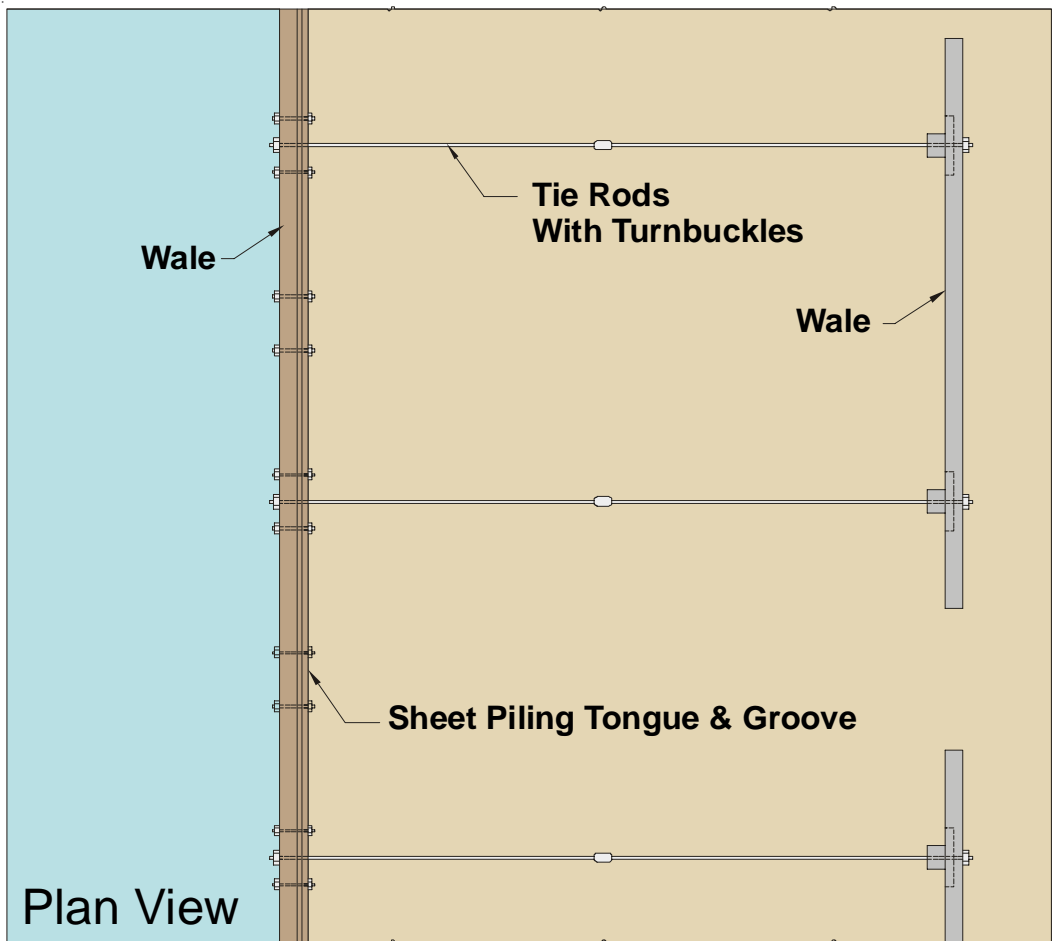
Figure 14C
Bulkhead schematic
(After AWPI, 1969).

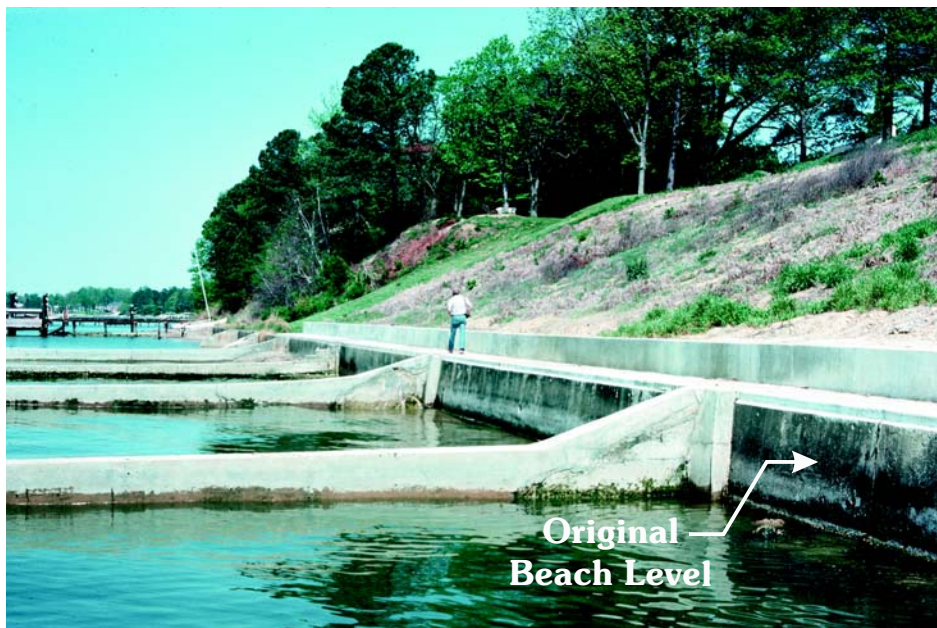
Figure 15A (top)
Concrete seawall on James River in Newport News, Va.

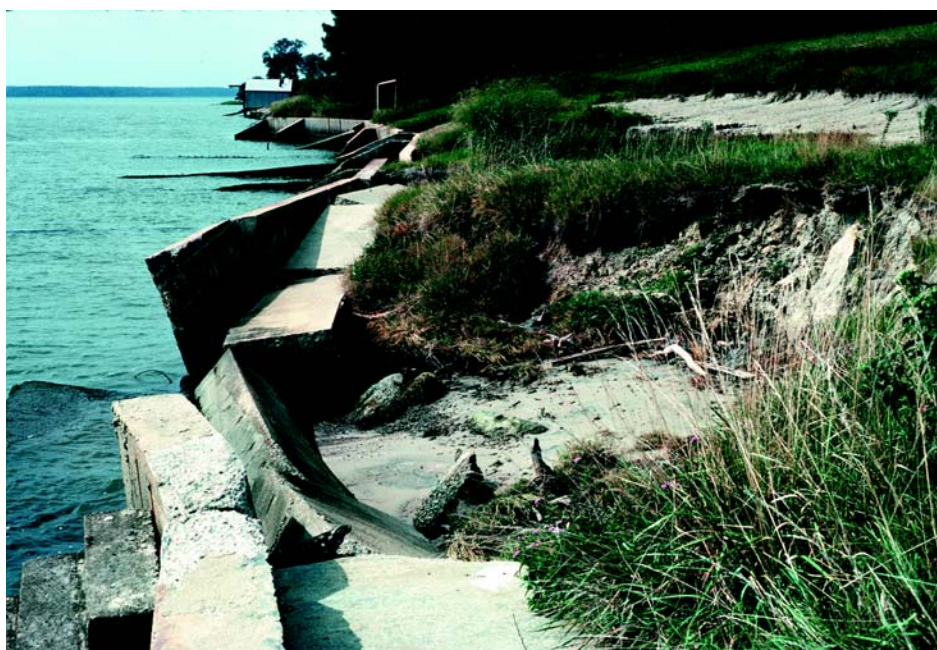
Figure 15B (bottom)
Concrete seawall failure due to hydrostatic loading.

massive failure due to hydrostatic loading of water trapped behind the structure.

Providing weep or drain holes in the face of the structure allows hydrostatic pressures (water force from the land side from groundwater or water trapped due to storm surge) to be released. Figure 15B shows a similar seawall situation with

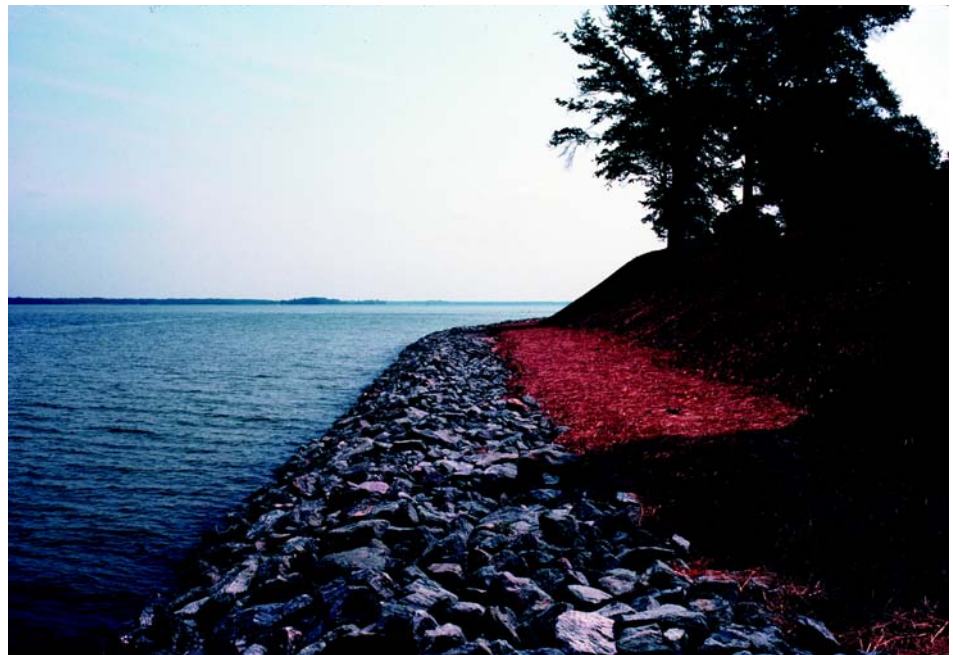
Figure 16A

Stone revetment shortly after construction on the Potomac River, Va.

Figures 16A & 16B show an example and a typical design cross-section of a stone revetment placed along a high bank. Revetments need to be high enough to withstand waves that may break over the top of the structure in extreme conditions. Banks usually need to be graded in order to obtain a stable slope. Armor stone must be good quality and proper size in order to support the size structure needed for a given shoreline. Armor made of
