Shoreline Management In Chesapeake Bay

Special Report in Applied Marine Science and Ocean Engineering Number 356

Virginia Sea Grant Publication VSG-99-11

October 1999

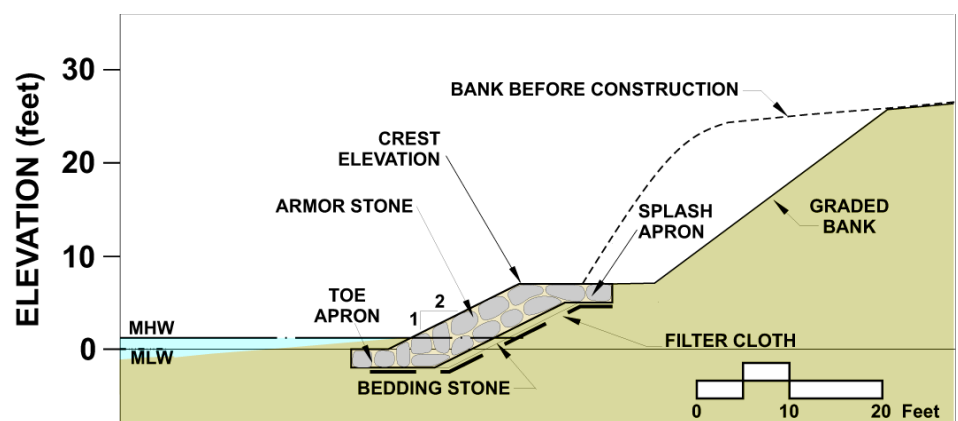
Figure 16B.

Figures 16A & 16B show an example and a typical design cross-section of a stone revetment placed along a high bank. Revetments need to be high enough to withstand waves that may break over the top of the structure in extreme conditions. Banks usually need to be graded in order to obtain a stable slope. Armor stone must be good quality and proper size in order to support the size structure needed for a given shoreline. Armor made of

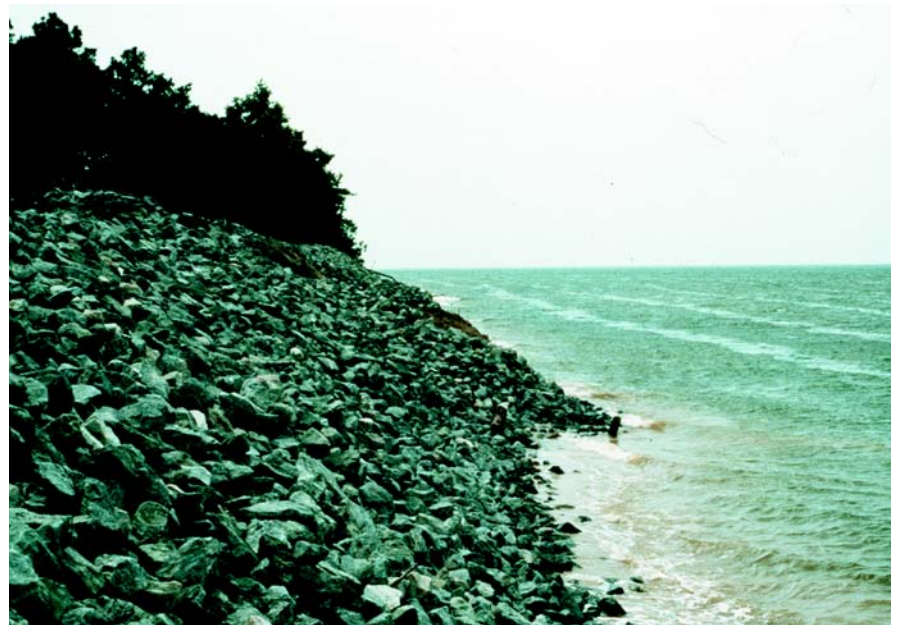
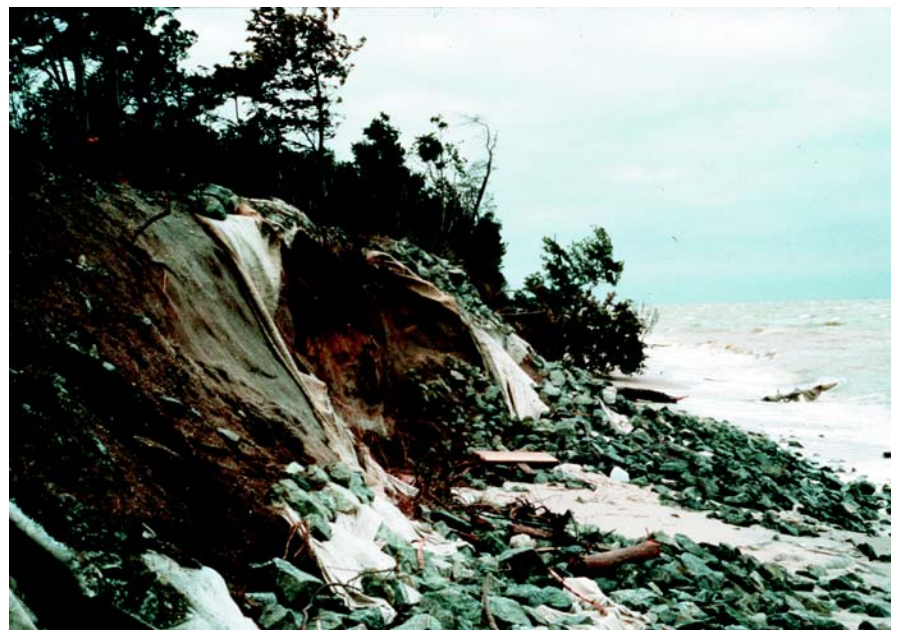
Failure of above structure after a modest storm event.

Problems can occur when the armor stone is undersized, placed in only one layer, or on too steep a slope. [Figures 17A and 17B](#) illustrate how such design flaws can result in total structural failure of a revetment.

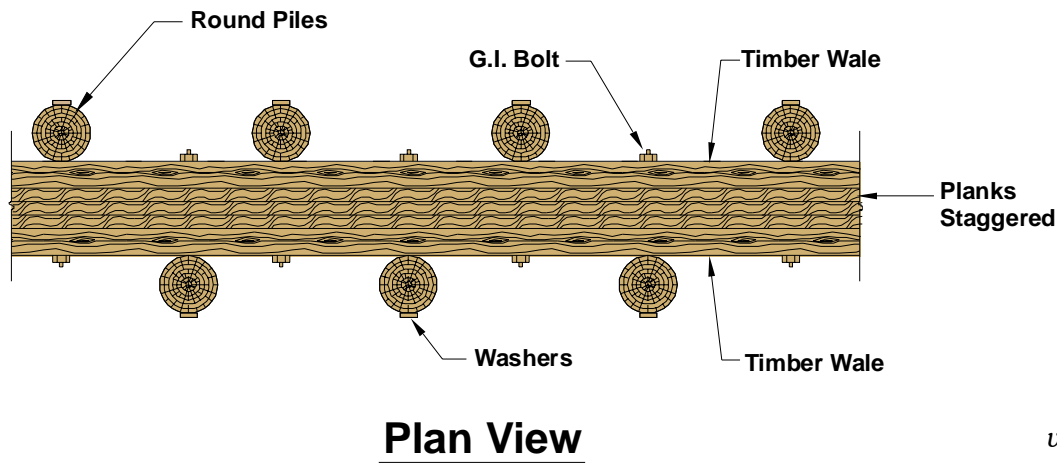
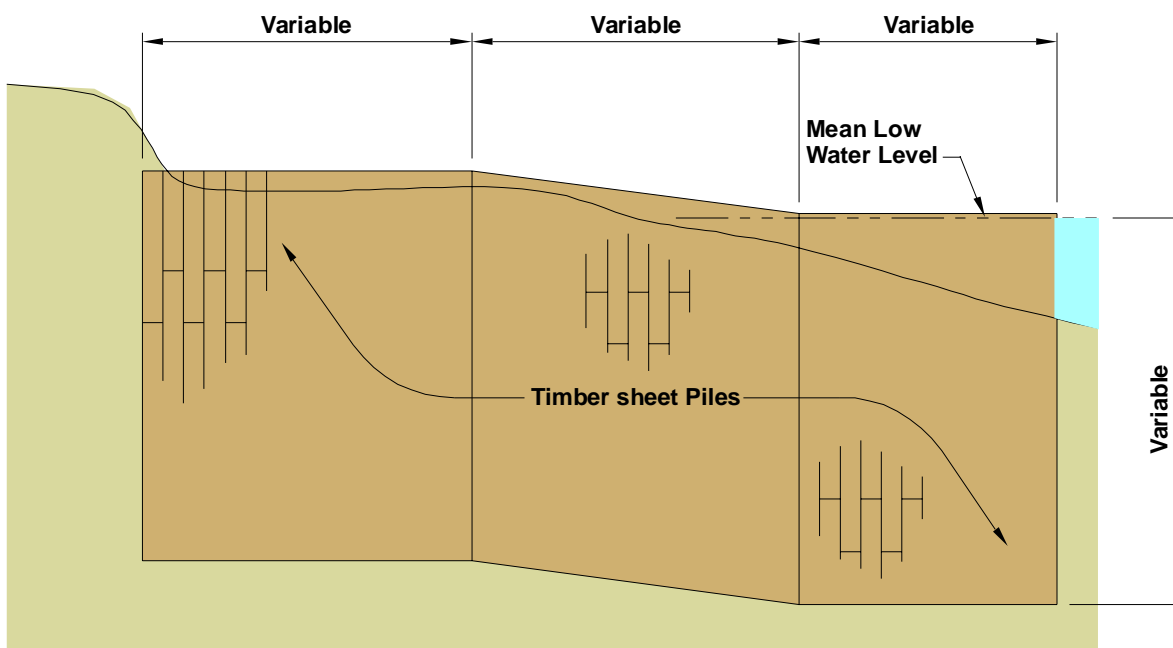
Figure 18
Wood bulkhead and groin: typical cross-sections and plan views (after USACE, 1984).

Between the 1950s and 1980s, groins were a popular way to trap sand and build a modest beach area. Traditionally these structures are constructed of wood (Figure 18). When used with or without a bulkhead or

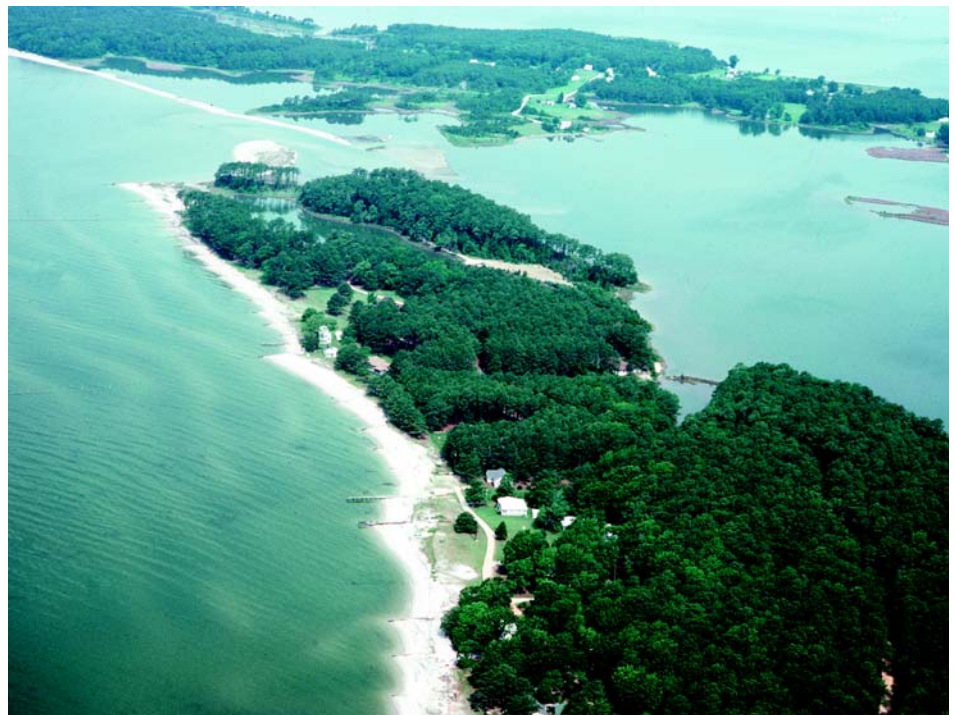
Figure 19A (top)
Groin field on Rappahannock River, Va., with adequate sand supply to provide a protective beach zone to upland property.

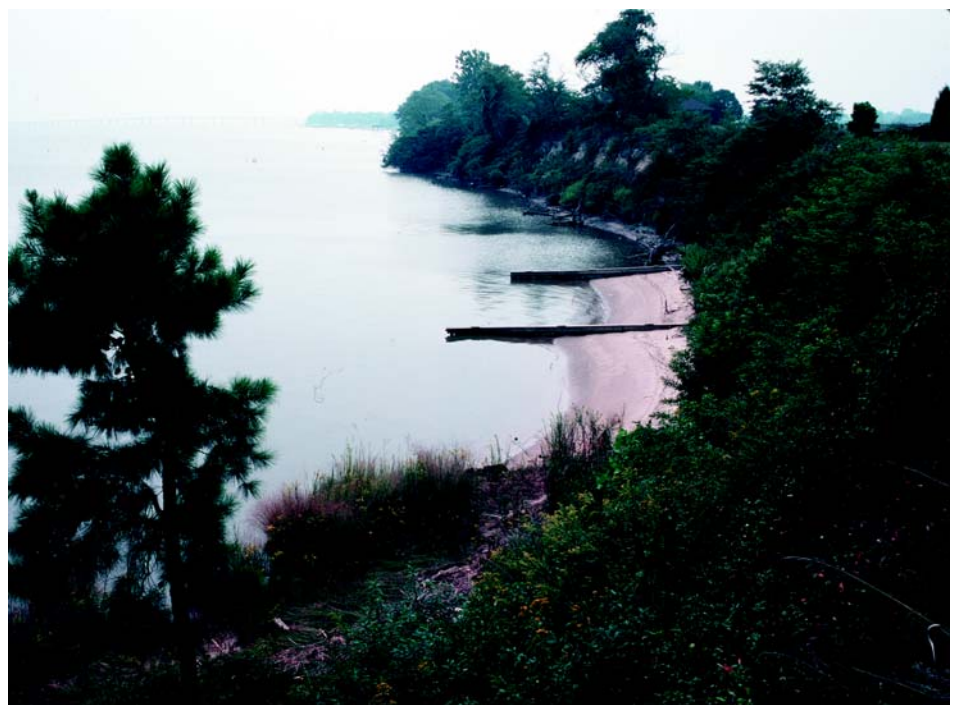
Figure 19B (bottom)
Inadequate sand supply along shore reach. The topmost groin acts as a littoral barrier.

thereby decreasing beach widths and increasing the potential for shoreline erosion in these areas (Figure 19B). Counting on a long-term, “endless” supply of sand is unwise; if a property owner installs an erosion mitigation structure updrift of your site, you may see your supply of sand—and thus your beach—greatly reduced. Groins may not be appropriate in areas with little or no sand supply, and if utilized, accompanying beach nourishment is recommended.

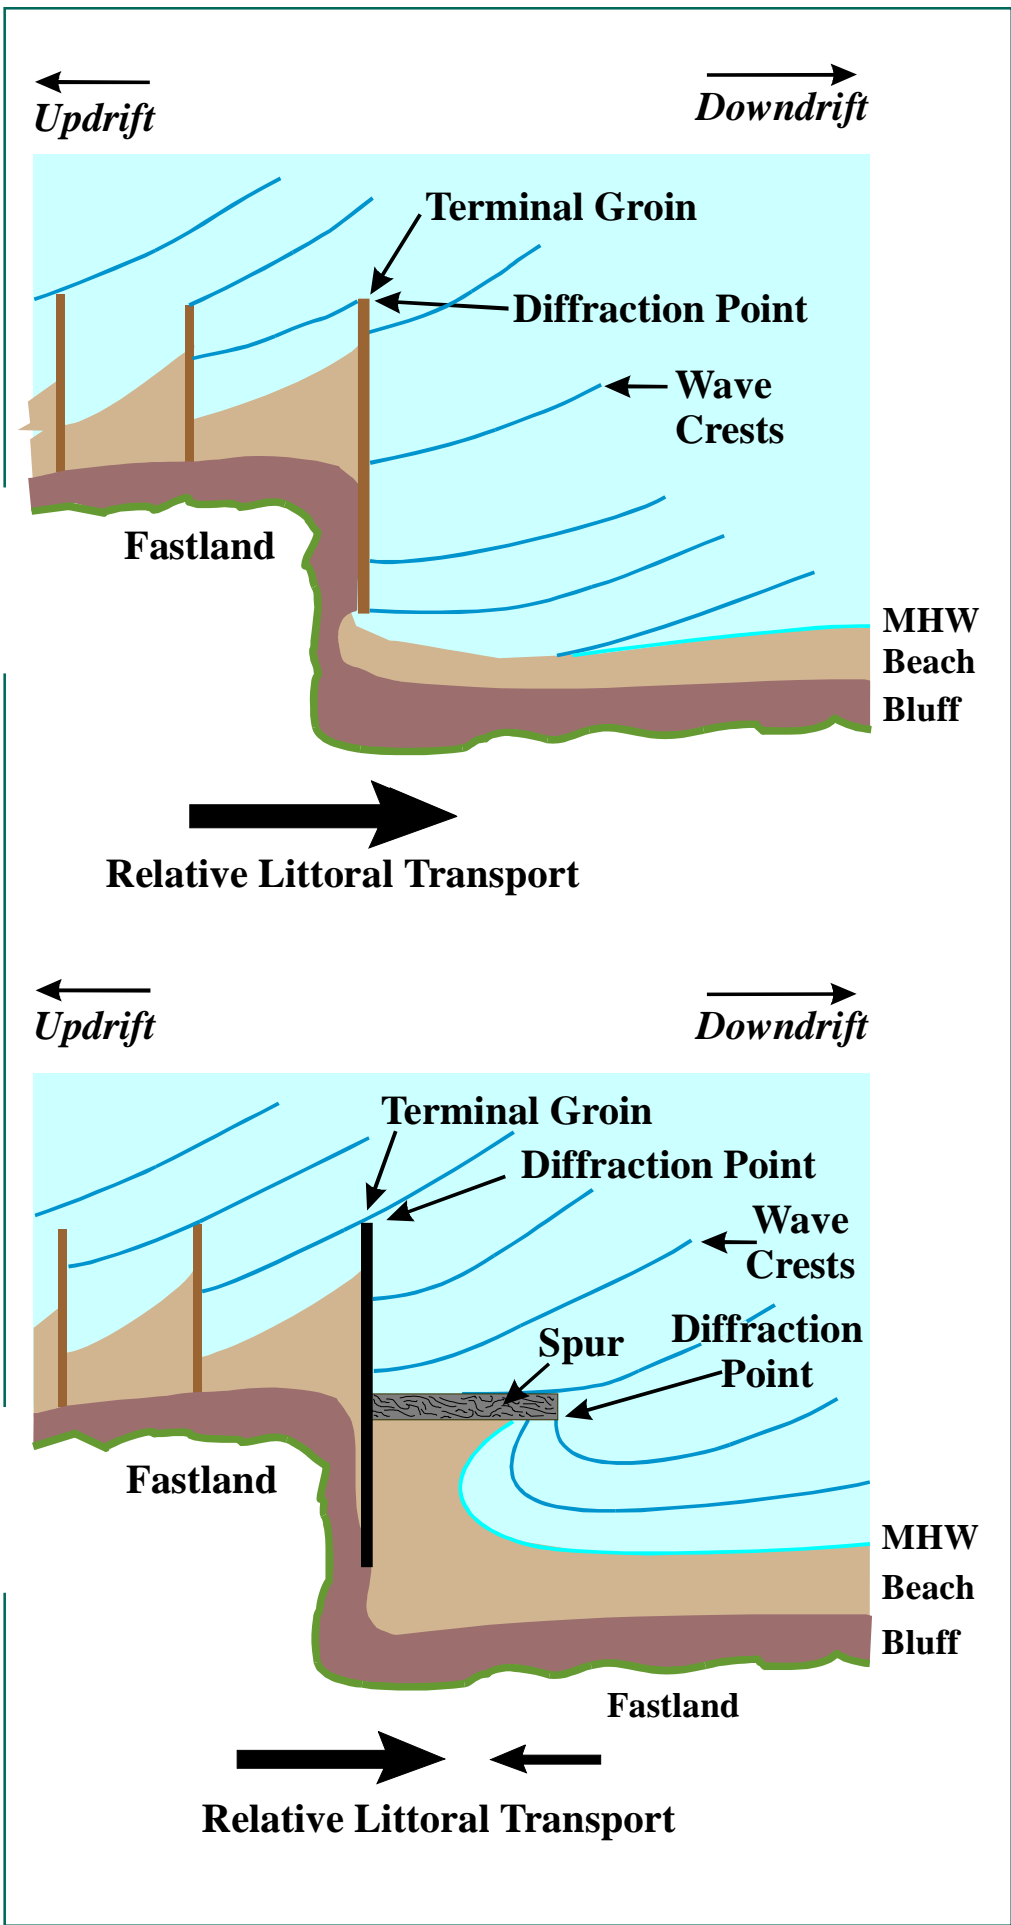
Figure 20A (top)
 Groin field depicting downdrift offset and direction of wave approach (After Anderson et al., 1983).

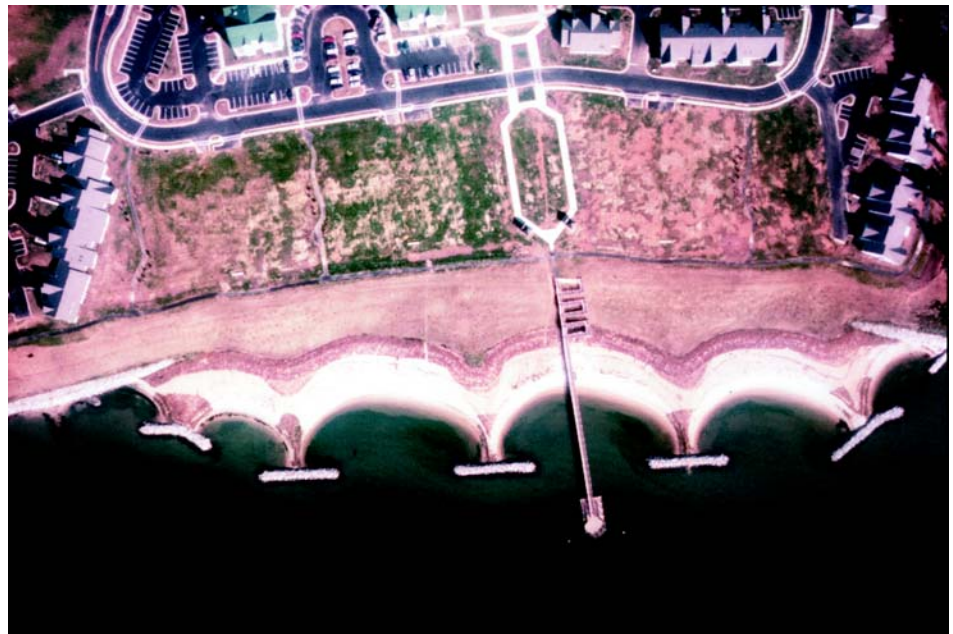
Figure 21A (top)

Breakwater system on Patuxent River in Calvert County, Md.

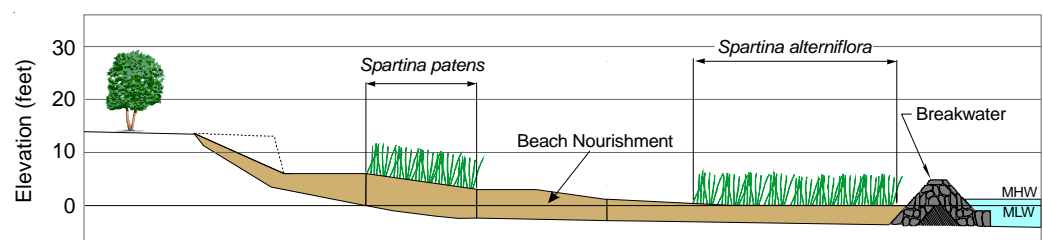
Typical breakwater cross-section.

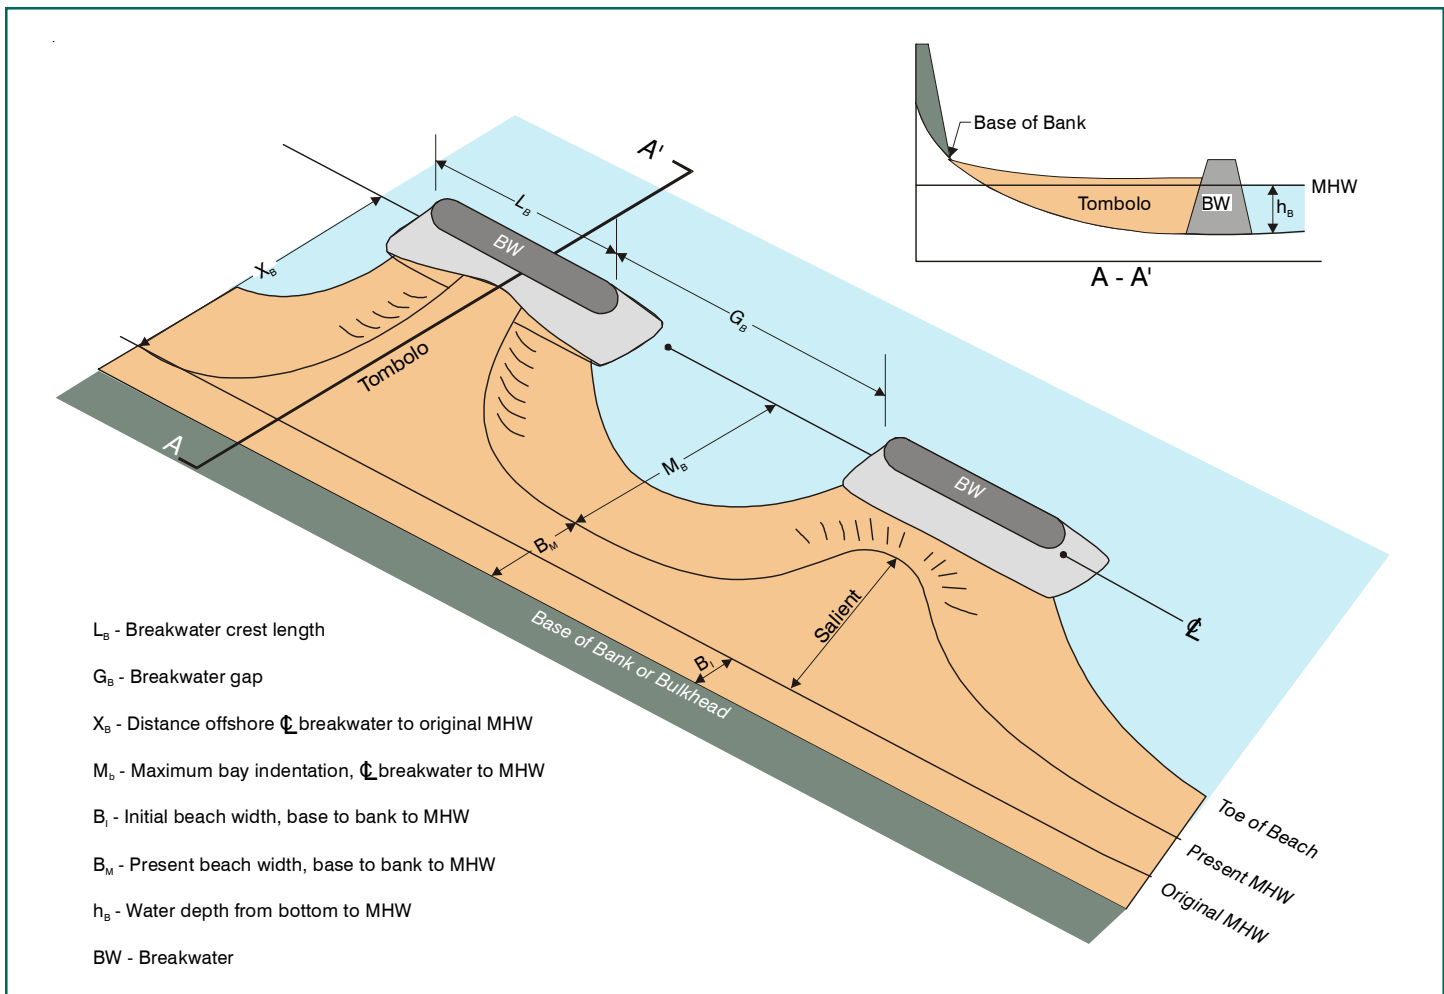
Figure 22 Breakwater design parameters (After Suh, 1987).

protection. In general, a B_m width of 40 to 60 feet is necessary for minimum bay shoreline protection. Hardaway *et al.* (1991) found the ratio for a stable embayed shore planform is a $M_b:G_b$ ratio of 1:1.65.

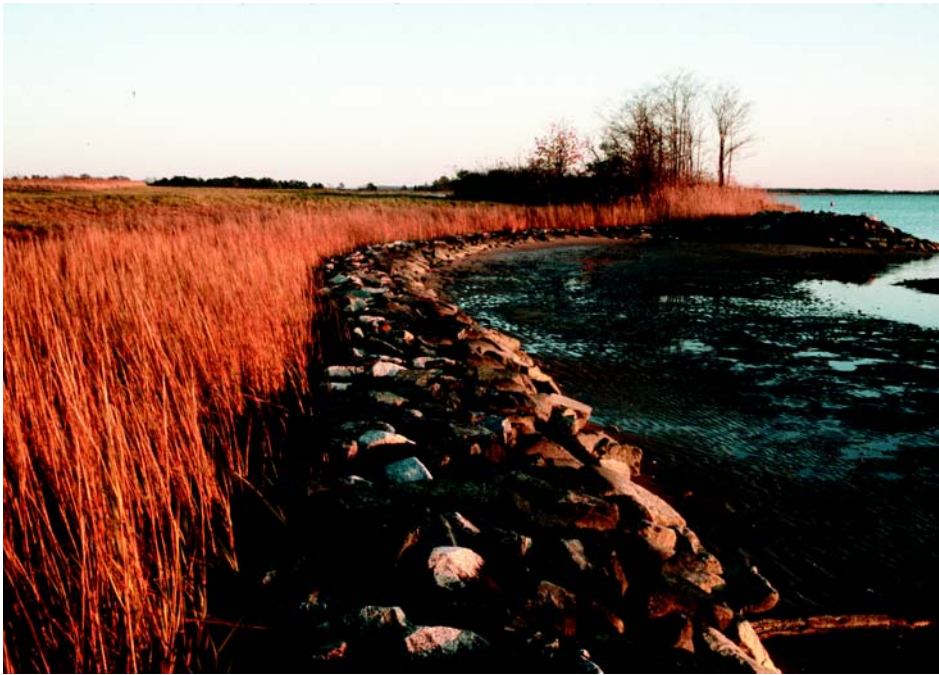
Figure 23A

Stone sill with marsh planting on Chester River, Kent County, Md.

relatively close to shore, and are usually continuous (Figure 23A). Typically, beach fill is needed to supplement the backshore so a marsh fringe can be established in the lee of the sill. Sills can be used in higher wave energy regimens to establish intertidal marsh grasses. Once again, potential impacts to adjacent shorelines must be considered. Figures 23B & 23C show a curvilinear sill, connected to breakwaters with marsh grass planted behind, soon after construction and five years later.

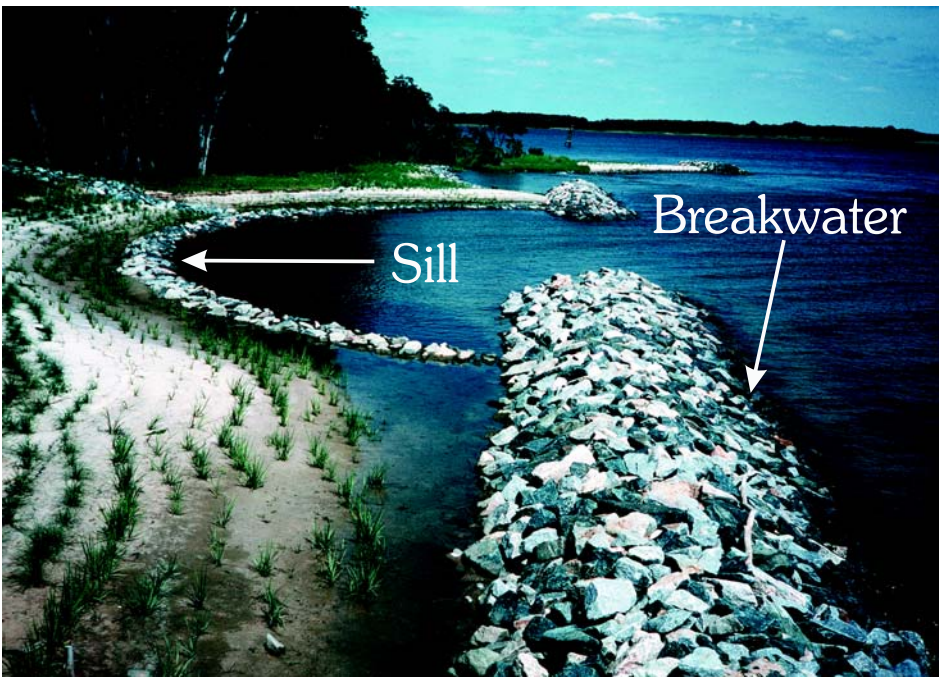
Figure 23B

Stone sill connecting breakwaters with sand fill and marsh implantation on Choptank River, Talbot County, Md.

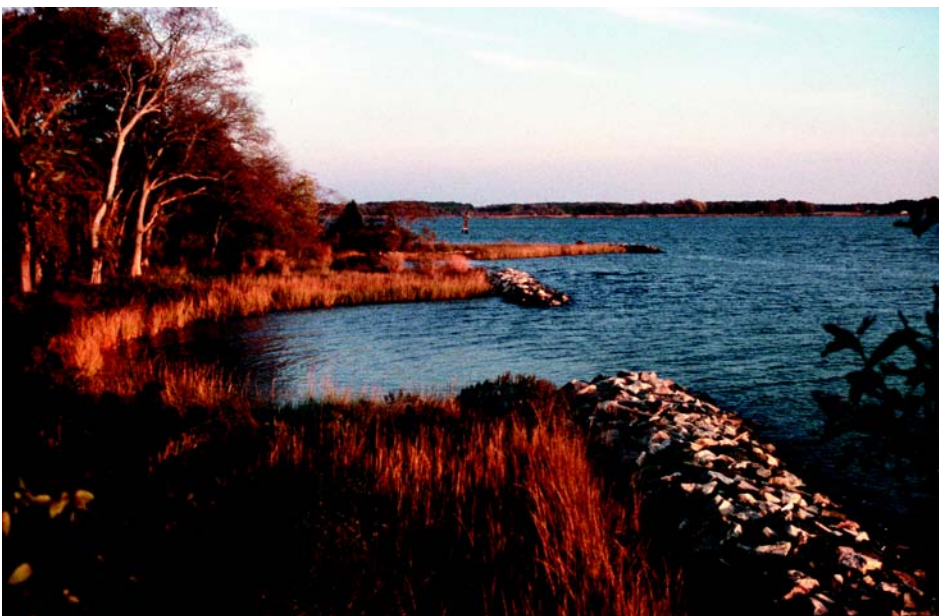
Figure 23C

Breakwater and sill project after 5 years.

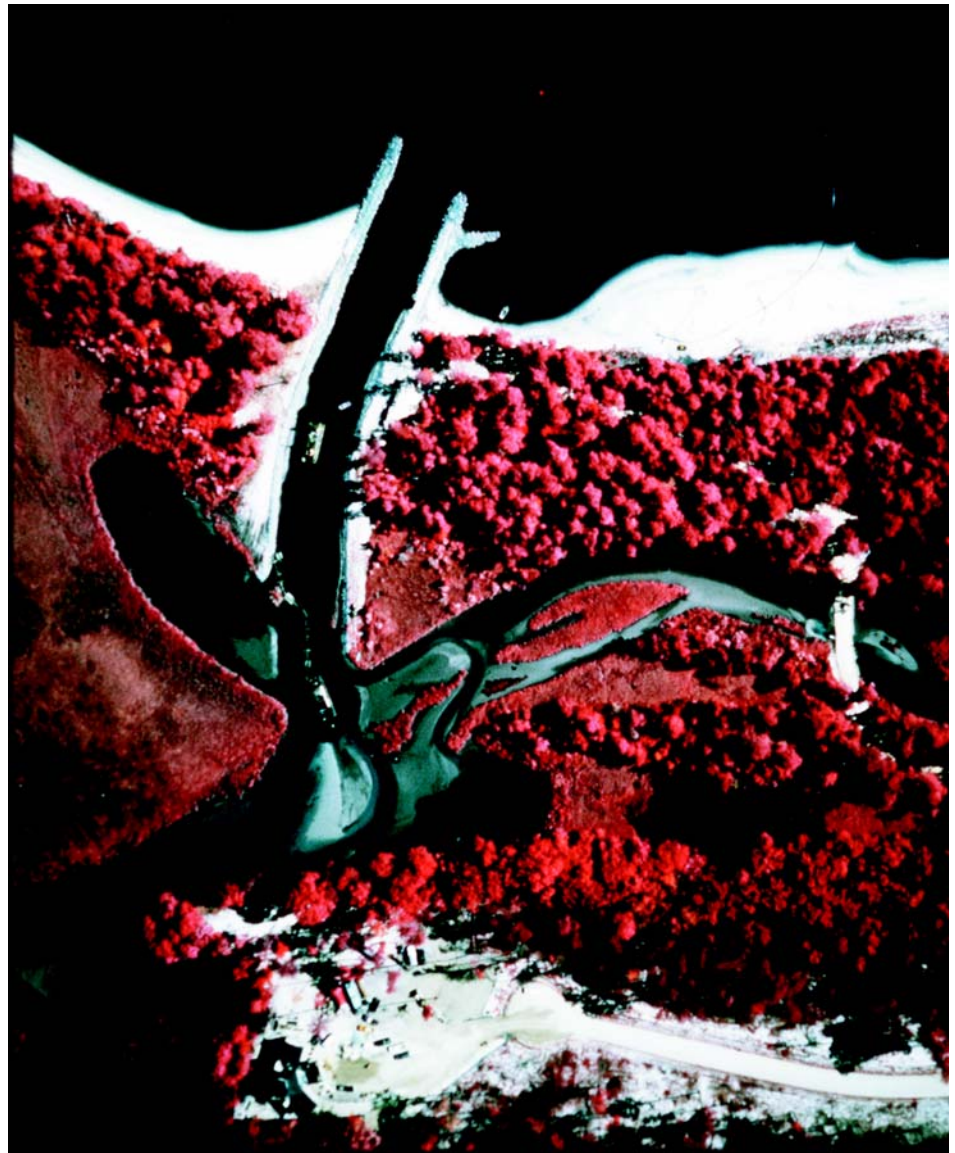
Figure 24

Cabin Point Creek, Westmoreland County, Va. New inlet established in 1981, with jetties to stabilize inlet channel. Spur and dredged channel sands placed downdrift (right side of inlet) permit sediment bypass and erosion control.

Current policy in Virginia and Maryland assigns beach nourishment as a priority mode of disposal for sand dredged from navigation channels, maintenance, or construction (Figure 24). Cost factors can limit this application to beaches

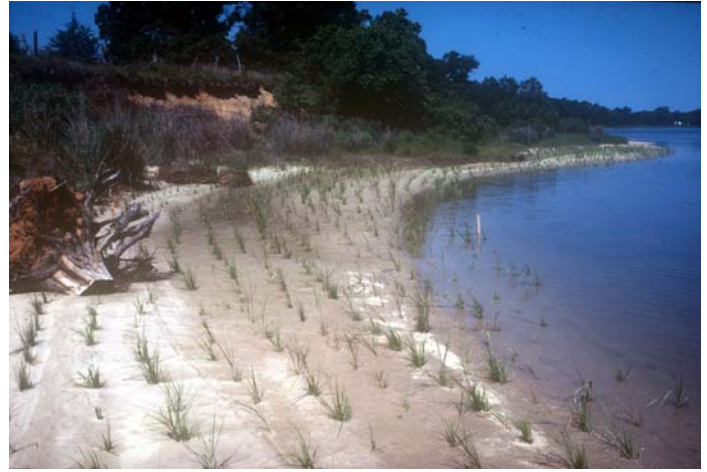
Figure 25A (top)
Marsh planting along Occahannock Creek, Northampton County, Va.

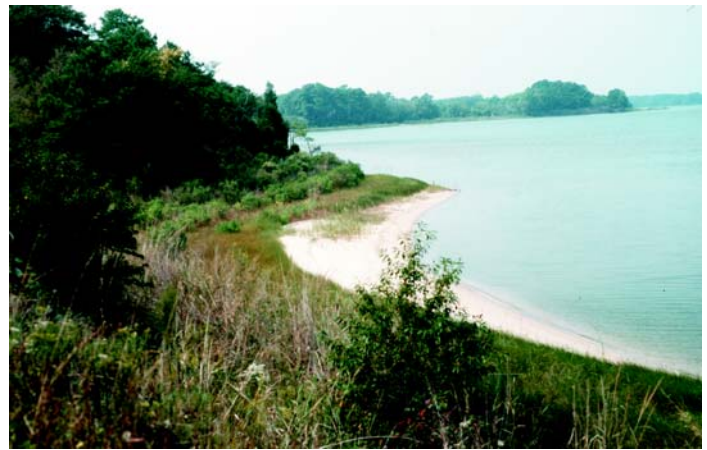
Figure 25C (lower)
Occahannock Creek marsh planting after 10 years of growth.

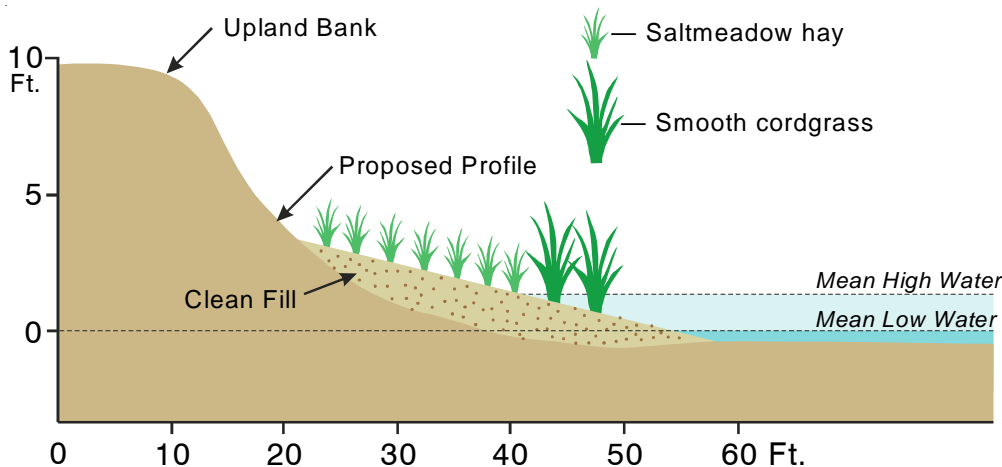
Figure 25D
This cross section shows a proposal plan to stabilize a typical eroding shoreline using clean sand to create the appropriate planting area.

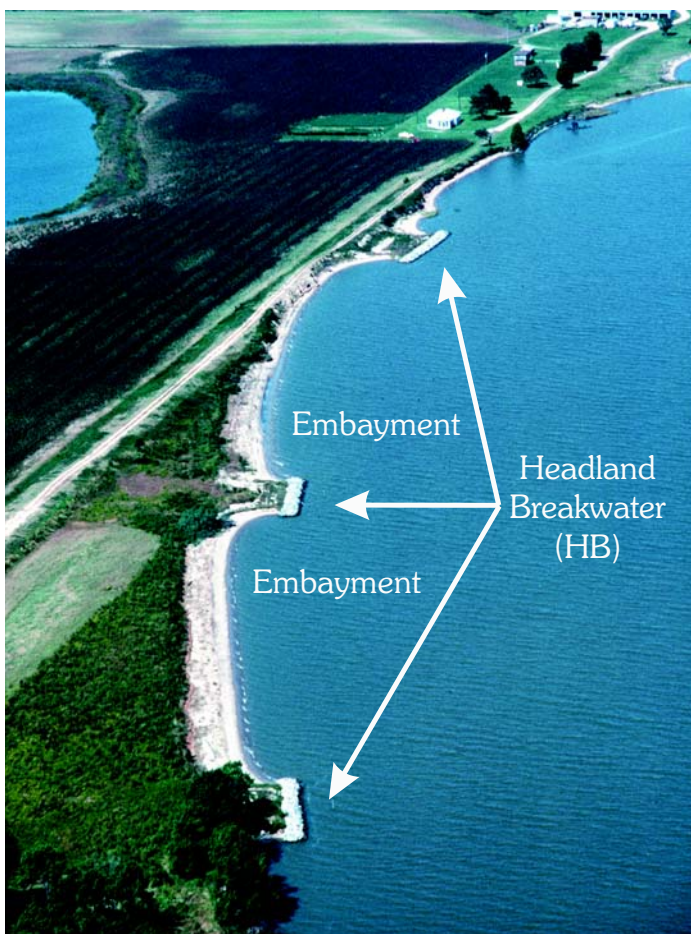
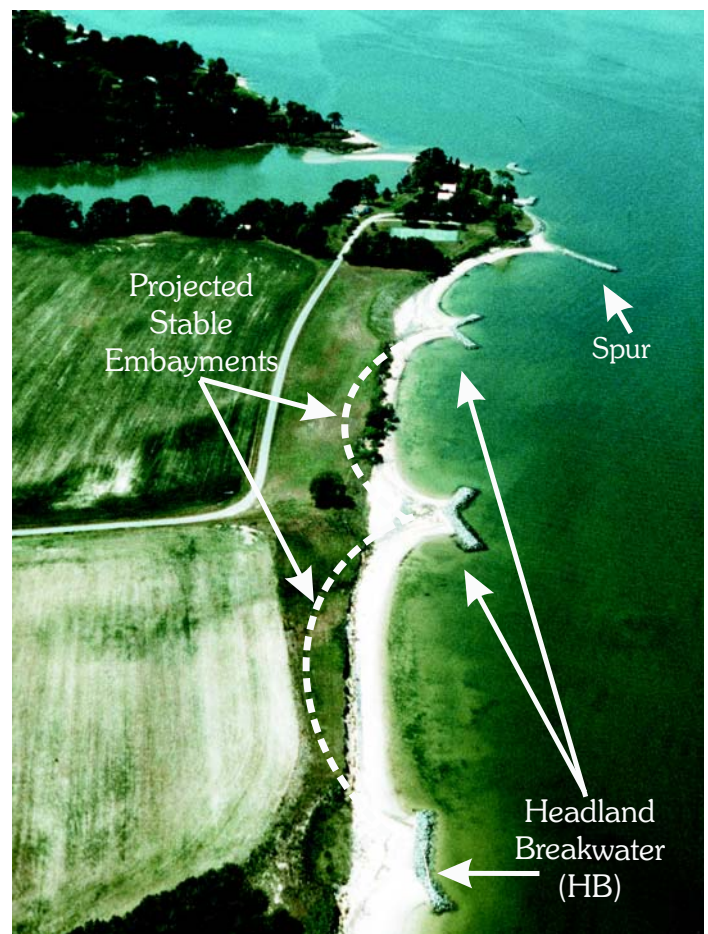
Headland control system in Westmoreland Co., Va. in Potomac River, installed 1998.

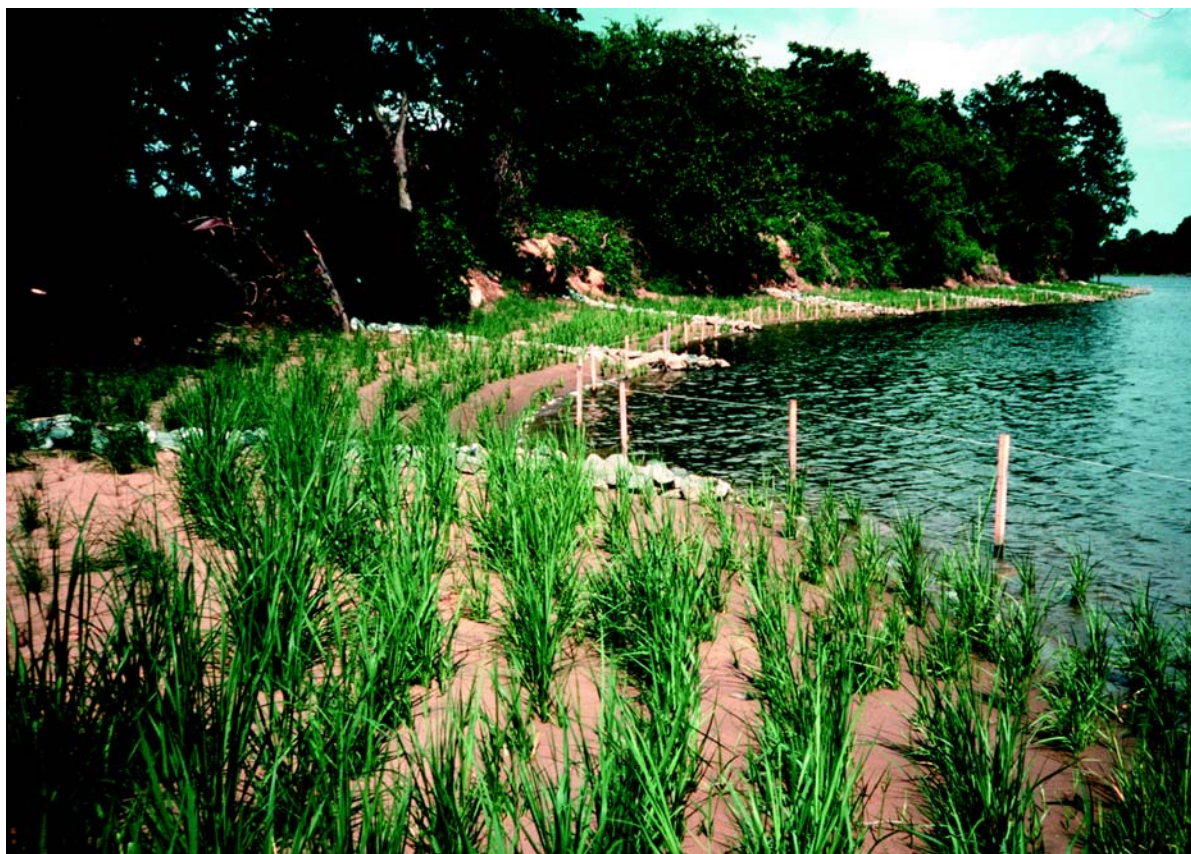
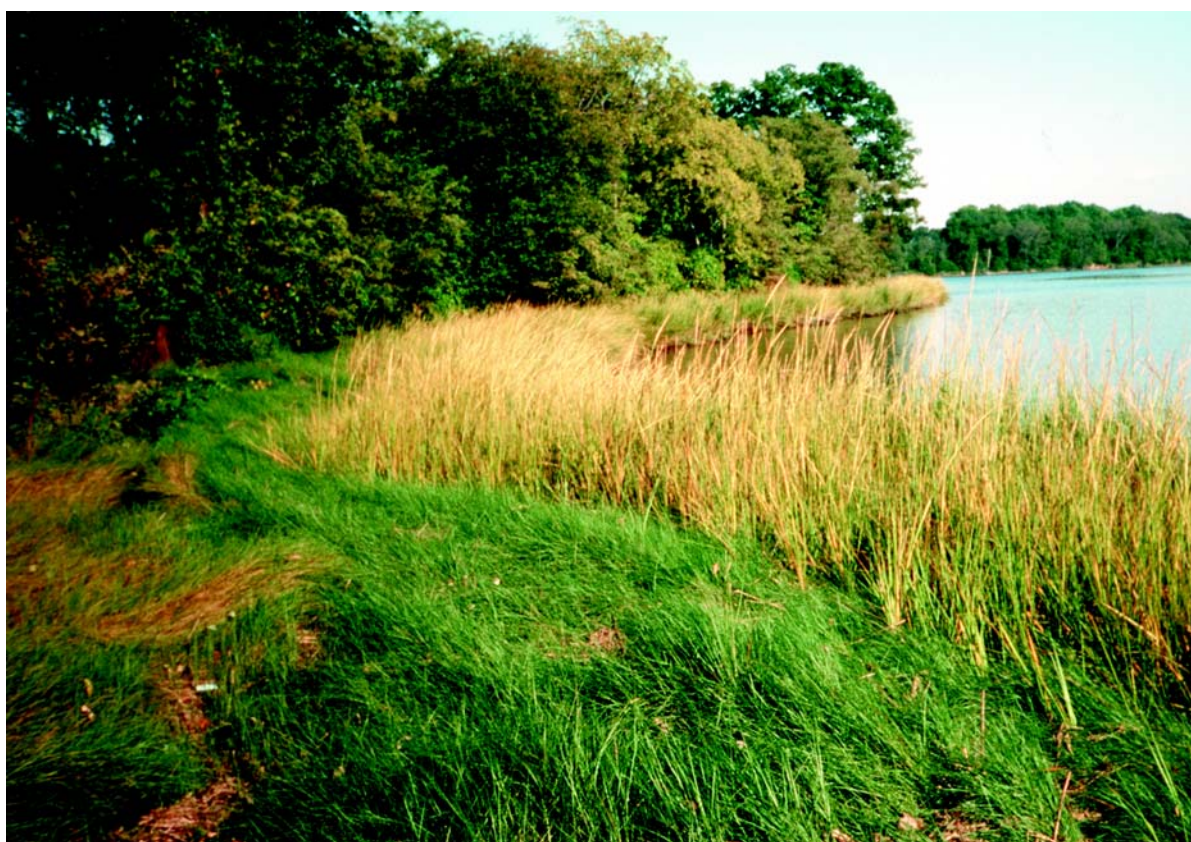
Wye Island project 4 years after construction.

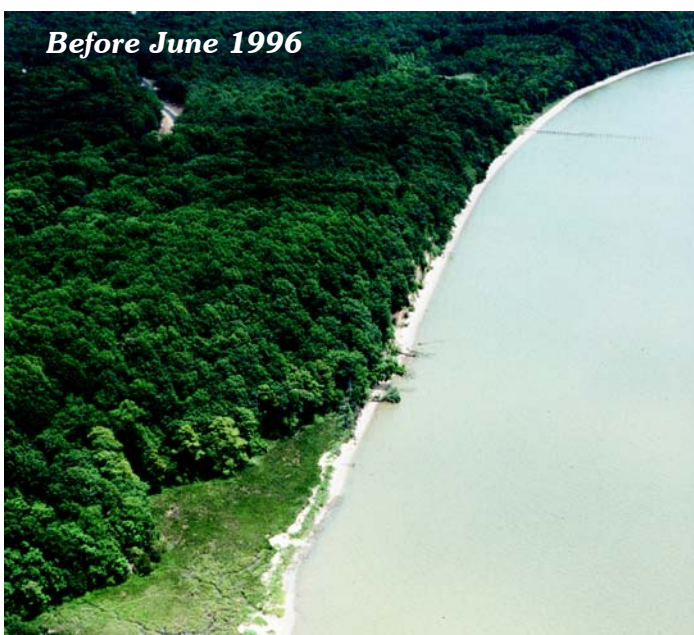
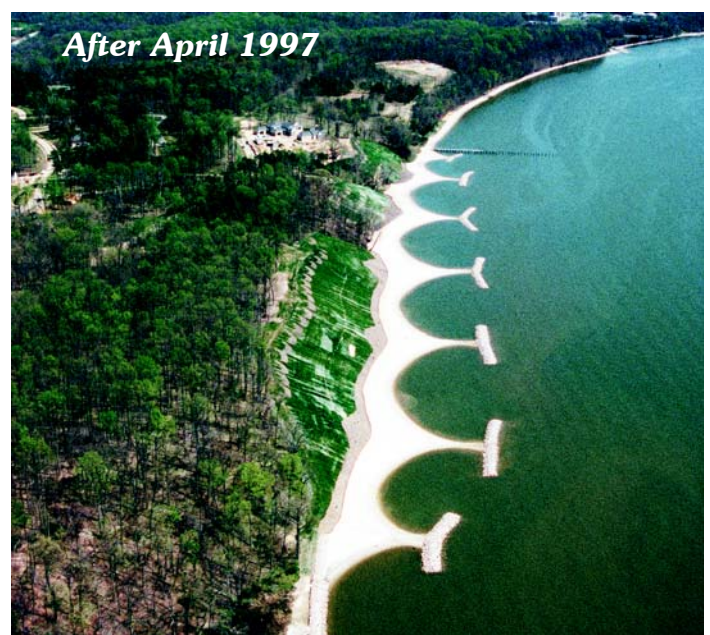
Figure 28

Kingsmill on the James, James City County, Va. Shore protection system utilizing headland, breakwaters, beach fill with wetland vegetation, bank grading with upland vegetation, a revetment, and an interfacing low-crested breakwater.

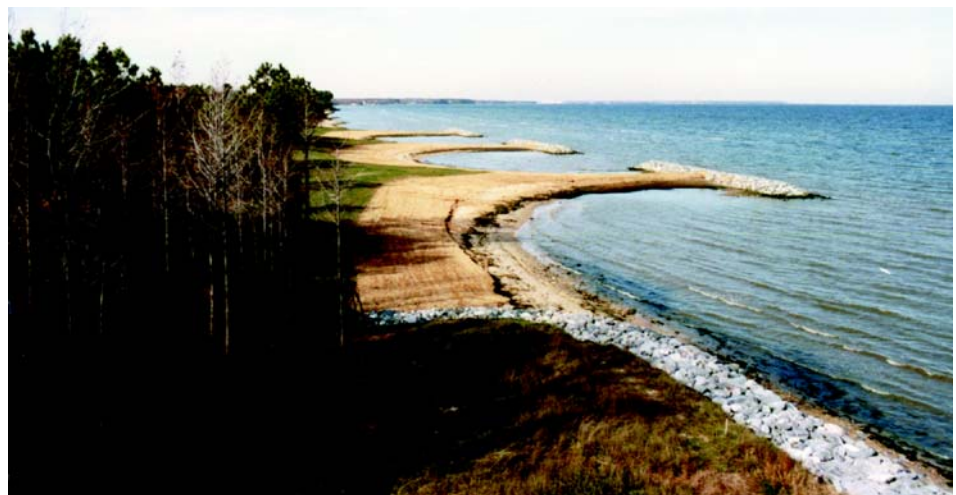
Figure 29

Breakwater system on Chesapeake Bay, Elm's Beach, St. Mary's County, Md.

Breakwater systems along high-energy shorelines work best when there is at least 300 feet of shoreline—or better yet, the entire reach—to be considered (*Figure 29*) so impacts to adjacent beaches can be taken into account. When possible, such strategies should end at a convenient reach break such as an existing shoreline structure, inlet jetty, or a natural headland to minimize any effects on neighboring beaches. The mid-bay beach width should be 45 to 65 feet from mean high water to the base of the bank with an elevation of 3 to 4 feet above mean high water where the backshore meets the bank. Beach nourishment is usually necessary to achieve these beach widths. Armor stone should be a minimum of 1000 to 2,500 pounds, but a better range is 2,000 to 5,000 pounds
