City of Hampton, Virginia Shoreline Inventory Report Methods and Guidelines

**Comprehensive Coastal Inventory Program
Center for Coastal Resources Management
Virginia Institute of Marine Science, College of William and Mary
Gloucester Point, Virginia
November, 2011**

Special report in Applied Marine Science and Ocean Engineering No. 428 of the Virginia Institute of Marine Science

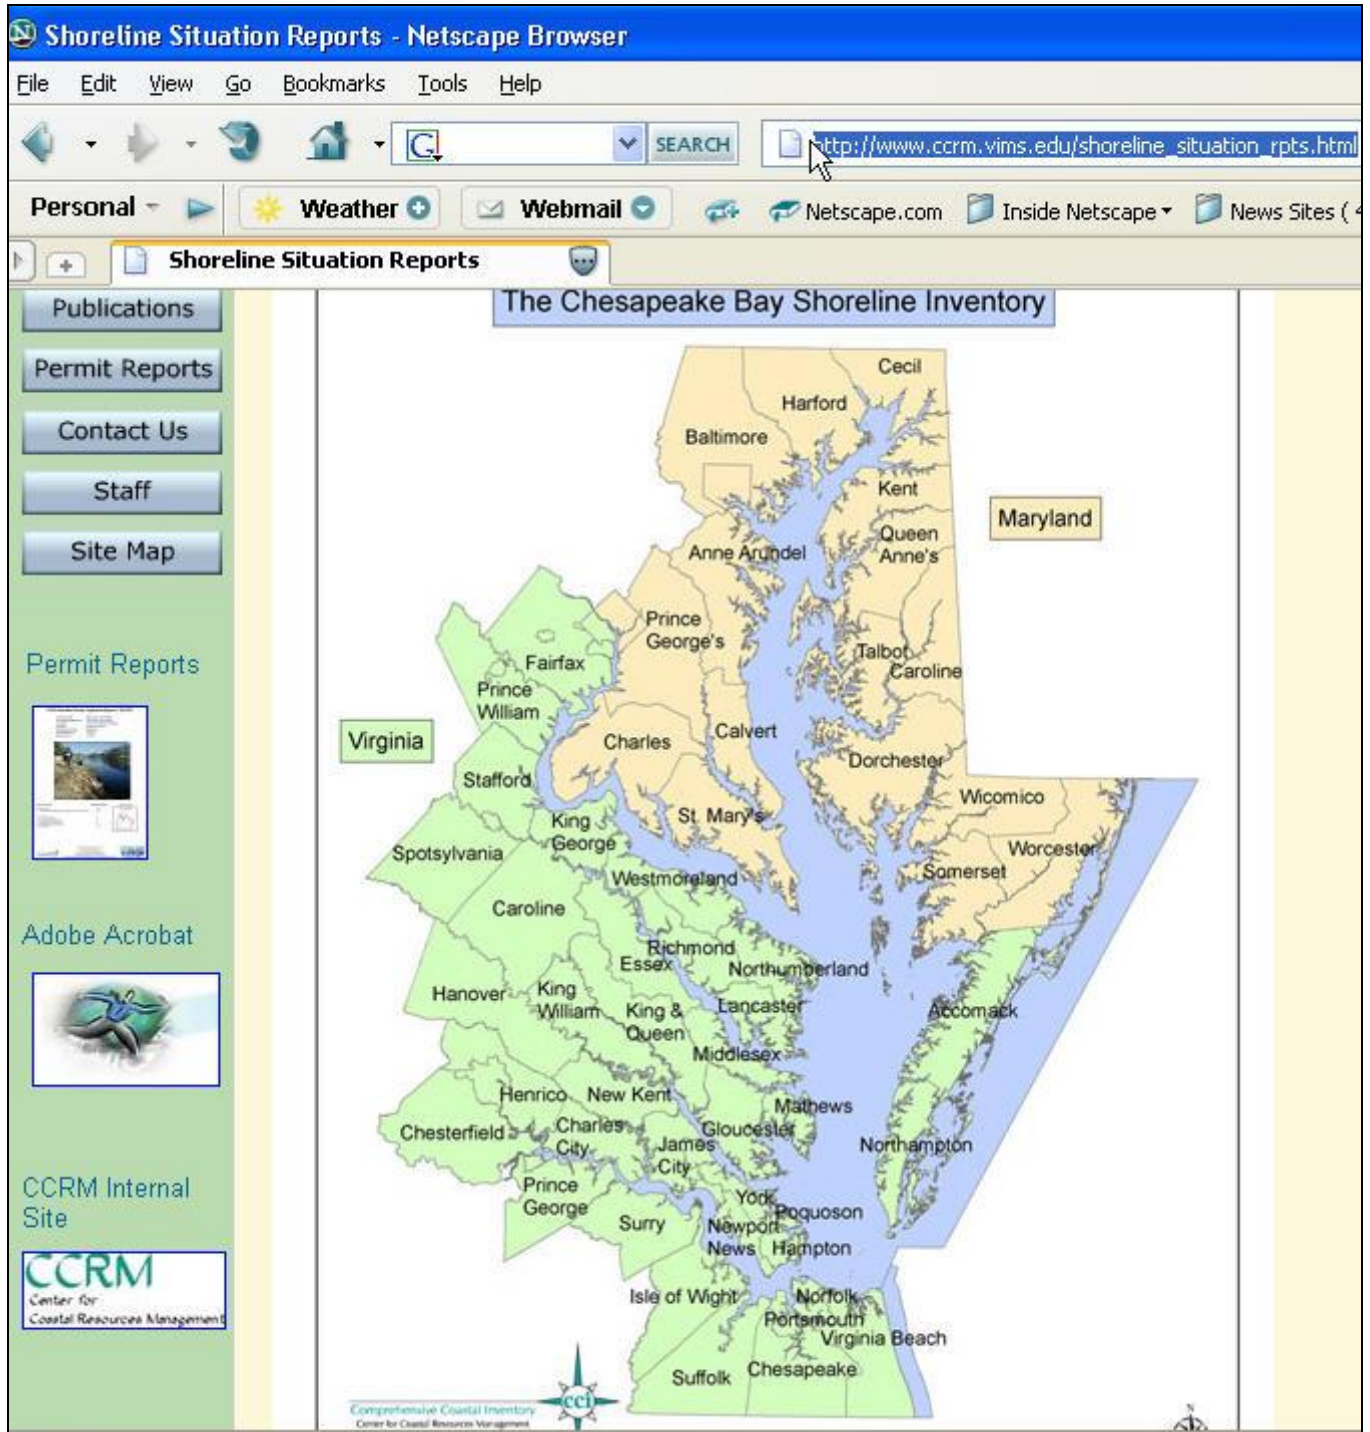
Figure 1. Shoreline Inventory Website

website (Figure 1), an index is provided to help users locate the area of interest and view the orientation of the maps to each other (Figure 2). Each plate can be individually selected and viewed from the plate list along the left hand column of the index page.

Shoreline Inventory Reports are only available electronically. From this website: http://ccrm.vims.edu/gis_data_maps/shoreline_inventories/index.html users can access digital maps, tables, reports, GIS data, and metadata. The website is organized to encourage users to navigate through a series of informational pages before downloading the data. A map of the Chesapeake Bay region depicting counties and cities is shown (Figure 1). Scroll over the City name to link to the completed inventory. There is a list of completed inventories by state below the map. Click on “City of Hampton” to access all the information available.

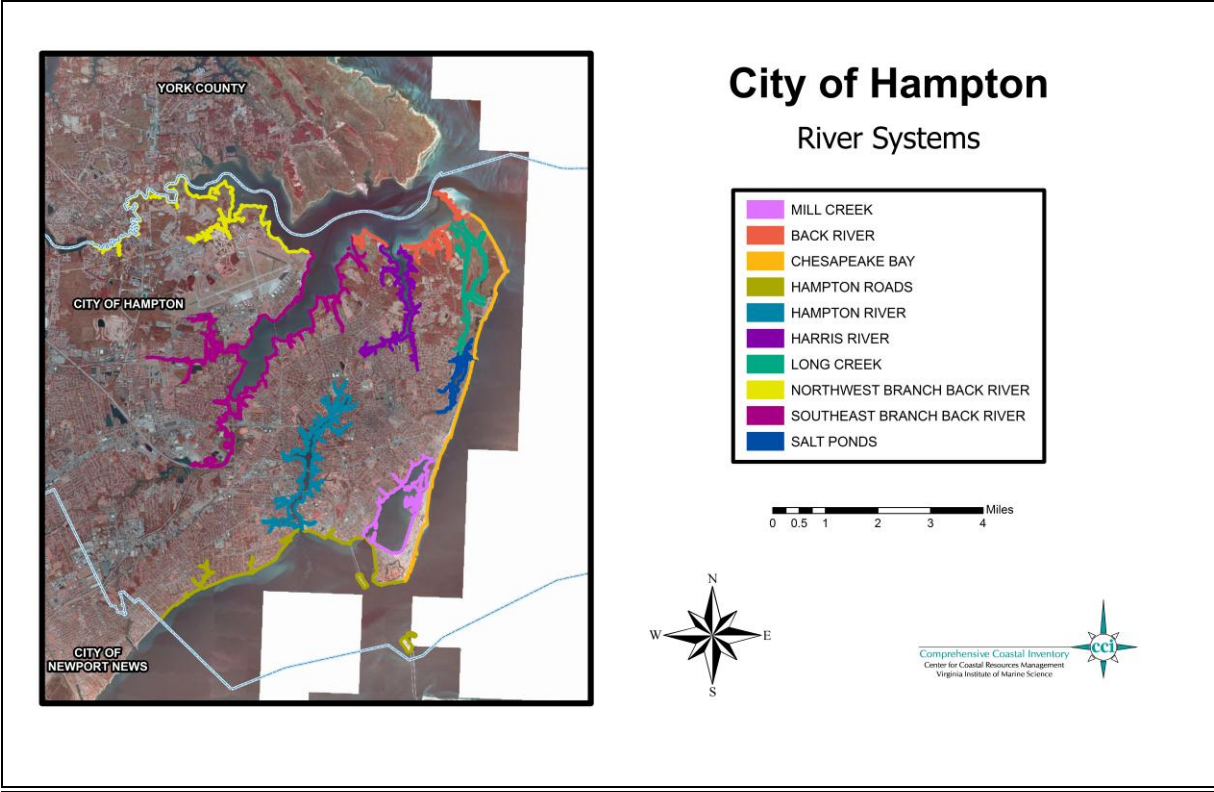
Figure 3. Delineation of City river systems used for data reporting

Tables 4, 5, 6 and 7 quantify features and conditions mapped along the rivers using frequency analysis techniques in ArcInfo. The values quantify features by river systems (Figure 3). For linear features, values are reported in actual miles surveyed. Point features are enumerated. The total miles of shoreline surveyed for each tributary is reported. For the City, a total of 157.54 miles were surveyed in the field. Approximately 47.88 miles of shoreline were surveyed using remote sensing techniques. Figure 4 illustrates where field surveys were conducted and where remote sensing techniques were applied. Remote techniques were used in places where navigation was restricted. Table 6 reports the survey dates, miles surveyed, and miles surveyed remotely.

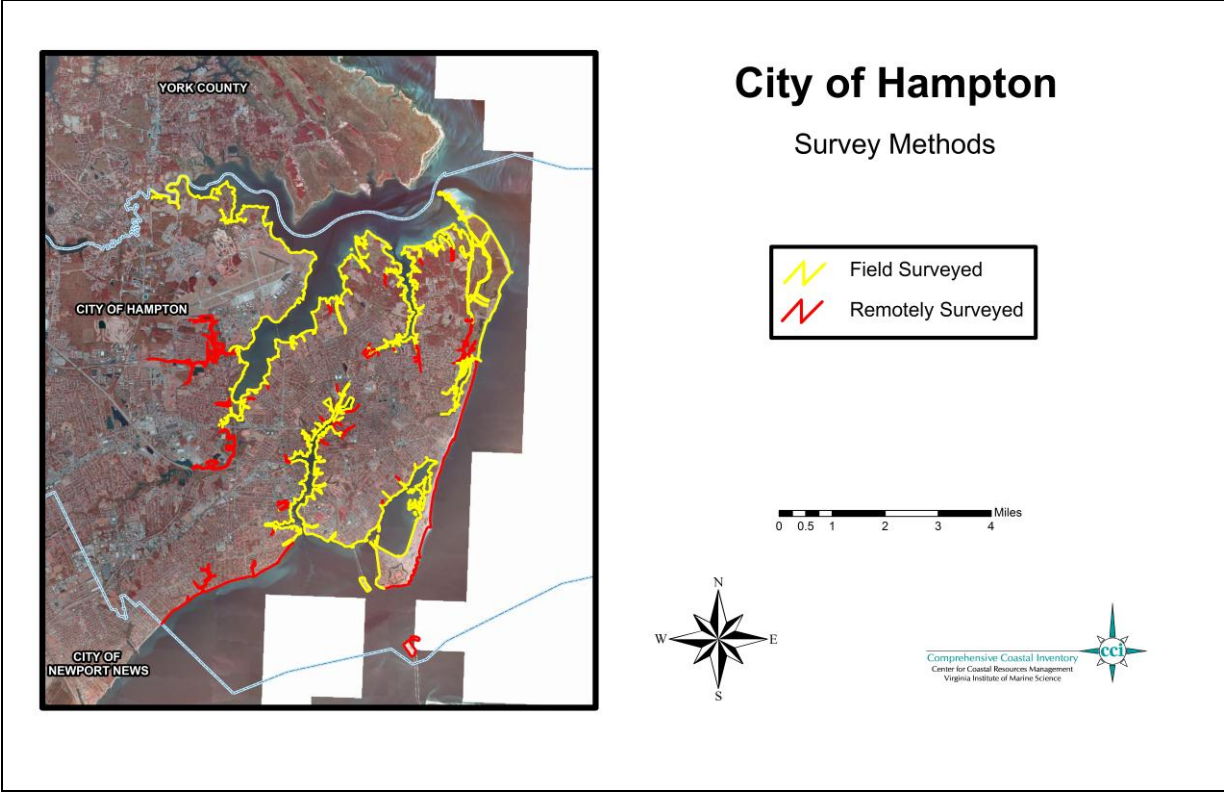
Figure 4. Location of field surveys and remotely sensed data collection.

Shoreline condition is described for City of Hampton along primary and secondary shoreline. Characteristics are described for all navigable tidal waterways contiguous to these shorelines. A total of 157.54 miles of the total 168.88 miles of shoreline are described. Less than 48 miles (47.88 miles) were using remote sensing techniques because water depths restricted access by boat.

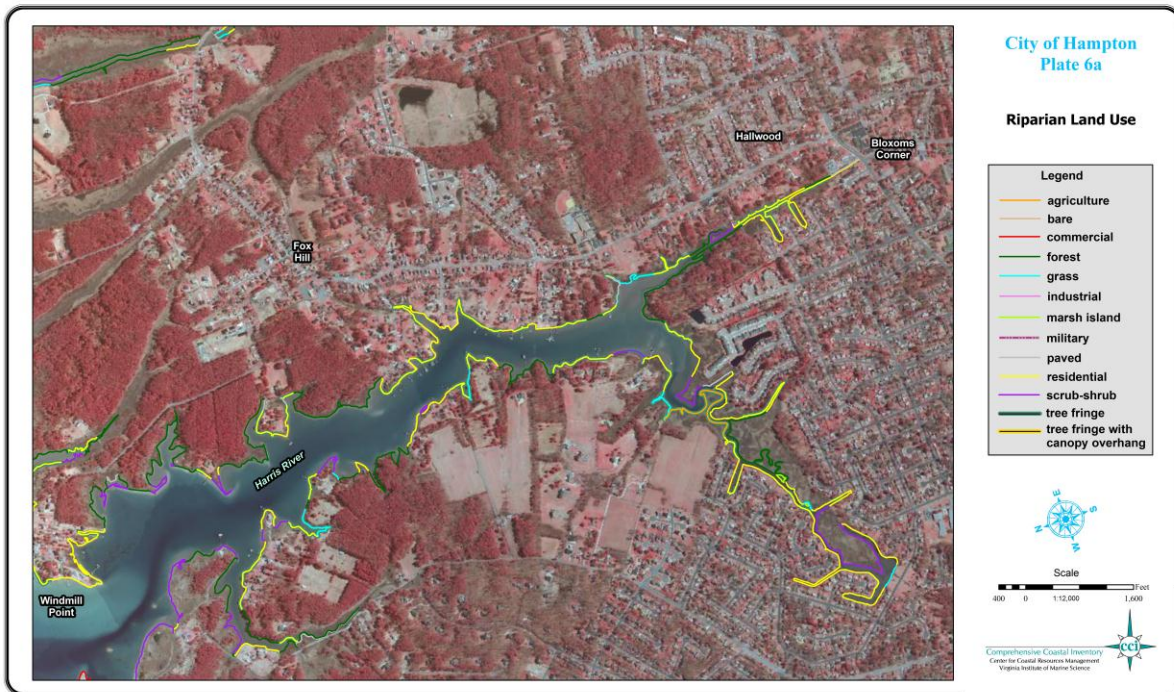
Figure 6. Sample riparian land use map for the City of Hampton

Plate A describes the riparian land use as color-coded bars along the shore. If the line is highlighted underneath with green, there is tree fringe on site. Tree fringe suggests a spattering of trees along the shoreline but not at a density sufficient to classify the lot as being forested. If the line is highlighted underneath with yellow, there is tree fringe with canopy overhang. Canopy overhang is captured because of its attribute value in developing management strategies. The background imagery is infrared color VBMP imagery at a publication scale of 1:12,000.

Once you determine which plate you want, the scroll down menu on the left has links to the four part series for each plate (Figure 5). At the top of the scroll bar Riparian Land Use (plate a) is first. You can scroll down to see links to maps illustrating Bank Conditions (plate b), Shoreline Features (plate c), and Natural Buffers (plate d). The content and details of the four part plate series was described in detail in Chapter 2. The actual map will come up when you click on the plate number. For example, Figure 6 is the riparian land use map for plate 6. Figure 7 is the map illustrating bank conditions for plate 6. Figure 8 shows all the shoreline features for that same area, and Figure 9 the natural buffers associated with that section.

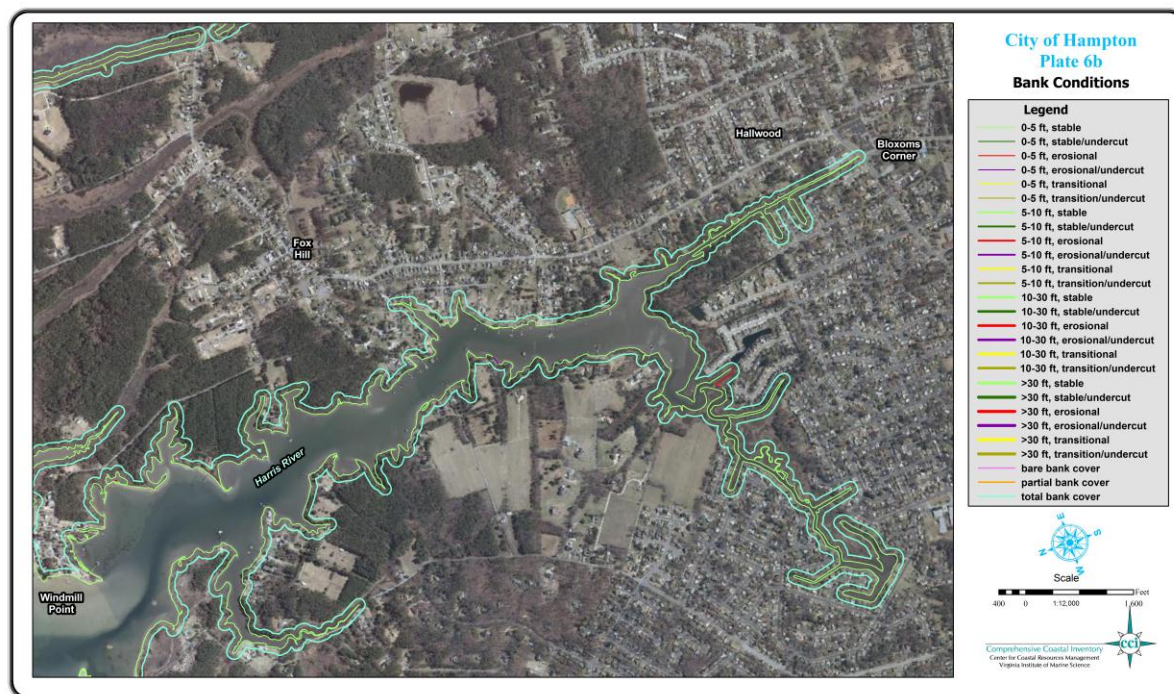
Figure 7. Map illustrating bank conditions for plate 6 in the City of Hampton

Plate B depicts stability and height and cover of the bank. The shoreline is color-coded light green, red and yellow to report if the bank is stable, erosional, or transitional, respectively. If each of these conditions occurs with undercutting at the base of the bank, the colors become, dark green, purple, and olive green, respectively. The thickness of the line reflects the bank height; where the thickest lines designate the highest banks (> 30 feet). Plate B uses natural color VBMP imagery for the backdrop.

Plate B also illustrates bank cover. Bank cover is designated as a separate line that is inland of the shoreline. Bank cover addresses cover by vegetation or structures. Fuchsia suggests the bank is bare with exposed soil in most places. Partial cover is illustrated in orange and total cover is shown in sea foam green.
