## City of Chesapeake, Virginia Shoreline Inventory Report Methods and Guidelines

# City of Chesapeake, Virginia Shoreline Inventory Report Methods and Guidelines

Special report in Applied Marine Science and Ocean Engineering No. 451 of the Virginia Institute of Marine Science

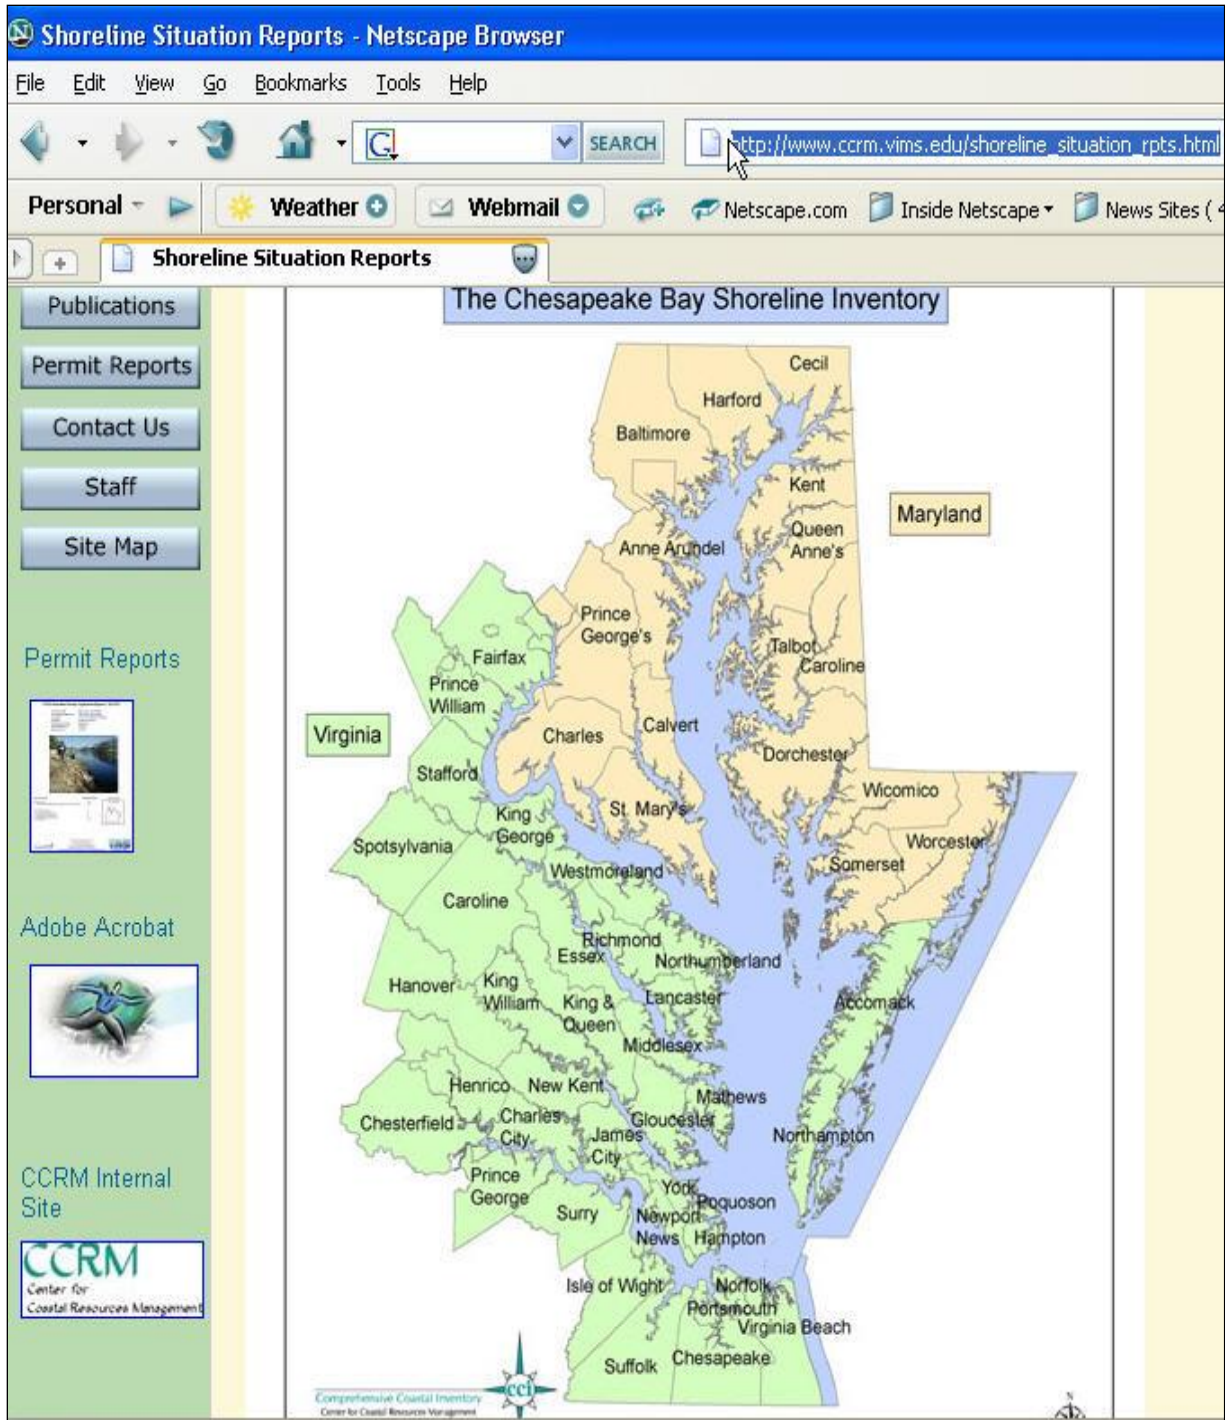
Figure 1. Shoreline Inventory Website

2.4c.) Map Viewer and Summary Tables: The City of Chesapeake Shoreline Inventory is delivered to the end user through a website; [http://ccrm.vims.edu/gis\\_data\\_maps/shoreline\\_inventories/index.html](http://ccrm.vims.edu/gis_data_maps/shoreline_inventories/index.html) (Figure 1.), by clicking on City of Chesapeake in the map or list of localities. The new format for Shoreline Inventories includes a map viewing tool rather than maps in pdf format. The map viewer allows users to interact with the datasets within a familiar “google” type map service that was developed with Javascript. Here they can view data of their choice and customize map products for printing themselves. Access to the GIS data, summary tables and methods report is also available through this website.

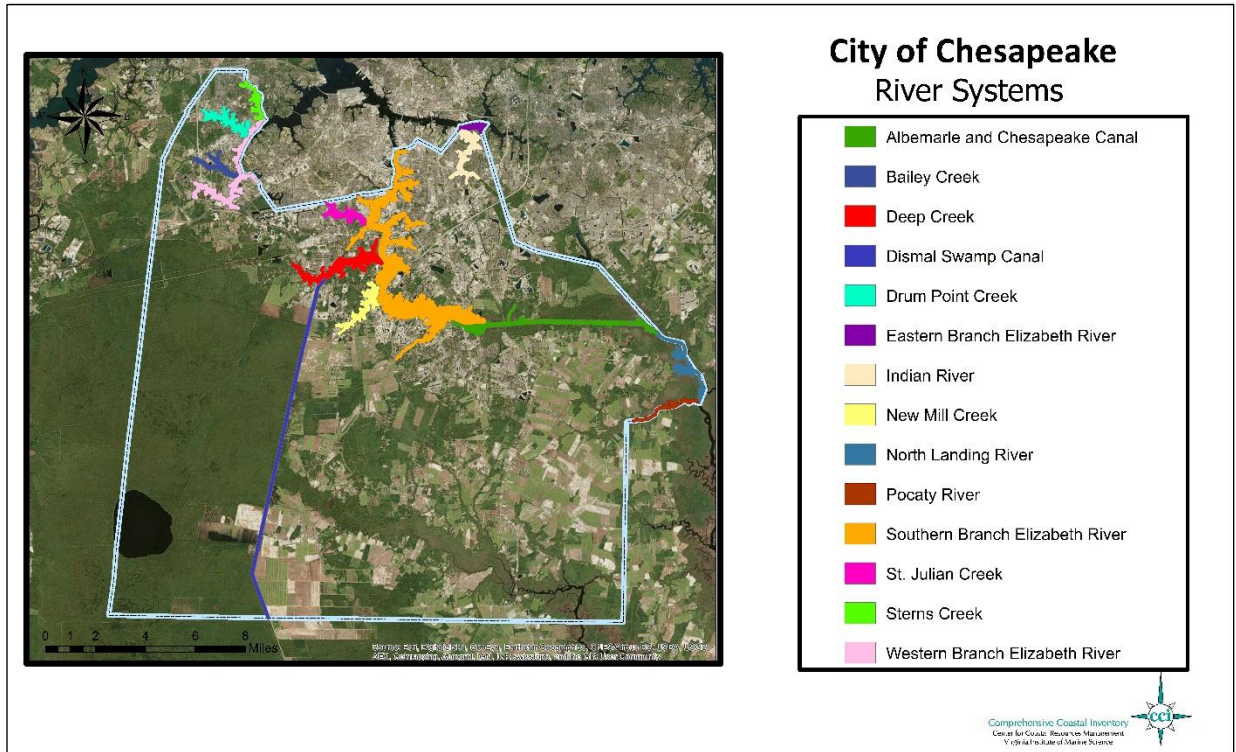
Figure 2. River Systems in the City of Chesapeake

Summary tables (Tables 4-7) quantify conditions observed on the basis of river systems (Figure 2). Refer to Figure 2 for the location of these river systems. Note, river systems do not correspond to watershed boundaries. They were developed for convenience in reporting data.

The top toolbar also includes tabs to access some important status information for the locality. By clicking on the “River System Pie Charts” button, users can obtain a statistical summary distribution of the riparian land use and amount of hardened shoreline for a specific water body selected from the drop down menu in the upper left (Figure 7). More detailed results in table format can be found by clicking the City of Chesapeake Summary PDF button also in the window. The summary statistics are reported by river systems (Figure 2).

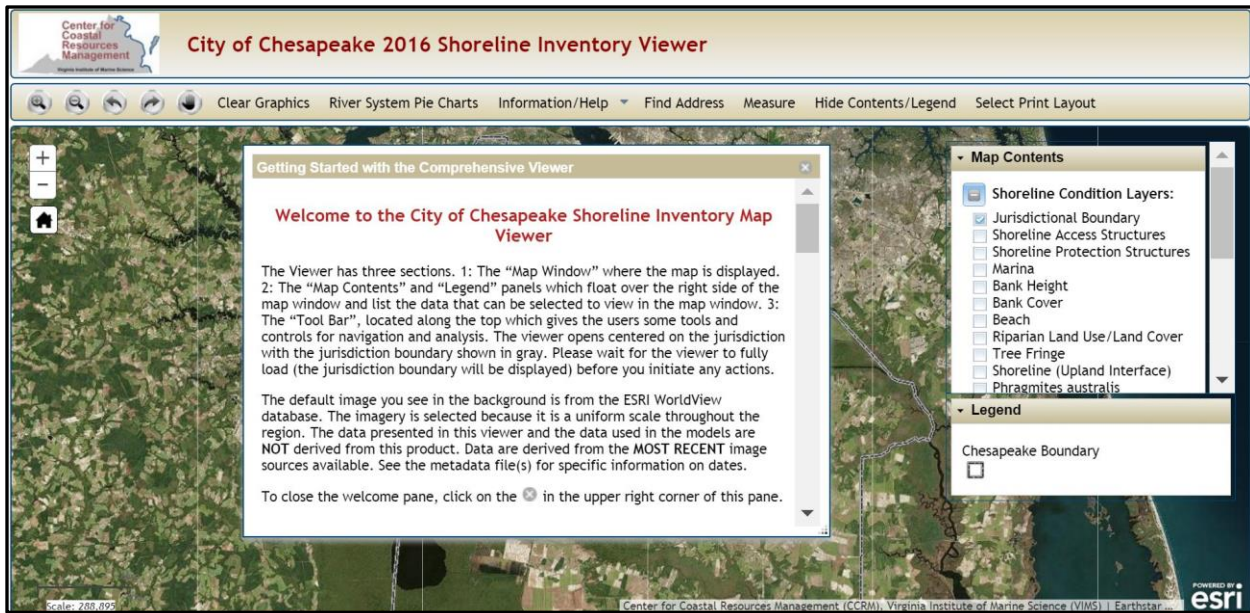
Figure 3. Opening page for the City of Chesapeake Shoreline Inventory Viewer

The Viewer has two panels: “Map Window”, where the map is displayed and “Map Contents and Legend”, where data that can be selected and viewed in the map window are listed. A tool bar is located along the top of the “Map Window” which gives users some controls for navigation and analysis (Figure 3.).

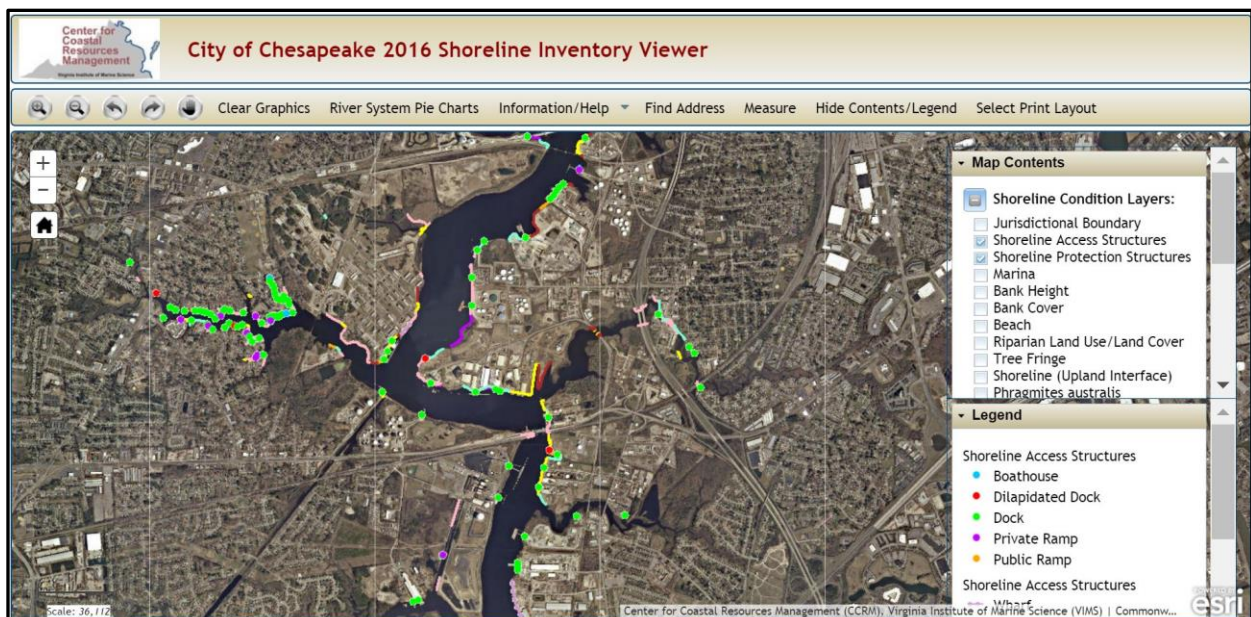
Figure 4. Map Viewer illustrates Shoreline Access and Protection Structures for a section of the City of Chesapeake.

In Figure 4 Shoreline Access Structures, and Shoreline Protection structures are selected. Shoreline Access structures are point features that includes piers and boat ramps. The actual footprint of these structures is not measured; only their location. Shoreline Protection Structures are line features and are mapped and illustrated in the viewer to show where they occur along the shoreline. Figure 5 illustrates riparian land use in the riparian zone for the same section of the County.

From the “Map Contents” the user may check various attribute layers on or off. The user must use the scroll bar on the far right to see the complete list of layers available. When layers are turned on, the corresponding legend appears in the “Legend” panel, and the data are displayed in the “Map Window” (Figure 4).

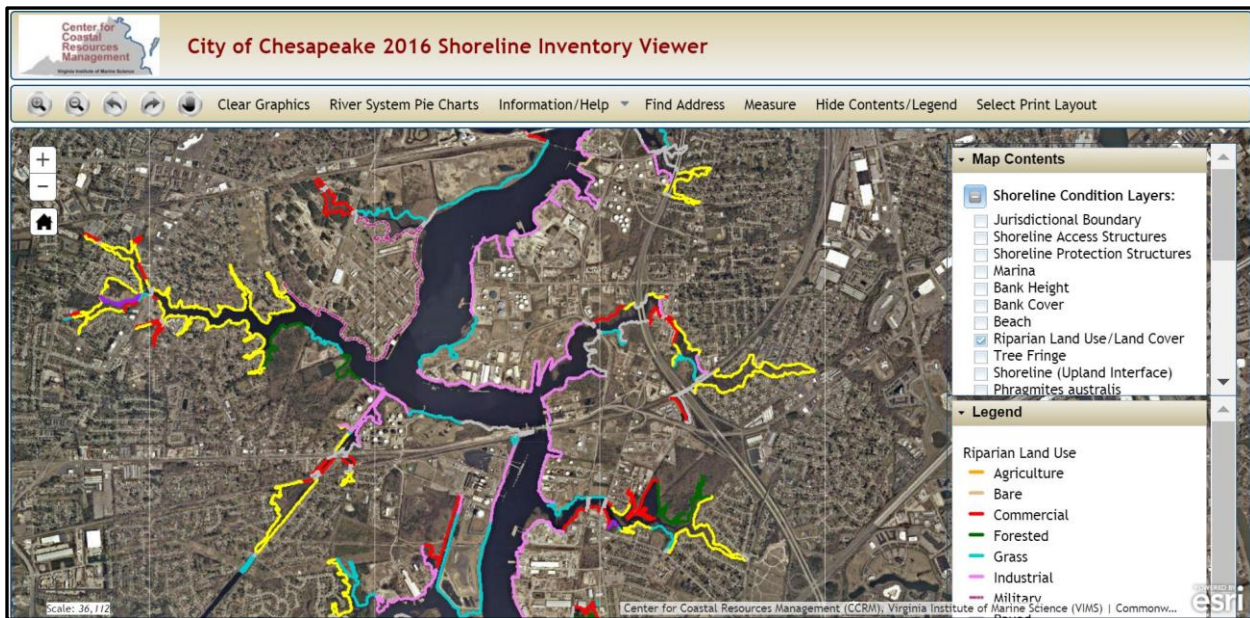
Figure 5. Distribution of land use in the riparian zone is displayed for this region of the City of Chesapeake.

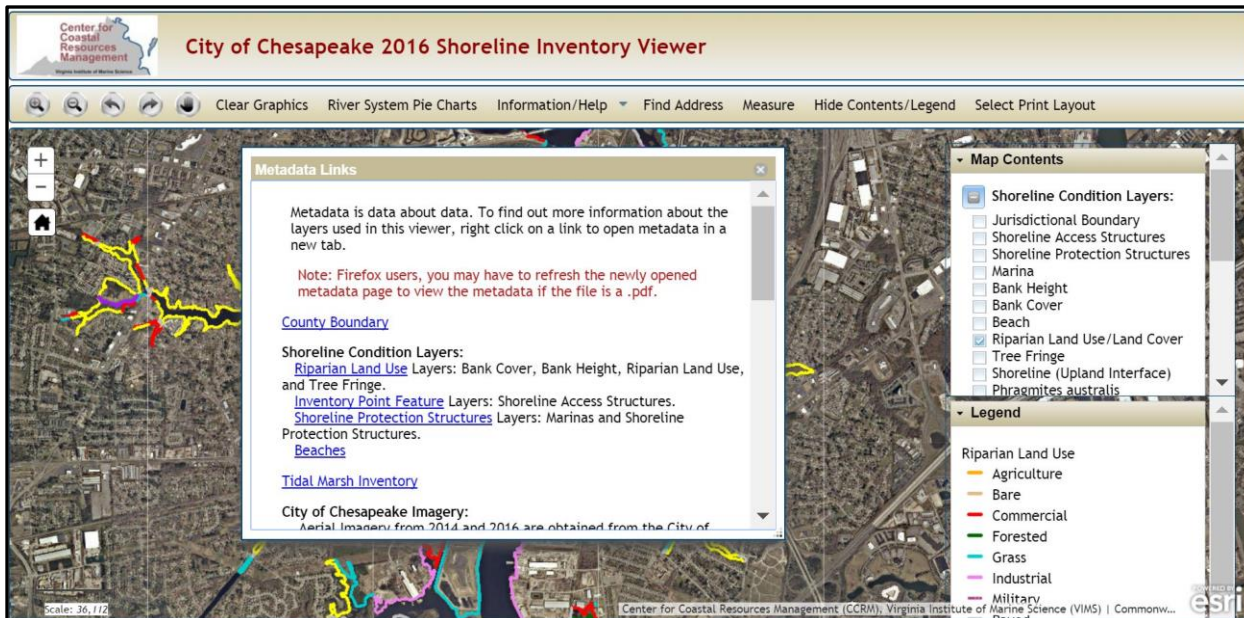
Figure 6. Link to Metadata records has been selected from the top Information tab in the toolbar.

The user can use the zoom and pan tools from the top toolbar or the slide bar on the left side of the map window to change their map extent. If the map resolution is exceeded the window will become illegible. Detailed information can be obtained about the data by selecting the "Information/Help" tab at the top of the map viewer. From here the inventory glossary and metadata records can be easily accessed. In Figure 6 the selection for metadata has been made and different records can be retrieved.

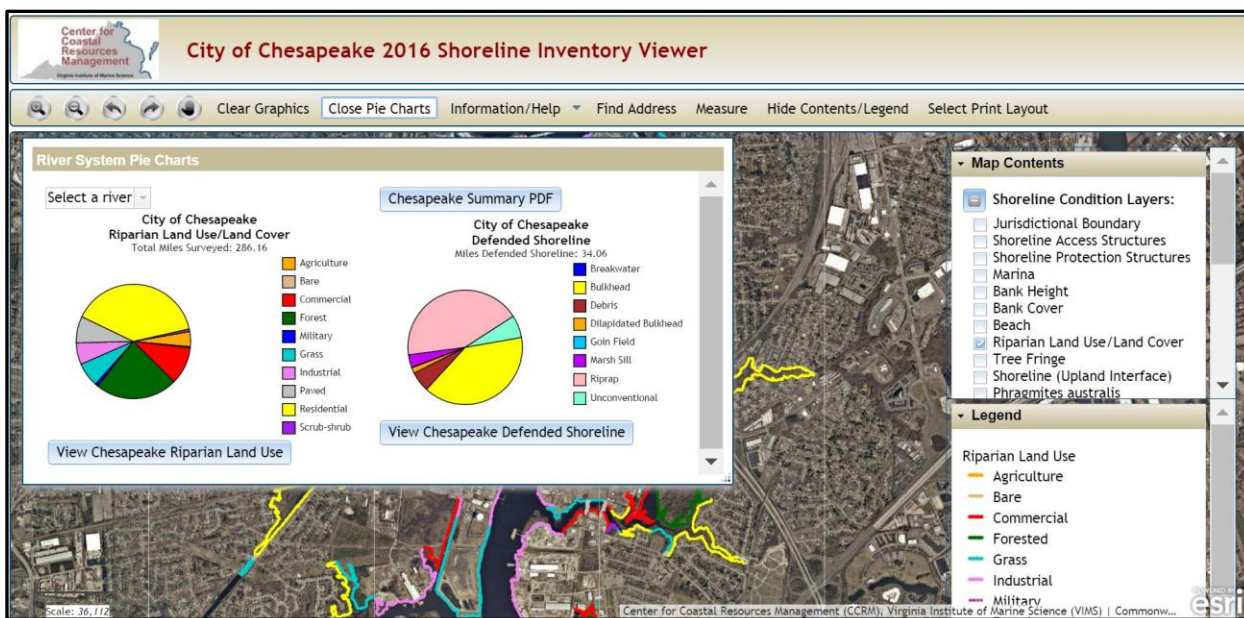
Figure 7. Pie charts display land use and shoreline hardening statistics for each tributary.

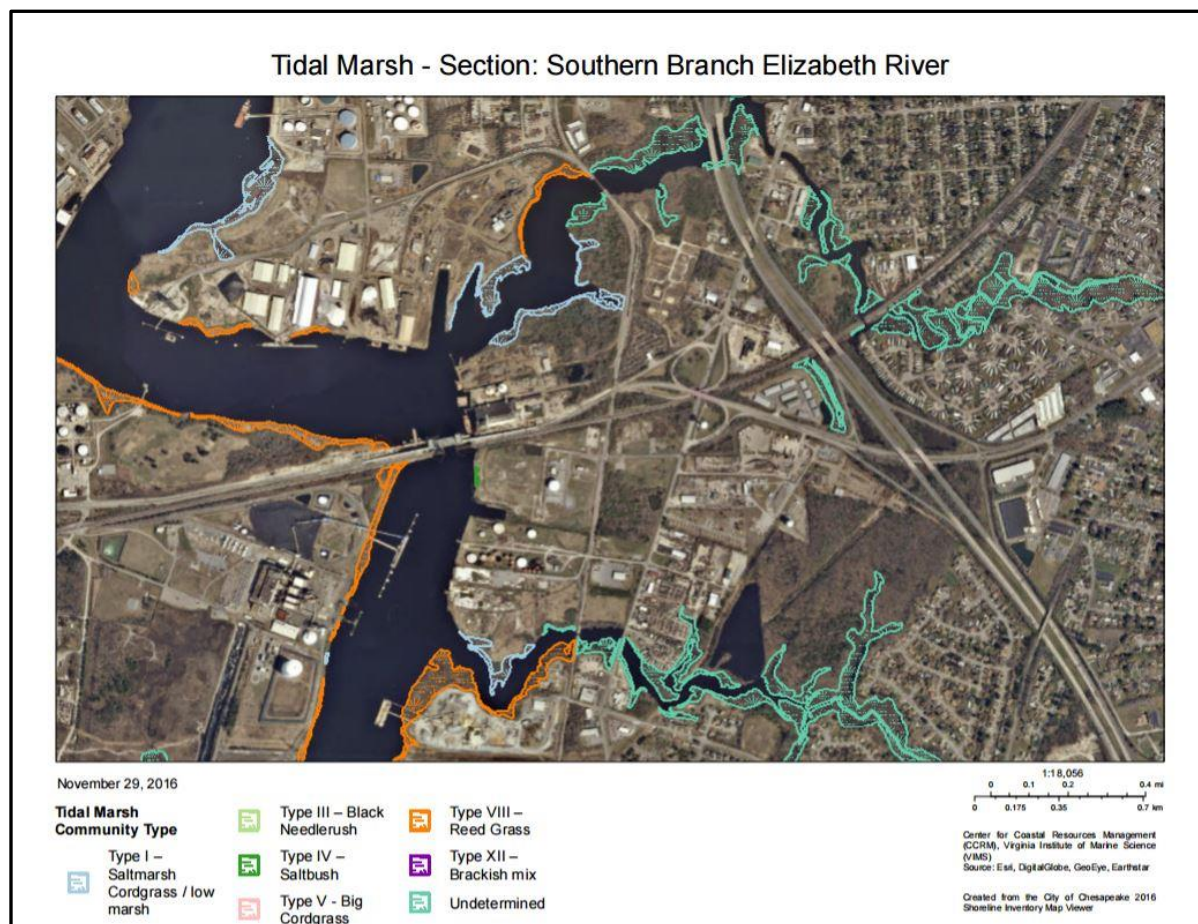
Figure 8. Customized print window for a section of the Elizabeth River (Southern Branch)

Finally, users have the option to personalize their own maps (i.e. map extent, data displayed, map title, etc.) and save them as a pdf file by clicking “Select Print Layout” button. The page can be set up for printing to 8.5 x 11 portrait or landscape style. Figure 8 is an example of a customized map generated for a section of the Elizabeth River (Southern Branch). Here the tidal marsh communities are displayed, and the community type is reported in the legend beside the illustration.
