**November 2016**

# Prince George County Shoreline Management Plan

*Prepared for  
Prince George County and  
Virginia Coastal Zone Management Program*

*Shoreline Studies Program*

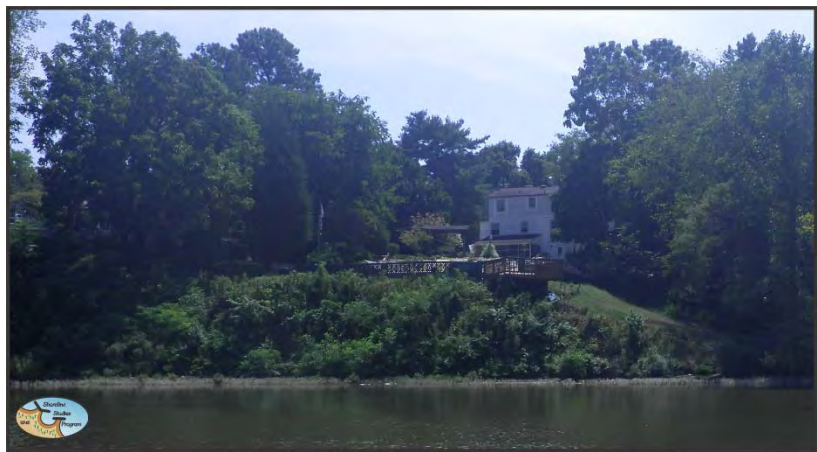
**Figure 2-6.** High upland bank along the Appomattox River.

**Reach 1** contains upland banks upriver of the Route 10 Bridge that are 40 to 50 feet high with sparse residential development (Figure 2-6). Past the bridge the banks are generally vegetated slopes with slightly undercut base of banks. City Point at the mouth of the Appomattox River is heavily armored with rock (Figure 2-7) and marks the end of Reach 1.

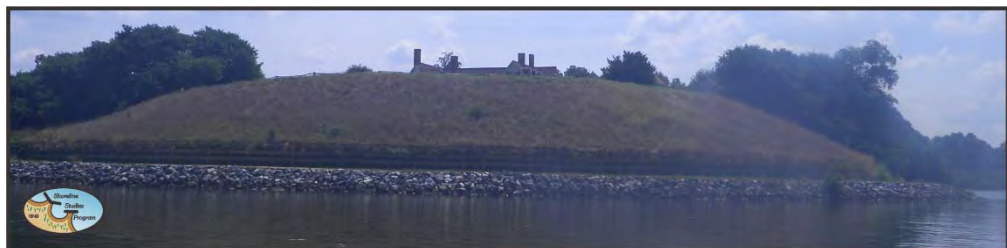
**Figure 2-7.** Armored shoreline at City Point at the confluence of the Appomattox and James Rivers.

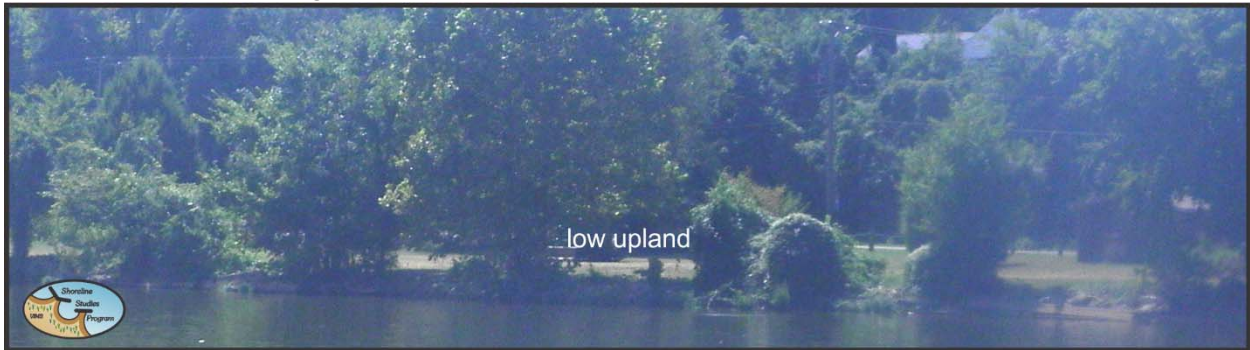
**Figure 2-8.** Very low park shoreline along the James River in Reach 2 downriver of City Point.

**Reach 2** begins at City Point. The channel is very close to the shoreline with the 18 foot bathymetric contour less than 100 feet offshore. The uplands drop down to about 5 feet along a public park coast (Figure 2-8) and extends along the industrial coast of Hopewell (Figure 2-9). Hopewell ends at Bailey Creek and the high upland banks downriver are intermittently exposed but relatively stable.

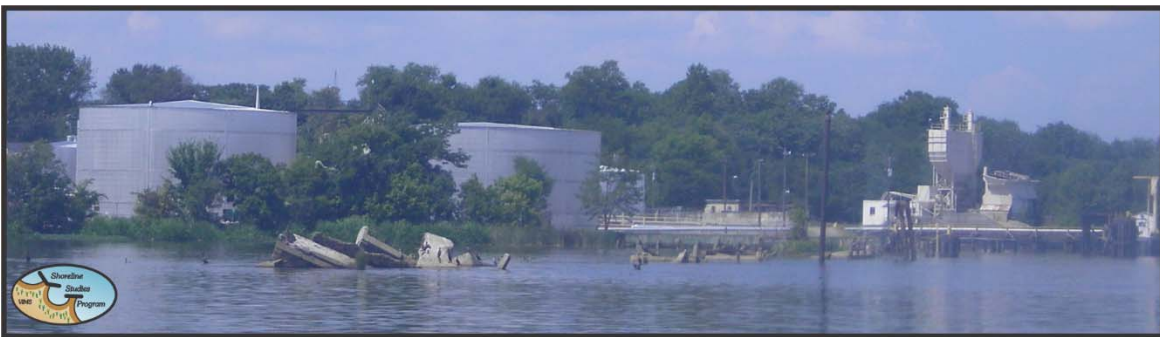
**Figure 2-9.** Industrial development in Reach 2 along the low banks on the James River.

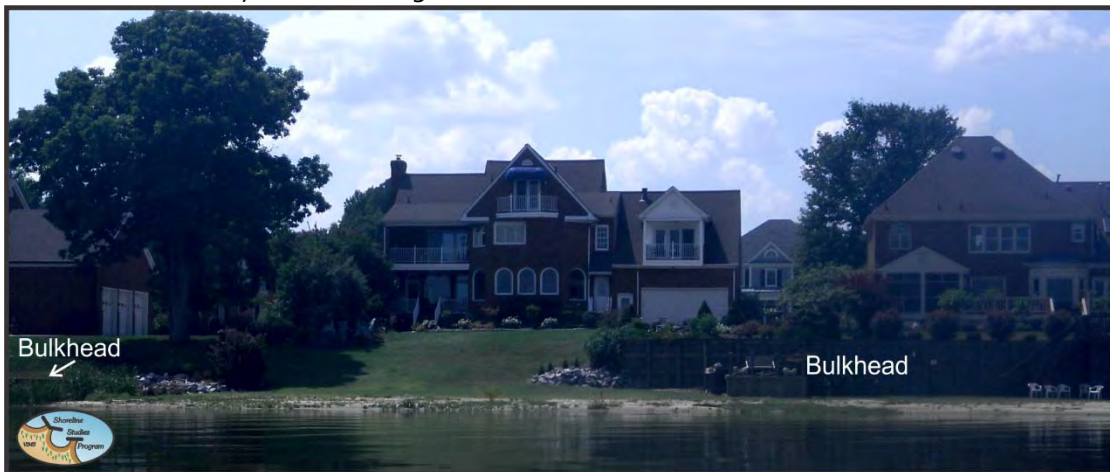
**Figure 2-10.** Residential development along the James River. The shoreline is intermittently protected with structures.

The shoreline is mostly residential for about 3,000 feet past the Marina along a 10-foot upland bank that is intermittently hardened (Figure 2-10). The shoreline then transitions to fresh water swamp

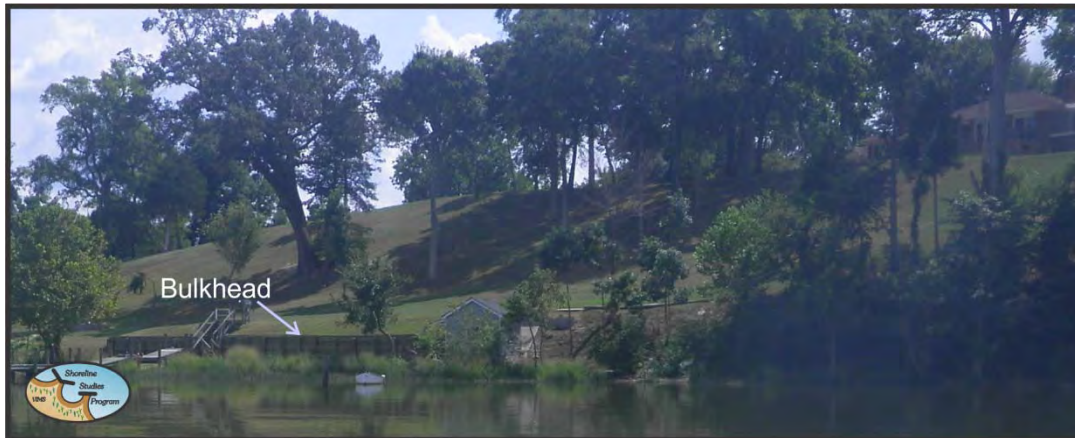
**Figure 2-11.** High upland, residential banks at Coggins Point on the James River in Reach 2 as it transitions from +60 ft high to +30 ft high.

shorelines. There is sparse development up to Coggins Point which is where a high upland scarp (+60 feet) intersects the James River and where the coastline landscape decreases in elevation to about +20 to +30 feet (Figure 2-11).

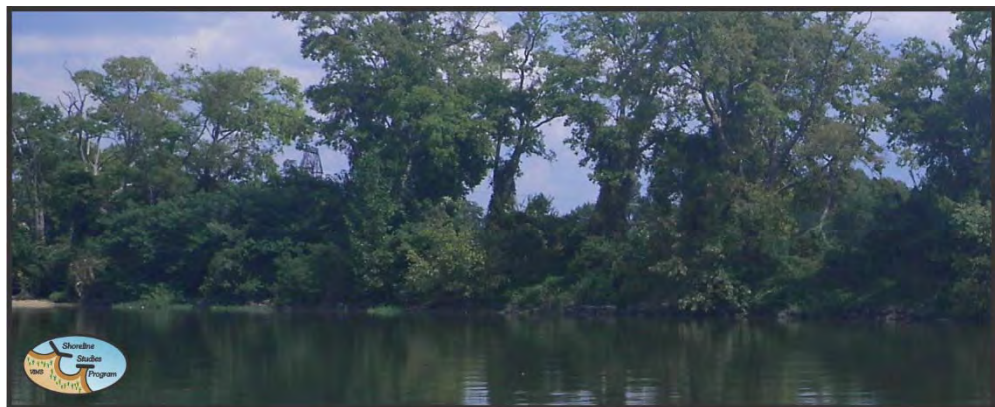
**Figure 2-12.** Agricultural land with trees and shrubs along the shoreline at Flowerdew Hundred, James River.

**Reach 3:** Powell Creek enters the James River just downriver of Coggins Point where the shallow embayed upland shoreline continues to Maycocks Point. Prince George's James River shoreline continues eastward and downriver for about three miles to Windmill Point. This subreach of coast is mostly stable, heavily vegetated high bank shoreline with intermittent marsh fringe which, when absent, is due to overhanging trees and shading. Minor base of bank scarping is evident and some more exposed banks occur farther downriver. There is little or no residential development until Flowerdew Hundred, one of the earliest English settlements in the New World. Here the bank height decreases and a few homes occur. Farther downriver, the upland landuse becomes agricultural with a narrow line of trees along the shoreline to Windmill Point (Figure 2-12).

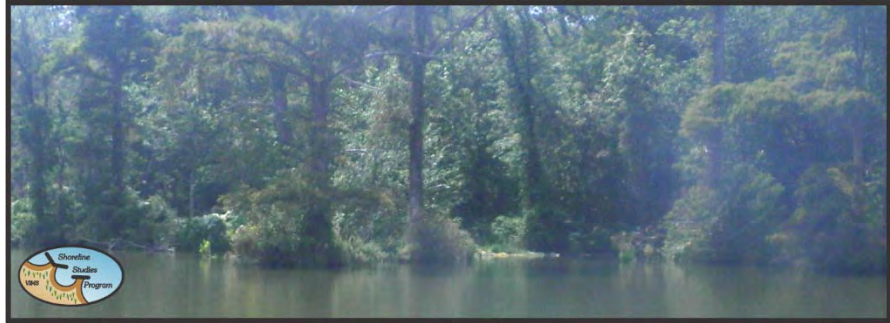
**Figure 2-13.** Cypress trees along the shoreline tend to disguise the actual location of the upland bank.

**Reach 4:** The James River coast of Prince George County makes a sharp turn at Windmill Point and continues. For about 7,000 feet south of Windmill Point, the shore zone is swamp forest with numerous cypress trees. This type of coast makes it difficult to see where the actual shoreline is located (Figure 2-13). The landuse goes from

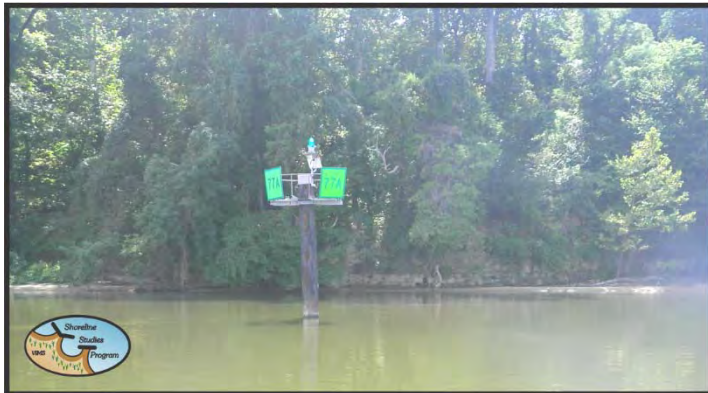
**Figure 2-14.** Fort Powhatan in Reach 4 where the natural channel is only a few yards from the shoreline.

The neck of land from Flowerdew Hundred Creek and Ward Creek is about one mile in length and begins as an upland bank in transition as the treed fringe becomes sparse and less effective at wave attenuation and the shore becomes more exposed to a northeast fetch of over 4 miles. This is also the site of Fort Powhatan, a US Army secondary coastal fort established in 1808. It was used during the Civil War by both sides because of its strategic location, where the James River narrows to about 1,300 feet and the natural channel is only a few yards from the shoreline (Figure 2-14). The wooded upland shoreline continues down to the mouth of Wards Creek with the exception of a small residential development.

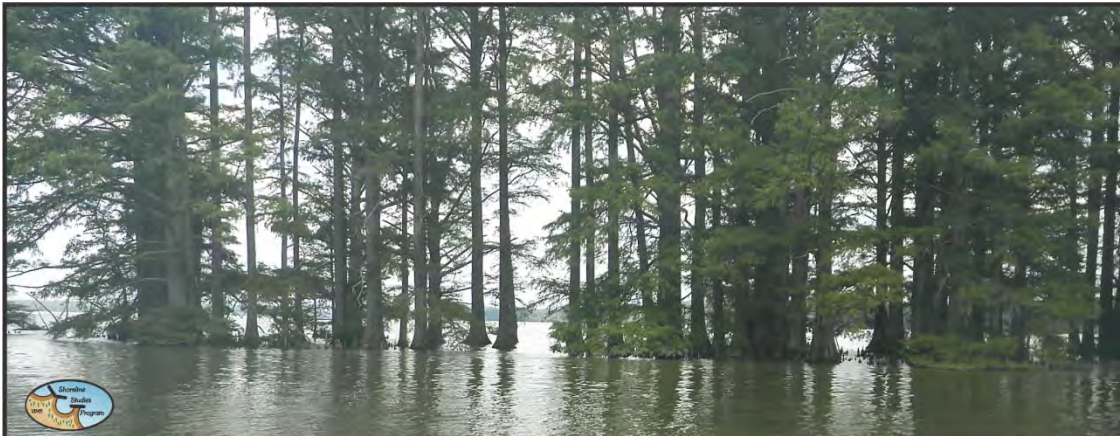
**Figure 2-15.** Cypress tree “spit” at the mouth of Wards Creek in Reach 4 along the James River.

Wards Creek has a wide swamp forest coast. The mouth of the downriver side has a cypress tree “spit” (Figure 2-15). The shoreline continues northeastward about 2,000 feet downriver as extensive swamp forest with many solitary cypress guarding the shore. The wide swamp forest transitions into an exposed upland bank with few shore trees where land use becomes agriculture and the trees may have been felled for lumber. Some of the wooded upland banks have exposed bank faces (Figure 2-16). Sparse upland

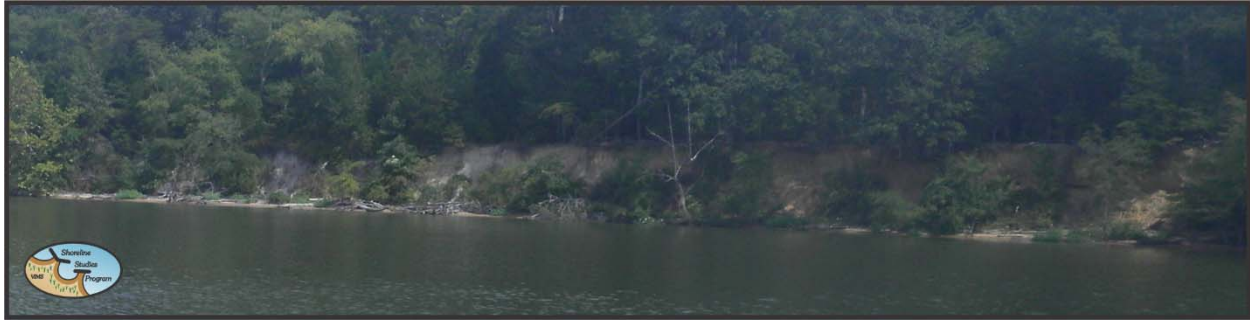
**Figure 2-16.** Exposed, eroding upland banks along the James River in Reach 4.

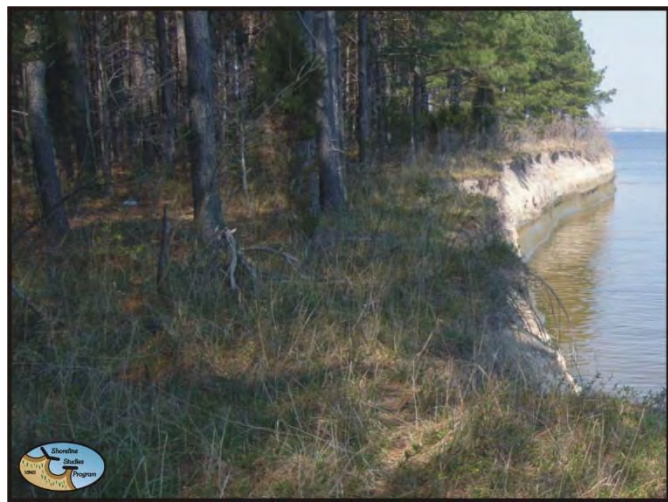
**Figure 3-1.** One example of forest management. The edge of the bank is kept free of tree and shrub growth to reduce bank loss from tree fall.

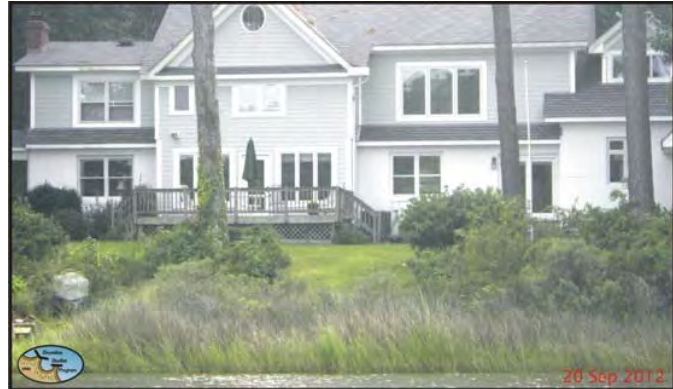
**Figure 3-2.** Maintaining and enhancing the riparian and marsh buffers can maintain a stable coastal slope.

Enhancement of both riparian and existing marsh buffers together can be an effective practice to stabilize the coastal slope (Figure 3-2) from the intertidal area to the upland by allowing plants to occupy suitable elevations in dynamic fashion to respond to seasonal fluctuations, shifts in precipitation or gradual storm recovery. At the upland end of the slope, forest buffer restoration and the planting of ornamental grasses, native shrubs and small trees is recommended. Enhancement of the marsh could include marsh plantings, the use of sand

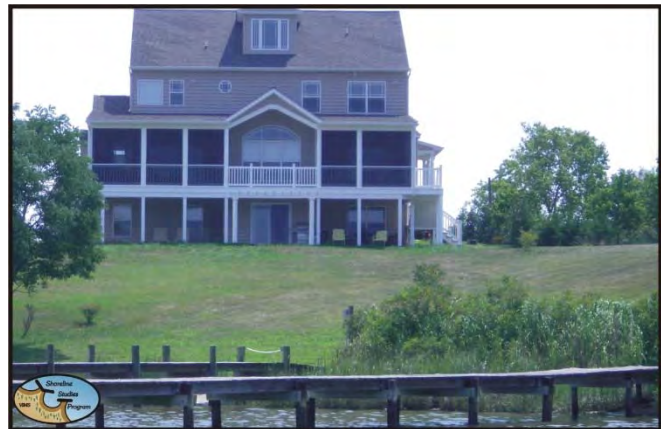
**Figure 3-3.** Bank grading reduces steepness and will improve growing conditions for vegetation stabilization.

In cases where the bank is unstable, medium or high in elevation, and very steep, bank grading may be necessary to reduce the steepness of bank slopes for wave run-up and to improve growing conditions for vegetation stabilization (Figure 3-3). The ability to grade a bank may be limited by upland structures, existing defense structures, adjacent property conditions, and/or dense vegetation providing desirable ecosystem services.

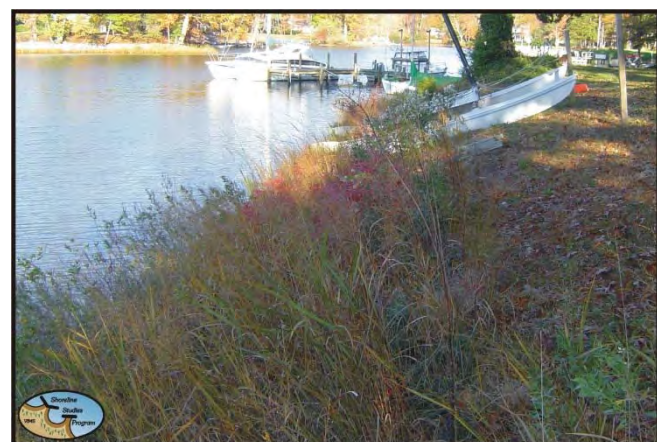
**Figure 3-4.** This low-energy site had minor bank grading, sand added, and *Spartina alterniflora* planted. This photo shows the site after 24 years.

Along the shoreline, protection becomes focused on stabilizing the toe of the bank and preventing future loss of existing beach sand or tidal marshes. Simple practices such as: avoiding the use of herbicides, discouraging mowing in the vicinity of the marsh, and removing tidal debris from the marsh surface can help maintain the marsh. Enhancing the existing marsh by adding vegetation may be enough (Figure 3-4).

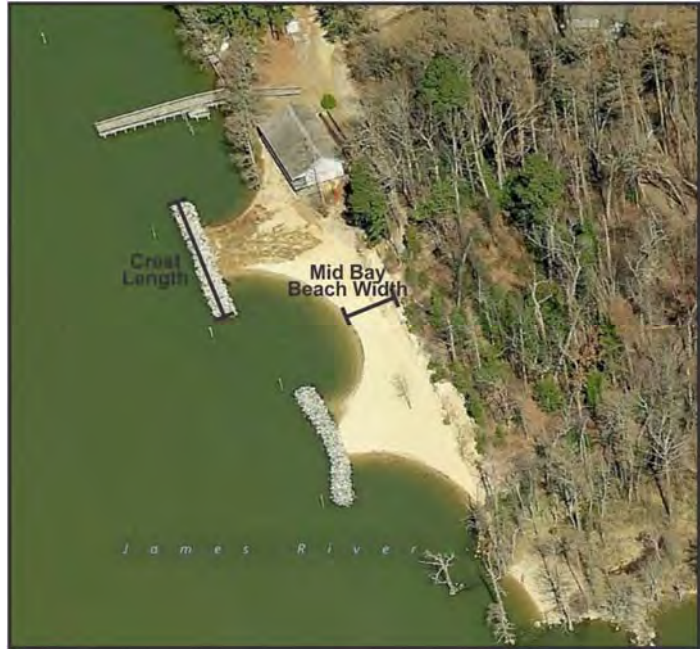
**Figure 3-7.** Breakwaters along the James River designed to provide a recreational beach as well as storm erosion protection.

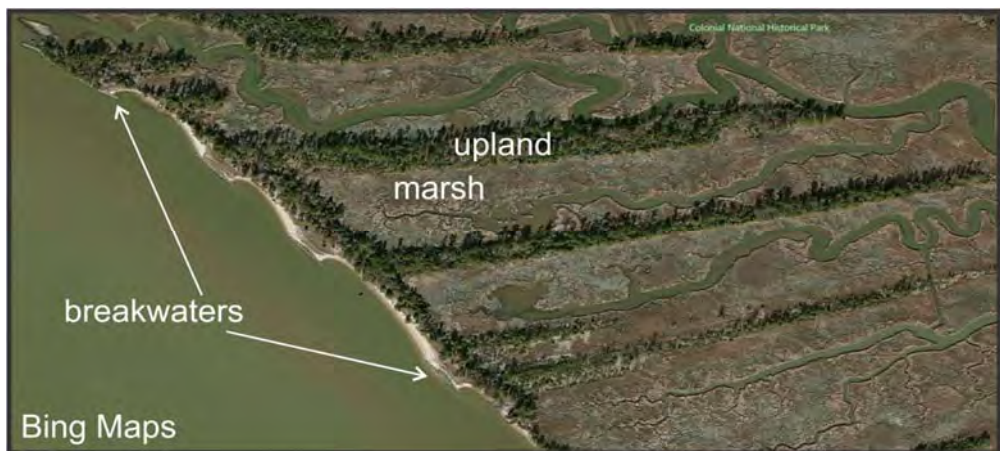
**Figure 3-8.** Bing map showing headland breakwaters that were built along Jamestown Island's James River shore.

Headland Control is a unique shoreline management technique whereby existing geomorphic features (*i.e.* headlands) are enhanced by breakwaters or sills. Headland Control also can include placing stone breakwaters or sills strategically place along eroding coasts to create headlands (Figure 3-8). These enhanced or created shore headlands are widely-spaced for economy. The adjacent coasts are allowed to continue to erode toward an equilibrium shore position or planform. The final equilibrium planform is a large pocket beach whose dimensions will depend on the amount of sand that will come to reside in the evolving embayment. Sand often is placed directly behind the created headland during construction and then vegetated. Headland control is applied to long reaches of agricultural or unmanaged woodland shores to begin the process of shore stabilization.

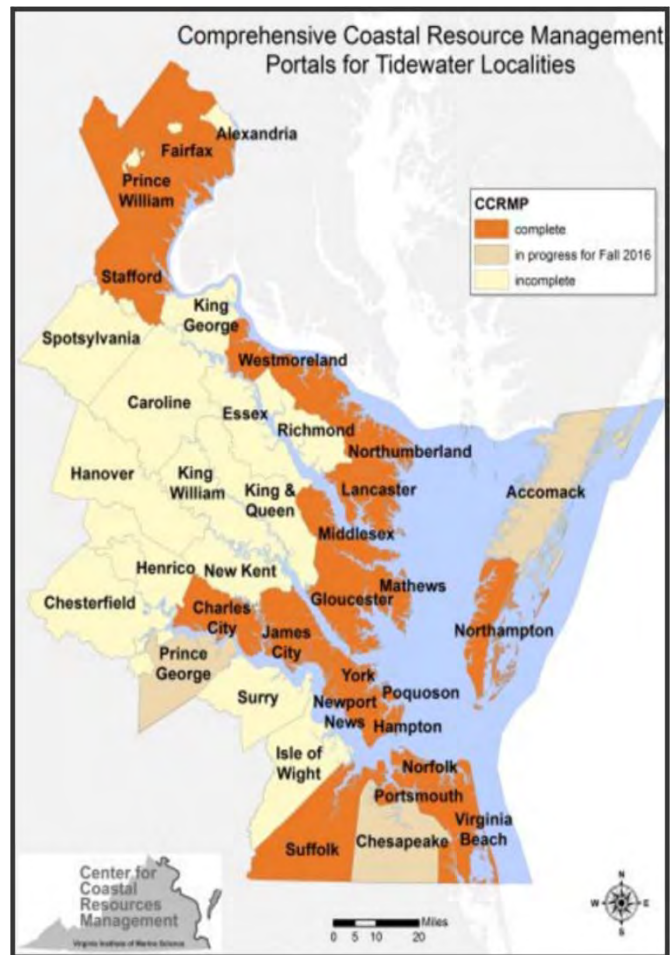
**Figure 5-1.** Portal for Comprehensive Coastal Resource Management.

To view the model output when it becomes publically-available, the Center for Coastal Resources Management has developed a Comprehensive Coastal Resource Management portal (Figure 5-1) which includes a pdf file depicting the SMM output, an interactive map viewer that illustrates the SMM output as well as the baseline data for the model and will be accessed at this website: <http://ccrm.vims.edu/ccrmp/index.html>.

When “Shoreline Management Model BMPs” is selected from the list in the right hand panel and toggled “on” the delineation of shoreline BMPs is illustrated in the map viewing window. The clickable interface conveniently allows the user to click anywhere in the map window to receive specific information that pertains to conditions onsite and the recommended shoreline strategy. Figure 5-3 demonstrates a pop-up window displayed onscreen when a shoreline segment is clicked in the map window.

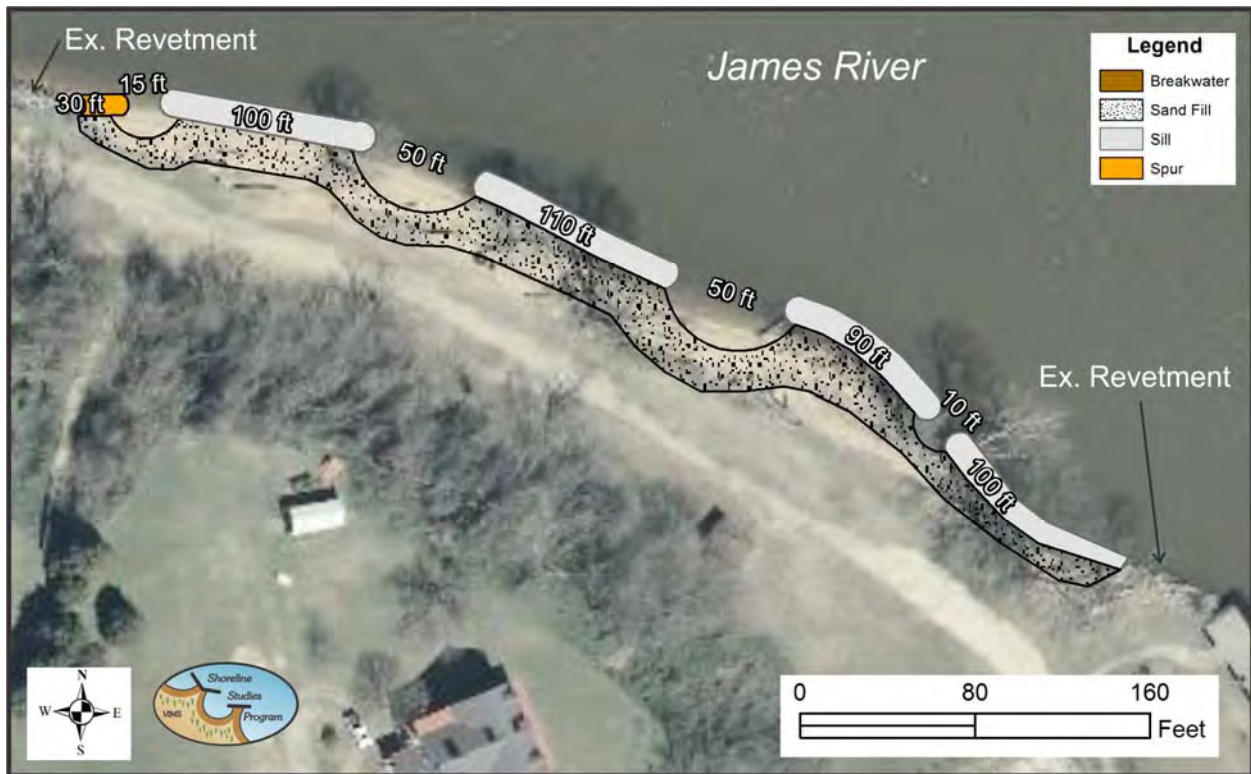
Figure 5-5. Conceptual design of a shore protection system for the eroding shoreline along the park at City Point.

The SSM recommends a breakwater system but due to the very deep nearshore and very low bank, a sill with wide gaps is recommended. The wide gaps are to provide additional recreational access to the river (Figure 5-5). The cross-section for a typical sill for this site is shown in Appendix 3, Figure 1.

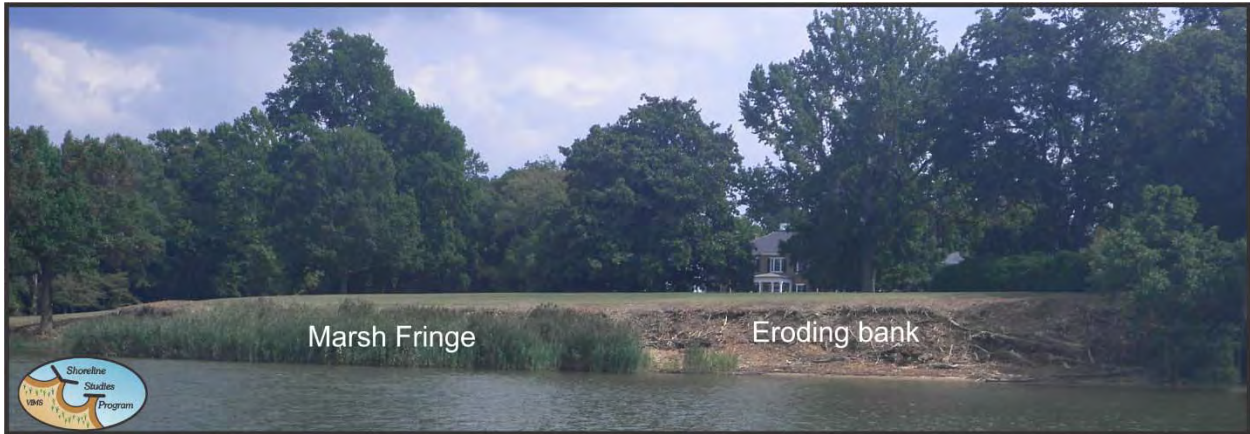
Figure 5-8. Eroding bank and marsh fringe at Upper Brandon Area of Interest.

Upper Brandon is a large farm/planation complex on the James River (Figure 2-4). The project site is about 1,000 feet long in front of the house. The eroding upland bank is about 10 feet high on the upriver end and decreasing to less than 5 feet high on the downriver end (Figure 5-8). The SSM recommends a sill. The conceptual plan is seen in Figure 5-9. An

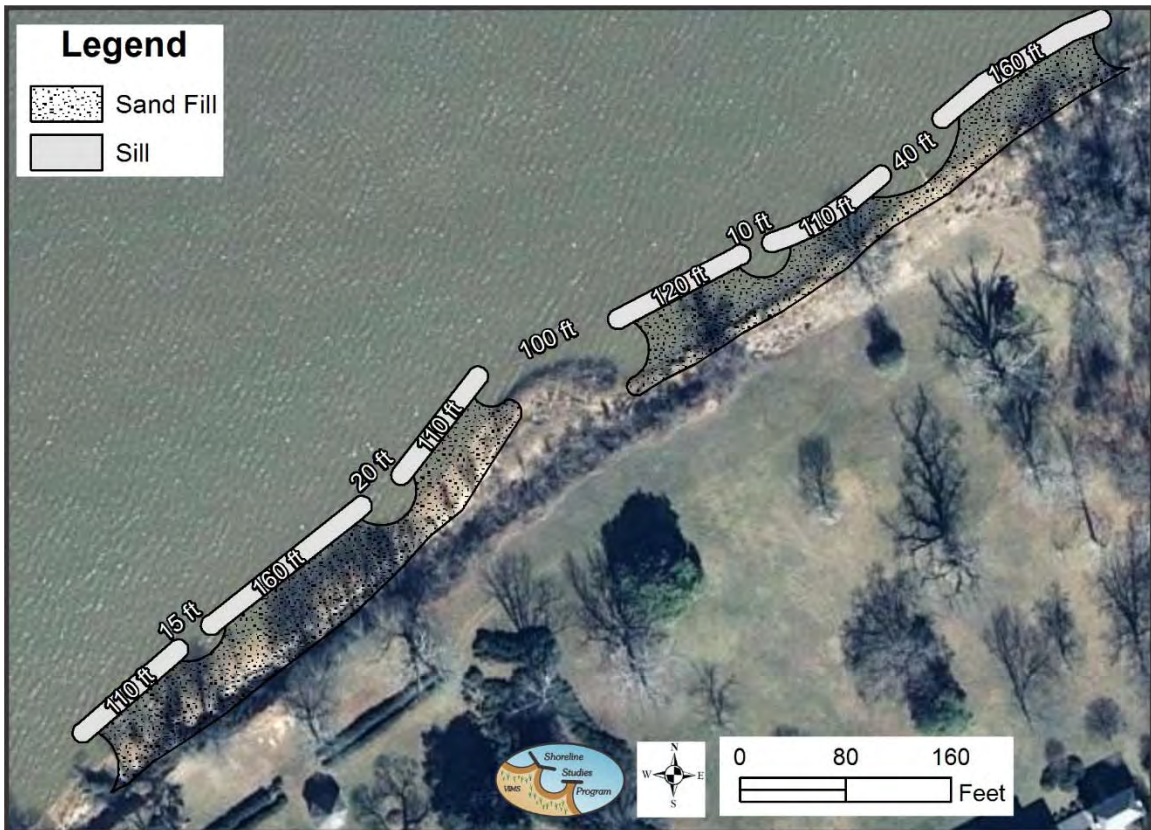
Figure 5-9. Conceptual design of a shore protection system for the eroding shoreline at Upper Brandon on the James River.

existing marsh headland separates the upriver and downriver sill systems. The cross-section for a typical sill for this site is shown in Appendix 3, Figure 2.

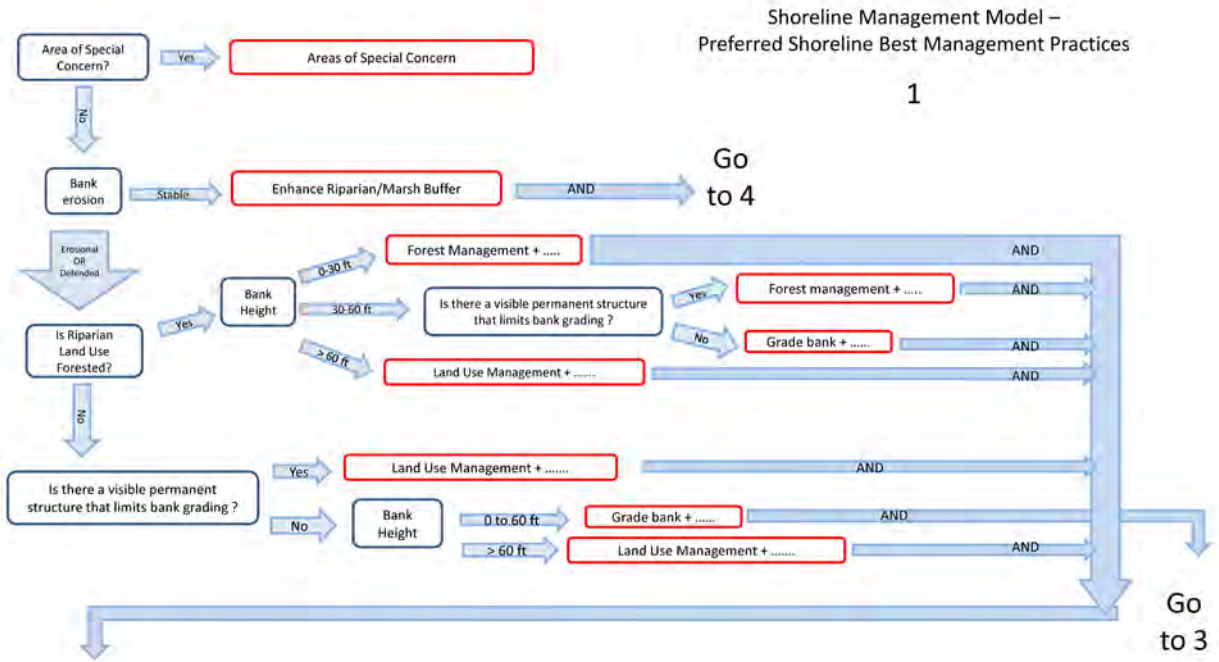
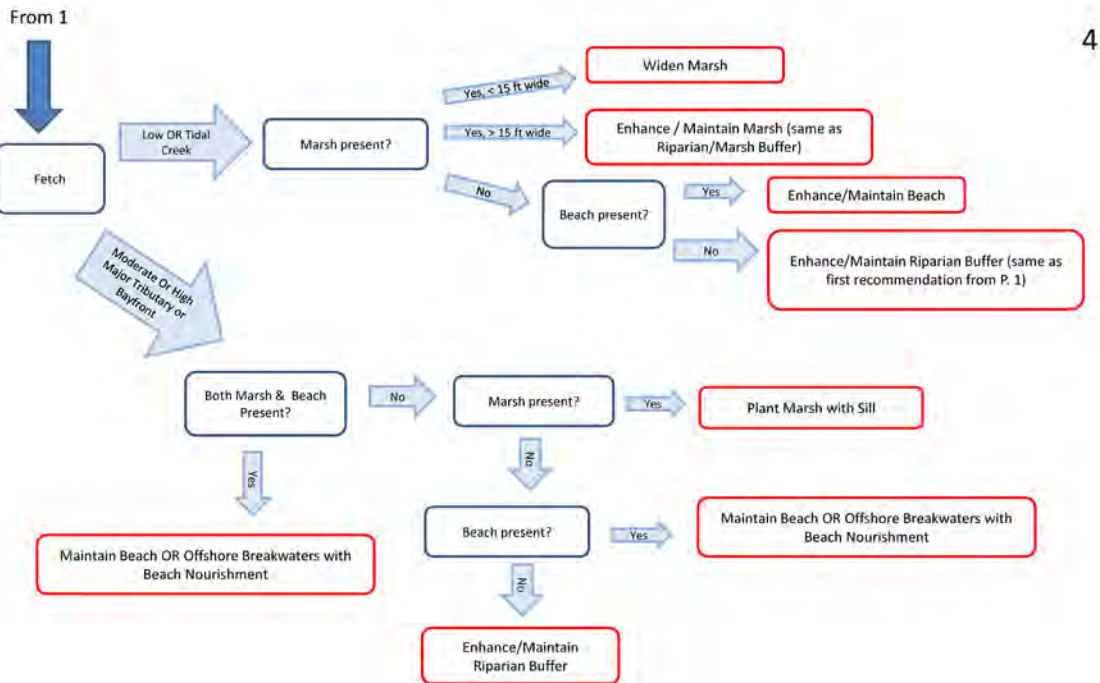
## Shoreline Management Model Flow Diagram

The model is constructed using multiple decision-tree pathways that lead the user to a final recommended strategy or strategies in some cases. There are four major pathways levels. The pathways are determined based on responses to questions that determine onsite conditions. Along the upland and the bank, the model queries a site for bank stability, bank height, presence of existing infrastructure, land use, and whether the bank is defended to arrive at an upland management strategy. At the shore the model queries a site for presence and condition of beaches, marshes, the fetch, nearshore water depth, presence of specific types of erosion control structures, and creek setting to drive the shore recommendations. Appendix 1 illustrates the logic model structure.
