Living Shorelines: A Novel Remedial Approach for Contaminated Sediments

C. Hauser¹, J. Mattei², M. Beekey², M. Liberati³
¹AECOM ²Sacred Heart University ³E.I. du Pont de Nemours and Company

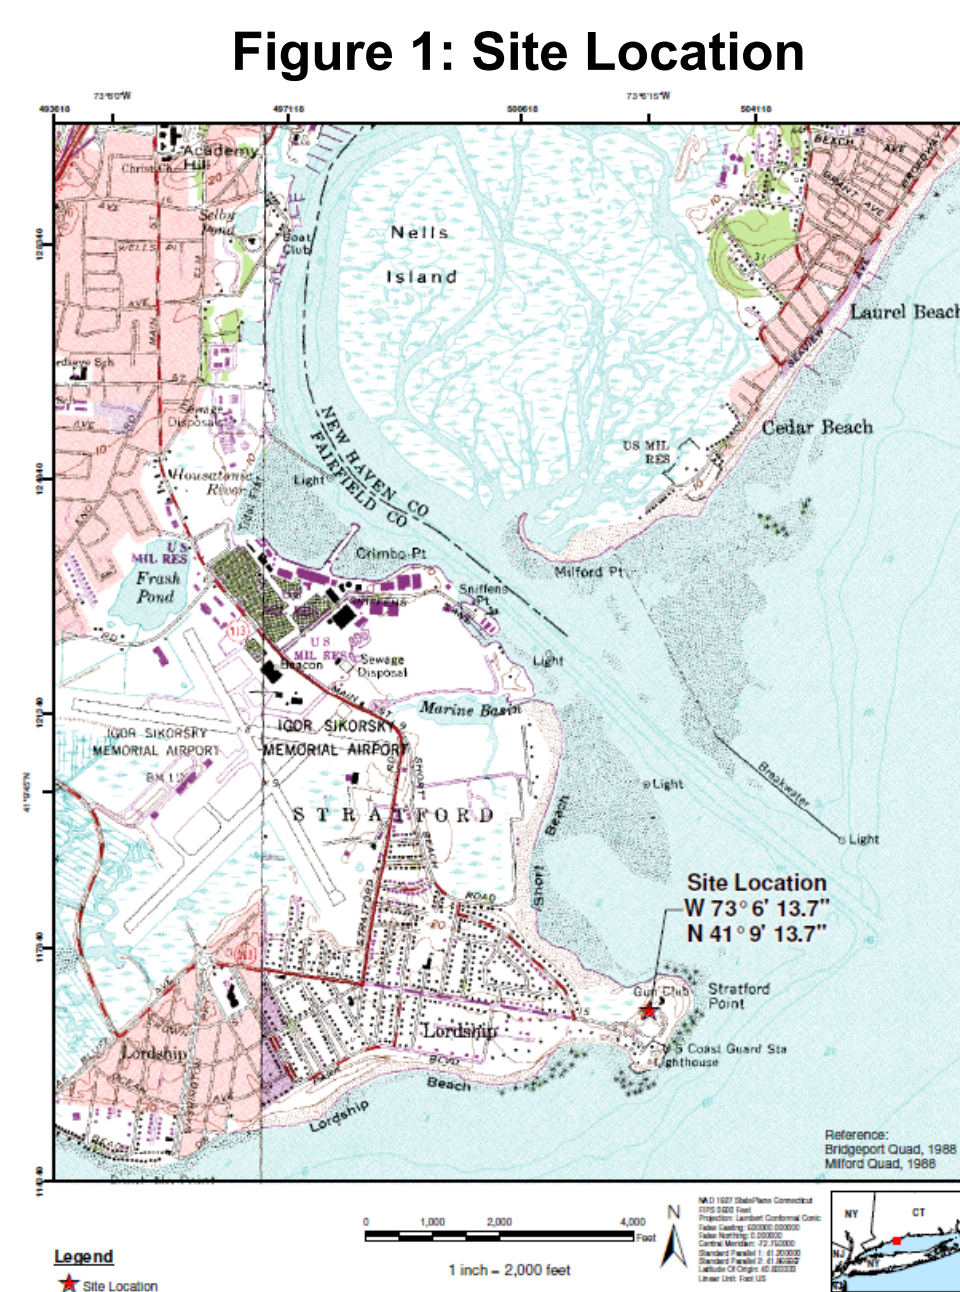
- Complex hydrodynamic setting (Figure 1)
 - Variable estuary discharge
 - Increasing prevalence / intensity of coastal storms
- Substantial erosion, shoreline migration over the past decade (Figure 2)
- Subsequent concentration of lead shot on the sediment surface (i.e., winnowing)

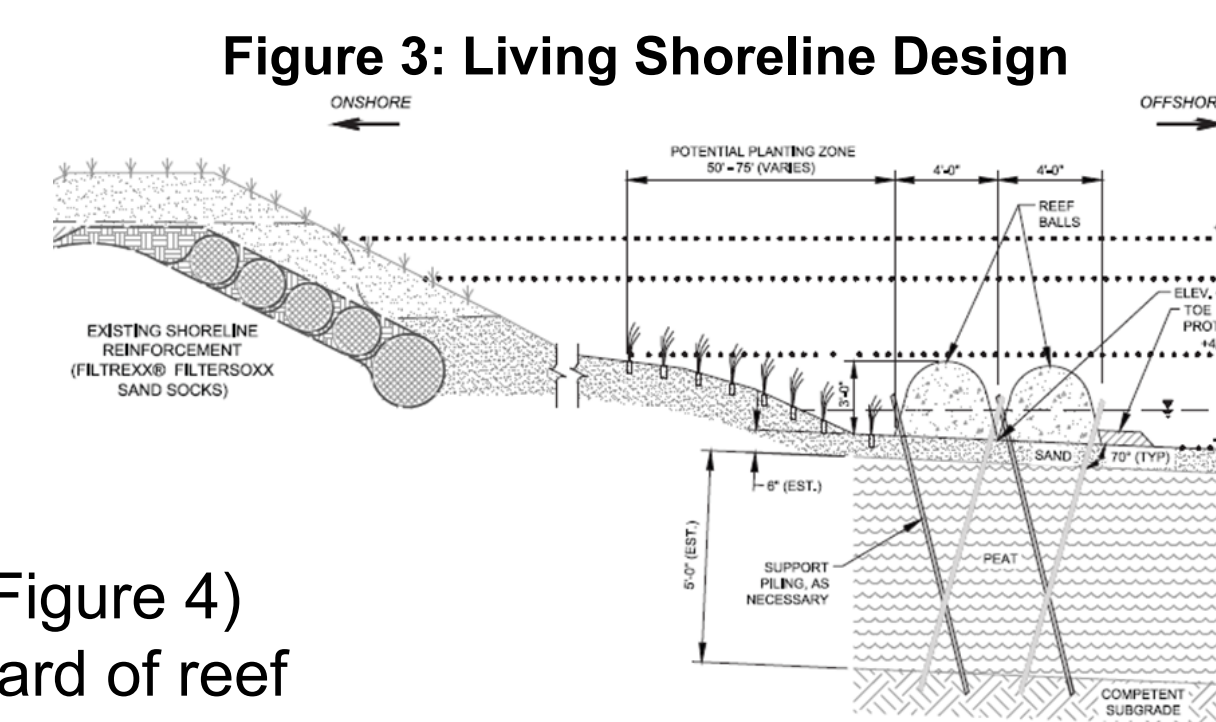
- 2 rows of pallet balls (Figure 3)
- Attenuation for design storms
 - 2-year: 74%
 - 5-year: 41%
 - 10-year: 32%
 - 25-year: 25%
- Located ~ 75 ft. seaward of MLW (Figure 4)
- *Spartina alterniflora* planted landward of reef

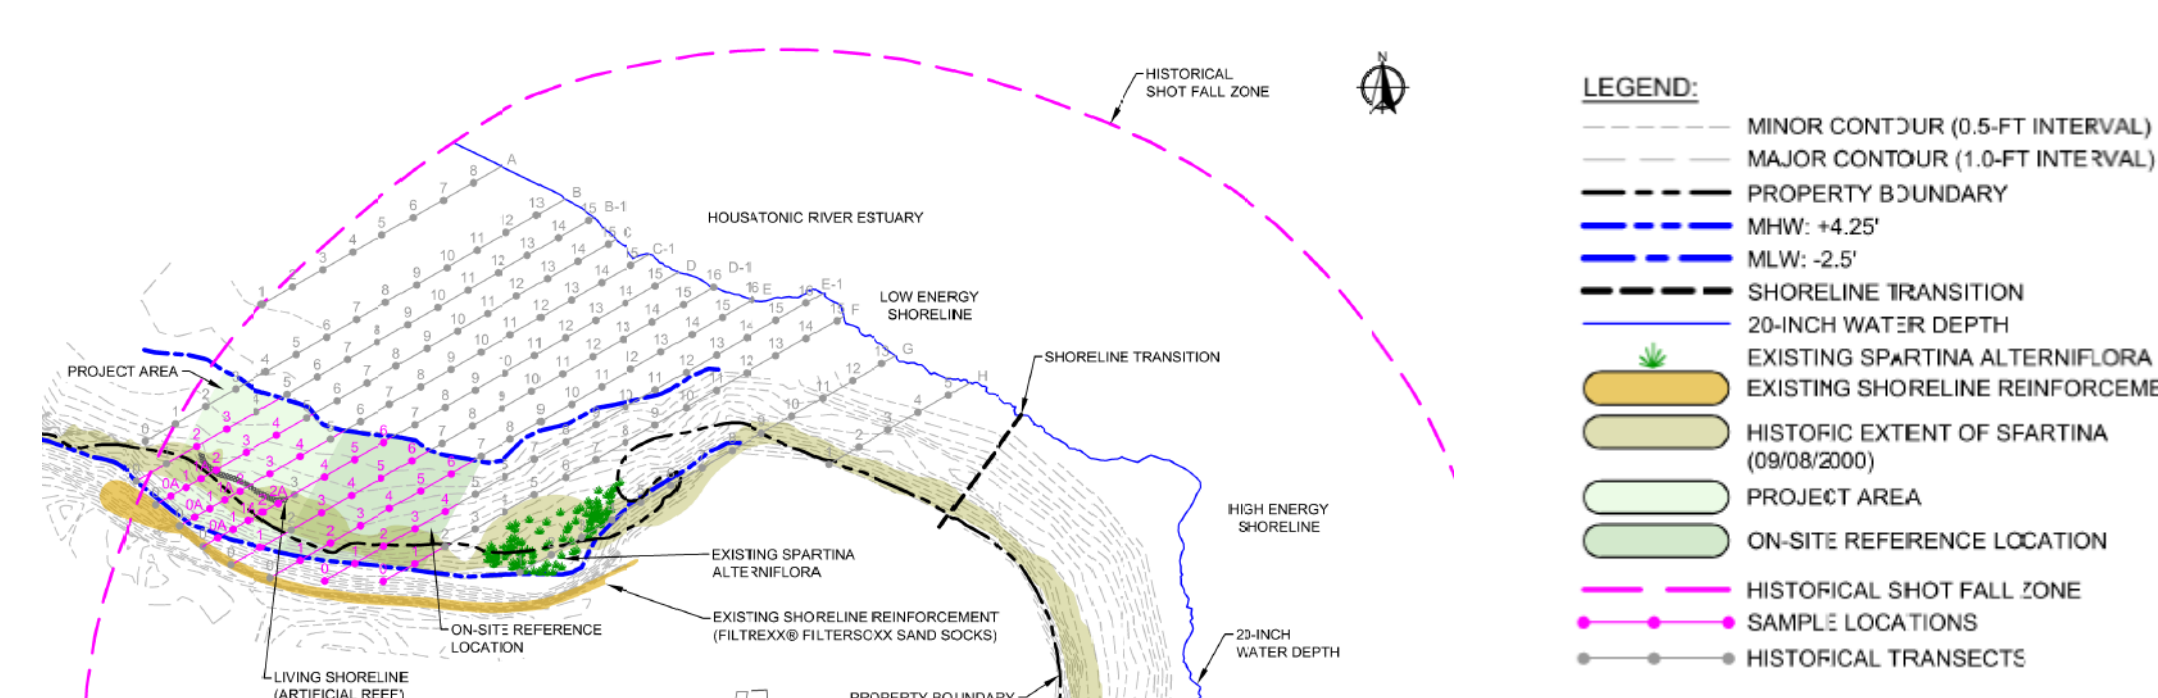
Figure 5: Monitoring Transects

- Build on historical site investigations to document change over time (Figure 5)
- Use an adaptive management framework to inform future actions

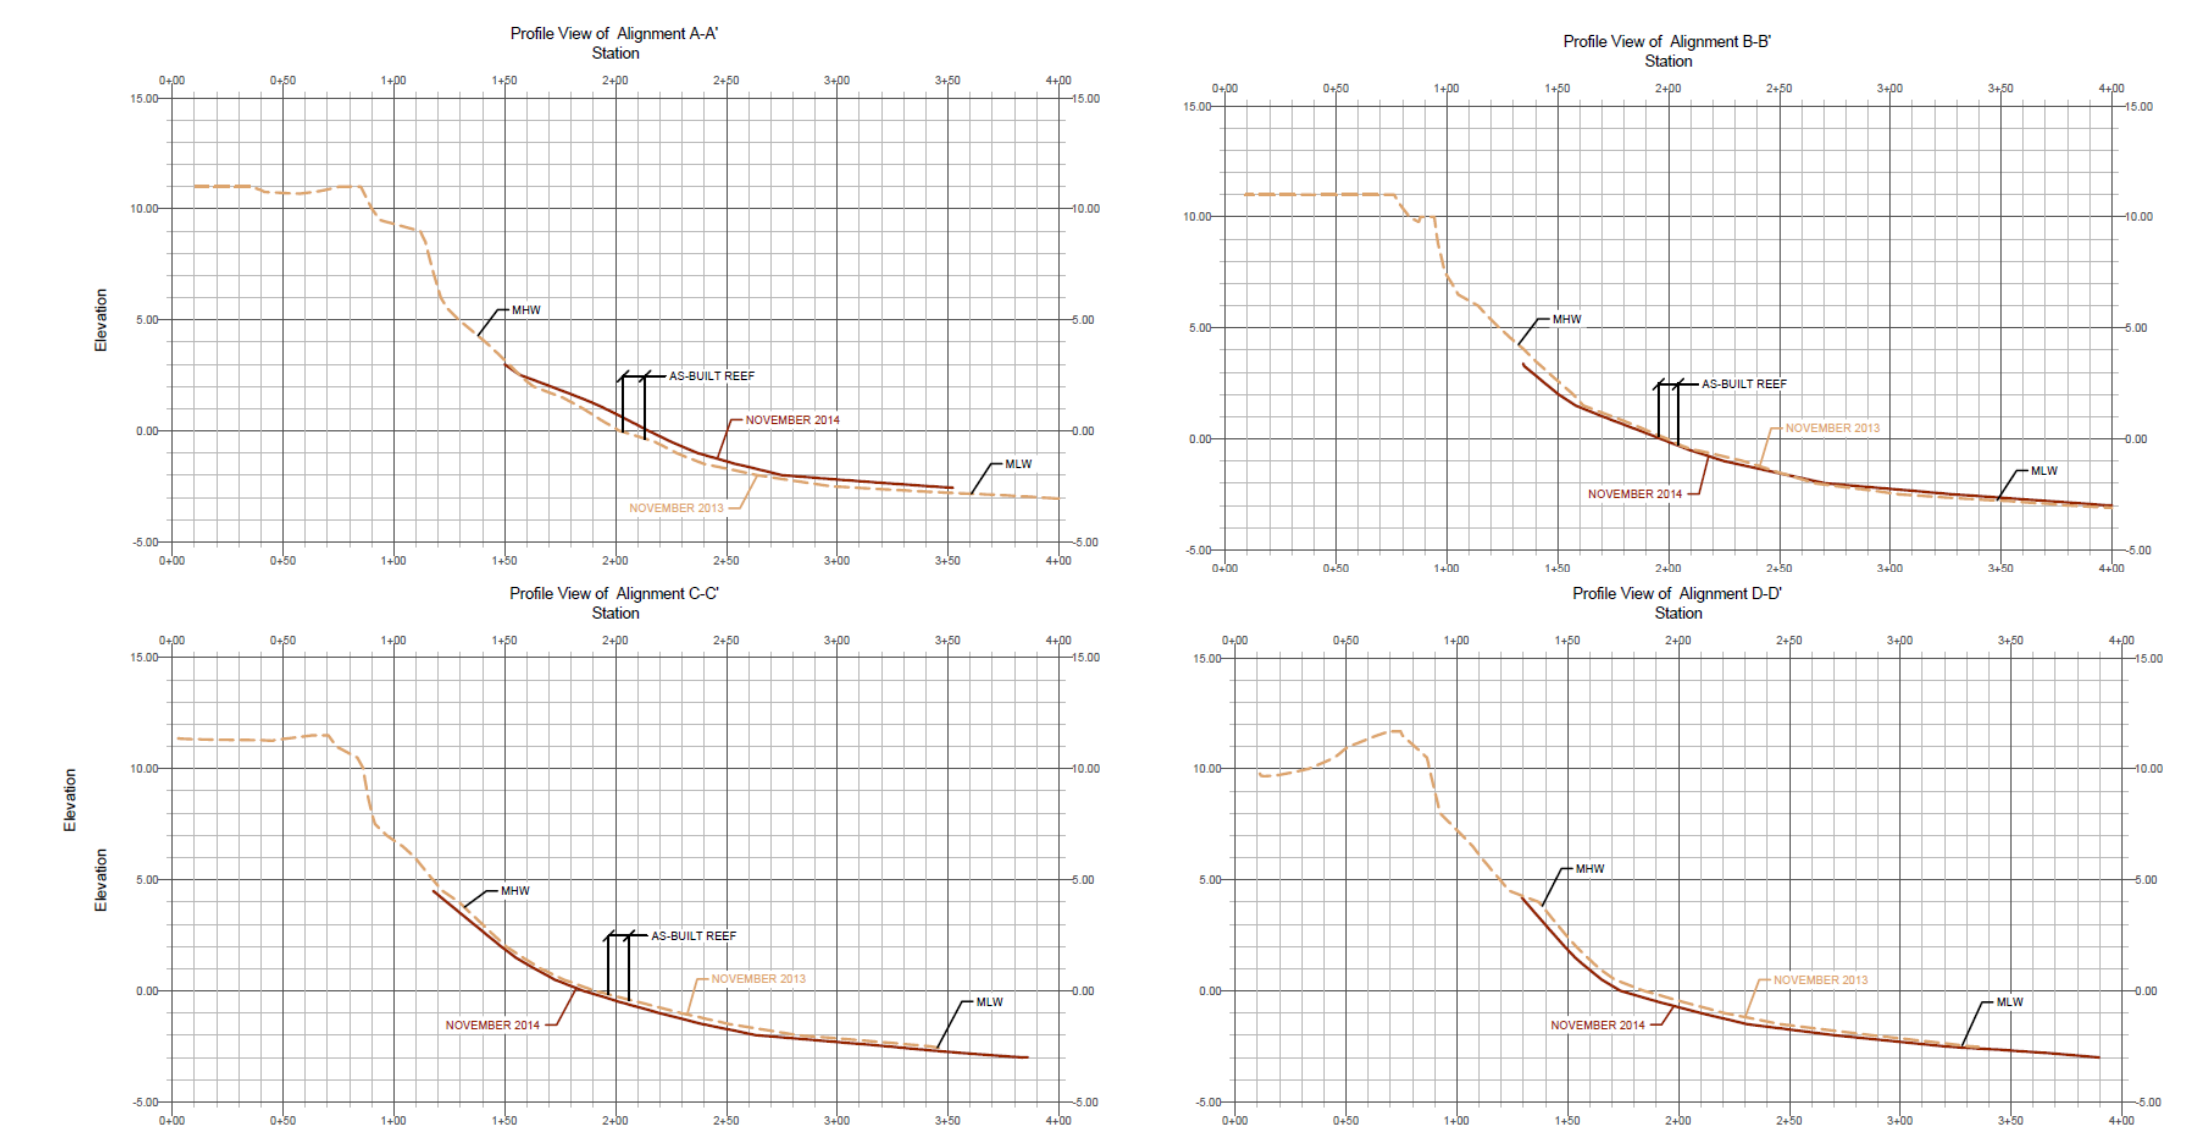
Figure 6: Change in Elevation

- Erosion (Figure 6)
- Lead shot density (Figure 7)
- Non-shot particulate lead concentrations in sediment
- Dissolved lead concentrations in interstitial pore water

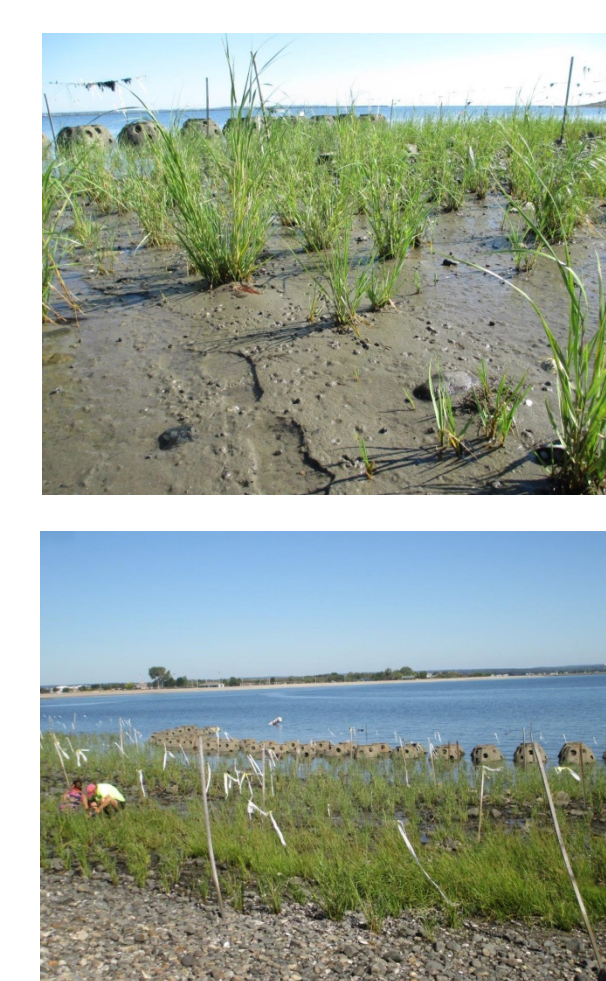
Figure 8: One Year Post-Construction

- No further erosion
- Accumulation of >6 in. fine grained sediment (Figure 8)
